Eisenhower Barracks at West Point

WEST POINT, NEW YORK

SUBMITTED BY STRUCTURAL, A STRUCTURAL TECHNOLOGIES COMPANY

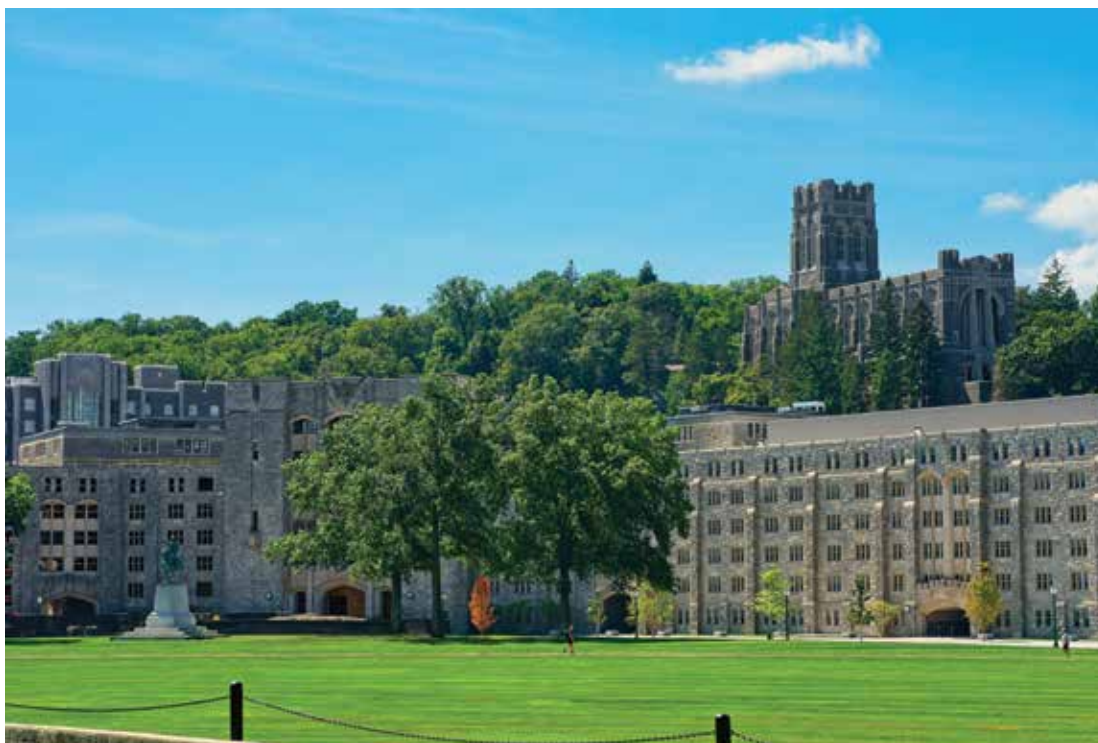
Fig. 1: Eisenhower Barracks

For five decades, the housing unit had served well under its current load and use; however, dramatic signs of deterioration began to appear. The overstress from heaving moment, punching shear, and localized beam shear caused cracking. The cracking, concrete delamination and spalling, and other aesthetic modifications adjusted the way the building reacted when supporting new loads. With the

Based on the evaluation, the primary task for the project team was to restore and strengthen the structure's load capacity. This included

strengthening six floors of slab with concrete repairs, penetration and crack infills, shear capitals, and CFRP installation. The renovation also included concrete repairs to the walls, ceiling, and beams, in addition to strengthening the beam's shear with CFRP.

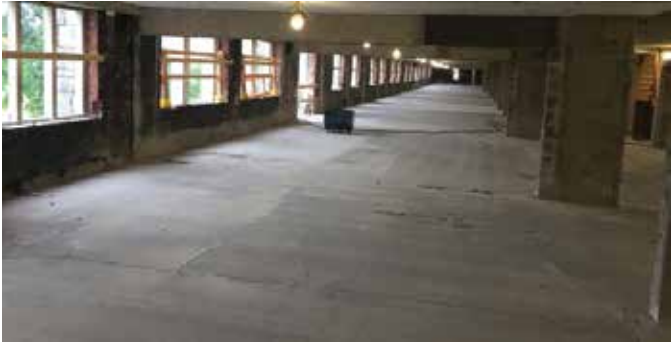
Fig. 2: Barrack slabs prepared by shotblasting before installing the crack infills and CFRP

Prior to demolition, the existing interior fixtures were completely removed by the general contractor. The project team utilized a laydown area and containment unit on-site. Then, crews hydro-blasted the column tops and shotblasted the slabs (Fig. 2 and 3). Ultra high-pressure hand lances were also used to create the required surface profile and strengthen the punching shear drop panels. Once the site was prepared for construction, the repairs started on the sixth floor and worked downward to the basement and were performed from ceiling to floor.

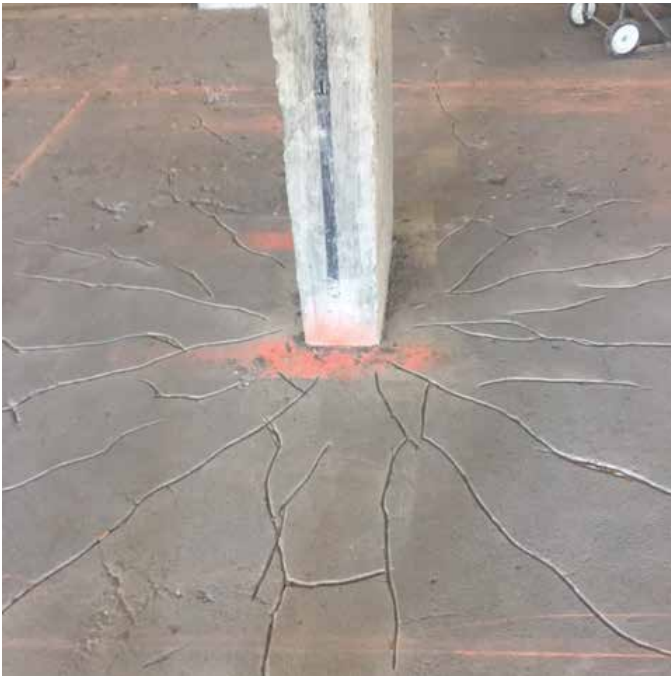
Fig. 3: Prepared slab around a column prior to installing the crack infill and CFRP

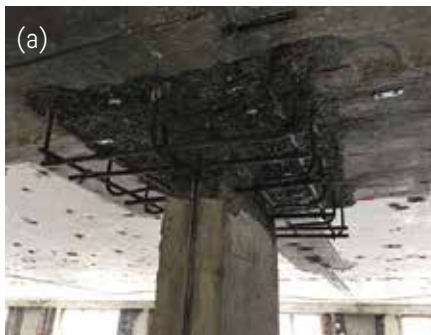
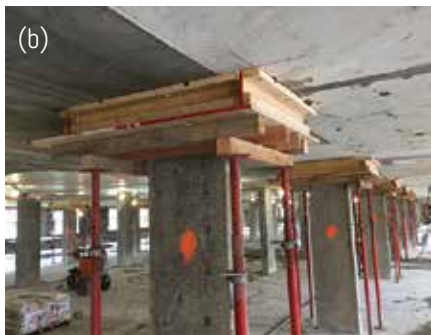
Fig. 4: Shear capital repair: (a) preparing and reinforcing the concrete surface, and (b) installed formwork prior to concrete pumping

The shear capitals were reconstructed not only by using a CFRP solution, but also incorporating formwork and utilizing versa pumps that put pressure on the shear capitals to ensure an integral bond between the new and existing concrete (Fig. 4). By utilizing the pressurized form and pump method of concrete placement for the overhead drop panels, structural integrity was restored.

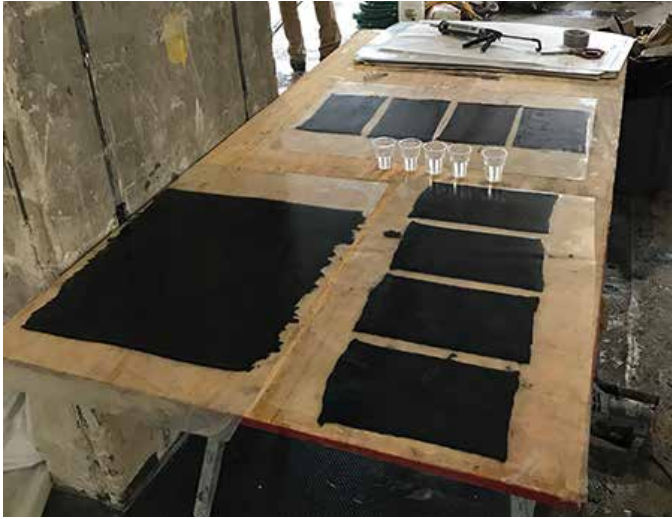
Fig. 5: Witness panels and epoxy resin cups for the QA/QC plan

Prior to installing the CFRP solution, standard QA/QC tests were conducted (Fig. 5). By setting and pulling bare concrete "pucks" on each floor, a map of all crack repairs was developed and updated daily to stay ahead of installation.

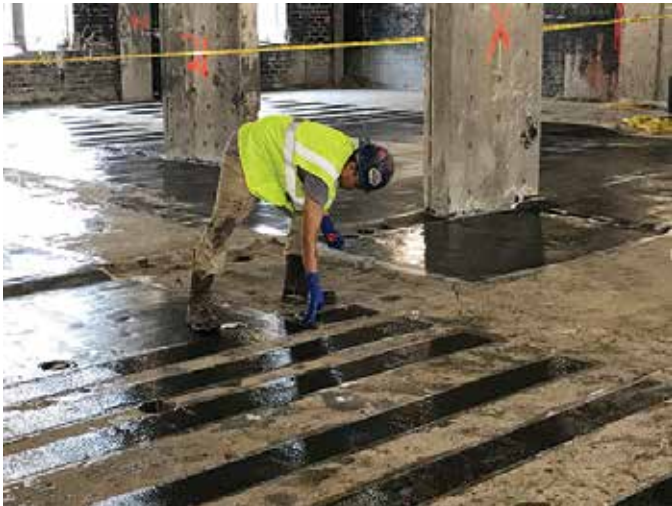
Fig. 6: Installing the final epoxy resin layer for CFRP (also performed to “knock down” any fiber edges)

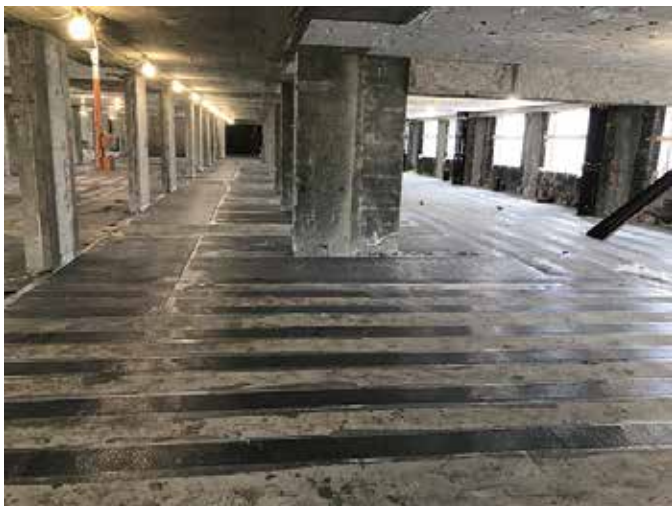
Fig. 7: The hallway and room slabs after the CFRP installation, focusing on the 8 in (200 mm) wide application

Once the strengthening work was complete, deteriorated wall and column slabs were restored and included over 2100 sf (195 sm) of spall repairs and crack, wall, and slab infills. Once everything cured, the CFRP was installed on the floor slabs, and included the installation of 8 in (200 mm) and 50 in (1270 mm) of CFRP (Fig. 7, 8 and 9).

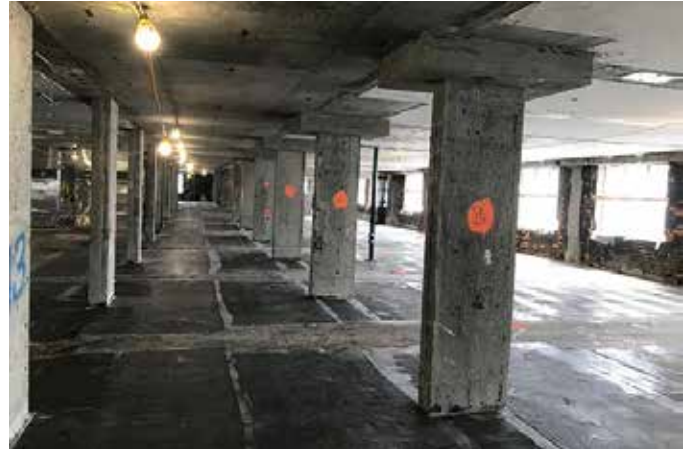
Fig. 8: The hallway and room slabs after the CFRP installation, focusing on the 50 in (1270 mm) wide application
