# Baltimore Garage Restoration

DETROIT, MI

SUBMITTED BY PULLMAN SST, INC.

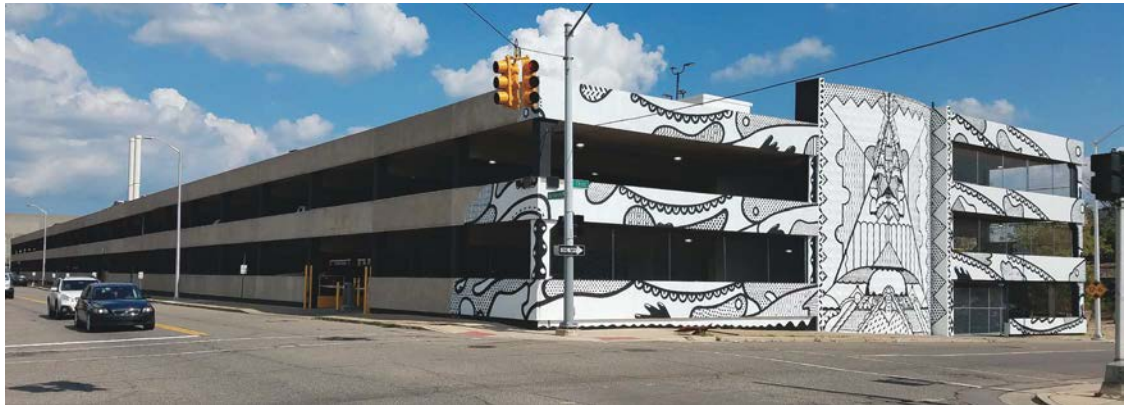
Fig. 1: Baltimore Parking Garage after repairs and showcasing a new exterior mural

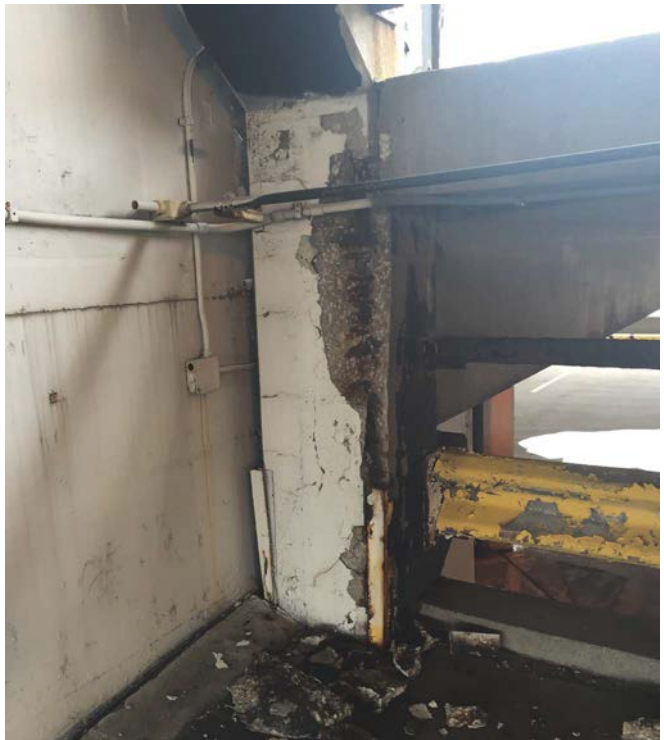
Fig. 2: Existing condition discovered at an interior column

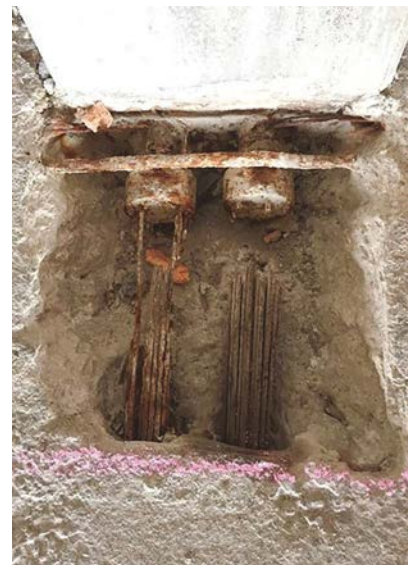
The assessment, conducted simultaneously with initial repair construction, identified a much larger number of severely corroded tendons than indicated by the preliminary visual assessment (Fig. 3). Initial structural analysis also indicated less 'add tendon' reinforcing of the end spans than provided by current design practice. This condition increased the number of slab PT repairs.

Fig. 3: Many beams were observed to have completely corroded through tendons

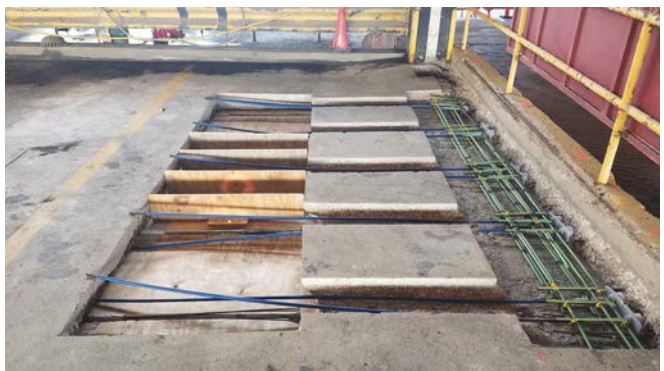
Fig. 4: Placement of new PT anchors

To develop an economic repair plan (as construction was continuing), the slab concrete was cored and tested to determine the in-situ concrete compressive strength instead of using assumed values. Then, an elasto-plastic finite element analysis was conducted for the slab. This advanced analysis utilized moment redistribution within the indeterminate structure, resulting in a more accurate (higher) calculated capacity of the structural system than provided by typical simplified elastic examination methods. Based on the results from the advanced investigation, 234 critical corroded tendon locations in the slabs were repaired to provide sufficient capacity to support the required loads (Fig. 4). This more precise repair plan saved the owner almost US \$1.2 million.

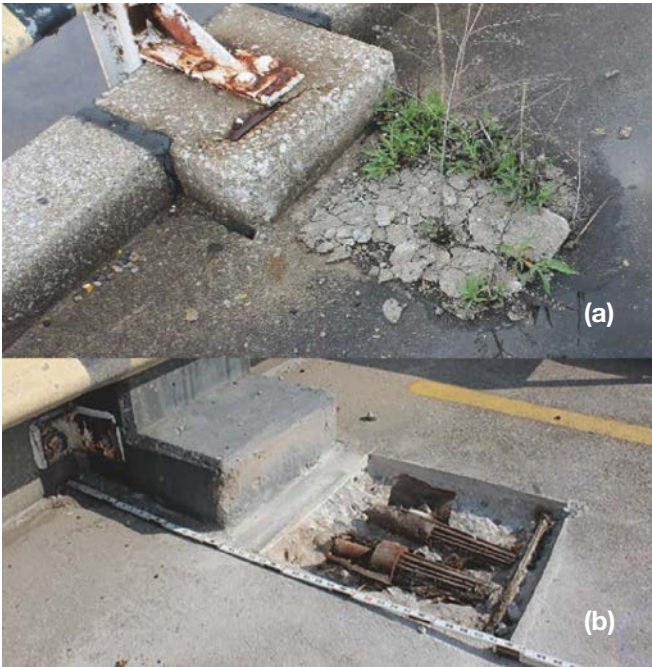
A total of approximately 130 precast single-tee beams are used to support the five elevated parking slabs. These beams are typically reinforced with eight ½-in (12.7 mm) diameter straight bonded prestressed and two draped twenty-wire unbonded post-tensioning tendons. The unbonded PT tendons exit the beam ends above the beam flange (within the concrete topping), where they connect to threaded anchorage rods that extend through the reinforced concrete columns to anchor at the outer face of the column. This anchorage system allows negative bending moment to develop at beam ends and provides structural integrity at the beam-to-column connections. The unbonded tendon ends and anchorage rods at the beam ends were encased within a shallow grout pocket, which were typically found to be cracked and debonded from the substrate (Fig. 5).

Unsound grout pockets in the beams were opened for inspection, and the unbonded wires were often found to be severely corroded, with a large proportion of wires completely failed. In-situ deflections of the beams were measured to correlate the condition of the tendons to the measured deflections of the beams. Based on the developed correlation, sound grout pockets at beams that exhibited a measured deflection exceeding the developed critical deflection threshold were opened for inspection, as well as beams that were next to slab drains (i.e. likely often exposed to ponding water), and beams that were located to adjacent distress. As a result, emergency shoring was provided for 20 beams and a total of 32 beams were repaired due to significant tendon section loss. The beam repair design was subject to multiple constraints, including structural integrity requirements at beam-column connections, fire-protection, and construction accessibility

Fig. 5: (a) Many grout pockets on the roof were delaminated and some had vegetation growing, and (b) Grout pocket after concrete removal and cleaning

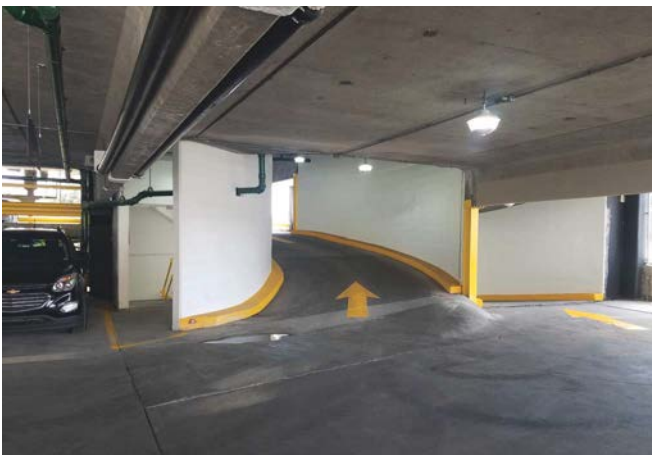
Fig. 7: Ramp and staircase area at end of construction

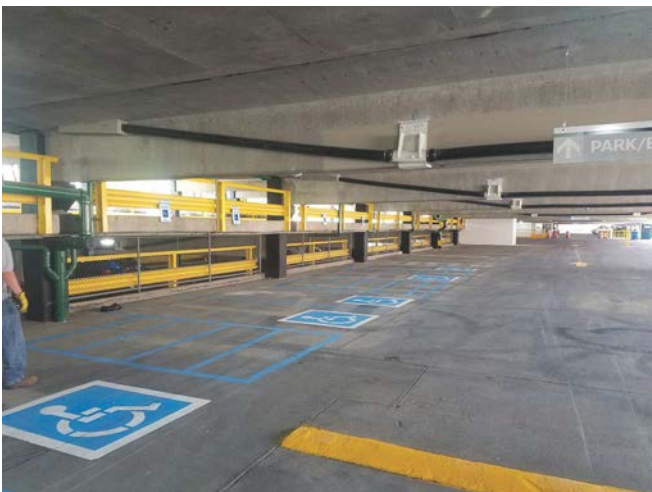
Fig. 8: Completed repairs to beams and columns, updated drainage system, and painting observed during final project walkthrough

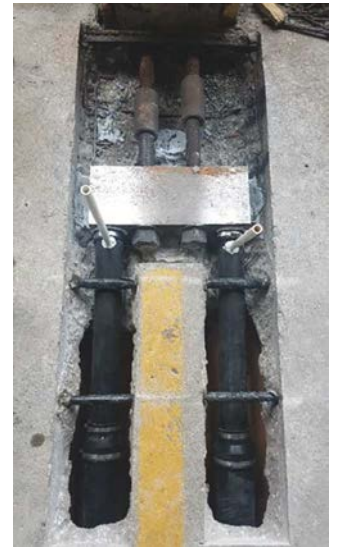
Fig. 6: External PT beam repair prior to running tendons through conduit

constraints, along with financial and scheduling concerns. Evaluating many repair options, it was decided to abandon the existing failed tendons and replace them with two external draped tendons (each consisting of four 0.6-in [15.2 mm] diameter strands) placed symmetrically on both sides of the beam web. The new external tendons were connected to the existing threaded anchorage rods and post-tensioned from the top side (Fig. 6). The external tendons were also embedded in HDPE conduits that were fully grouted to comply with fire-resistance requirements. To further extend the life of the beams and structure, the water management system was repaired to ensure no standing water would occur on the concrete deck. To protect the existing and newly installed PT tendons, waterproof membranes were installed over anchorage zones.
