# 10 and 120 South Riverside Plaza Overbuild Restoration

Chicago, IL

Submitted by Carl Walker, Inc.

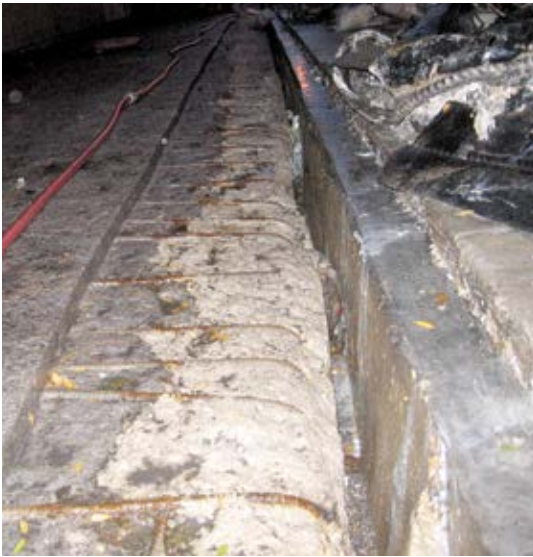
The existing plaza was deteriorated and the waterproofing system was 23 years old and in poor condition. The plazas exhibited widespread leaking, particularly at the expansion joints, drains, and other

*Example of deteriorated expansion joint*

Hot-applied waterproofing was selected to accommodate the variety of existing conditions, configurations, and overburden systems. Perimeter expansion joints, which were previously installed a few years prior due to a prioritized phasing approach, were designed with an integral gutter system to accept and control water. They were also designed with a removable concrete bulkhead to allow subsequent installation and tie-in of the new plaza system without affecting the expansion joint itself.

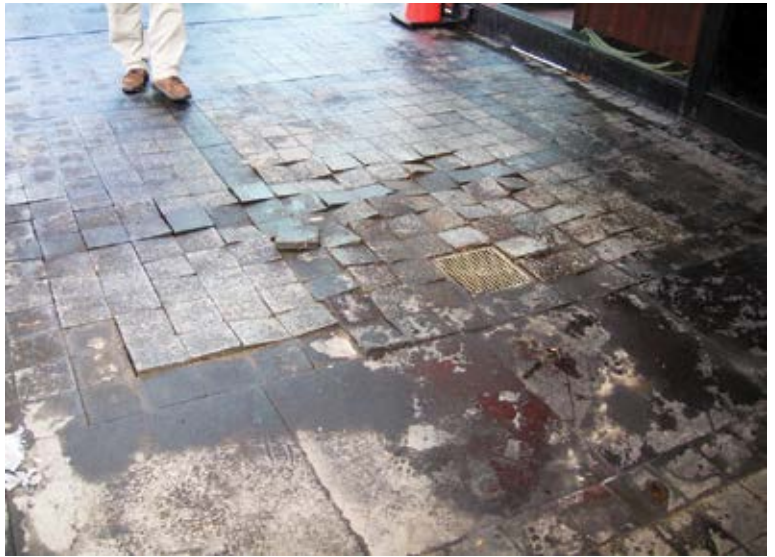
Poor drainage characteristics at the plaza level caused frequent buckling of the paver system during winter freeze-thaw cycles, resulting in uneven walking surfaces. Existing planter walls were also deteriorated due to 23 years of leaking and chloride exposure.

*Poor drainage and improper slopes caused widespread deterioration*

Precast concrete pavers on a pedestal support system were used to address difficulties in providing adequate surface drainage in limited-depth conditions and eliminate ponding on the surface.

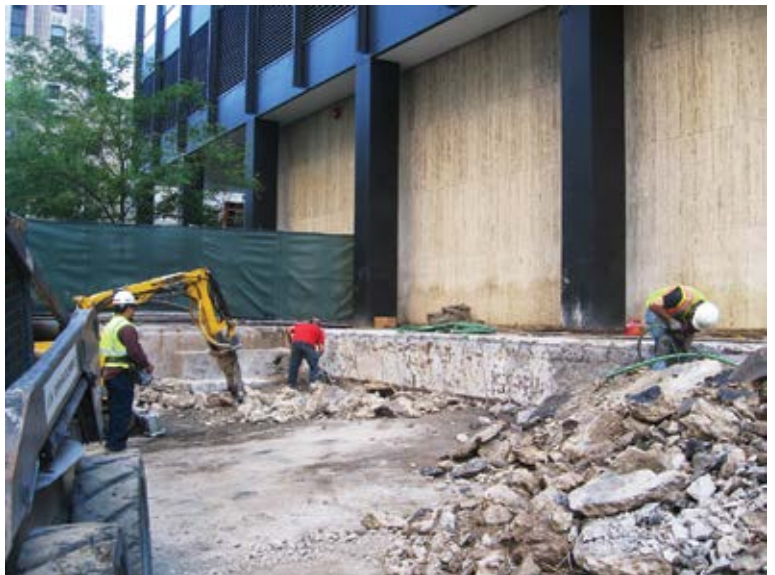
*Repairs were designed with a removable concrete bulkhead*

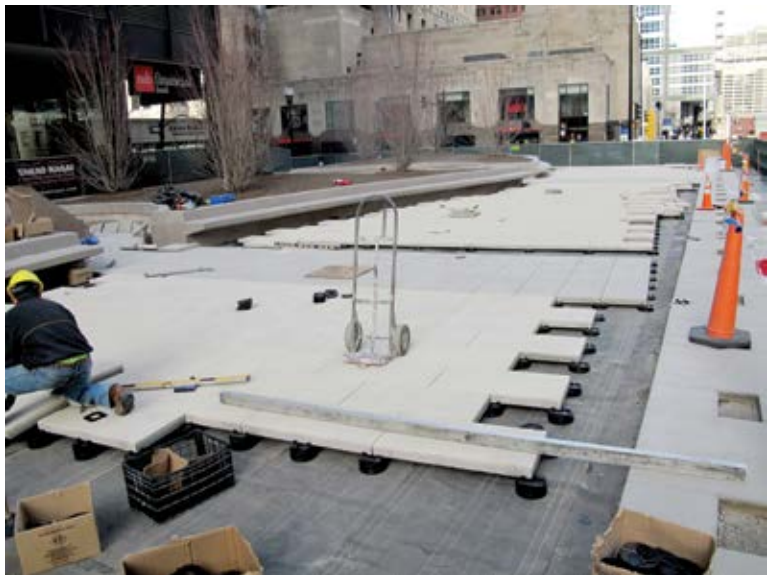
*Precast concrete pavers on pedestal support system*
