FINALIST - 2017 PROJECT OF THE YEAR

Chase Field Repairs

PHOENIX, AZ

SUBMITTED BY GERVASIO & ASSOCIATES INC.

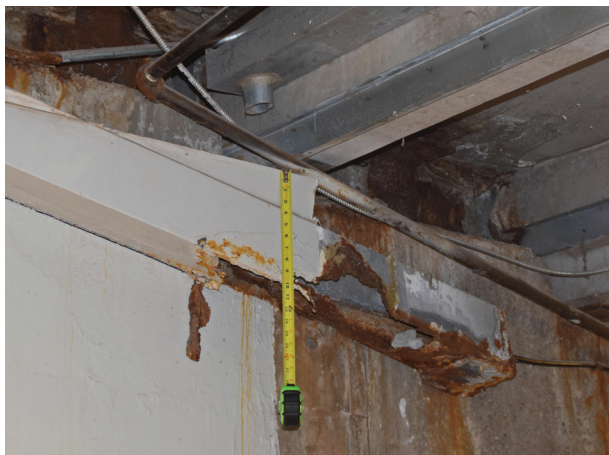
Although the original design did not include waterproofing, it did include an extensive “rain gutter” system beneath the precast joints to collect water if joints leaked, diverting it into uninhabited spaces (Fig. 2). Because leaking water never created a “problem” (or puddle) on the floor, the full extent of the leaking was not recognized, but there were efflorescence stains on the columns and raker beams. Further investigation and implementation of repairs led to discovery of the full corrosion extent. Evaluation and testing methods utilized visual evaluation; hammer sounding; ground-penetrating radar (GPR); destructive investigation; petrographic examination; chloride and carbonation testing; and air entrainment, density, and compressive strength testing.

Fig. 2: Bottom side of seating riser at support—seating riser bearings and seismic restraint plates are visible on the bottom side. Moisture penetration through building expansion joint into mineral wool (each side of L-shaped plate) resulted in severe corrosion. Rain gutter system completely corroded through as it enters uninhabited space.

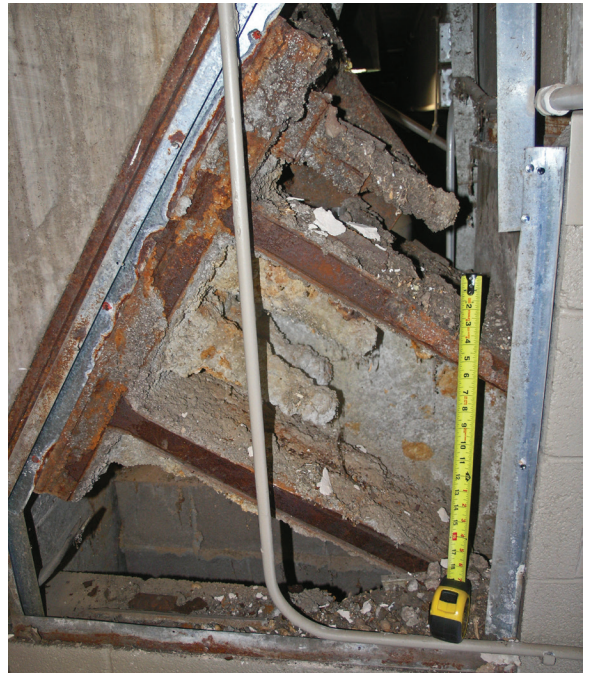
Repairs were located in areas requiring up to 3-hour fire ratings. The original fireproofing (spray applied cementitious, or mineral wool), absorbed moisture, never drying out, while holding it against structural elements, thereby promoting corrosion (Fig. 3-5). Repairs included intumescent epoxy coating (1/4 to 1/2 in [6 to 13 mm] thick waterproof epoxy) on all steel raker trusses and threaded rebar anchors to achieve the required 3-hour fire rating (Fig. 6). Instead of moisture-absorbing mineral wool, fire rated building-expansion joints or intumescent tape were used at precast caulk joints to achieve floor-floor fire ratings. A standard UL rated fire caulk assembly was not possible because the bottom side of the joint was over the concrete raker beam/wall and inaccessible.

Fig. 3: Raker truss tieback anchor—connection between steel raker truss and concrete frame with sixteen 1-3/8" (35mm) diameter high strength threaded rebar anchor rods. Connection is completely hidden between two masonry walls in a dead space with leaking precast joint directly above. Spray-applied fireproofing absorbs water and never dries out.

high-strength threaded rebar. Sixteen threaded anchor rods are embedded into concrete columns and raker beams to transfer the 200,000 lb (90,720 kg) tension force from the steel raker truss to the concrete. The raker truss and tieback connections are concealed in a small inaccessible “dead space,” with leaking precast caulk/building-expansion joints directly above. Spray-applied fireproofing absorbed moisture, never drying out, causing severe corrosion.

The upper seating level has 32 tieback connections. All locations were investigated, prioritized, and 19 locations have been repaired. None of the anchor rods had experienced enough corrosion yet that repairs were required to restore the rod’s tensile strength. Severely corroded nuts required replacement.

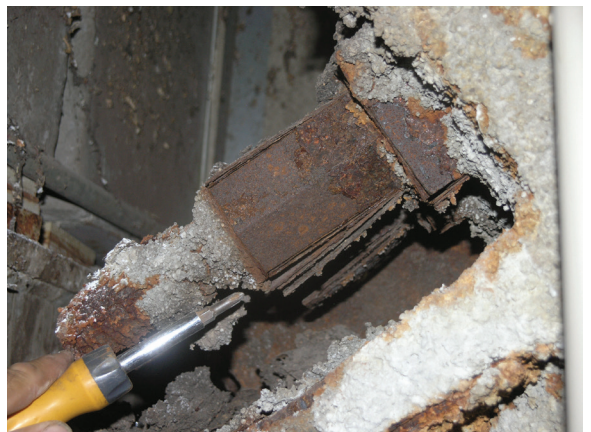
Fig. 4: Threaded rebar anchor nut—Severe deterioration of the nut. Corrosion of the threaded anchor rod is not visible due to fireproofing and debris.

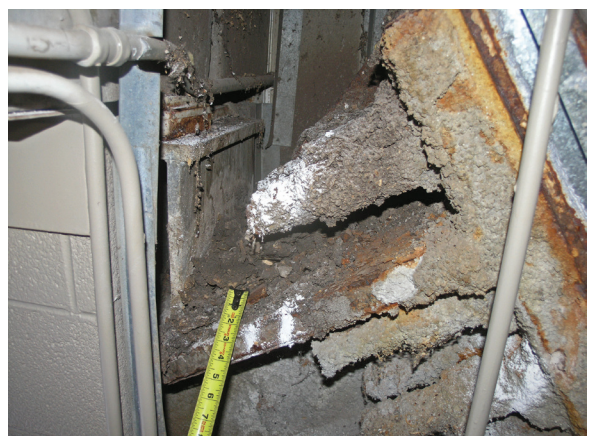
Fig. 5: Threaded rebar anchor—large mound at end of tape measure is peanut shells and debris washed through failed joint above.

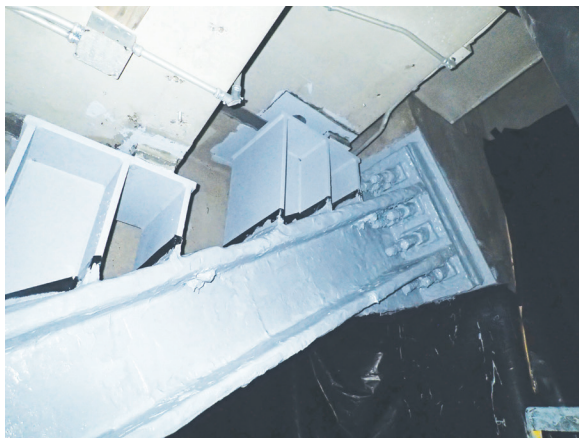
Fig. 6: Raker truss tieback anchor connection—completed repair with epoxy intumescent fireproofing to achieve 3-hour fire rating and provide corrosion protection to the beam and threaded rebar anchors.

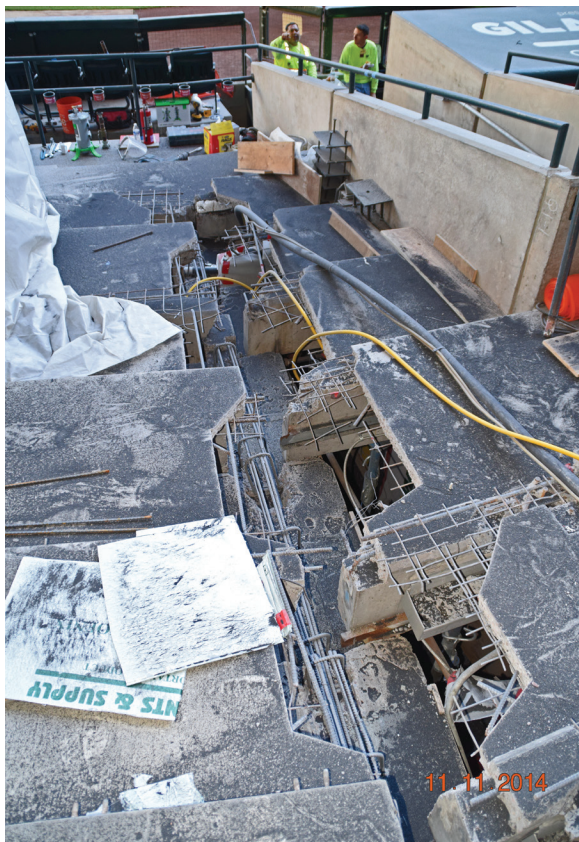
Fig. 7: Precast joint repairs—typical example of demolition required to repair the joints between the precast seating sections. Seismic restraint plates have been completely removed for replacement. Bearing repairs for stems have not started. Nearly every row was affected.

Precast is supported by typical embedded plates at bearings. Bearing plates in precast members, steel shims, and bearing plates in supporting members experienced various corrosion levels. Repairs varied from simply sandblasting exposed surfaces of the bearings and epoxy coating, to chipping out both precast and supporting members, replacing bearing plates/pads, re-pouring, sandblasting/epoxy coating exposed surfaces, and recasting (Fig. 7).

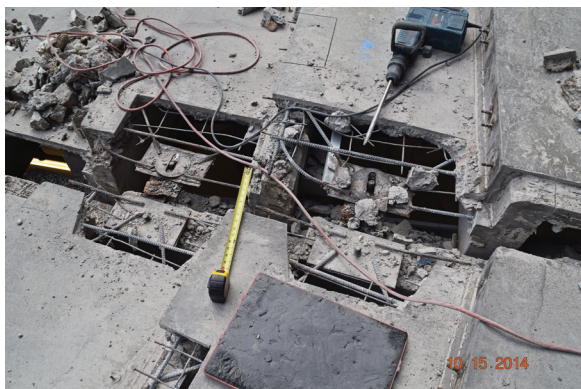
To restrain seismic loading, large epoxy-coated steel embed plates, cast into the seating riser’s horizontal portion directly adjacent to transverse joints, deteriorated severely (Fig. 8 and 9).

Fig. 8: Typical Precast Joint Repairs—Water leaking through building expansion joint between precast seating sections was absorbed by mineral wool fireproofing in the joint, resulting in severe deterioration. Large steel plates are seismic restraints.

Building expansion joint repairs utilized pre-compressed silicone-impregnated foam expansion material providing a long-lasting waterproof joint, with walking surfaces suitable for high-heeled shoes without metal cover plates.

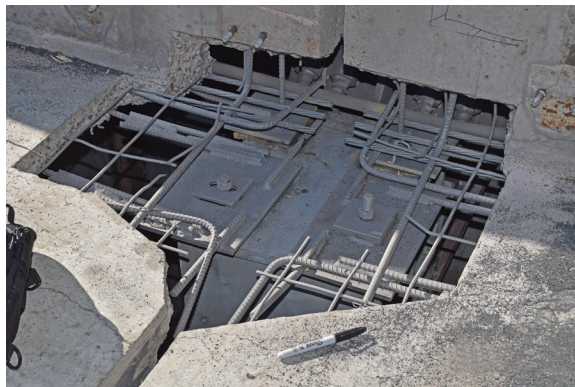
Fig. 9: Typical precast joint repairs—seismic restraint plate (embed with bolt) and precast bearing seat assembly (below prestressing strands) after existing plates replaced, rebar welded back, and sandblasted prior to epoxy coating and pour back.

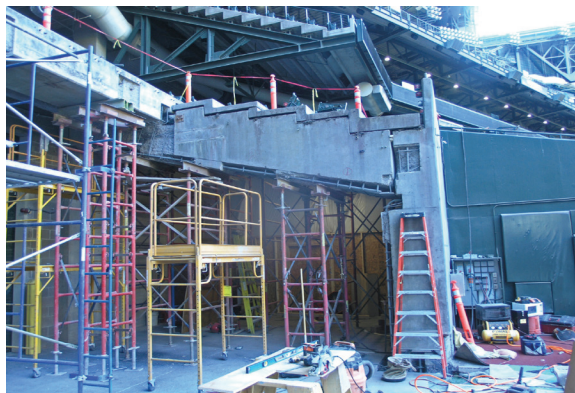
Mobility of this seating riser results in large joints where it butts into the adjoining precast. Years of wash-down resulted in severe deterioration of adjacent concrete beams and columns. Investigation revealed spalling and loss of corbel ties directly under a large girder bearing. This required emergency shoring to support the 45,000 lb (20,410 kg) load throughout the season until off-season repairs (Fig. 10).

Fig. 10: Elephant Trunk Door Repairs—Water leaking between the door and precast resulted in severe corrosion, requiring emergency shoring during the baseball season.
