WATER SYSTEMS CATEGORY

Chats Falls Generating Station

FITZROY HARBOUR, ONTARIO, CANADA
SUBMITTED BY KING PACKAGED MATERIALS COMPANY

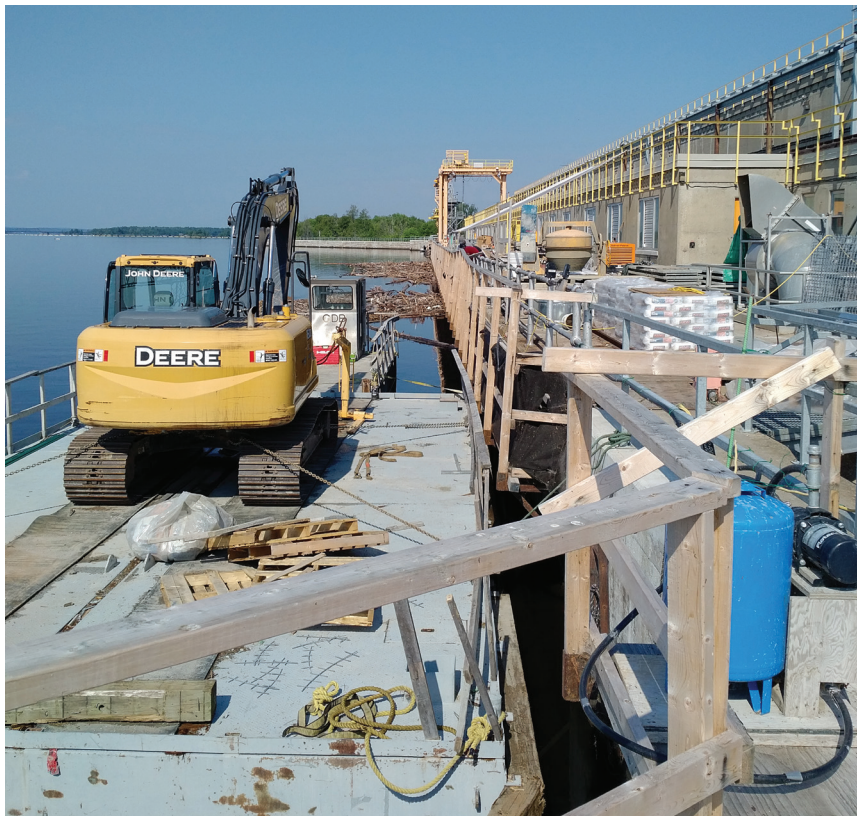
Fig. 1: Barge and deck

had to be transported across the Ottawa River. The majority of the river crossings were made by boat and barge (Fig. 1); however, during periods when the spillways were open, some of the materials and equipment had to be transported by helicopter (Fig. 2). While work was being performed on the Quebec side, workers on the project had to travel back and forth daily from the staging area to the work stations using boats.

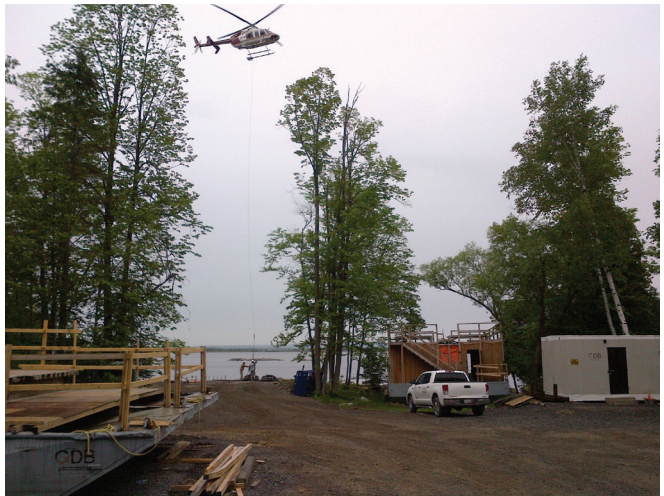
Fig. 2: Helicopter transports materials and equipment

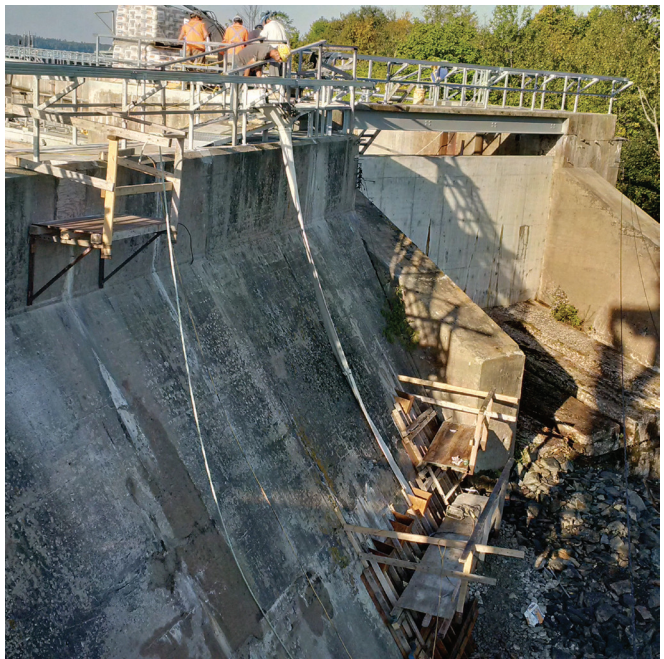
Fig. 3: Placing concrete into wall forms

The downstream vertical walls were formed and placed with a high performance, pre-packaged, self-consolidating concrete (SCC) mix to provide low shrinkage, low permeability and good compatibility with the existing concrete (Fig. 3 and 4). The 26 in (650 mm) slump flow of the SCC provided a fluid mix without bleeding or segregation. The forms were left in place for a minimum of 7 days for curing. Since there were many large repair sections, it was important to protect the repairs from water evaporation to reduce the potential of shrinkage cracking and to ensure the durability of the repaired concrete. The horizontal top slab of the dam was placed with a high performance, pre-packaged, concrete mix to provide low shrinkage, low permeability and good compatibility with the existing concrete (Fig. 5 and 6). The concrete was trowel finished with magnesium trowels. In total, over 28,250 cf (800 cm) of concrete was replaced.

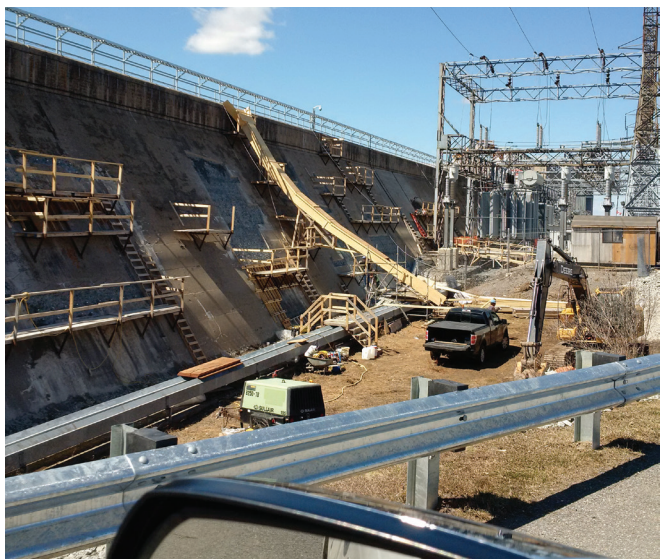
Fig. 4: Concrete formwork

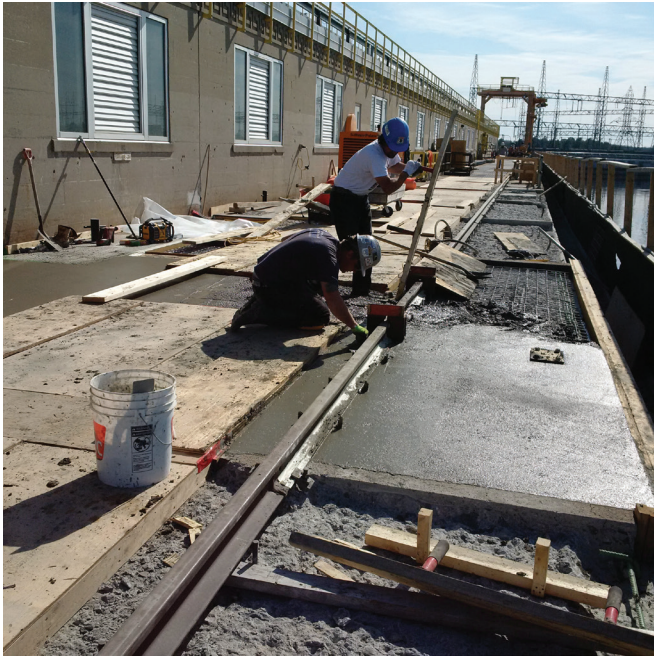
Fig. 5: Finishing deck concrete

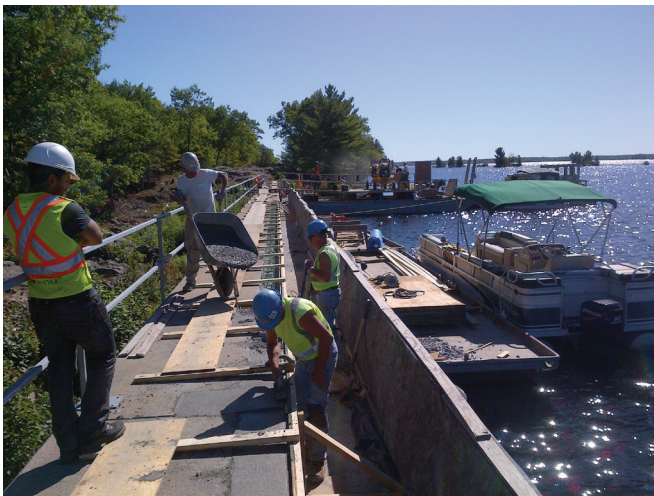
Fig. 6: Placing deck concrete
