HISTORIC CATEGORY

# Child's Restaurant at Coney Island & Seaside Park

NEW YORK, NY  
SUBMITTED BY PULLMAN

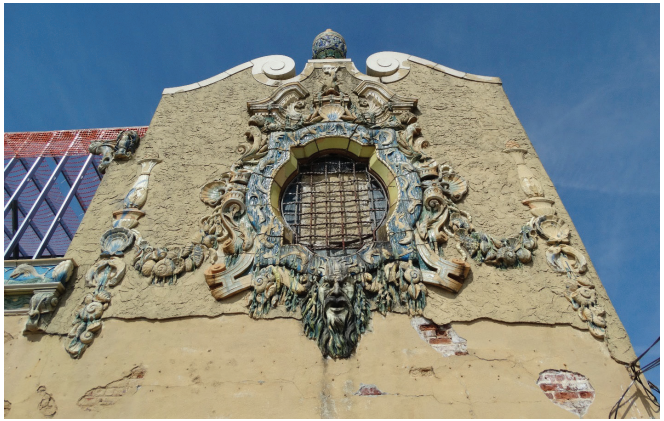
Due to the building's close proximity to the ocean, it has been highly affected by corrosion, erosion, biological growth, and freeze/thaw cycles. The result of the water effects was most prominent on the ornamental terra cotta pieces and stucco on the exterior walls, where erosion and biological growths caused the glazing to shake off the terra cotta bisque itself (Fig. 2). In addition, the western wall acted as a firebreak for a massive multi-block fire in 1932. The physical damage to the brick required the removal and replacement of the exterior wythe of brick. Salvaged common brick with similar physical properties was located and installed—reclaimed brick from Detroit was used that closely matched the moisture content and firing of the original brick for seamless integration.

Fig. 2: Water damage of ornamental terra cotta pieces

The terra cotta was also affected by biological growth and modifications to building openings to accommodate changes in use. Although many pieces were suitable for reuse, new cartouches, rondels and window and door surrounds were required. Existing pieces were removed from the building and sent as models for reproduction of color and sculpture. The original backup masonry walls were removed and rebuilt with salvaged common brick to their original five wythe widths. The sophistication and humor of the installation became apparent within the terra cotta pieces. Photographs from a 1924 *American Architect* article were extremely helpful in determining some of the very subtle differences in what appeared to be identical ornamentation.

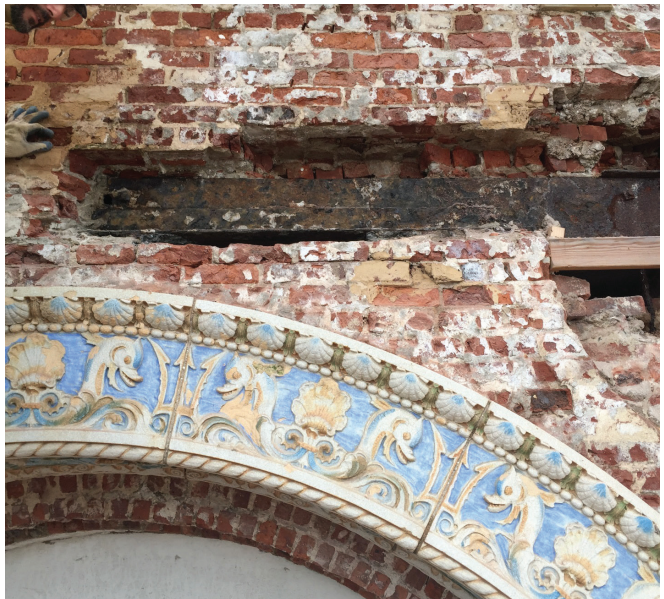
A layer of incompatible 1960s stucco was removed from the south and east walls along with all asbestos-containing waterproofing materials, resulting in the discovery of numerous cracks related to deteriorated steel roof framing and miscellaneous steel installations including lintels. All of the façade steel had to be either repaired or replaced. Three cartouches surrounding the window openings on the corners of the building suffered the effects of steel deterioration from both the lintels and the decorative grilles (Fig. 3).

Fig. 3: Steel deterioration near window openings

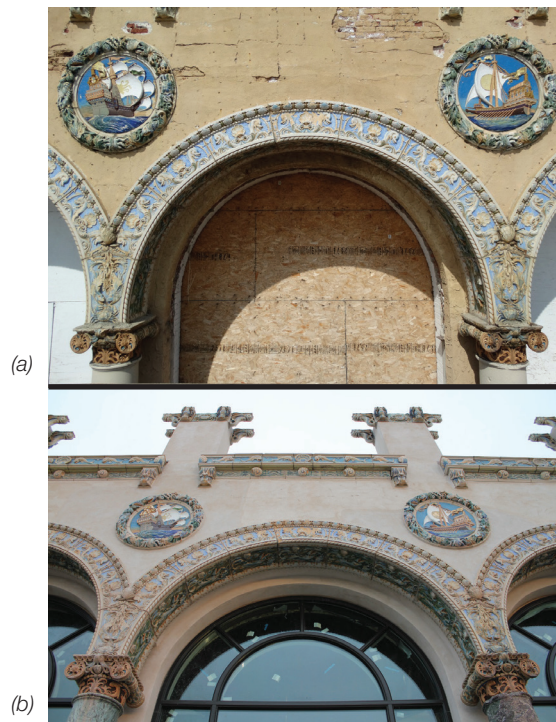
Fig. 4: (a) Terra cotta detail before, (b) and after

Each of the medallion infill pieces had a gold luster glaze. Thirty-six glazes were developed from over 600 samples and a total of 752 new pieces were replicated for the building; 102 were salvaged and reset, and 171 were repaired on site. Extreme care was taken to match the original as closely as possible (Fig. 4). The assemblies were also laid out onsite in the yard and fit with other components such as the window grilles and plywood templates of openings to aid in proper placement and dimensional tolerances for each piece in an assembly (Fig. 5). Highly damaged terra cotta stones were replaced with newly replicated ones. The replication process began with printing a model of the original piece from a CNC machine which allowed a mold to be cast around the model. On-site, the pieces were carefully installed with modern stainless steel anchors and tied

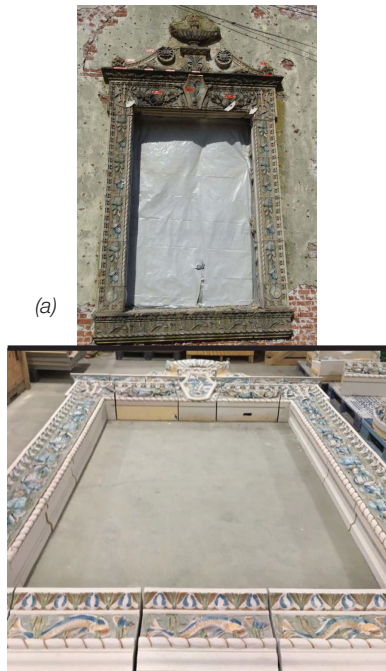
Fig. 5: (a) Original window before, (b) and window replica

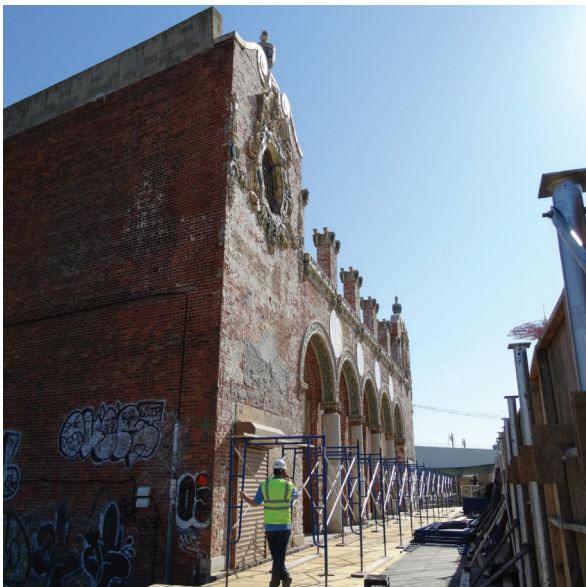
Fig. 6: Scaffolding was erected and re-erected numerous times throughout the project

On several occasions, scaffolding had to be built, worked on for several weeks, and then dismantled to make way for another critical path item—only to be rebuilt right after to continue the exterior work (Fig. 6). Custom scaffold towers were built to lift up to 950 lbs (430 kg) terra cotta units in place. The overall job was performed on traditional pipe-frame scaffolding.
