2020
AWARD OF
EXCELLENCE

Rehabilitation of 30-Year-Old Monolithic Salt Dome

SAVAGE, MINNESOTA

SUBMITTED BY VECTOR CONSTRUCTION, INC.

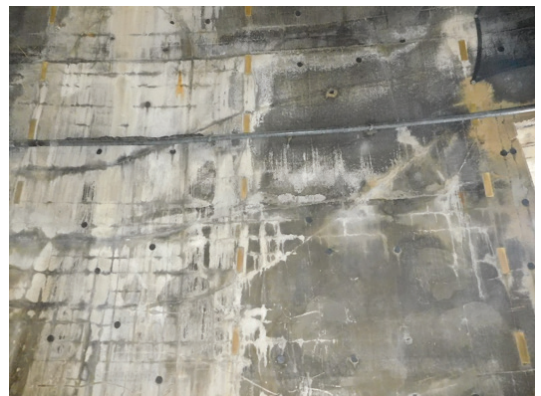
- Widespread shadowing in shotcrete behind reinforcing (Fig. 4);
- Chloride contamination and carbonation, and a loss of alkalinity due to exposure to atmospheric carbon dioxide, progressed along the cracks causing localized corrosion that severed the steel reinforcement;
- Water infiltration and increased humidity around the skylights and penthouse structure on top of the dome, combined with chloride contamination at the level of the reinforcement, caused localized corrosion-induced concrete spalling and delaminations; and
- Exposed and corroding post-tension anchors, poor concrete consolidation behind some anchors, and complete loss of prestress in all tested tendons (Fig. 5).

Fig. 4: Shadowing of shotcrete created voids behind welded wire fabric reinforcement and post-tensioned tendons

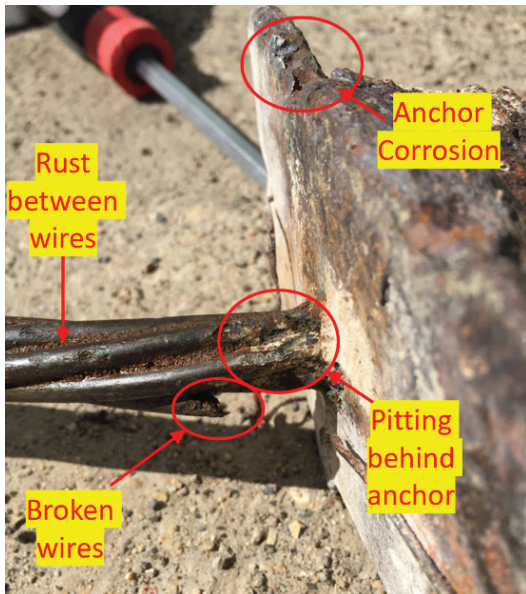
Fig. 5: Condition of extracted post-tension anchor and tendon

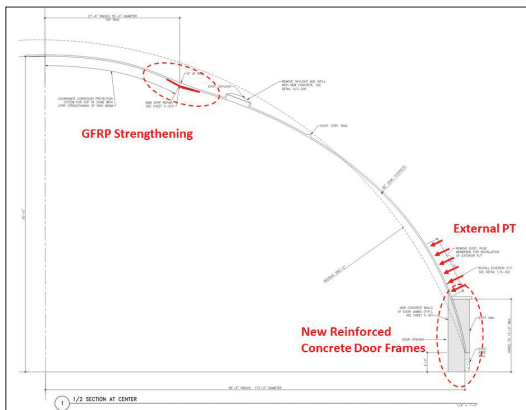
The structural engineer performed a finite element analysis utilizing the data collected from the laser survey and assumed complete loss of tension in the PT system. This information was critical to developing an appropriate repair/strengthening solution (Fig. 6).

Fig. 6: General strengthening plan including GFRP and external post-tensioning

- Removal of conveyor loads;
- Repair of spalled and delaminated concrete utilizing ICRI 310.1R¹, Guide for Surface Preparation for the Repair of Deteriorated Concrete Resulting from Reinforcing Steel Corrosion;
- Removal of skylights and filling in cavities to eliminate locations for potential water leakage from the exterior;
- Inject and bond/seal larger vertical cracks with low viscosity epoxy resin and strengthen with strips of glass fiber reinforced polymer (GFRP) applied to the concrete surface across the cracks;
- Removal and replacement of post-tension tendons between the doors;
- Casting of new doorjamb and eyebrows;
- Installation of external post-tensioning above the eyebrows (Fig. 7) with pilaster encasement of post-tension dog-bones; and
- Application of surface-applied GFRP strengthening at the top of the dome around stiffener ring (Fig. 8) and over epoxy-injected cracks.

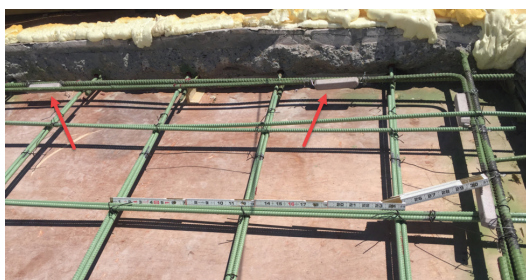
Fig. 9: Type 1A embedded galvanic anodes were installed in traditional concrete repairs and skylight closure pours

- Discrete galvanic anodes were placed at the perimeter of all concrete repairs and around the interface between the new and old concrete where the skylights were infilled (Fig. 9);
- Distributed alkali-activated galvanic anode strips were used in reconstructed doorjamb and eyebrows at the interface between new and old concrete, and to address the potential for new corrosion activity at these construction joints; and
- Surface-applied zinc anode sheets were installed around remaining penetrations into the dome (conveyor locations, etc.), connected to the embedded reinforcing steel and covered with the newly-applied roofing system.
