# Garage Repairs at Wynford Tower

TORONTO, ONTARIO, CANADA

SUBMITTED BY SENSE ENGINEERING, LTD

35 Wynford Heights Crescent, Toronto, Ontario, Canada

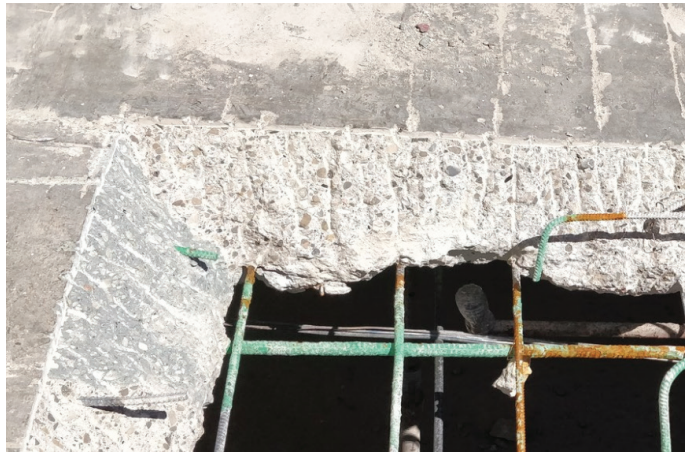
The garage podium slab, although protected by a membrane since original construction, and having been previously repaired (Fig. 1), had widespread leakage and soffit deterioration visible from the underside. A test excavation through the overburden revealed that the membrane had lost its elasticity, a clear sign that it had reached the end of its useful life.

Fig. 1: Existing reinforcing steel corroded at the edge of a previous repair (incipient anode effect)

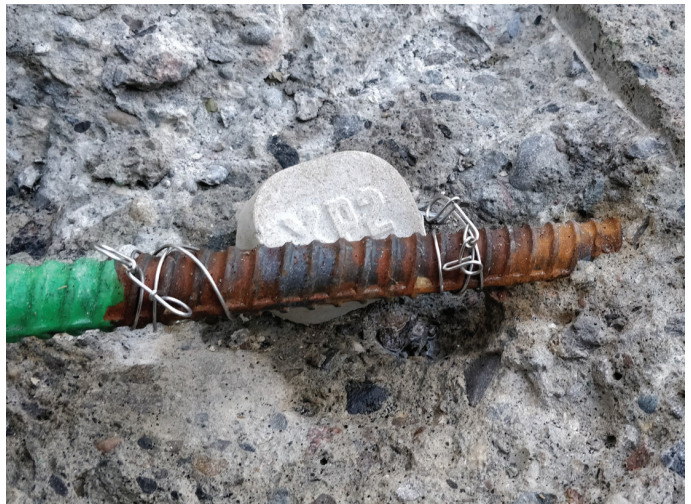
Fig. 2: Galvanic anodes inside a concrete repair area

Field epoxy coating and galvanic anodes were used within concrete repairs to help mitigate future deterioration due to incipient anodes (Fig. 2). Cores were drilled in a grid pattern and cylindrical shaped galvanic anodes were installed where half-cell testing identified active corrosion in sound concrete on the podium slab (Fig. 3).

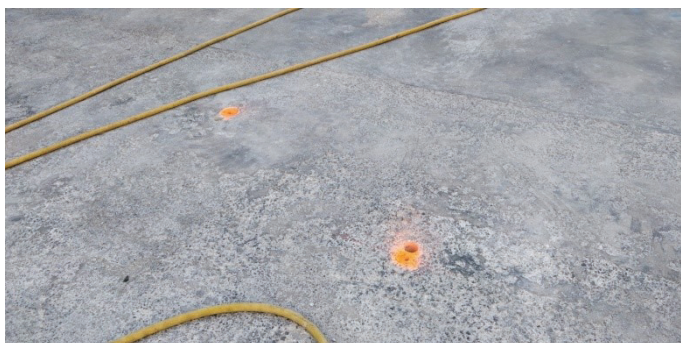
Fig. 3: Anodes installed in sound parent concrete where corrosion potential was high

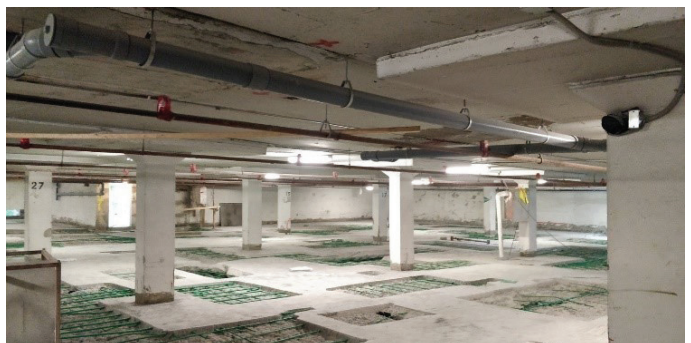
Fig. 4: Concrete repairs on intermediate slab

As was done on the podium slab, the exposed reinforcing steel was field coated with epoxy on the intermediate slab (Fig. 4) to reduce the driving force to create incipient anodes. The corrosion mitigation strategy for the remaining sound concrete was changed after the corrosion potential testing on the full intermediate slab revealed greater corrosion activity than had been identified in our initial test areas. Coring and installing anodes in numerous areas of high corrosion potential would have been cost prohibitive. A less costly strategy was adopted where a corrosion inhibiting sealer was applied to the entire intermediate slab with additional coats around the edges of repair areas to mitigate the incipient anode effect. Cores were taken from treated concrete to ensure adequate inhibitor penetration and concentration.

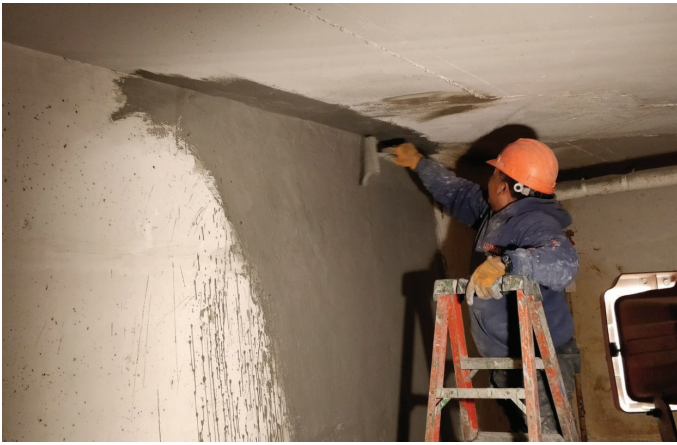
Fig. 5: Crystalline waterproofing the negative side of foundation wall

be removed daily or isolated with a special filter sock and covered with tarps. To avoid sediments from excavations and for waterproofing around the podium slab perimeter, crystalline waterproofing was installed on the negative side of the foundation walls to address water leakage (Fig. 5).

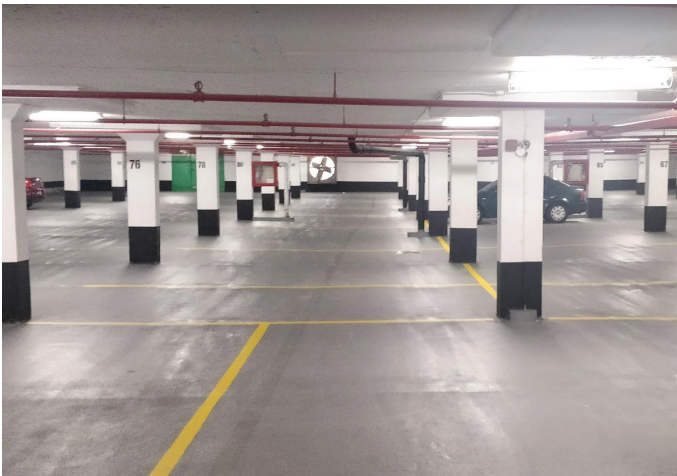
Fig. 6: Completed intermediate slab with traffic coating system

Significant steps were taken to increase durability as the owner intends to keep the properties for the long term. In addition to the corrosion mitigation technologies, a life-cycle cost analysis was completed to help select the optimal traffic deck coating system. Despite being more expensive initially, a coating system with a very durable epoxy wear course was ultimately used (Fig. 6). The life-cycle cost analysis showed that this system had a lower net present value, i.e., would be less expensive over the long term.

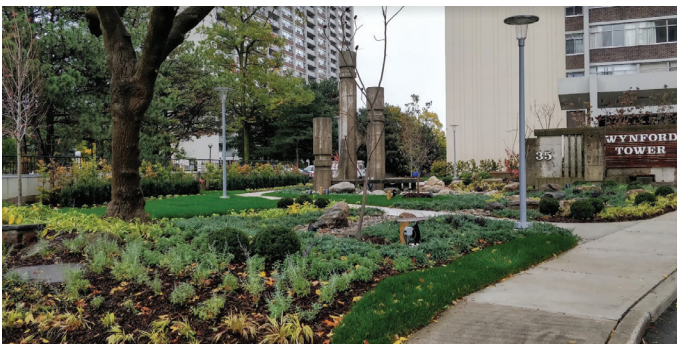
Fig. 7: Completed podium deck

Due to open communication and collaboration between the owner, contractor and engineer, the garage repairs were deemed to be very successful. The project (Fig. 7) was completed on budget and on schedule much to the appreciation of the owners and residents!
