WATER SYSTEMS CATEGORY

Gold Bar Influent Channel No. 2 Repair and Long-Term Protection

EDMONTON, ALBERTA, CANADA
SUBMITTED BY READ JONES CHRISTOFFERSEN LTD.

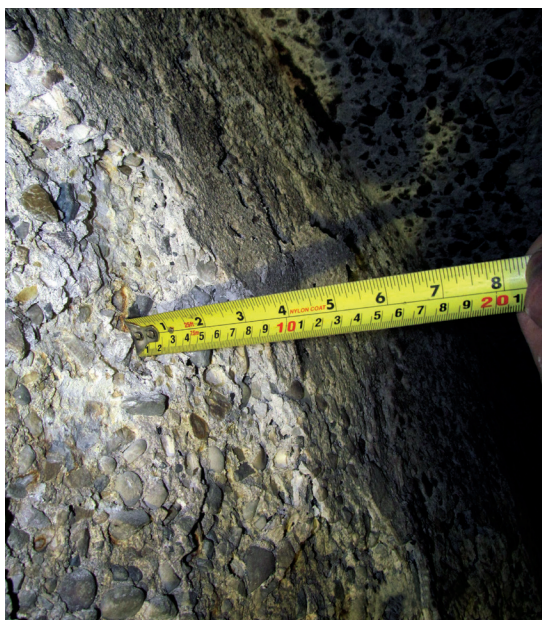
Fig. 1: Extensive depth of concrete deterioration on channel walls

In 2014, an interior inspection of the tunnel identified significant concrete deterioration and erosion. The inspection identified between 1.25 and 3 in (32 to 76 mm) of deteriorated and unsound concrete on interior surfaces of the channel walls, columns and roof members (Fig. 1 and 2). Significant erosion and loss of concrete wall thickness, often to the depth of the reinforcing steel, was noted. The concrete cover on the underside of the roof slabs had deteriorated exposing the lower mat of reinforcing steel. Beam stirrups and bottom layer reinforcement steel were exposed and heavily corroded, with loss of cross-sectional area.

Original construction details showed approximately 1.5 to 2 in (38 to 51 mm) of concrete cover over the embedded steel reinforcing steel. The severe extent of concrete cover loss, the resulting reduction in concrete member thickness, and the loss of reinforcing steel cross-sectional area were considered of structural concern, indicating a significant reduction in load-carrying capacity.

- Removal of deteriorated and unsound concrete, and cleaning and preparation of substrate surfaces in preparation for the repair assembly;
- Installation of a cast-in-place, bonded, reinforced concrete overlay to the channel's interior roof and wall surfaces;
- Casting a proprietary high density polyethylene protective liner assembly into the surface of the concrete overlays, providing a significantly longer service life than that of typical surface applied coatings when exposed to H_2S and acid attack while providing improved wastewater influent flow rates;

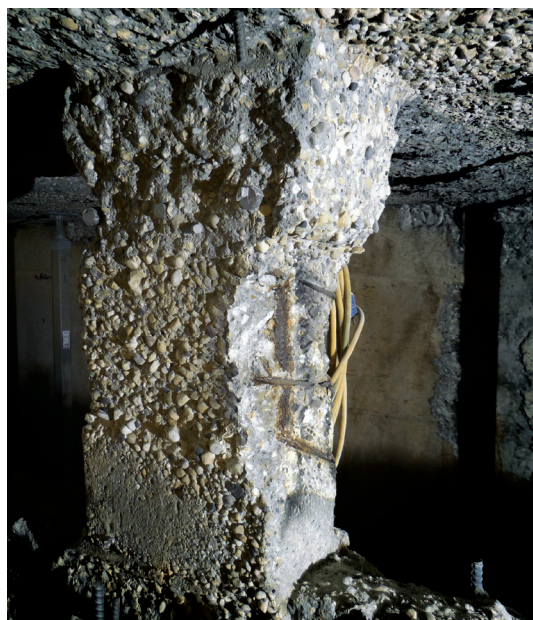
Fig. 2: Column and ceiling deterioration

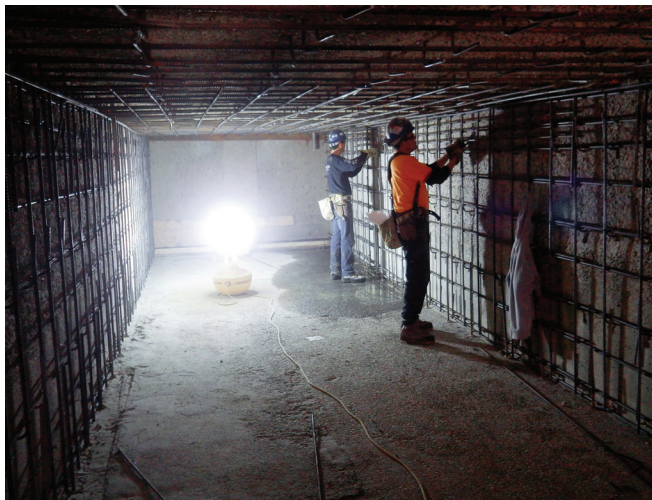
Fig. 3: Reinforcing installation within channel

portions of the existing structure and the new concrete overlay through material bonding and sufficient reinforcement dowelling at the shear interface (Fig. 3 and 4).

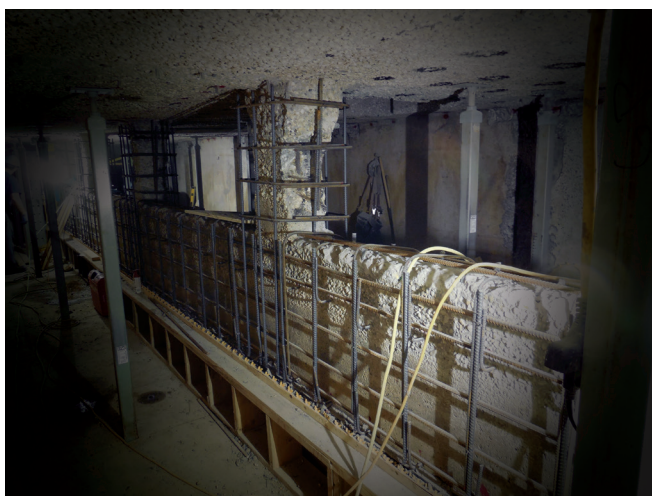
Fig. 4: Overlay reinforcement at overflow weir

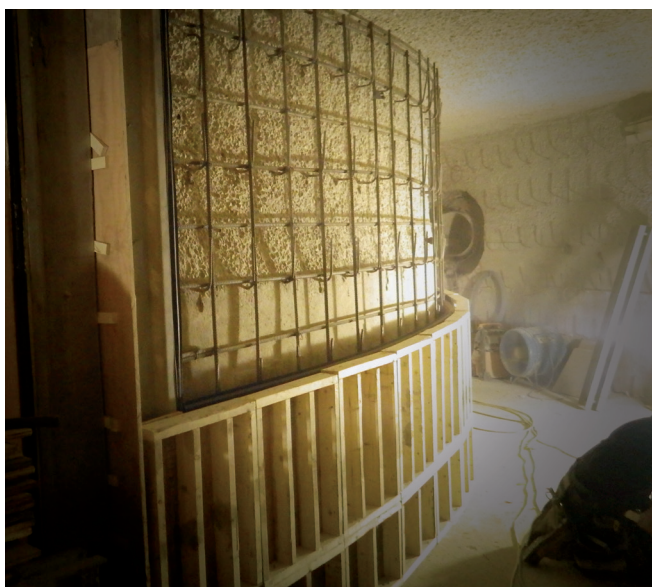
Fig. 5: Wall liner, reinforcement, and formwork

Construction of the bonded overlay and HDPE protective liner assembly provided further unique challenges for the contractor (Fig. 5 and 6). It was required that formwork and bracing systems introduce the fewest possible penetrations through the protective liner to minimize liner patching required before returning the channel into service. The lack of formwork tiebacks into the concrete substrate introduced the further challenge of ensuring that the HDPE liner did not wrinkle or warp during placement of the self-consolidating concrete overlay materials (Fig. 7).

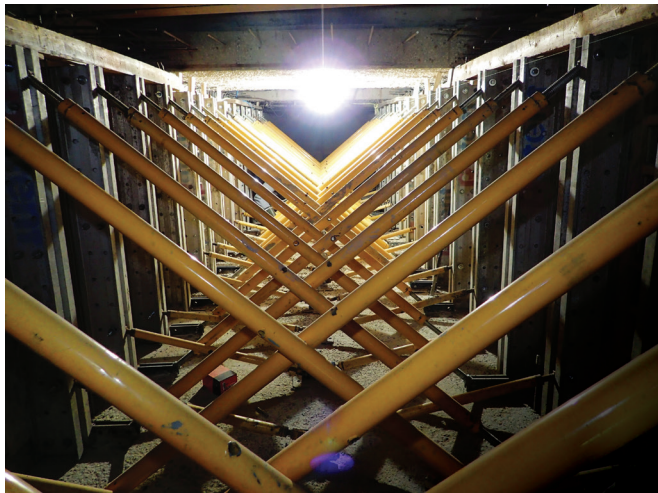
Fig. 6: Formwork and bracing

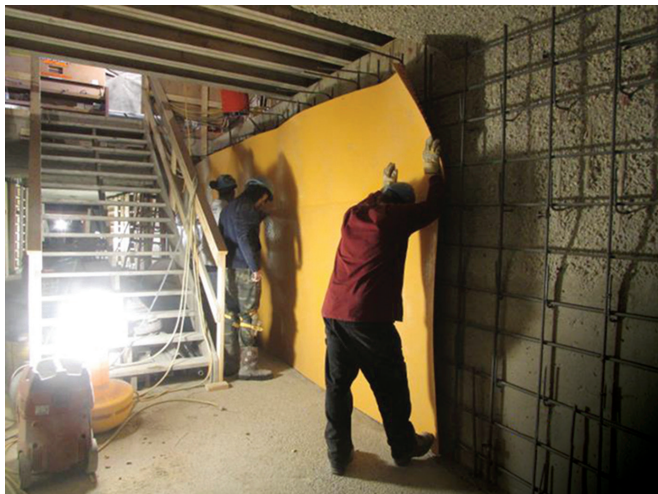
Fig. 7: Trial fit of HDPE liner prior to erection of formwork

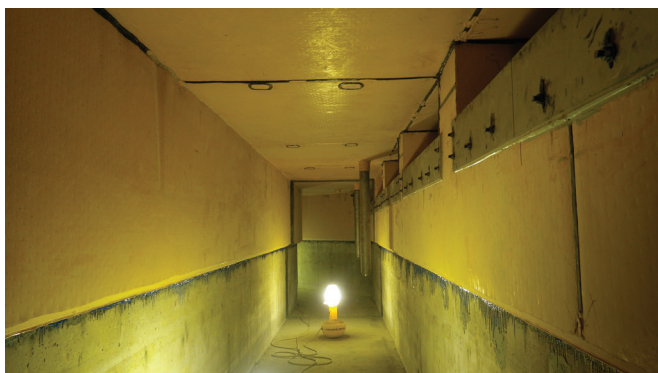
Fig. 8: Nearing completion of overlay and HDPE liner assembly at overflow weir

The construction of a new bonded concrete overlay with integral HDPE protective liner assembly (Fig. 8) was successful in restoring and enhancing the channel's load-carrying capacity, and to provide appropriate long-term protection against the corrosive environmental exposure.
