FINALIST - 2017 PROJECT OF THE YEAR

Harvard Towers Parking Garage Concrete Repair and Waterproofing

CAMBRIDGE, MA

SUBMITTED BY SIMPSON GUMPERTZ & HEGER, INC.

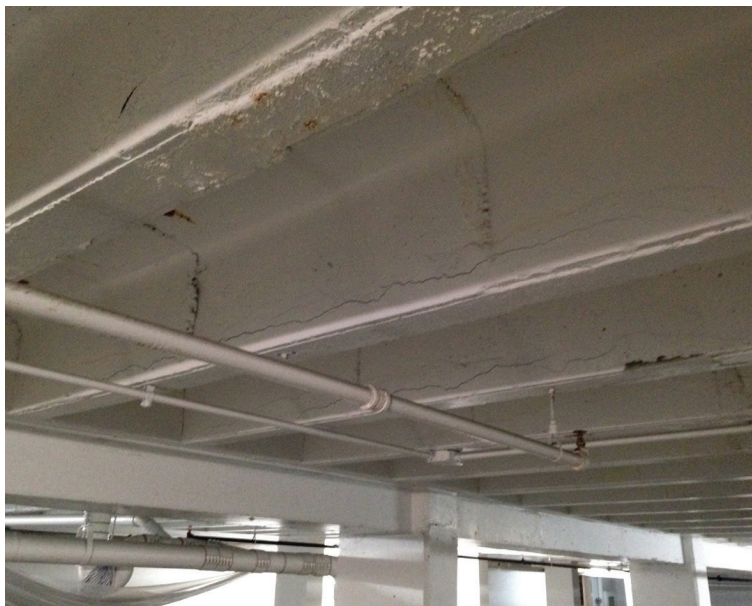
Fig. 1: Concrete deterioration at existing concrete joist.

The parking garage had been exposed to chlorides for more than 50 years by significant quantities of deicing salts brought into the garage by vehicles. This exposure caused corrosion of the embedded steel reinforcement, and subsequent delamination and spalling of the concrete. Findings included the following:

- Concrete deterioration in the slabs and joists of the pan-joint system of Level G1 and Plaza Level was widespread and severe in several instances (Fig. 1 and 2). Approximately 90

percent of the surveyed slabs and joists showed signs of moderate to severe concrete deterioration or distress, mostly at previous repairs;

- Replacing the entire Level G1 pan-joist system (leaving the beams) with a new pan-joist system;
- Performing conventional concrete repairs at the beams at Level G1, at the Plaza Level pan-joist system, and at the columns and walls at Level G2 and G1; and
- Installing a new vehicular-traffic-bearing waterproofing (VTBW) system on Level G1 and a new plaza waterproofing system on the Plaza Level.

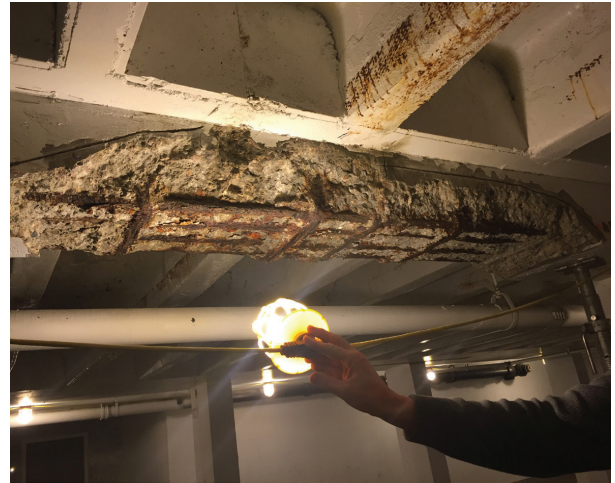
Fig. 2: Concrete deterioration at existing concrete beam.

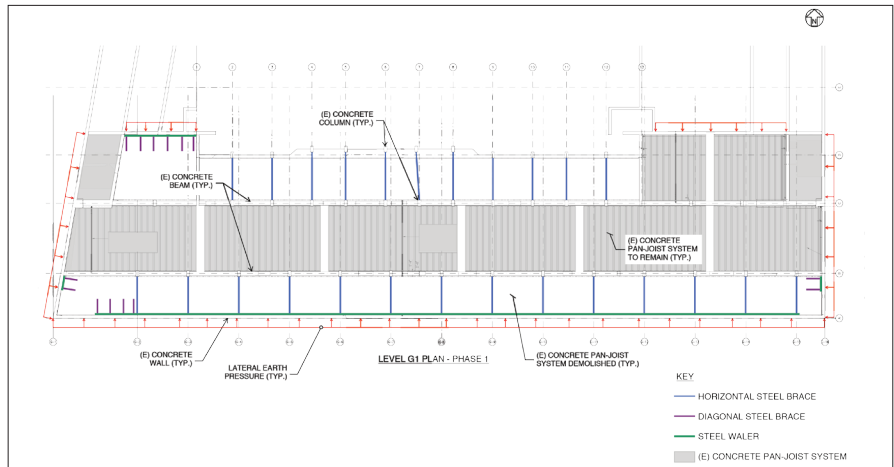
Fig. 3: Phase 1 Demolition and Temporary Lateral Bracing Plan for Level G1

Phase 1 (Fig. 3 and 4)

- Install Phase 1 lateral bracing system, comprised of horizontal steel walers along the foundation wall, horizontal steel struts bracing the walls and columns, and diagonal steel braces at the garage corners;
- Demolish the outer two spans of Level G1 (with the existing middle span of Level G1 remaining);
- Demolish strips within the middle span of Level G1 for construction of concrete struts (to be utilized during Phase 2); and
- Construct a new pan-joist system in the outer two spans of Level G1 and in the middle span at concrete strut locations.

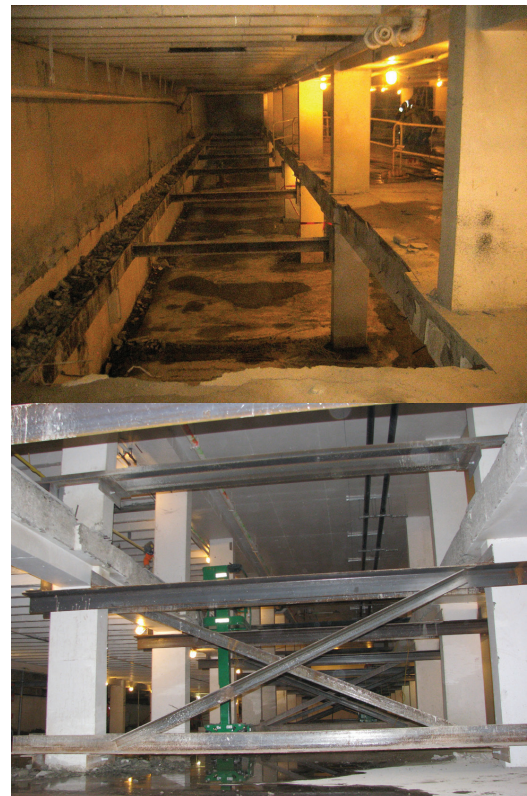
Fig. 4: Demolition and temporary lateral bracing in Phase 1

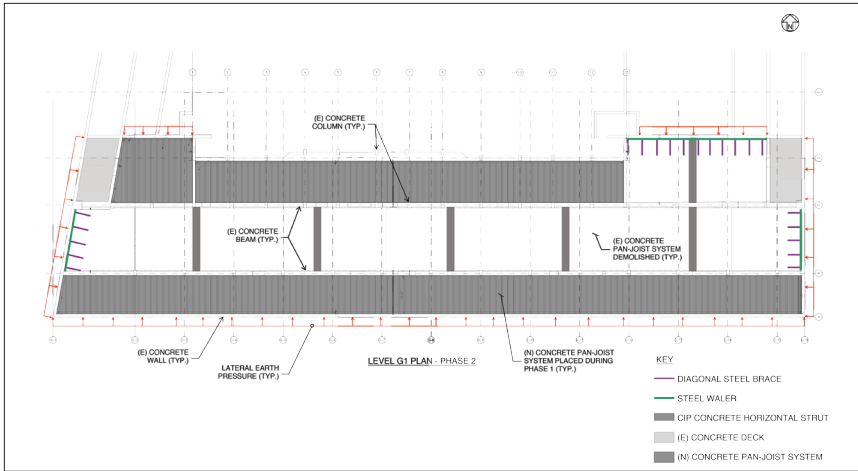
Fig. 5: Phase 2 Demolition and Temporary Lateral Bracing Plan for Level G1

Phase 2 (Fig. 5 and 6)

- Install Phase 2 lateral bracing system, comprised of horizontal steel walers along the foundation walls, and diagonal steel braces at the garage ends;
- Demolish the inner span of Level G1 (with the new outer spans and concrete struts at the inner span remaining); and
- Construct a new pan-joist system in the inner span of Level G1.

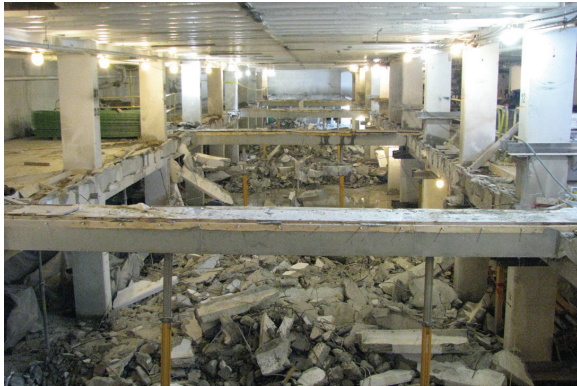
Fig. 6: Demolition and temporary lateral bracing in Phase 2

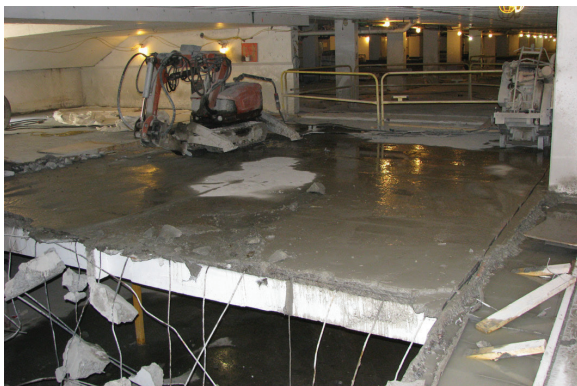
Fig. 7: Large-scale demolition during Phase 2

Large heavy-duty sawcutting and jack-hammering machines were utilized to perform the large-scale demolition. The pan-joist system was sawcut along the beams and allowed to collapse to Level G2 below (Fig. 7). Chipping guns were utilized for most of the demolition detail work (Fig. 8). Hydrodemolition was utilized to remove the concrete from the topside of the existing beams.

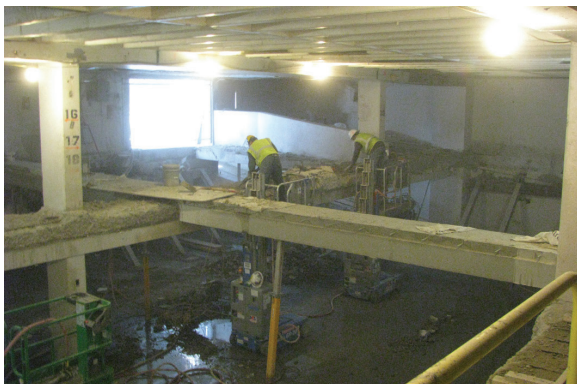
Fig. 8: Detail demolition during Phase 2

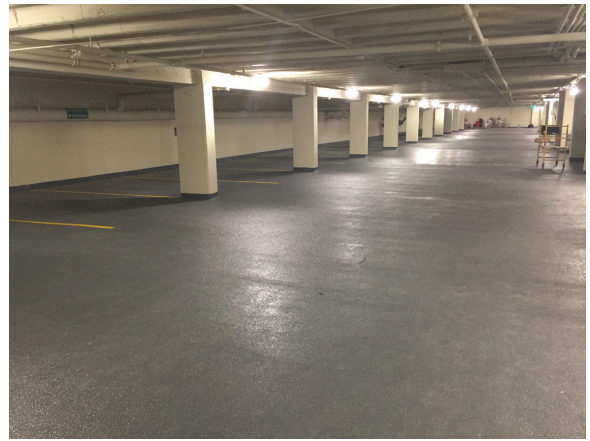
Fig. 11: Vehicular traffic-bearing waterproofing (VTBW) system installed on Level G1

To protect the new and existing concrete elements and reduce water intrusion to the new repairs on the underside surfaces and to the elements below, a VTBW system was installed on Level G1 (Fig. 11).

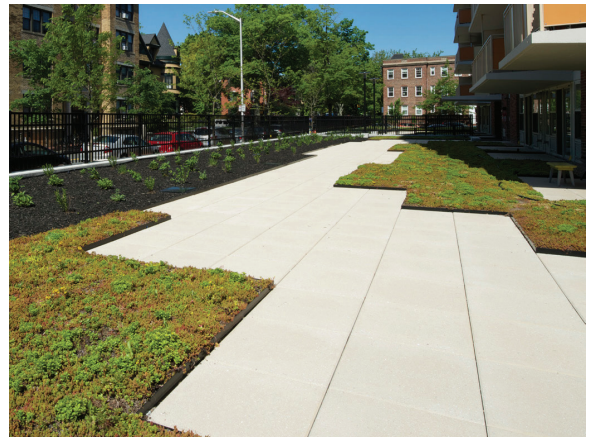
Fig. 12: New landscaping on the Plaza Level topside)

As part of the apartment building renovation project, the topside of the Plaza Level was developed and landscaped to include unit pavers and green roof plantings (Fig. 12). Below the new landscaping elements, a plaza waterproofing system was installed to reduce water intrusion and protect concrete elements below.

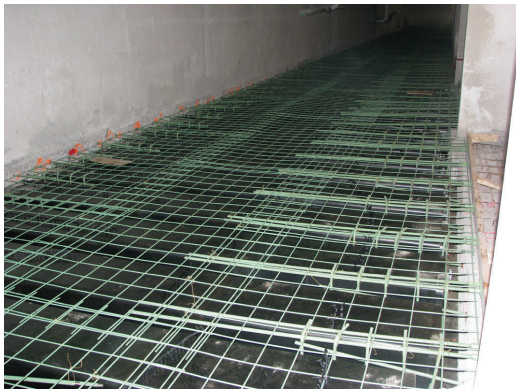
Fig. 9: Steel reinforcement for new pan-joist system (Phase 1)

A new reinforced concrete pan-joist system was designed for Level G1, connected to existing concrete elements (Fig. 9 and 10). Due to the phased demolition, continuity of the top steel reinforcement was provided at the topside of the existing beams to remain through use of form saver couplers and threaded steel bars.

Special surface preparation requirements were specified at existing concrete elements to remain (i.e., foundation walls and beams). In addition to dowels, all existing concrete in contact with new concrete was roughened and keyed to provide a “seat” for the new pan-joist system.

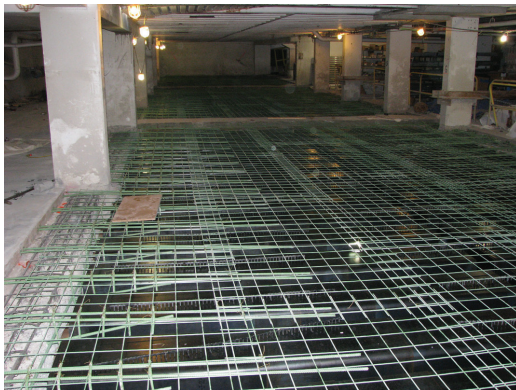
Fig. 10: Steel reinforcement for new pan-joist system (Phase 2)
