AWARD OF EXCELLENCE

LONGEVITY CATEGORY

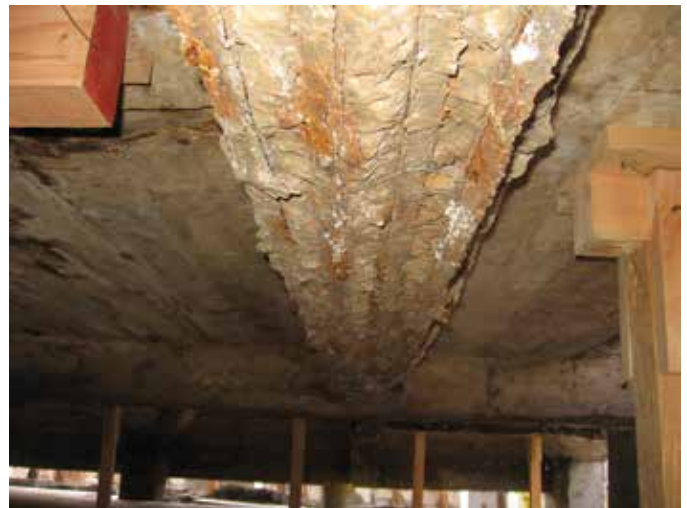
Fig. 2: Extensive spalling of the beams, girders, and slabs caused by severe corrosion of the reinforcing steel

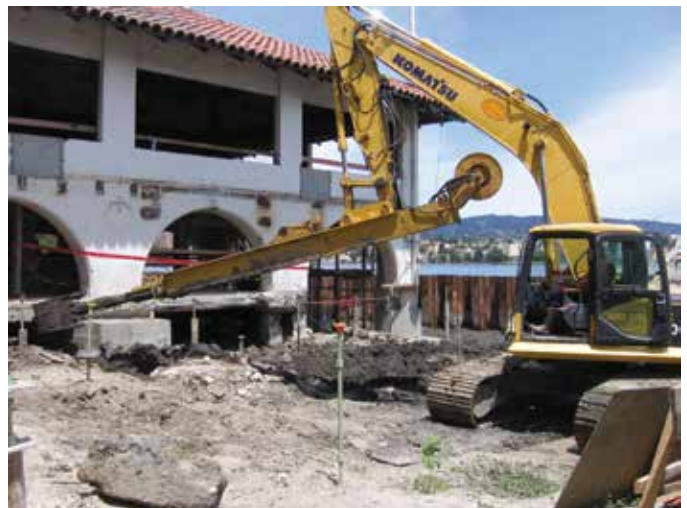
Fig. 3: Modified excavation equipment to remove the mucky soil under the supported slab

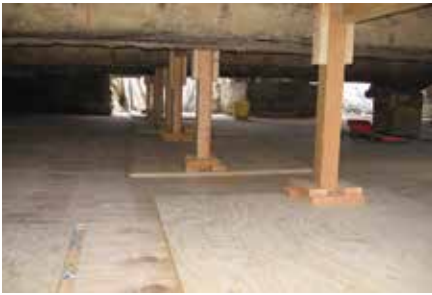
Fig. 5: Work platform and shoring installed ahead of demolition (note corroded steel throughout and the tight working conditions)

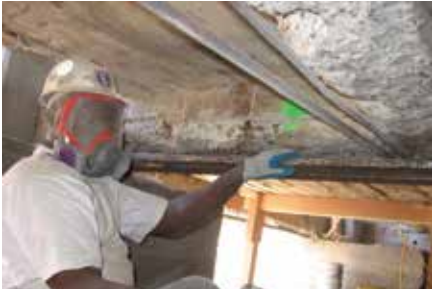
Fig. 6: Significant demolition required to remove spalled concrete and expose corroded reinforcing steel

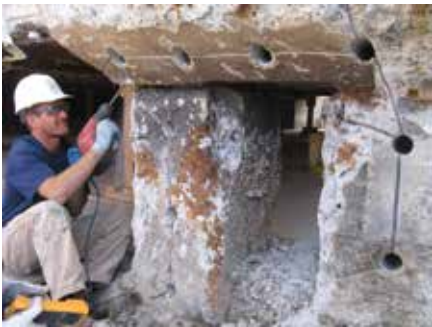
Fig. 7: Anodes installed throughout to combat the high chloride content in the concrete

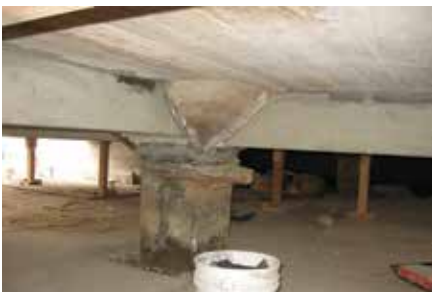
Fig. 8: Girders after concrete placement and repair

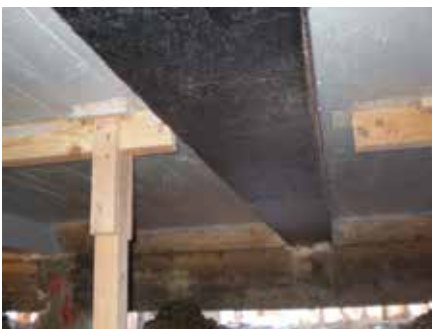
Fig. 9: Girder after application of CFRP and slab after application of epoxy coating (note areas of shoring that required later touchup)
