AZP Girder Strengthening

MOORESBORO, NORTH CAROLINA SUBMITTED BY FREYSSINET, INC.

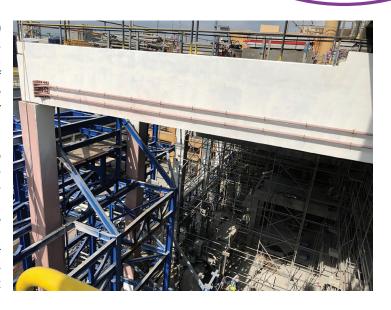
n April 2019, the American Zinc Products LLC (AZP) facility, located in Mooresboro, North Carolina, unfortunately caught fire in the electrolytic cell house. The high-temperature flames impacted the condition of the girders and double-tees. It was imperative that the contractor begin work immediately to reopen the facility as soon as possible.

Prior to beginning work, the contractor took time to analyze the as-built drawings to establish the best way to strengthen the weakened girders and double-tees. The contractor determined that the most effective method to enhance durability and fire protection would be utilizing external post-tensioning, where tendons would be encased in stainless steel conduit and grouted after stressing. In addition to the necessary girder and double-tee repair, the scope of work included epoxy crack injection at designated stems of the double-tees.

and fast-tracked schedule, the contractor developed two work crews so work could be completed concurrently. One crew was assigned to lay out girder and double-tee stem pre-stress strands and steel reinforcement locations, from prior GPR work, for the purpose of coring through concrete for base and anchor plates supporting post-tension anchors. The second crew prepared and proceeded with epoxy crack injection repairs. Coring had to be precise for the installation of all thread rods utilized in connecting post-tension base plates on opposite sides of each of the girder ends.

turnaround for each girder, with an extra day added for the double-tee stems (pair). In a matter of several weeks, a total of six concrete girders and six double-tees were strengthened by the use of external post-tensioning.
