The Austonian: Slab Edge Repairs

AUSTIN, TEXAS

SUBMITTED BY PIVOT ENGINEERS

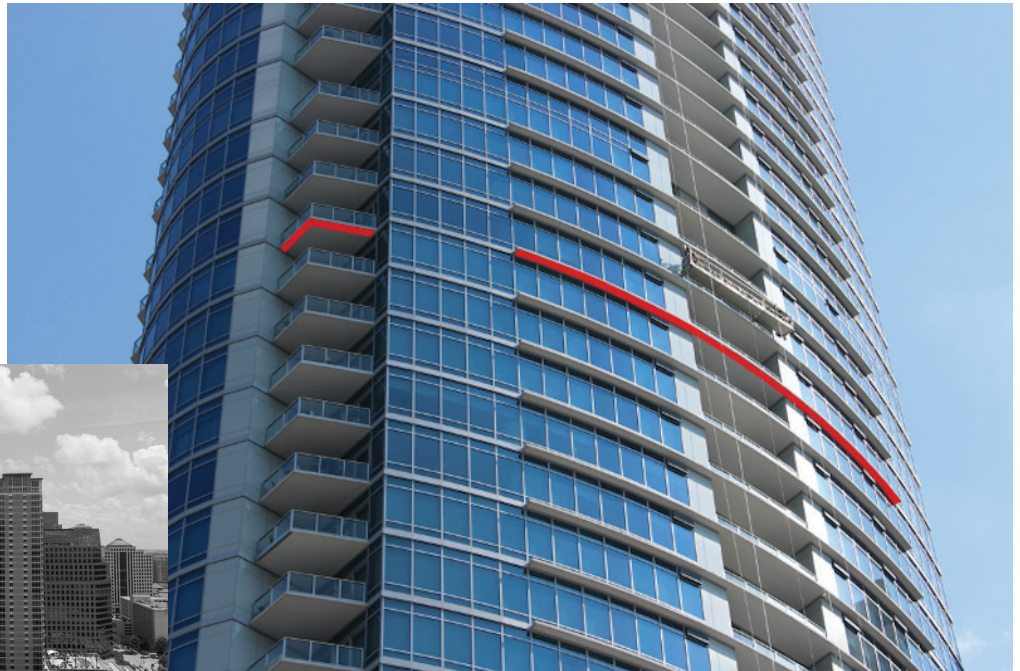
Fig. 2: Slab edges at the Austonian (red lines highlight typical exposed edges)

The Austonian is a 59-story, 683 ft (208 m) tall high-rise condominium that was completed in 2010 and is located in downtown Austin, Texas (Fig. 1). The building is comprised of reinforced concrete structural elements and unbonded, post-tensioned (PT) concrete slabs. The majority of the slab edges in a typical floor are covered with aluminum cladding, while the remaining slab edges are exposed to the elements. The building has approximately 1.75 linear miles (2.8 km) of exposed slab edges distributed over the entire height of the structure (Fig. 2).

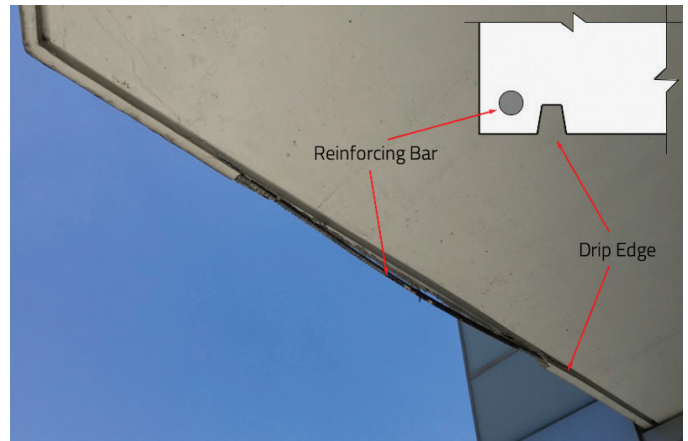
Six years after construction, a 5 ft (1.5 m) long concrete segment (Fig. 3) detached from a balcony edge, fell more than 200 ft (60 m), and almost hit a staff member. Fortunately, no one was injured, and the spalled concrete caused limited property damage. Immediately after the incident, a visual survey identified 31 slab edge locations with evidence of severe cracking and distress (Fig. 4). The distressed slab edges were distributed throughout the building and were not concentrated in any particular area. To mitigate the risk of falling hazards, temporary protective

The investigation determined that carbonation-induced corrosion was the primary cause of the premature damage. Due to poor concrete consolidation around reinforcement with shallow concrete cover, the carbonation process progressed rapidly and initiated corrosion activity.

Fig. 3: Concrete spalled from a balcony, exposing a reinforcing bar

Given the widespread nature of the issue, immediate repairs were needed to restore the safety and durability of the exposed slab edges. Full-depth repairs of the exposed slab edges were used to address the deficient slab edges and involved concrete removal of approximately 3 in (75 mm) into the slab. This removal depth limit was selected to preclude concrete removal in front of PT anchors, which could cause dangerous and uncontrolled release of PT tendons. The removal was sufficient to expose the improperly placed reinforcing bars, which were then cut and removed. Repair details specified roughening the concrete substrate to a concrete surface profile of CSP 7¹ to ensure adequate bond between the original concrete and the new repair material.

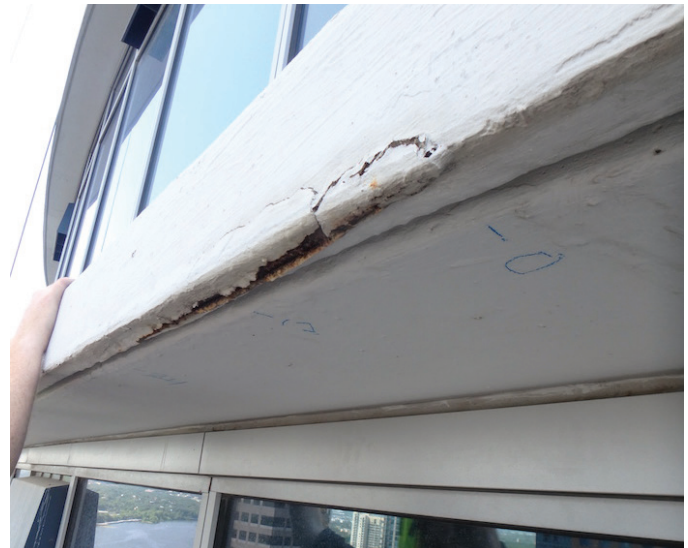
The investigation determined that more than 85% of the examined slab edges contained reinforcing bars with inadequate concrete cover. More than 40% of the examined edge reinforcement had concrete cover that was less than 0.5 in (13 mm), which is the minimum cover allowed by the building code, including tolerances. The concrete cover deficiency was systemic throughout the building. The results also demonstrated improper placement and support of the edge steel reinforcement during original construction.

Fig. 4: Corrosion-induced damage at an exposed slab edge

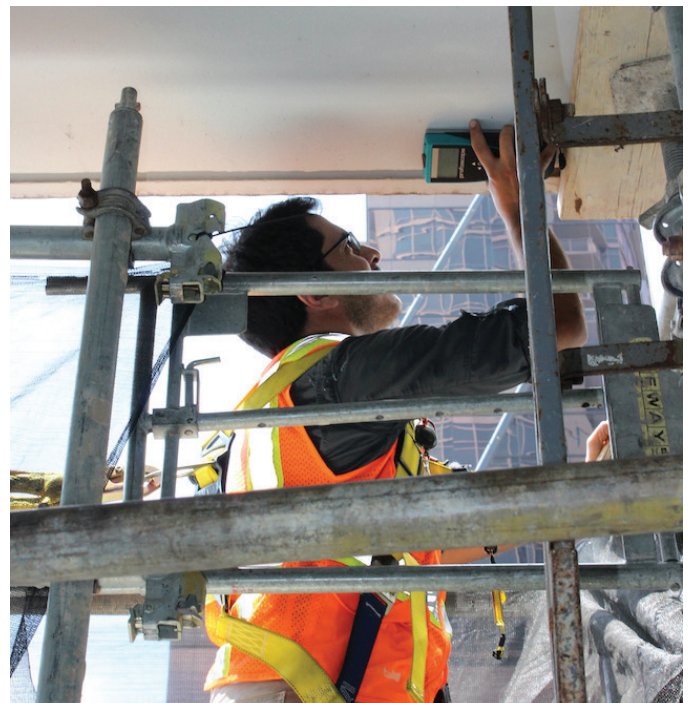
The investigation used several non-destructive and destructive evaluation techniques to estimate the in-situ concrete cover and evaluate the risk of ongoing corrosion activity. For the concrete cover survey, a cover meter (Fig. 5) and surface penetrating radar were used to locate the steel reinforcement and estimate the concrete cover.

Fig. 5: Obtaining concrete cover measurements

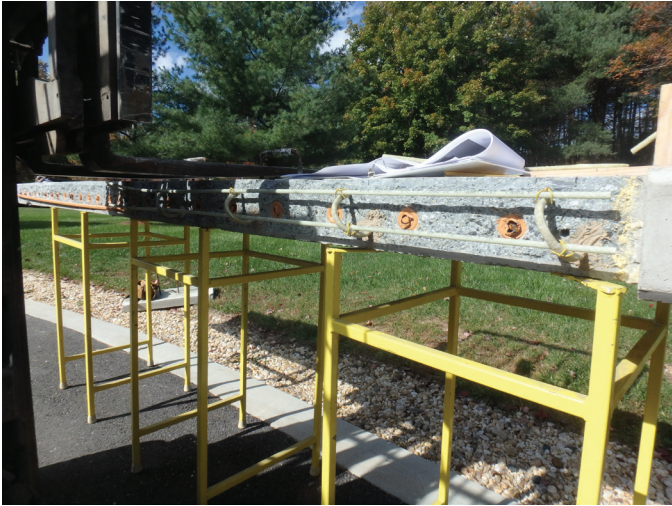
Fig. 6: Off-site mock-up showing conditions after reinforcement installation

Prior to the commencement of repair work, the contractor performed large scale mockups, both off-site and on-site (Fig. 6). The repair mock-ups allowed for: 1) early coordination between the repair team members; 2) identification of execution obstacles; and 3) fine tuning of the repair details. The findings of the mock-ups led to changes in the design and execution plans which benefitted the project. For example, the geometry and orientation of the GFRP dowels were adjusted due to installation difficulties observed during the off-site mock-ups. Similarly, the contractor also elected to use conventional concrete instead of the originally selected self-consolidating concrete, due to: 1) the long setting time; 2) finishing difficulties encountered in the mock-ups; and 3) sensitivity to variations in mixing conditions. The mockups strengthened the collaborative approach between the design team and contractor.

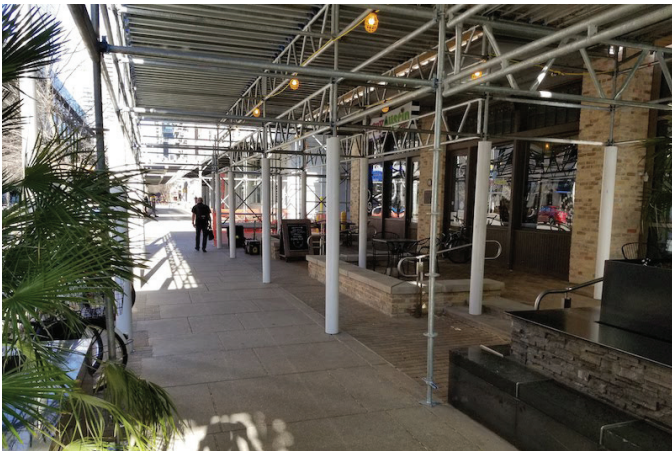
Fig. 7: Overhead protection installed around the site

Given the busy downtown setting and the substantial risk of falling hazards, the contractor worked with local businesses and several city departments to build overhead protection structures to protect the public prior to demolition (Fig. 7). The contractor also installed nets around work areas to catch debris and mitigate the falling hazard. Given the limited space at ground level, the contractor erected overhead protection and a work deck over the building podium to provide a staging area while also protecting property.

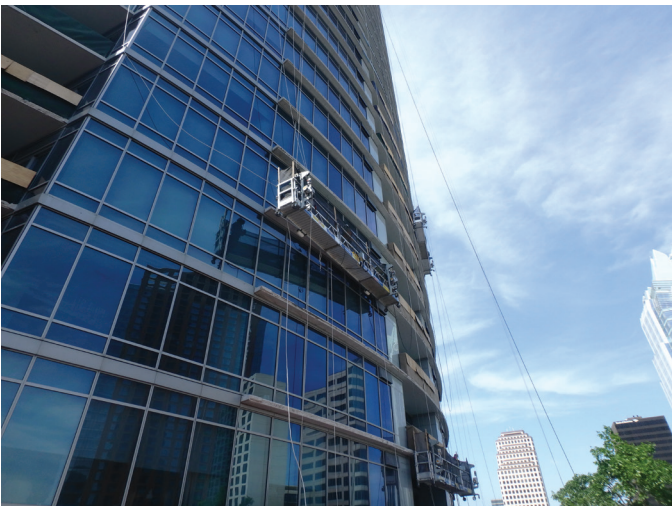
Fig. 8: Swing stages were used for access and material transportation

The contractor used swing stages to access repair areas and transport repair materials (Fig. 8). This allowed for repairs to be performed without the need to access the residential units which remained occupied. The height of the structure and the seasonal variation in wind patterns created logistical and access challenges. To limit delays due to high winds, the contractor divided the building perimeter into twelve independent drops. This allowed the contractor to continually perform the repair work, regardless of wind direction.

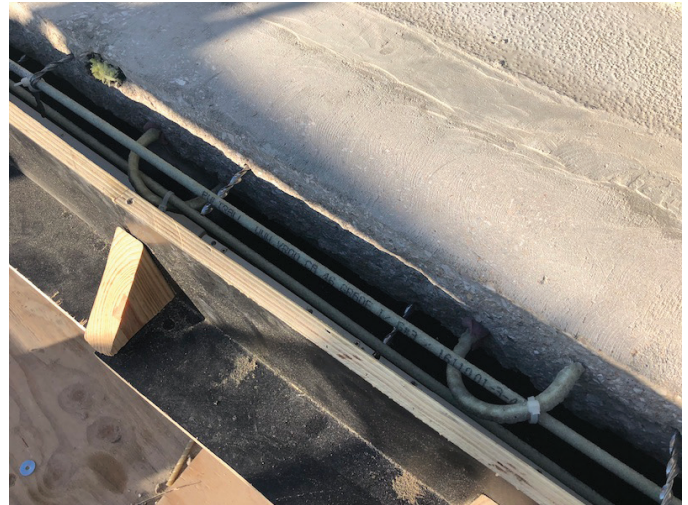
Fig. 9: Slab edge prior to concrete placement

cover was exposed and removed. To avoid logistical challenges associated with media blasting hundreds of feet in the air, needle scaling was used to prepare the concrete substrate without weakening the bond by introducing microcracks. Once surface preparation was completed, a pressure washer was used to clean the concrete surface. The GFRP dowels and bars were then installed and secured in place using plastic ties (Fig. 9).

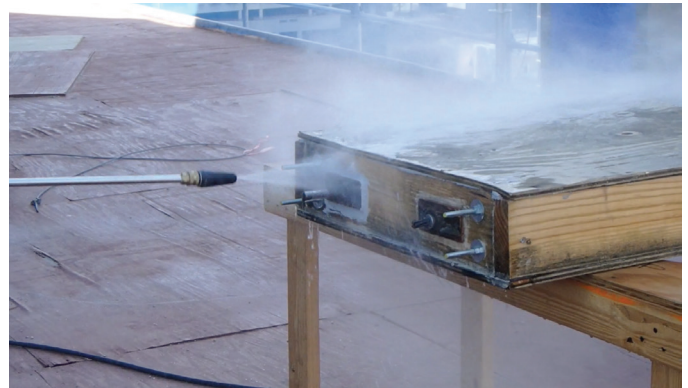
Fig. 10: Mock-up of temporary PT anchor protection

The concrete removal exposed numerous non-encapsulated PT anchorages. Because concrete placement often lagged behind concrete removal at a given location, some PT anchorages remained exposed for extended periods of time. To mitigate moisture ingress into the exposed PT tendons due to wind-driven rain and pressure washing, the project specifications required installation of temporary protective assemblies that sealed the ends of the anchors. The contractor developed PT protection systems that were evaluated using a mock-up assembly (Fig. 10).

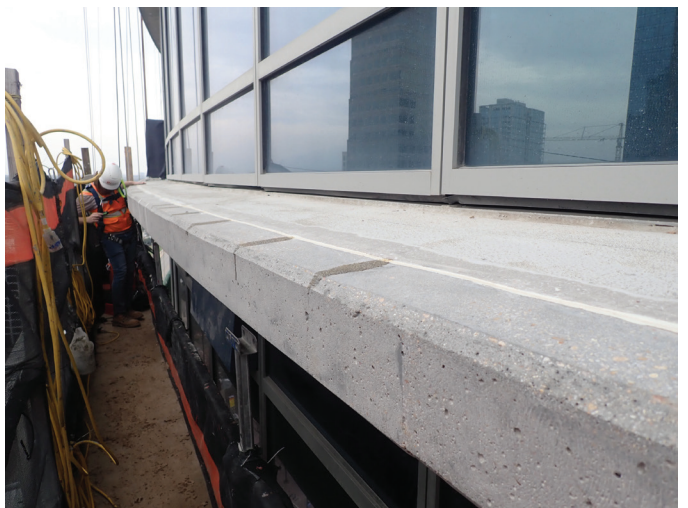
Fig. 11: Repaired slab edge after placement (note sealant joint and filled cracks)

Given the height of the structure and the limited volume of repair concrete needed at each location, the contractor selected a prepackaged material. The concrete was mixed in small batches at balconies located near the placement locations to prevent stiffening of the fresh concrete during transportation from the building podium to the intended repair location. Form and pencil vibrators were used to ensure adequate consolidation of the repair material. After curing, shrinkage cracks were treated, and a sealant joint was installed along the construction joint (Fig. 11).

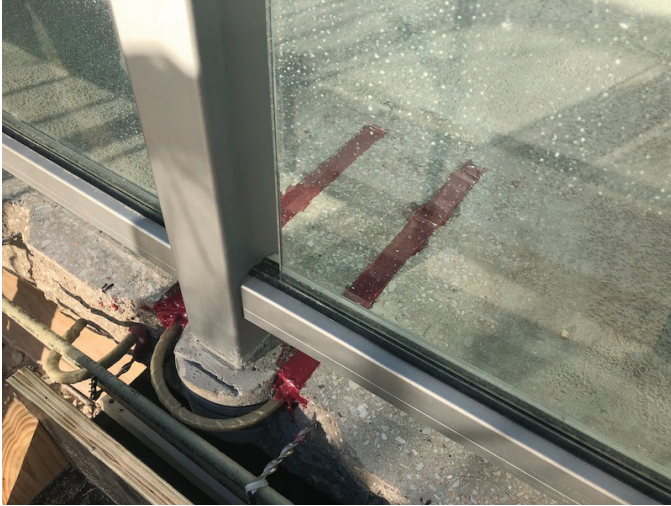
Fig. 12: Strengthening of a deficient railing anchorage

During repair execution, several unforeseen construction deficiencies were discovered at discrete locations. At 15 balconies, railing post anchorages did not have code-specified anchor reinforcement. To address this issue, near-surface-mounted GFRP hairpins were installed around the deficient railing anchors (Fig. 12).

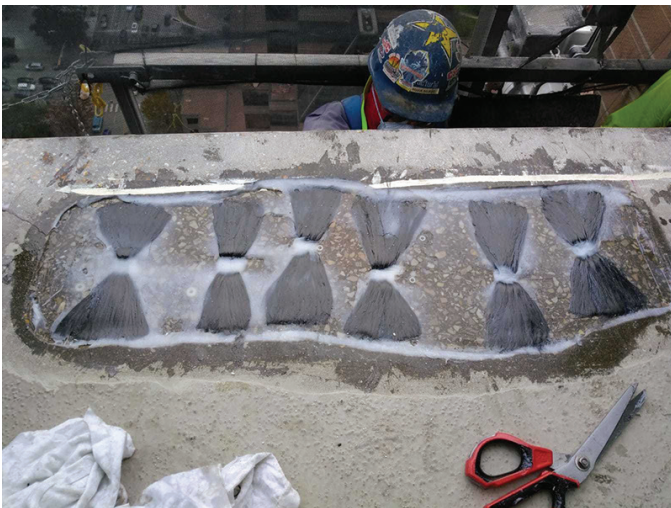
Fig. 13: Splay anchors installed to arrest existing PT bursting cracks

At seven locations, the demolition exposed significant bursting cracks around PT anchors. The repair team devised a unique solution that included epoxy injection of the cracks and installation of carbon fiber reinforced polymer thru-thickness splay anchors (Fig. 13). The splay anchors were designed to arrest existing cracks and in-plane delaminations.

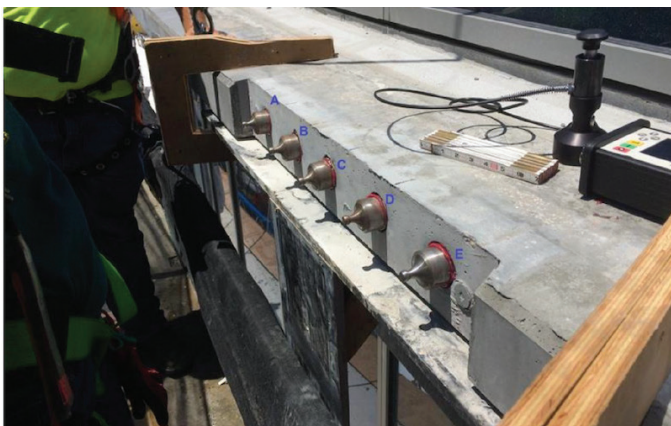
Fig. 14: A typical pull-off bond testing area

In addition to common concrete material testing, pull-off bond strength testing was performed at least once every 250 linear ft (75 m) of repaired slab edge. Given the orientation of the repair, horizontal coring of the repaired slab edges was needed for the testing. To reduce the effect of uneven coring on the results, a modified slab

edge geometry with reduced thickness was used in areas selected for pull-off bond testing (Fig. 14). After testing, the test area was repaired to match the adjacent slab edge repairs.
