FINALIST—
2020
PROJECT OF
THE YEAR

DAYTON ART INSTITUTE

DAYTON, OHIO

SUBMITTED BY LRT RESTORATION TECHNOLOGIES

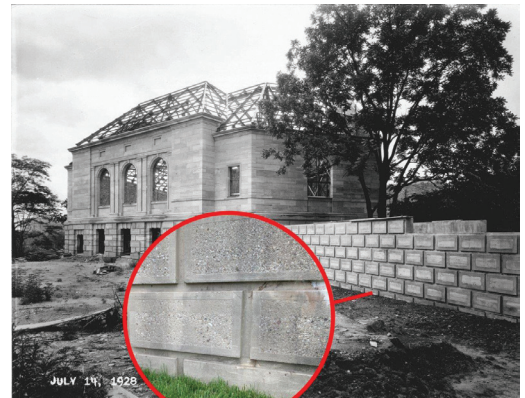
Original installers gave the architecturally exposed concrete a sandblasted-exposed aggregate finish (Fig. 3). Sandblasting was first patented in 1870, but this structure would be one of the first that utilized such a finish. The only other way the unique finish could have been created was with the use of a steel protective frame and use of a bush hammer. There are no known records of how this was achieved on this building in 1927-1930.

Fig. 3: Original exposed aggregate finish

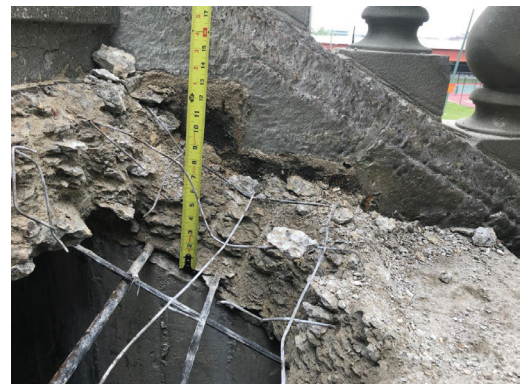
The Dayton Art Institute, located within the Rust Belt, was subjected to 90 years of extreme freeze-thaw cycles and heavy winter de-icing. Concrete air entrainment was later developed in the 1930s and wasn't utilized during the original construction. Concrete air entrainment increases the durability of the concrete by helping withstand continual freeze-thaw cycles. The original flagstone stair treads and risers were replaced during a previous restoration project, with poured concrete treads and risers, using the original 1930 structural slab without waterproofing between the old and new slabs (Fig. 4).

The concrete structural and topping slab experienced extreme damage from environmental changes, constant

de-icing to keep the museum patrons safe, and the lack of maintenance. The slab showed signs of extreme deterioration to the point of easily crumbling in one's hand. Eventually in 2011, the grand staircase was deemed unsafe and barricaded off to the public (Fig. 5).

Fig. 4: Condition of the existing structural slab with topping slab removed, illustrating the lack of waterproofing between the slabs

The original repair plan was to replace the topping slab and perform various localized concrete repairs to the structural slab. Due to the severe deterioration, there were concerns that a traditional localized concrete repair process could not be achieved and that replacement of the structural slab would occur regardless. An alternate plan was proposed to perform a full structural slab replacement as a cost savings to the owner, using the more advanced construction methods of today.

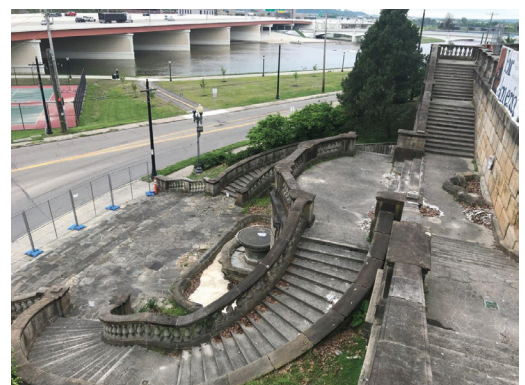
Fig. 5: Pre-construction condemned staircase

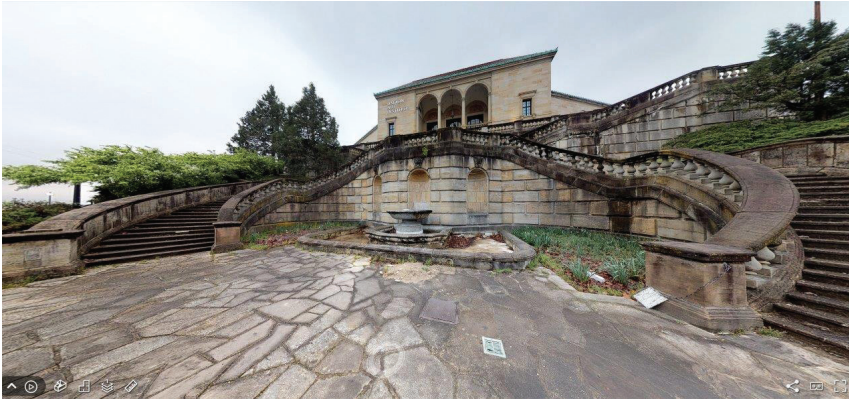
Fig. 6: 3-D scan of the grand staircase prior to construction

Because the grand staircase was historic, it was imperative that the final look be identical to the original construction with the added safety of the concrete treads and risers. Matching the original dimensions and profiles exactly was crucial. Prior to stair demolition, the stairs were 3-D scanned and 3-D photo documented (Fig. 6). This allowed for a high-resolution pre-construction documentation with a Google Maps navigation ability and produced a Revit model to assist with the final riser formwork design.

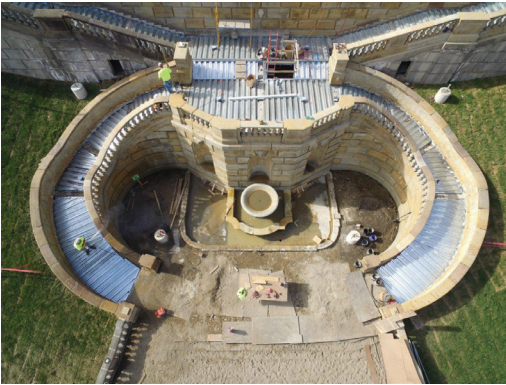
Fig. 7: Aerial view of the composite steel formwork

A steel support structure was designed that utilized a sacrificial 16-gauge galvanized G90 composite steel decking that could support the structural slab during the pour without additional shoring (Fig. 7). Countless meetings and discussions went into the overall design to ensure the unique formwork could be safely achieved, while also making ease of constructability a top priority for the field. This was a huge challenge because of the existing stair radii and slopes.

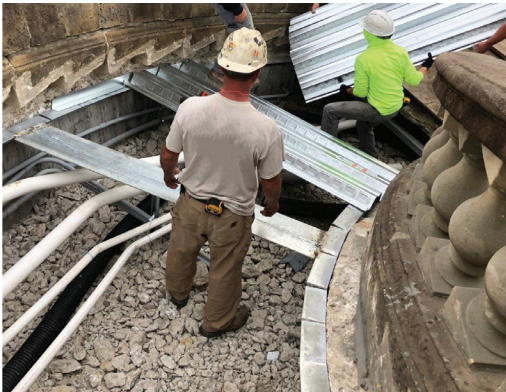
Fig. 8: Short attachment angles with center relief cut that follow the curvature of the staircase

Custom bending angles to anchor to the walls would be an extreme challenge and would be cost-prohibitive. After many meetings with the structural engineer, the final design was developed utilizing short attachment angles with a center relief cut installation so the angle could be field-bent for both the inner and outer wall, creating convex and concave curves (Fig. 8).

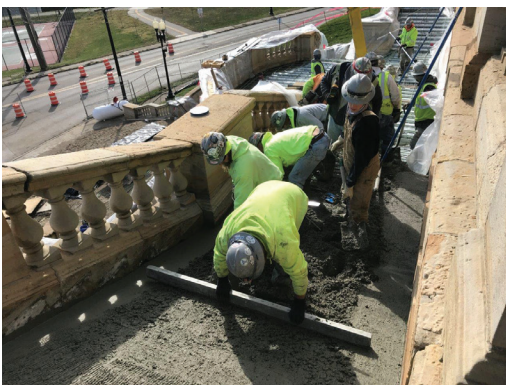
Fig. 9: Crews working on the graded slope of the grand staircase

After the decking was installed and the structural slab was poured (Fig. 9), the next challenge was the riser formwork (Fig. 10). The intent was to pour the structural slab and risers at the same time. The challenge was the limited amount of material that could be kick off to and anchor the formwork, so plans were modified. Everything surrounding the stairs was historic masonry, so anchoring into it was not an option. It was opted to pour the structural slab to help ease some of these challenges and allow for more formwork anchor locations. This helped, but with the curved stairs, the pours still needed to be limited to small sections. Each stair section was broken into two (2) smaller pours so that the straight formwork kickers could be utilized.

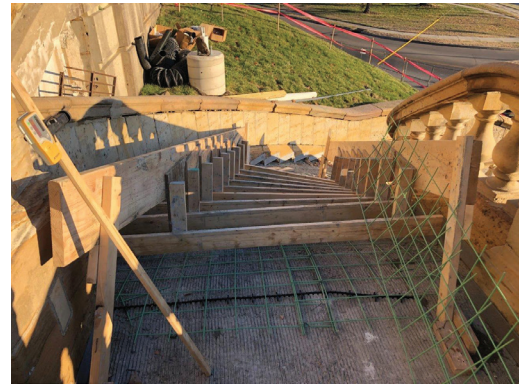
Fig. 10: Detailed formwork and anchoring

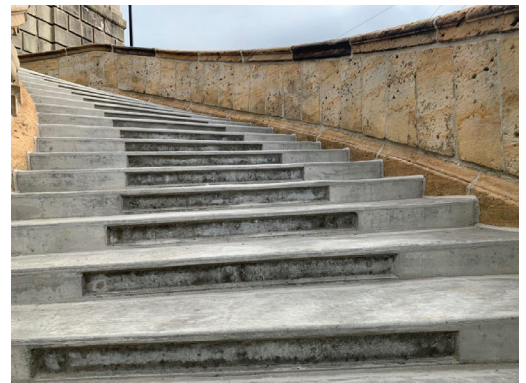
Fig. 11: Recessed boxcuts in stair risers for donor plaques

After much discussion and planning, 41 in (1041 mm) wide x 3 ¼ in (82 mm) tall boxouts with 45-degree beveled edges were installed (Fig. 11). Everything possible was done to help prevent damage to the stair nosing through the normal use of the stairs while also making the owner happy. Overall, these stairs were planned out and poured in eighteen (18) separate pours that matched the original historic measurements.

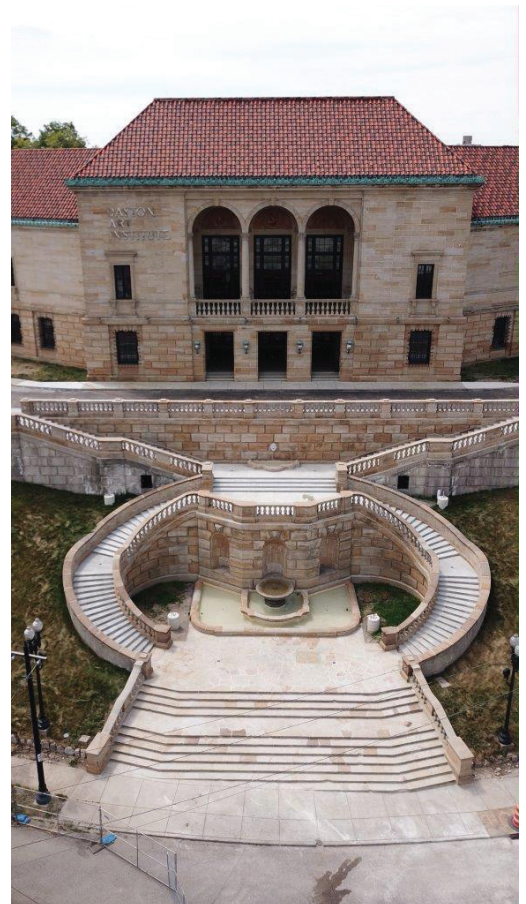
Fig. 12: Completed grand entry staircase project

Overall, the project was a success and provided the owner with a safe, structurally sound staircase that has been brought back to its former intended glory. The stairs now accent the beautiful historic museum building (Fig. 12). The total contract amount was roughly US \$1.7 million. The project duration was May 2019 through March 2020.
