# Paradise Island East Bridge Repairs and Renovations

NASSAU, BAHAMAS

SUBMITTED BY SIKA CORPORATION

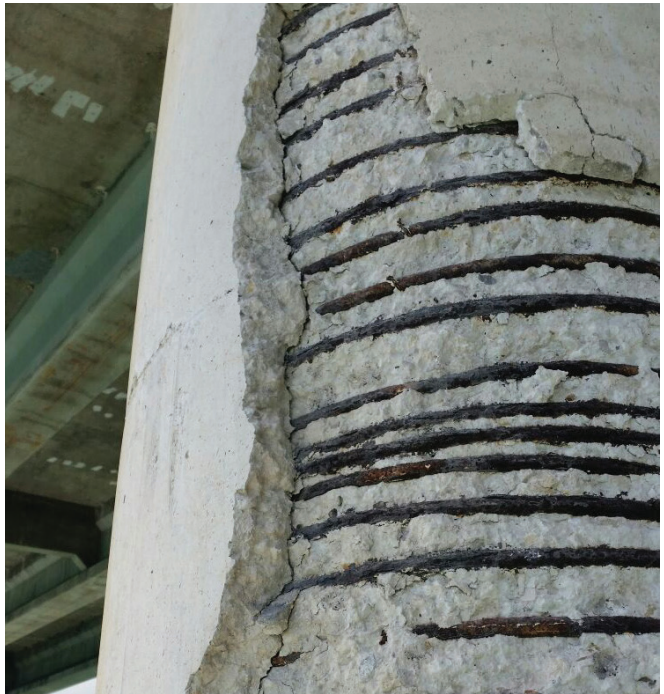
The tropical salt water environment had taken its toll on the reinforced concrete superstructure and substructure causing corrosion-induced cracking and spalling on the various structural elements of the 50-year-old bridge (Fig. 2).

In 2011, a detailed bridge inspection was carried out in accordance with the 2011 AASHTO Manual for Bridge Evaluation (Second Edition), and found that the structure was generally in good condition. However, several of the bridge components exhibited varying levels of deterioration due to corrosion of the embedded steel reinforcement which would require rehabilitation and subsequent regular maintenance.

Fig. 2: Column deterioration during the bridge inspection

The original design called for encapsulation of all columns from the pier cap to a height of 20 ft (6 m) and individual spall repairs on deteriorated concrete areas above that height. A spray-applied migrating corrosion inhibitor was also specified to help protect the column areas that were not being repaired. Soon after construction began, it was agreed that more value could be gained by totally encasing the columns above the 20 ft (6 m) height. As a result, most of the trowel-applied column spall repairs and the migrating corrosion inhibitor were eliminated from the project and instead the columns were totally encased with new, corrosion resistant concrete from top to bottom. This revised approach saved time, provided significant strengthening of the columns, and provided full protection for the column against corrosion by increasing concrete cover by 6 in (152 mm)

over 100% of the column surface area. In addition to providing corrosion protection by increasing column diameters, the concrete mix also contained corrosion inhibitor, silica fume, and polymer to provide a significantly higher level of corrosion protection than typical ready-mix concrete.

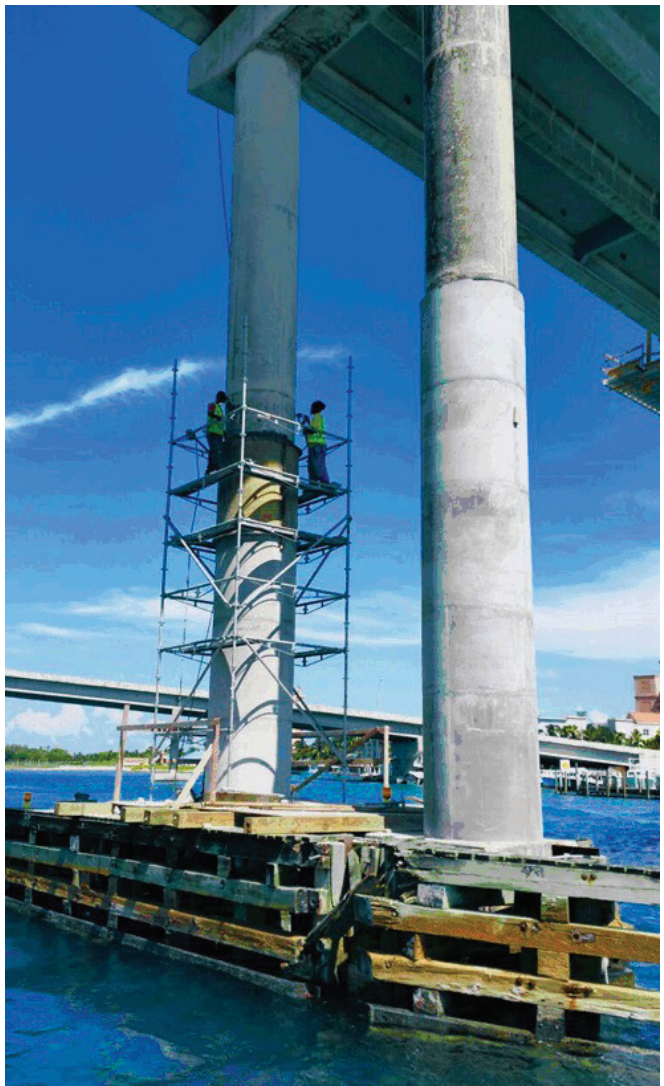
Fig. 3: Repair work at one of the columns

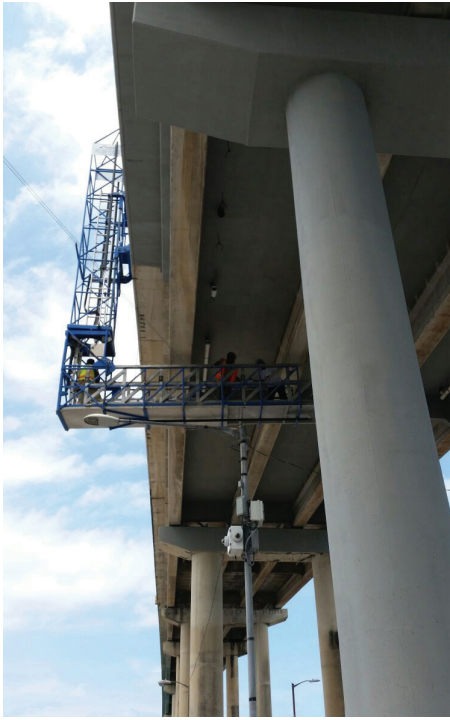
Fig. 4: Swinging platform to perform spall repairs and apply coating

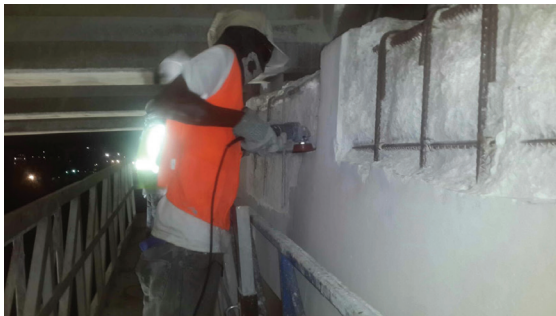
Fig. 5: Concrete repairs performed from swinging platform

In addition to the column encapsulation work, approximately 2,000 sf (185 sm) of isolated spalls on columns, beams, and piers were repaired utilizing a “trowel-applied” technique with a non-sag, polymer modified repair mortar with integral corrosion inhibitor. To get access to these areas, a trailer-mounted, retractable, self-propelled swinging platform was used and allowed workers to climb from the bridge deck to a secure working platform under the bridge deck (Fig. 4). From the platform, workers were able to perform hand-applied spall repairs (Fig. 5) as well as apply protective coatings.

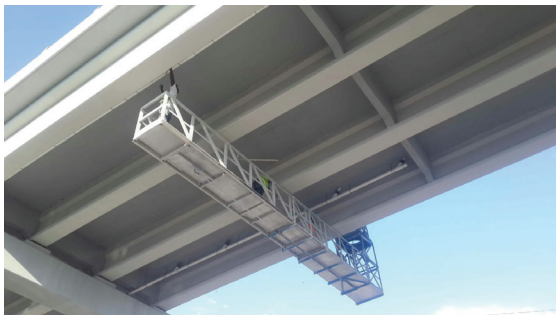
Fig. 6: Protective coating installation at bridge underside

To defend against chloride and moisture infiltration, a total of 220,000 sf (20,440 sm) of columns, beams, abutments, piers, and the underside of the bridge deck were protected with polymer-modified cementitious coating (Fig. 6). A secondary benefit of the protective coating was that it provided an aesthetically-pleasing finished product by giving the newly repaired bridge a monolithic/uniform appearance that made the bridge look new again.

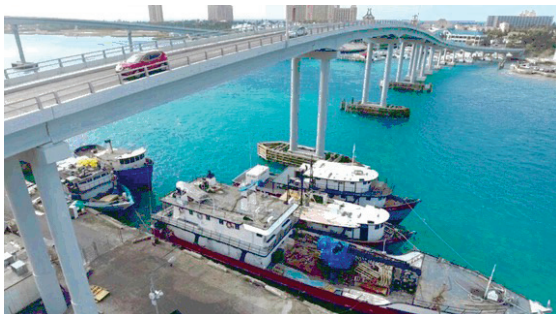
Fig. 7: Completed repairs at East Bridge

The Paradise Island East Bridge rehabilitation project was completed on time and for a fraction of the cost of replacement (Fig. 7). By using the right combination of methods and materials, and by choosing to not only repair but also protect the reinforced concrete against the deleterious effects of chloride-induced corrosion, it is expected that the service life of the Paradise Island East Bridge has been extended by 25 years. ■
