Plaza Deck Post Tensioning Repair, External Strengthening, and Waterproofing Rehabilitation

ALEXANDRIA, VA

SUBMITTED BY STRUCTURAL REHABILITATION GROUP, LLC

The Templeton of Alexandria Condominium Plaza Deck

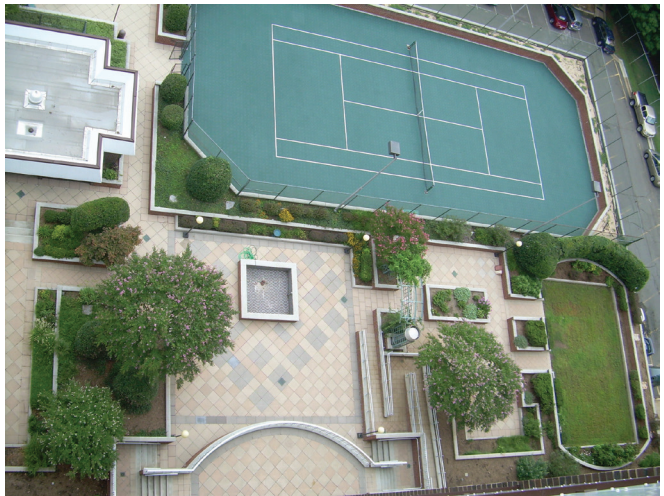
Fig. 2: Bird's eye view of the plaza (planters, pavers, soil and hardscaping)

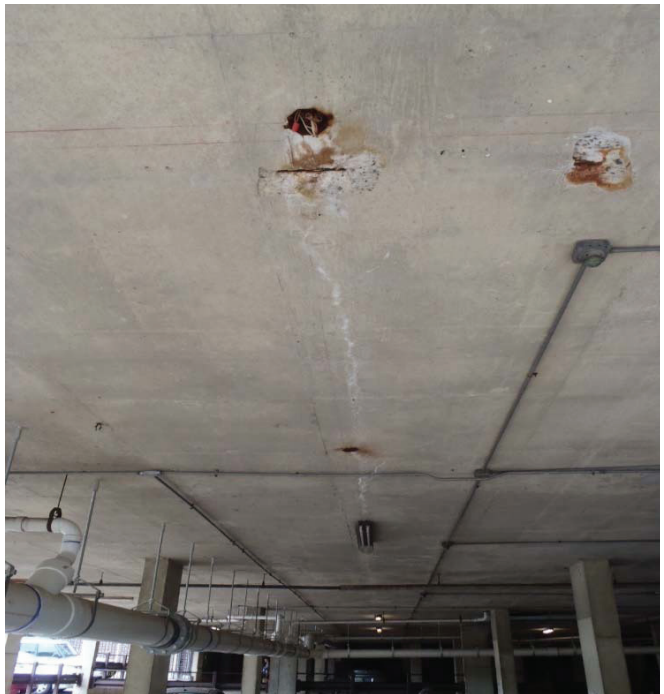
- The soffit of the post-tension plaza slab exhibited numerous areas of distress in the form of cracking and water leakage (Fig. 3); corrosion of embedded steel reinforcing, electrical conduits, and surface-mounted junction boxes; and leakage around drainage pipe penetrations;
- Discoloration of the concrete resulting from grease leaking from the un-bonded tendon sheath/covering; and
- 73 post-tensioning tendons were exposed, of which 13 were found to have lost post-tensioning force and 9 were found to have a partial loss of the stressing force.

Fig. 3: Cracking of the concrete slab aligned with the electrical conduits at mid-span

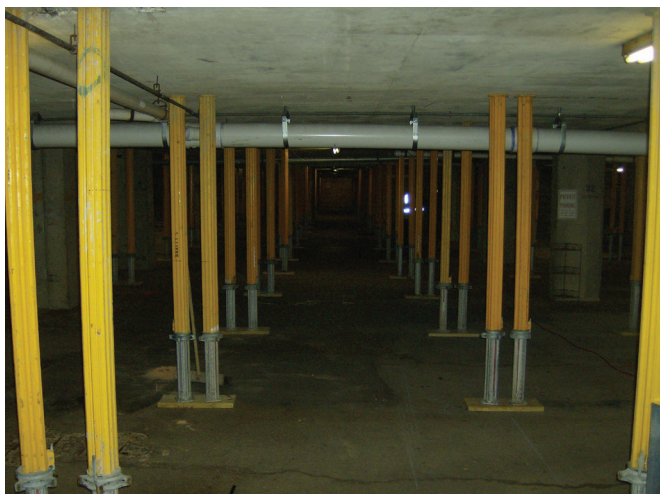
Fig. 4: Shoring for plaza during the emergency load reduction phase

The vehicular parking was closed under the plaza deck below the greenscaped and landscaped areas. Shoring was installed (Fig. 4) and a zero live load plaza restriction was mandated for the area, so the parking bays below the tennis court area could be reopened. The plaza level remained closed to pedestrians; however, pedestrian access at the garage level was restored in a defined walkway to accommodate building access.

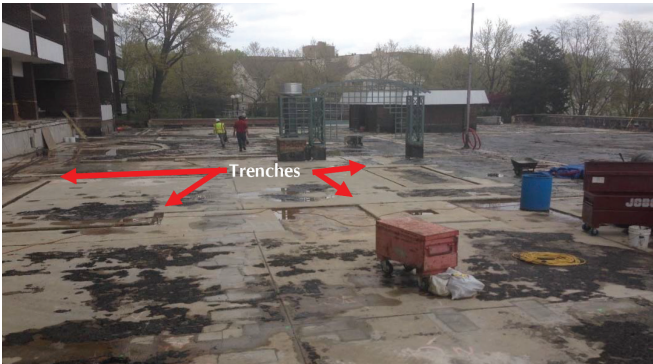
When the emergency load reduction work was completed, it was revealed that the renovation performed in the 1990s included the addition of concrete topping materials to enhance drainage (Fig. 5). A network of troughs/trenches remained where the prior site walls existed. These troughs were problematic in detailing the waterproofing system, and the topping slab/overlay represented additional dead load on a deck that was already overloaded and under-designed. In evaluating the options to address the topping/deck profile issues, three remedial options were considered including removing all toppings down to the structural deck, leaving the existing topping in place and infill the trough/trench areas, and leaving the existing topping in place and prove by testing and analysis that the toppings were acting compositely with the existing structural slab. The topping slab pull off tests revealed sufficient adhesion to confirm that the toppings were well bonded and could be considered to be acting compositely with the structural slab.

Fig. 5: Plaza demolition revealed topping slabs that overlaid the structural deck

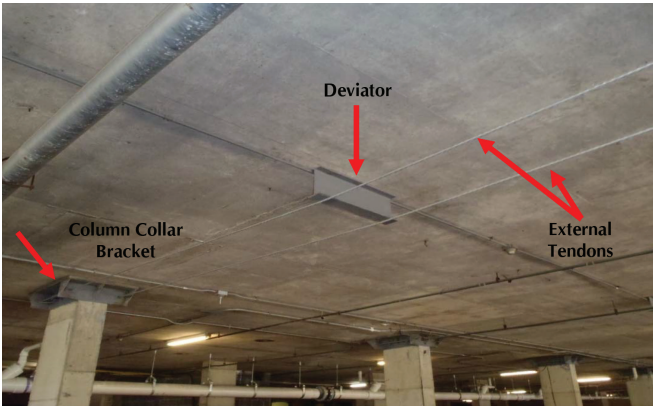
Fig. 6: Steel column collar brackets and intermediate deviators were installed

The use of external strengthening at targeted bays with longer spans facilitated the repurposing of the elevated plaza structure with increased capacity to accommodate the Owner's desired amenities and hardscaping/landscaping. Steel column collar brackets were installed to anchor the tendons and provide supplemental shear reinforcement at the column-to-slab connections. Mid-span deviators were installed to provide sufficient profile geometry for the tendons while maintaining head room in the garage space (Fig. 6).

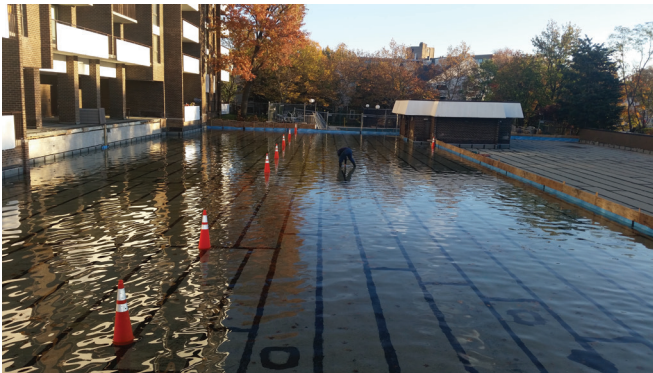
Fig. 7: Up slope hydrostatic water test performed to validate the waterproofing system installation

The plaza deck was then covered with a reinforced hot rubberized asphalt membrane and the membrane was covered with an aggregate surfaced cap sheet as a protection layer (Fig. 7).

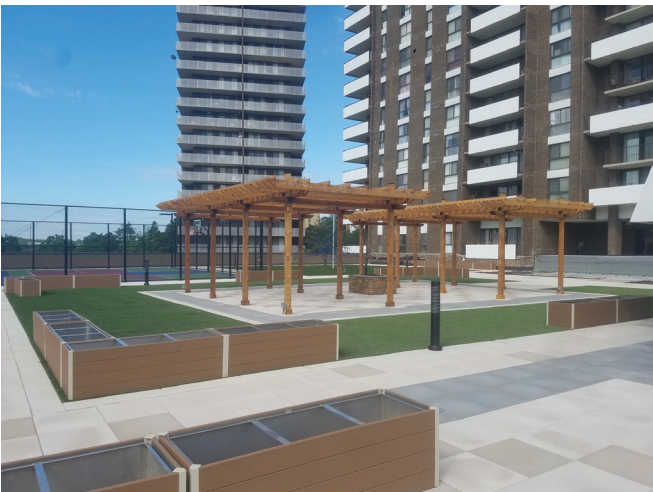
Fig. 8: Completed amenity space with hardscaping

The achieved results included a greatly extended service life, reduced future maintenance costs of the plaza deck/garage structure, and the opportunity to create an updated amenity space that will be serviceable and serve the building users well into the future (Fig. 8). The plaza has become an active and vibrant centerpiece for the occupants of the building, revitalizing the plaza into a meeting place and outdoor activity center for the community. ■
