# Post-Tensioned Garage Repairs

TORONTO, ONTARIO, CANADA  
SUBMITTED BY EDISON ENGINEERS, INC.

*Underground parking garage structure at 275 Bamburgh Circle in Markham, Ontario.*

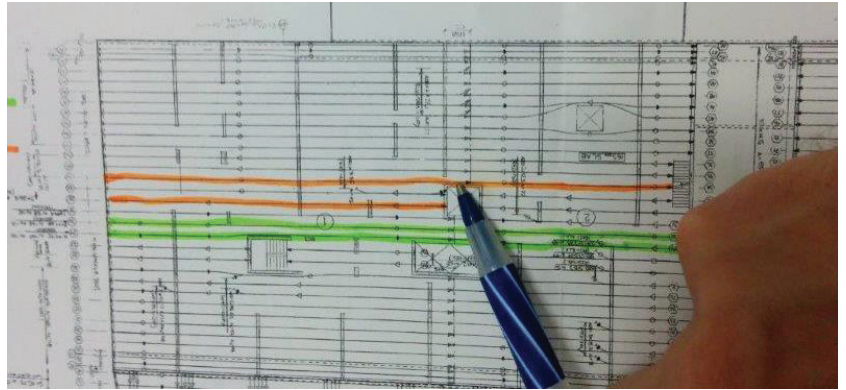
PT shop drawings were located in archived files from the original structural designer. Using these drawings, cables could be easily identified and located and made the investigation process more efficient (Fig. 1). During the garage assessment, a visual review was performed to identify locations where PT cable deterioration is more likely, such as leaking expansion joints. Forty-four (44) cables were assessed using penetration testing with a screwdriver and hammer. The test involves trying to wedge a flat-head screwdriver between the wires in a PT cable (Fig. 2). If penetration is achieved, the cable is likely not tensioned enough. The PT cables were categorized as totally loose, appears under-stressed, or appears adequately stressed. Three PT strands were found to be totally loose and in need of repair.

Fig. 1: Marked up PT shop drawing

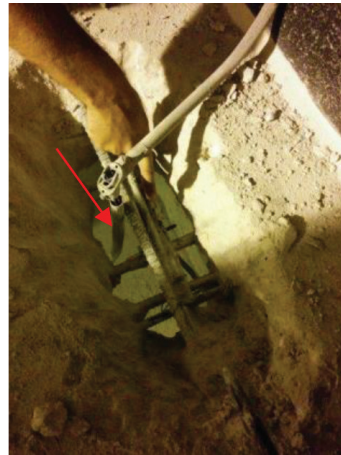
Previous contractors' work had apparently drilled, cored, jackhammered and cut concrete without knowing that the slab was post-tensioned. At one location, the rupture location was traced back to a slab penetration for an electrical conduit (Fig. 3).

Fig. 3: Electrical conduit (red arrow) and PT cables from top of slab

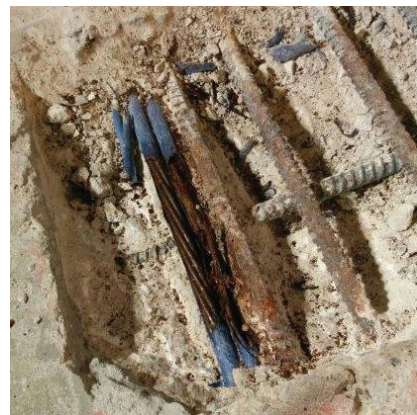
Finally, there were previous concrete repair areas that were found to be the source of PT cable deterioration (Fig. 4). The cables that intersected these repairs were severely corroded, the sheathing was damaged, and no waterproofing protection was applied to the surface. This condition allowed water and chlorides to reach the cables, causing aggressive corrosion.

Fig. 4: Localized corrosion in previous concrete repair

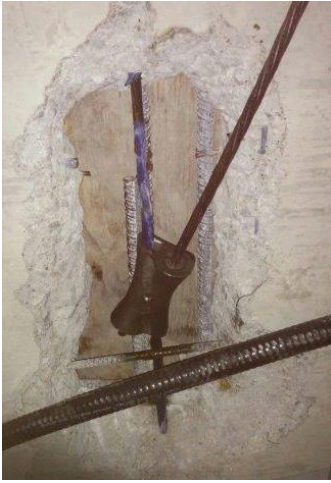
Fig. 5: "Dogbone" splice coupler

For cables that had been damaged by drilling but were otherwise in good condition, a splice repair was completed (Fig. 5), and the remainder of the cable including the anchors were salvaged. This repair saved time and was more economical than cable replacement.

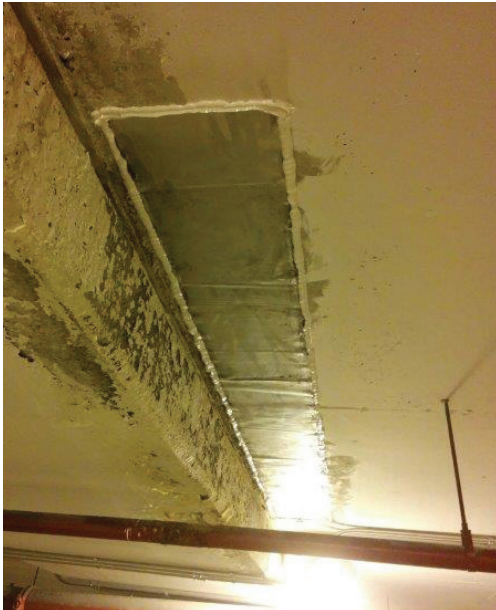
Fig. 7: Sacrificial zinc sheet at slab soffit

One area included corroded anchors and cables along a construction joint in the slab. In order to safely repair the hollow sounding (delaminated) concrete at the intermediate anchors, fifteen (15) existing cables were de-tensioned and re-tensioned following the repairs. Temporary shoring would have been needed along the entire length of the affected cables. In order to avoid this costly repair, a zinc sheet was installed on the soffit of the slab (Fig. 7) to sacrificially corrode instead of the anchors and cables. Holes were drilled through the slab to reach the bottom of the anchors, and the zinc sheet was electrically

connected to the intermediate anchors. The zinc sheet was approximately 20 ft (6 m) long. This repair provided a safe, cost-effective and timely solution for the Owner. The cables connected to the zinc sheet have test openings that can be re-tested in the future to check their tension. Eventually, the zinc sheet will need to be replaced but in the meantime, it will help protect the PT anchors and cables from corrosion.

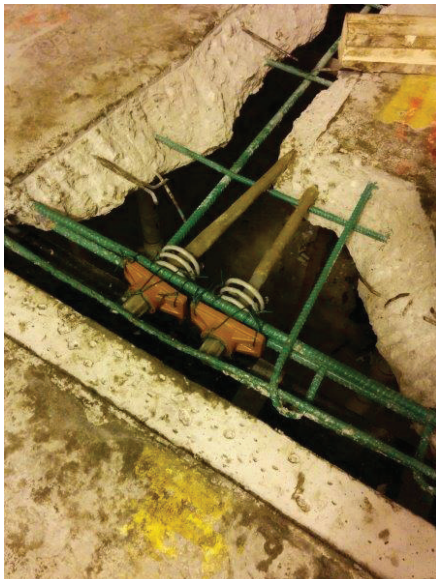
Fig. 8: New encapsulated PT anchors at expansion joint

Where new anchors were required, fully encapsulated and watertight anchors were installed (Fig. 8). Caulked expansion joint seals, that had failed many years ago, were replaced with new preformed neoprene glands.
