# AWARD OF EXCELLENCE

HIGH-RISE CATEGORY

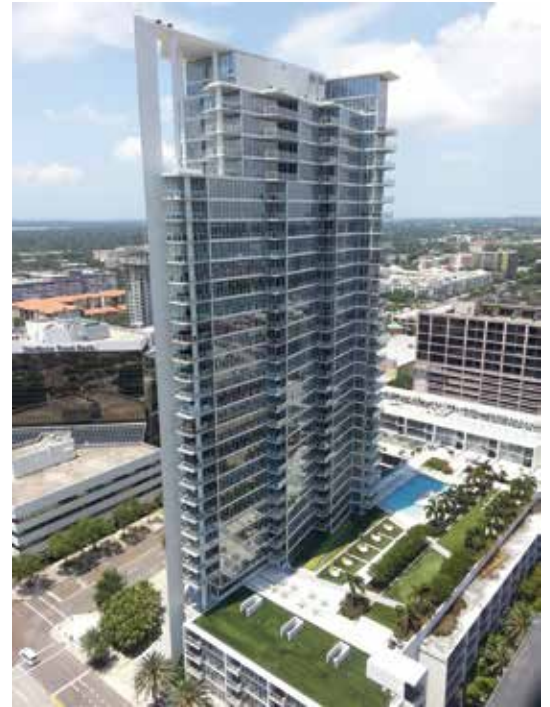
Fig. 1: Signature Place Condominium

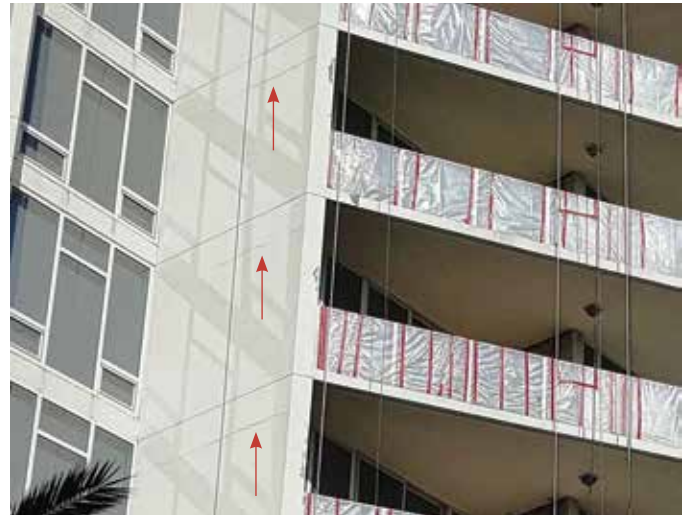
Fig. 2: Cracks in stucco on every floor at bottom of turndown beam to top of wall

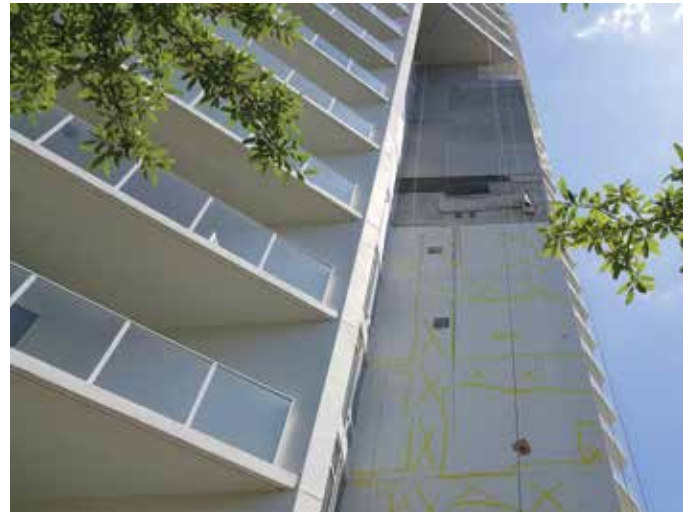
Fig. 3: Stucco marked up for removal after sounding

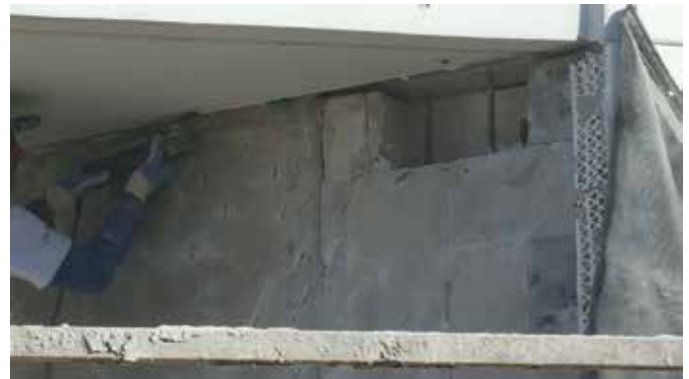
Fig. 4: CMU reinforced cells missing grout

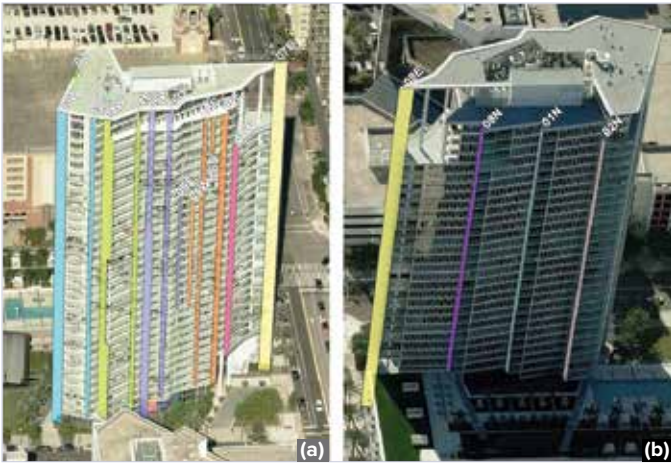
Fig. 5: Graphics showing shear wall elevations planned for repair: (a) south elevation, and (b) north elevation

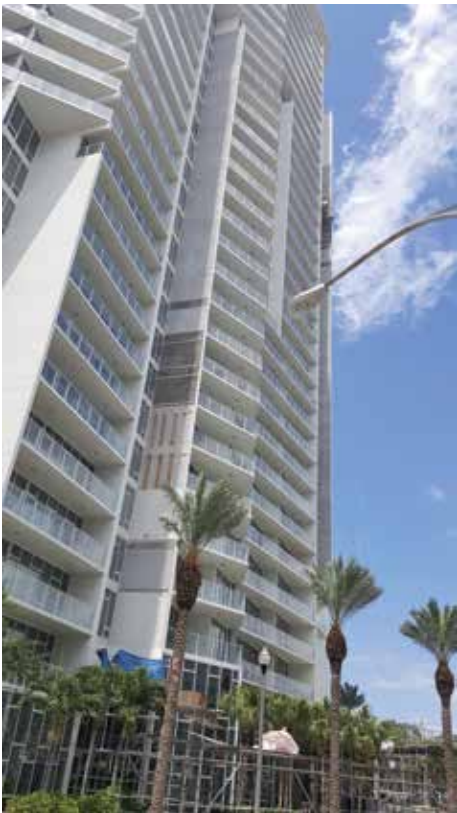
Fig. 6: Shear wall under various phases of repair

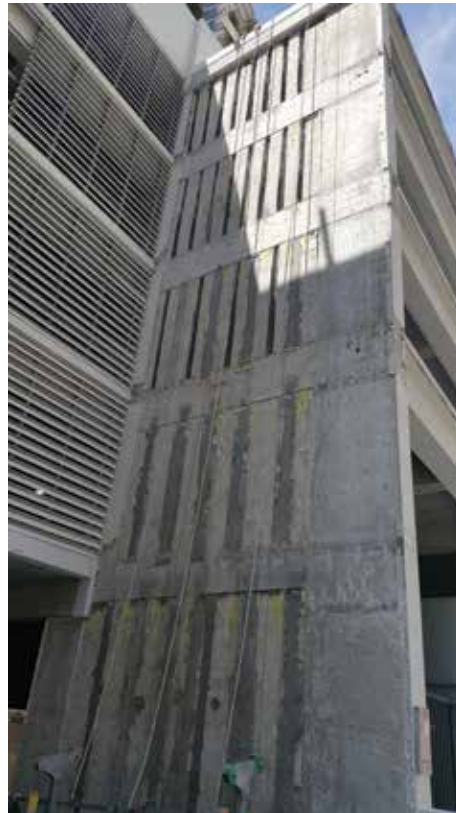
Fig. 7: Parking garage shear wall/barrier wall being reinforced

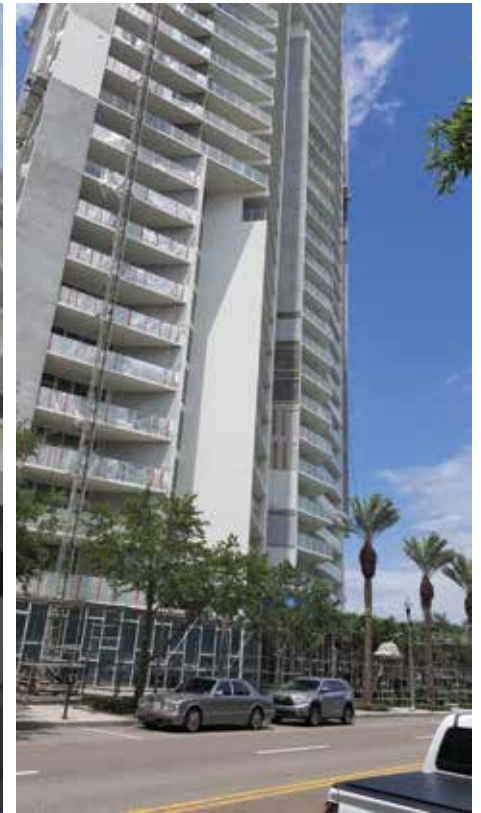
Fig. 8: Stucco replacement, CMU grouting, guardrail protection, overhead protection, and mast climber/swing stage access
