FINALIST - 2018 PROJECT OF THE YEAR

Smithfield-Liberty Helix Ramp Rehabilitation

PITTSBURGH, PA

SUBMITTED BY CARL WALKER CONSTRUCTION, INC.

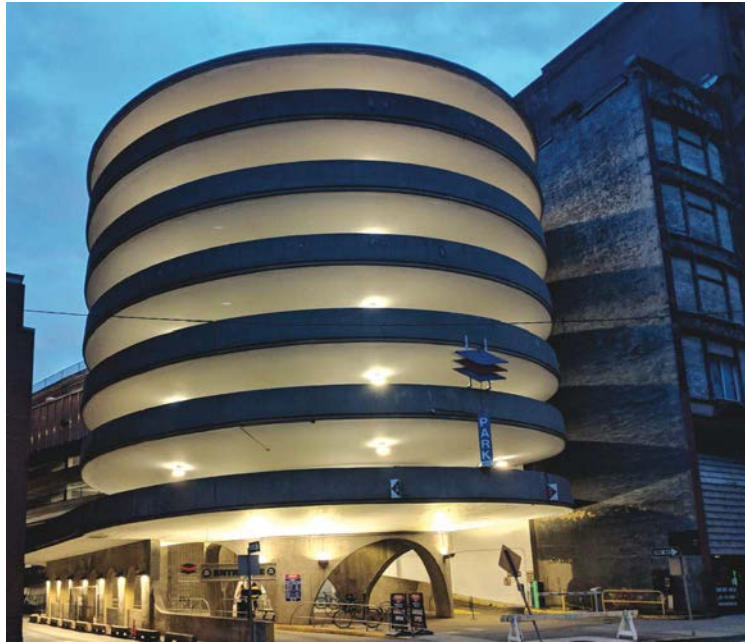
Fig. 1: Smithfield-Liberty Helix Ramp

The rehabilitation of the Smithfield-Liberty Parking Garage was undertaken in 1997 and, over 20 years later, the structure exhibits no additional deterioration (Fig. 1). Exposed to several hundred cars each day, this critical structure was rehabilitated using materials and methods designed and installed to provide a long-term service life. The success of the project is best evidenced by the fact that no additional structural repairs or rehabilitation have been required since the work was completed. The design and construction processes used to complete this project in the late 1990s is a testament to the longevity that the project has enjoyed. Based on its current state of performance, it is expected that the ramp will likely experience another 20-year extension of service life without the need for any significant attention.

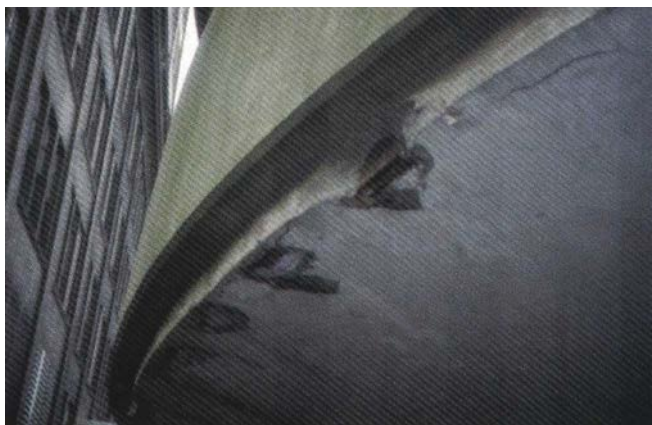
In late 1996, an evaluation of the helix ramp was performed to establish the cause of the observed distress in the structure. The evaluation included a condition assessment of the structure to record visible surface defects including cracks, spalling, and exposed corroding steel elements (Fig. 2); concrete material testing including petrographic analysis, concrete compressive strength testing, acid-soluble

After evaluating the results, the cause of the distress in the structure, consisting of delamination and spalling with exposed reinforcing steel, was determined and three primary causes for the observed distress were identified:

1. The distress recorded on the top of the ramp slabs was determined to be caused by high chloride ion levels in the lower five levels of the six-level ramp. On these levels, chloride contents exceeding the threshold amount necessary to induce corrosion of the reinforcing steel were found in the top 2.5 in (64 mm) of the slab.
2. The distress observed on the underside of the ramp slabs was caused by cracking at old repair areas in the top slab.
3. For the deterioration occurring on and below the concrete knee walls, insufficient concrete cover on the steel reinforcing and plates was identified as the cause of the distress.

Fig. 2: Original slab edge deterioration

To address the underside slab condition and water infiltration problems, conventional partial-area repairs were recommended

in conjunction with the application of a hybrid polyurethane fluid-applied membrane with epoxy wear course and specialized aggregate on the ramp top surface. The repair material recommended for the underside slab repairs was a polymer-modified cementitious material to facilitate use of the form-and-pump repair technique (Fig. 5 and 6). The repair material was selected to have compressive stiffness characteristics that closely matched that of the existing concrete. This was necessary to provide uniform compressive stress distribution throughout

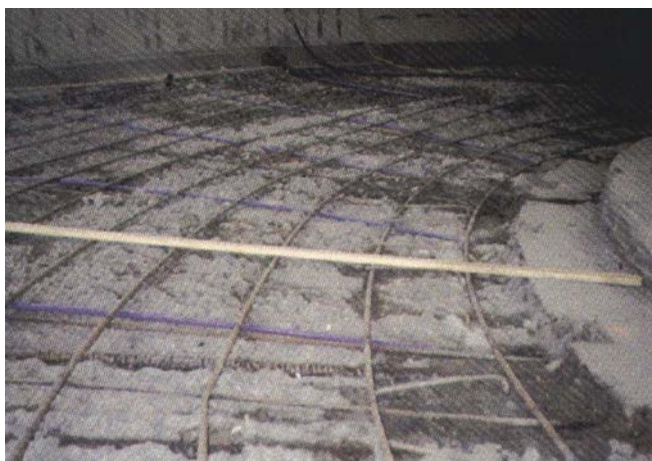
Fig. 3: Demolished ramp slab surface with supplemental post-tensioning cables installed throughout central cylinder

To address the chloride ion content problem with the ramp slabs, removal and replacement of the top 2.5 to 3 in (64 to 76 mm) of the concrete floor slab was selected to offer a long-term service life expectation. This solution represented a potential structural problem, however, given that the slab was post-tensioned. Prior to being able to recommend that the top portion of the slab be removed, a structural analysis was necessary to determine the post-tensioned reinforcing forces on the original slab section, the reduced slab section (once the top portion of the slab was removed), and the final slab section (with the original slab and new topping slab). Upon completion of the analysis, it was determined that the top slab section could be removed if the perimeter of the ramp was shored and supplemental post-tensioned cables were added to the final cross-section (Fig. 3 and 4).

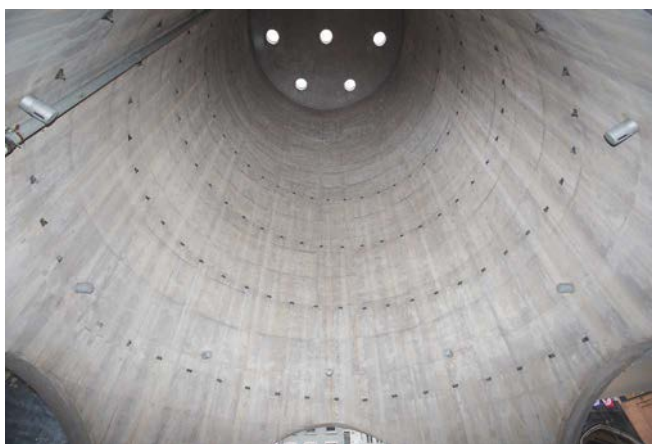
Fig. 4: Exposed post-tensioned tendon anchor heads at central cylinder

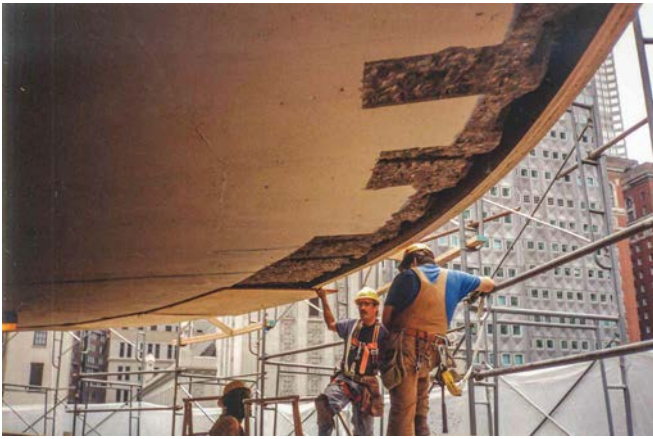
Fig. 5: Slab edge soffit demolition and formwork

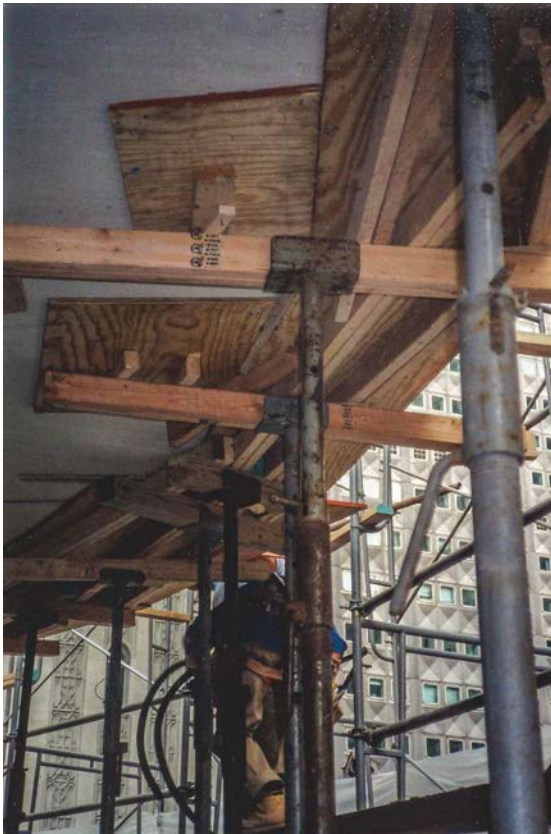
Fig. 6: Slab edge formwork and shoring

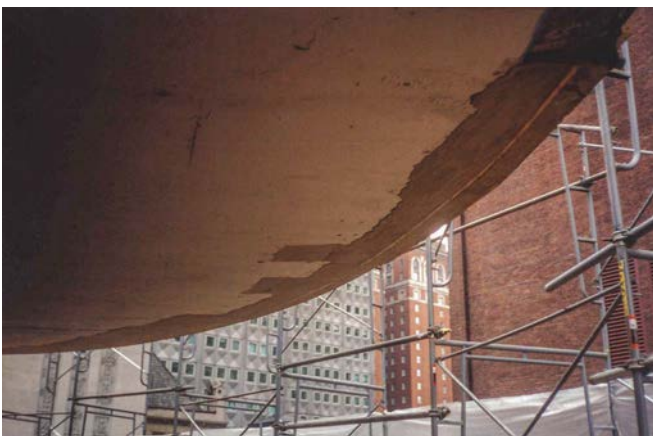
Fig. 7. Completed slab soffit repair with integral drip edge

To address the concrete cover problem on the post-tensioned reinforcing anchor plates on the perimeter of the ramp, a new concrete cap was installed to provide suitable cover for the plates. In addition, a drip edge was provided to prevent water from running down the underside of the ramps (Fig. 7). Although this repair detail reduced the depth of the reveal at the slab perimeter, the architectural appearance of the ramp was not significantly changed. To address the concrete cover problem on the existing reinforcing steel in the knee walls (Fig. 8), the repair areas were slightly over-built to obtain suitable concrete cover on the reinforcing steel.

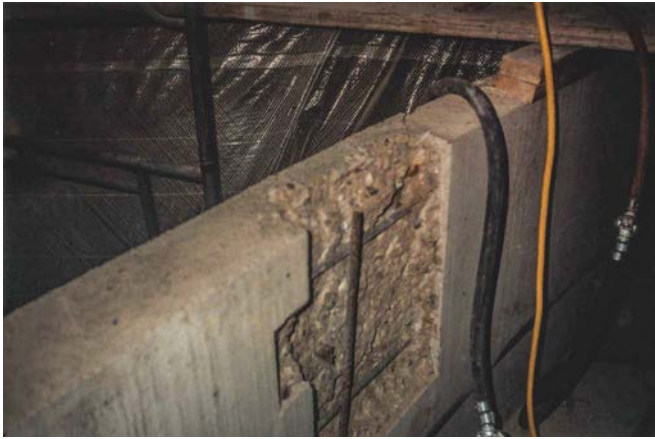
Fig. 8: Knee wall vertical repair demolition

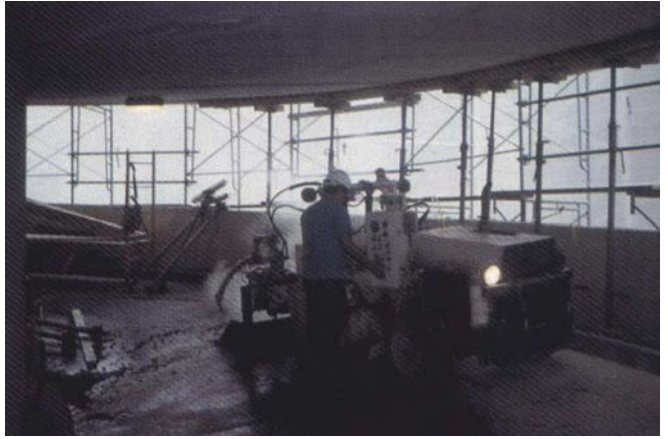
Fig. 9: Hydrodemolition of upper concrete layer at ramp slab

Once parking traffic was re-routed, the helix ramp was closed, and construction commenced. Given the aggressive construction schedule and limited work area, methods to expedite the repair process were implemented. The primary time-saving measure utilized during the rehabilitation was hydrodemolition, which is a process utilizing water under very high pressure (about 10,000 psi [69 MPa]) to demolish concrete (Fig. 9). This method was used in lieu of conventional jackhammers to remove the top section of chloride-contaminated concrete on the ramp slabs and resulted in significant time savings.
