# South Carolina Department of Natural Resources, Marine Resources Research Institute: Concrete Repair and Protection to the Wet Lab Areas—10 Years Later

COLUMBIA, SOUTH CAROLINA

SUBMITTED BY SIKA CORPORATION

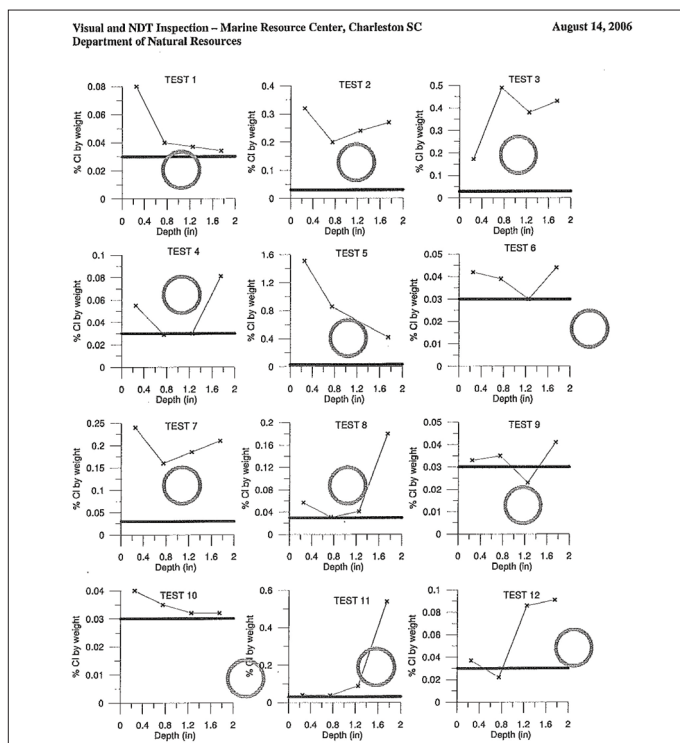
In the summer of 2006, an extensive visual and non-destructive testing (NDT) investigation was conducted on the concrete floor slabs, beams and columns at two locations that house the wet labs. The investigation included visual inspections and rapid chloride testing (Fig. 2), half cell potential, the use of ground penetrating radar and a cover meter.

It was determined that the root cause of the steel corrosion and resulting spalling was high chlorides and, in some cases, insufficient concrete cover. This situation was exacerbated by the marine environment in which the building is situated, as well as the saltwater tanks within the building and the routine washing of various areas throughout the lab.

Fig. 2: Chloride profiles for test locations 1-12 (the circle indicates the location of the first layer of reinforcement—the vertical scale varies between the plots)

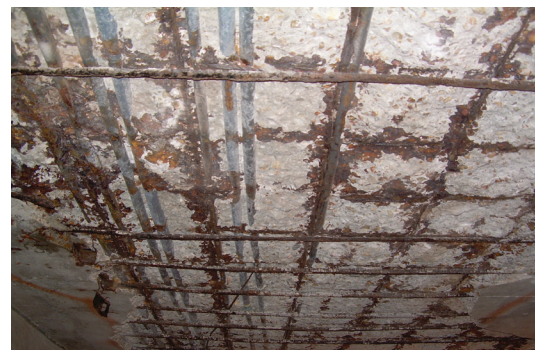
The visual investigations in both 2006 and 2008 found several degraded structural conditions, including deteriorated reinforcement, spalled concrete (Fig. 3), cracked concrete,

and rust-stained concrete. The 2008 destructive investigation uncovered many areas in which 25-50% section loss of the reinforcing steel had occurred. Some areas had complete section loss of the reinforcing steel. Approximately 20% of the 50,000 sf (46,45.15 m<sup>2</sup>) building required concrete repair.

Fig. 3: Underside spalling and steel corrosion

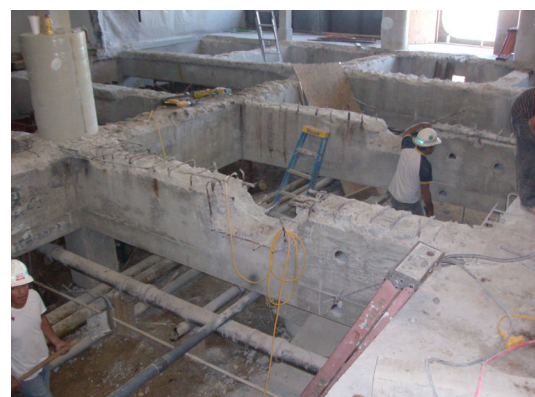
Fig. 4: Demolition at Lab A

Wet Lab Area A required complete removal of the concrete slab and the upper 5 in (125 mm) of the beams and girders (Fig. 4 and 5). Due to the connection of the new floor slab reinforcing being tied to the existing beam reinforcing, 100 sacrificial galvanic anodes were installed to reduce the effects of incipient anode corrosion. The new ready-mix concrete (approximately 50 cy [38 m<sup>3</sup>]) design included a corrosion-

inhibiting admixture to provide additional protection for reducing the incipient anode effect throughout the entire slab replacement areas.

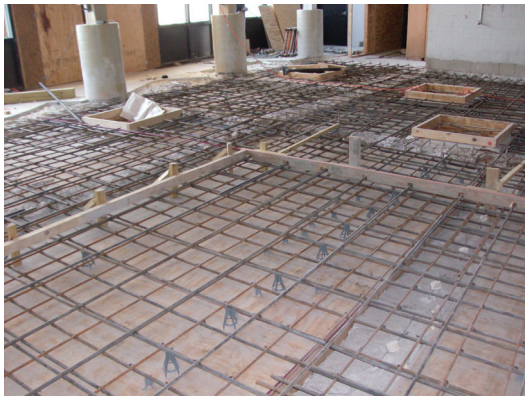
Fig. 5: New slab formed with new reinforcing steel

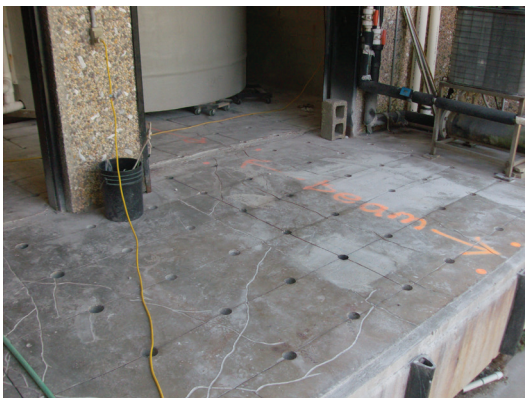
Fig. 6: Core holes and slots for galvanic protection in Lab B, 2010

It was determined that Wet Lab Area B did not require complete floor slab removal, but long-term corrosion protection was required. Due to the high levels of chlorides in the concrete, another system of sacrificial anodes was installed. Six hundred and thirty-four (634) anodes were installed by laying out the steel reinforcement grid, core drilling 2 ¼ in (57 mm) diameter holes approximately 3 in (75 mm) deep connecting them, 10 to a run, with a connection to the reinforcing steel made at the start and end of each run (Fig. 6).

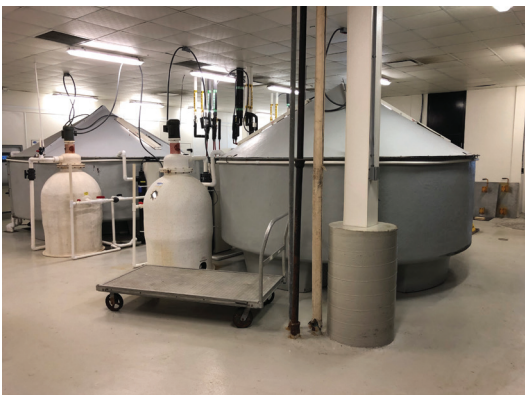
It has been over 10 years since this project was completed (Fig. 7). A recent visit to the site and discussion with the owner confirm the repairs are still performing. This project is an excellent testimony that when industry-proven practices are implemented, long-term durability is not only possible but probable!

Fig. 7: Lab A in 2020
