2019 PROJECT OF THE YEAR

The Île-aux-Tourtes Bridge Rehabilitation

MONTREAL, QUEBEC, CANADA

SUBMITTED BY SIKA CANADA, INC.

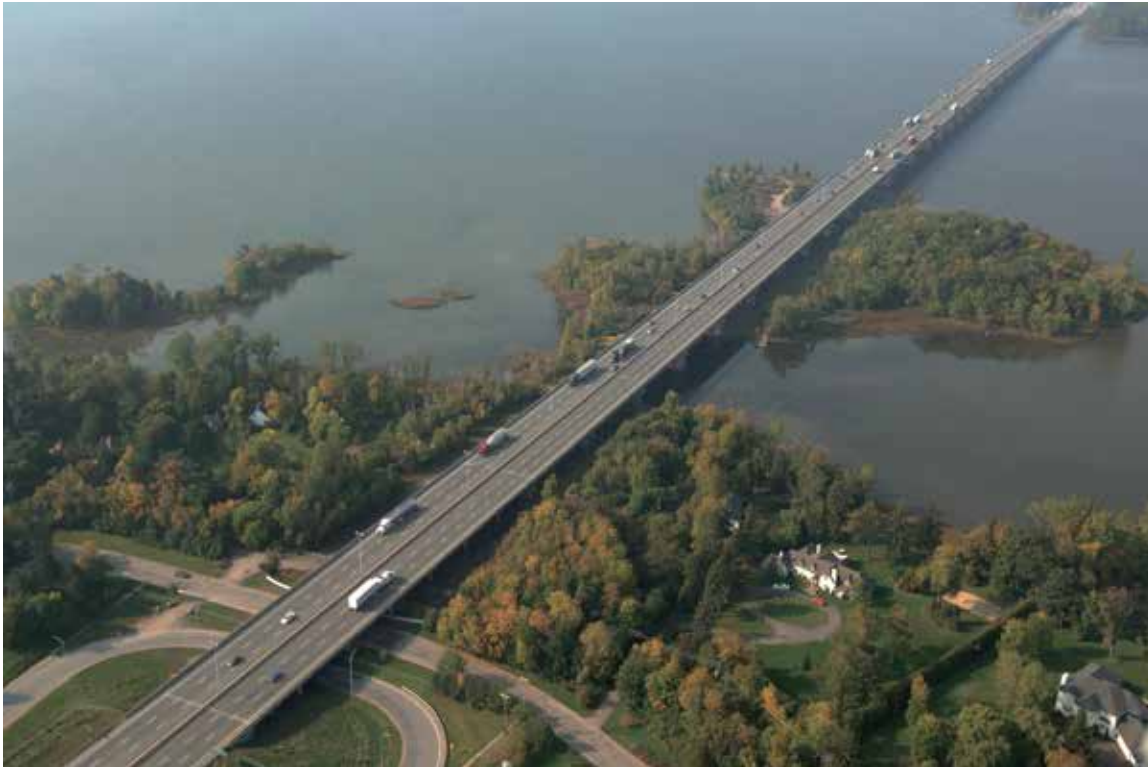
Fig. 1: The Île-aux-Tourtes Bridge

In 2017, the 54-year-old structure exhibited signs of deterioration at some girders and slabs, and the Ministry of Transportation of Quebec (MTQ) contracted for the reinforcing of two post-tension box girders over the Île-aux-Tourtes Bridge seaway. The construction segment began in mid-2017 and was completed in early August 2018.

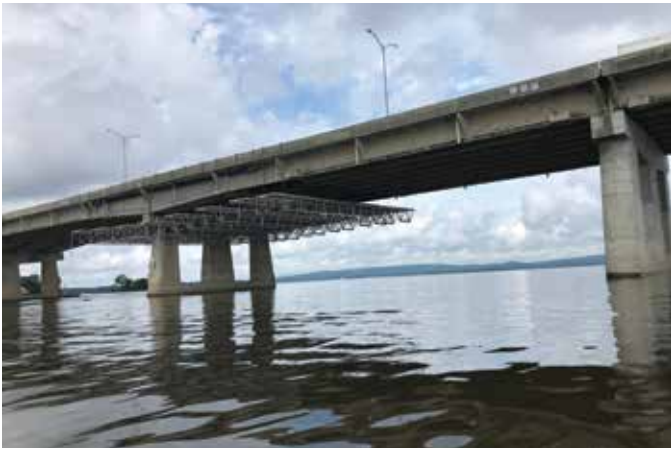
Fig. 2: Working platforms over the maritime corridor

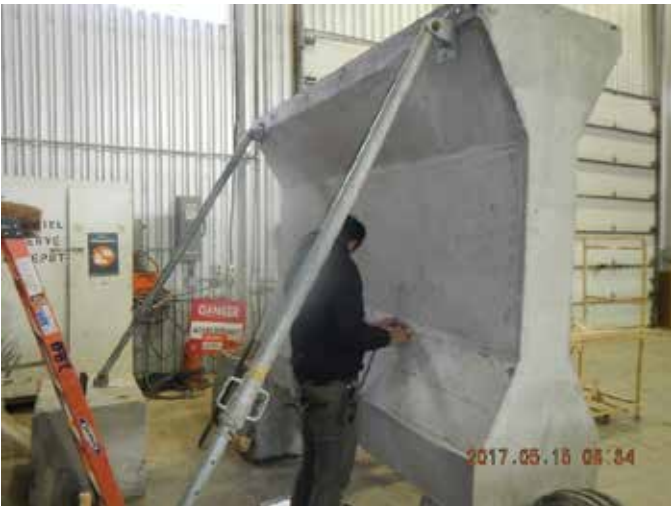
Fig. 3: Test beam

A small-scale girder section was produced in a factory to reproduce all girder work steps required (Fig. 3). This was specified by the designer to validate the contractor drilling template, hole preparation, 3D scanning, CFRP steel plate drawing, and the anchor plate installation. Once the test beam work was approved, the contractor started the on-site bridge rehabilitation work.

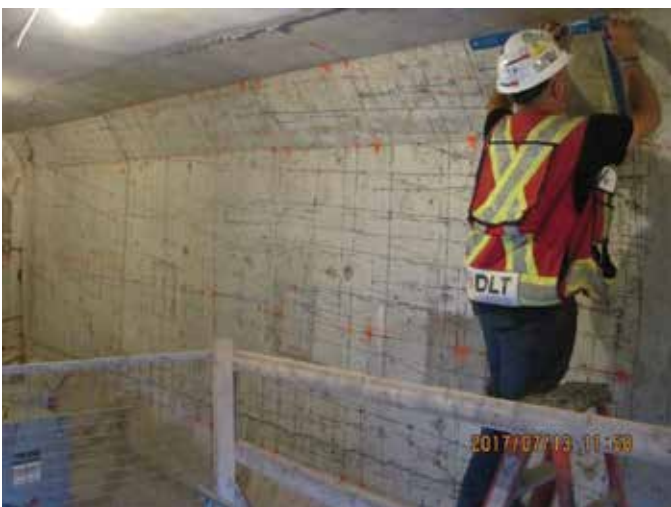
Fig. 4: Rebar and strand identification

The internal steel rebars and prestressing cables were located by radar detection to prevent damaging them during the drilling operation in the girder web, flanges, and top slab. All anchor plate holes and EPT steel block anchor hole locations were identified prior to the drilling operation (Fig. 4). This step was crucial because the CFRP strip locations were identified along with the required anchor holes for each plate.

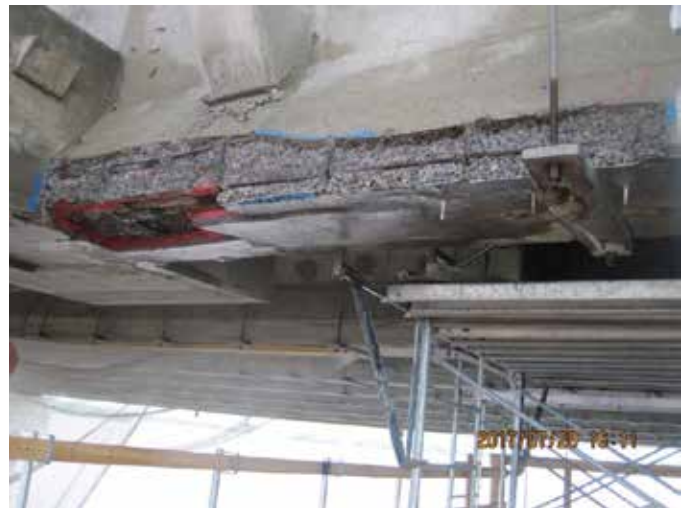
Fig. 5: Typical lower flange girder concrete demolition

The areas to be repaired were prepared to an ICRI surface profile of CSP 6 to 10. Prior to concreting, an anti-corrosion coating was used on the previously exposed rebar. High performance mortar was then used for girder repairs (Fig. 5 and 6). Web thickening locations for future EPT steel blocks were made with self-leveling concrete using mixed packaged materials to avoid a long curing process. CFRP strips were applied within 36-48 hours after concrete placement.

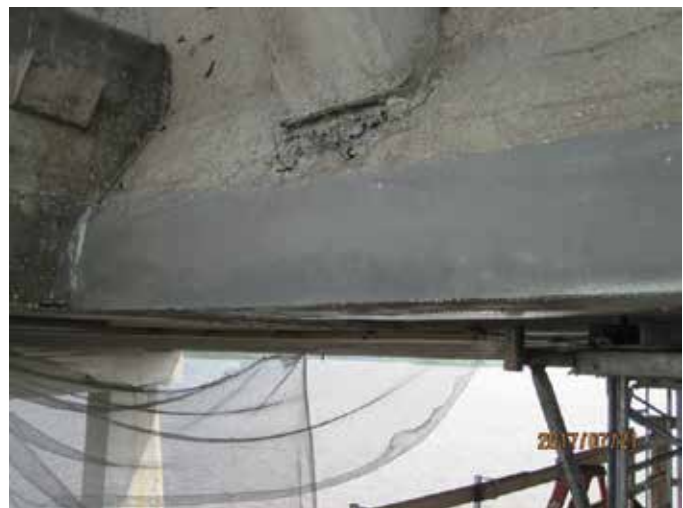
Fig. 6: Repaired girder using mortar concrete

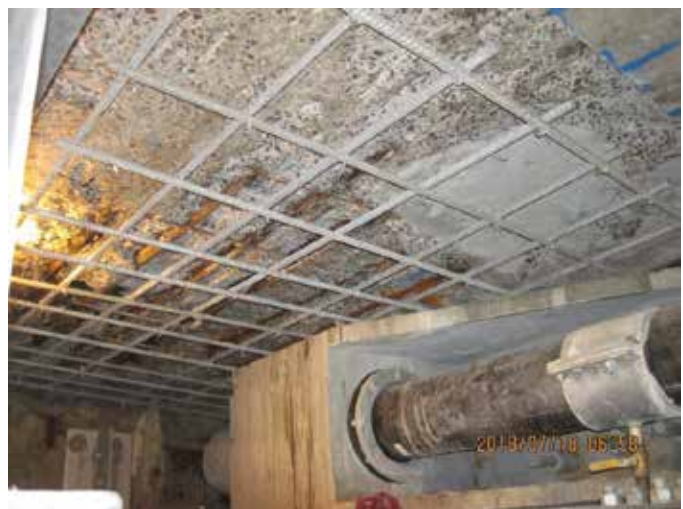
Fig. 7: Underside heavy duty slab repair prior to adding forms, concrete and steel deck and transverse beams

Heavy-duty slab repair utilized ultra-fast hardening self-leveling concrete placed from the top of the deck. This limited the bridge lane closure at night to about 30 minutes. Several areas of the slab had to be repaired by creating an extra thickness on the underside of the slab (Fig. 7). Cracks in the bridge slab and girders had to be repaired before the low-viscosity epoxy crack injection (Fig. 8).

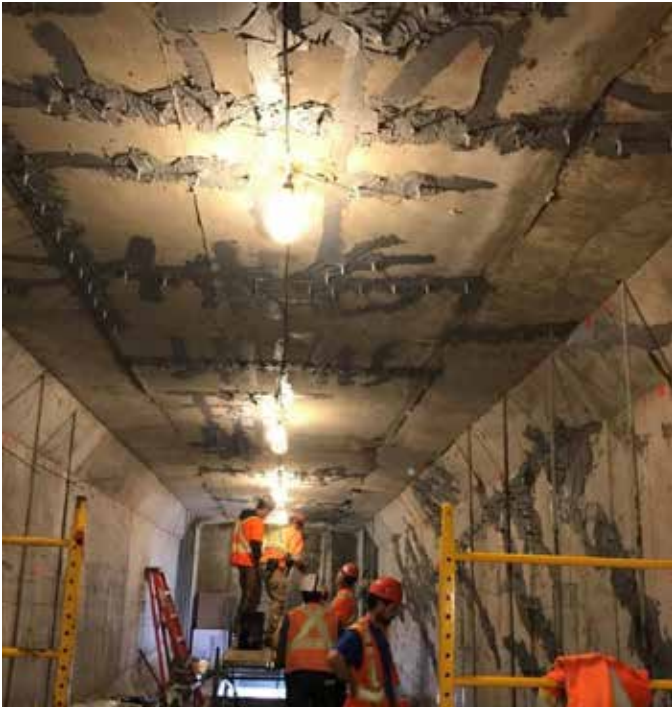
Fig. 8: Crack injection preparation

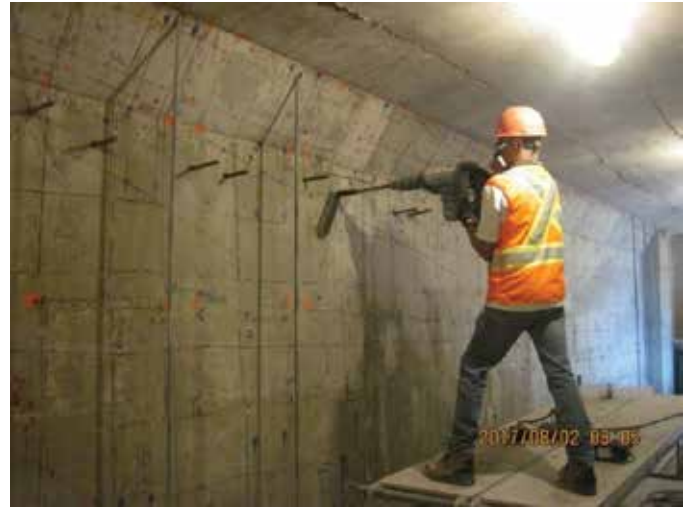
Fig. 9: Steel CFRP anchor plate horizontal hole drilling

1-1/8 in (28.6 mm) diameter vertical holes were drilled into the girder top and lower flanges (Fig. 9) to insert 1 in (25.4 mm) diameter anchor rods (4 required per CFRP anchor plate). The vertical anchor rods were designed to carry the CFRP strip tension load while the horizontal anchor rods were designed only to prevent the CFRP plate from web normal displacement (secondary bending due to vertical rod offset from web plane). These horizontal holes were filled with grease to only carry tension loading with no shear loads from CFRP strips. A total of 1,024 vertical anchor rods and 512 horizontal rods were required for the installation of all CFRP anchor plates. Holes were oversized to facilitate the on-site plate installation and were designed in tension only.

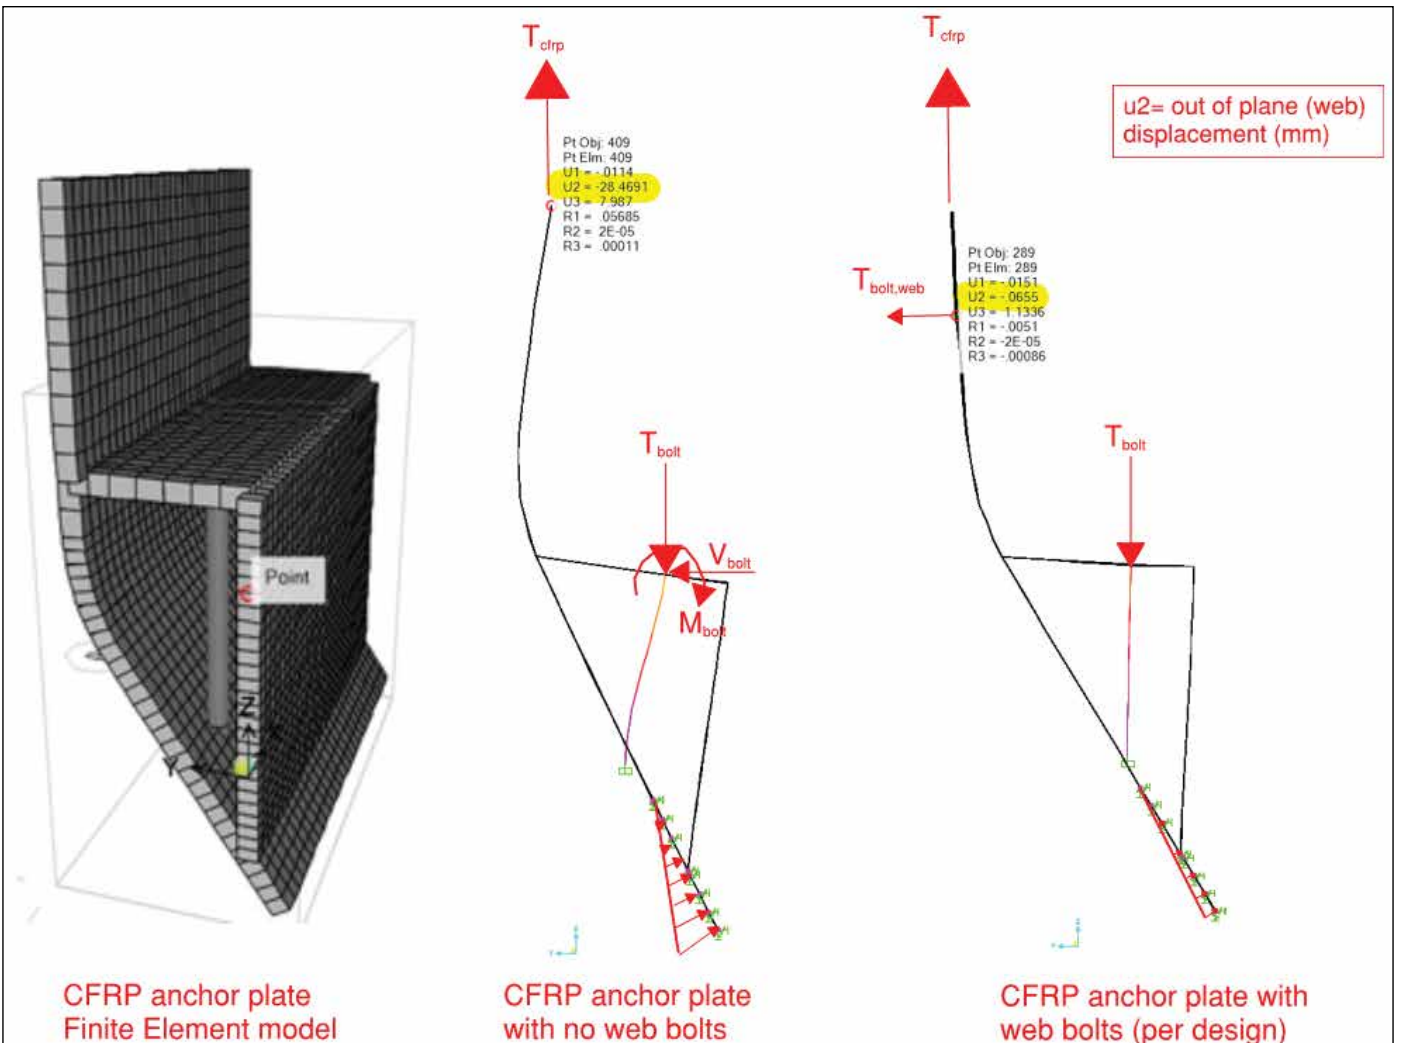
Fig. 10: 3D Steel CFRP anchor plate analysis model

Plates were designed using the latest 3D technology, design software, and 3D scanning to ensure proper fit in the field (Fig. 10 and 11). This step was important to assure that anchor plates matched the existing girder geometry which differed at many locations due to previous damage or repairs. Plates were bonded with a thixotropic epoxy to provide a contact surface to the CFRP fabric before torquing bolts (Fig. 12).

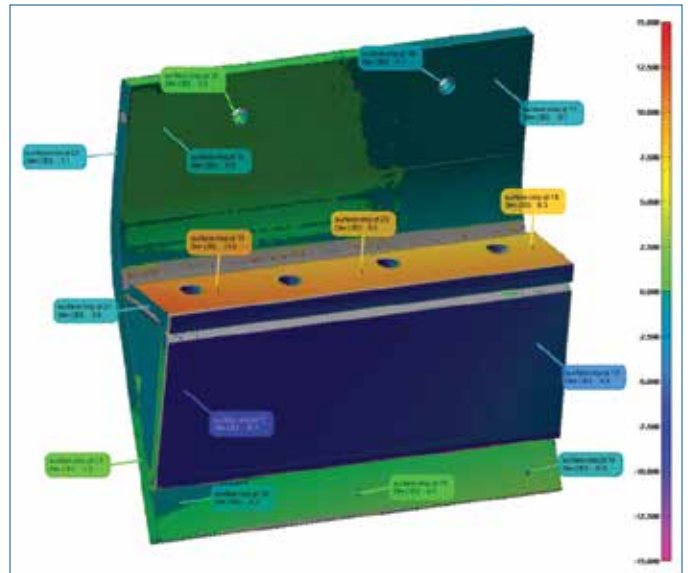
Fig. 11: 3D scanning of parts to generate 3D CAD models to correspond with girder profile

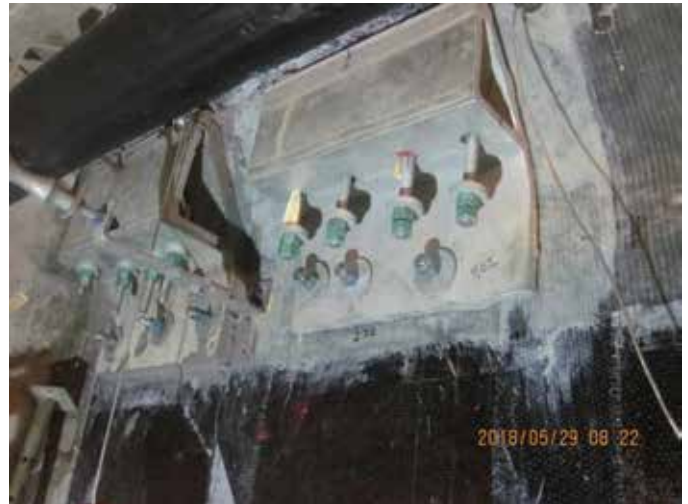
Fig. 12: Steel CFRP anchor plates

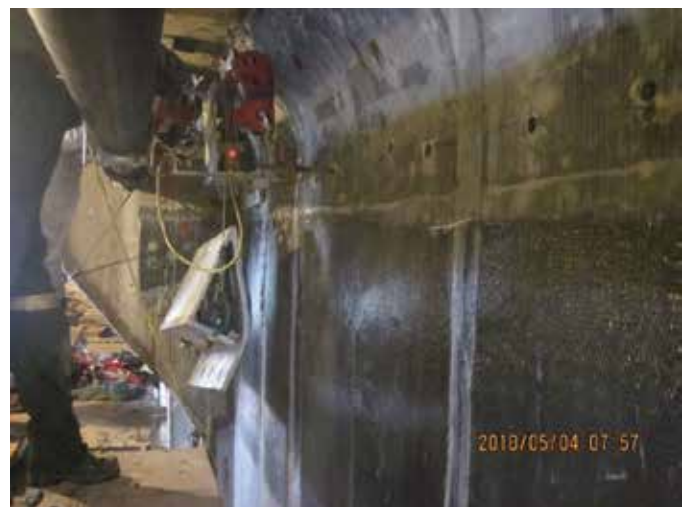
Fig. 13: Installed CFRP strips

A very high density fabric (1385 g/sm) was used for shear strengthening in both negative and positive moments. The entire length of the two girders was reinforced with CFRP fabric (Fig. 13). The girder shear CFRP strengthening used 2 plies of fabrics while the dap ends used up to 6 plies due to the higher required load capacity.

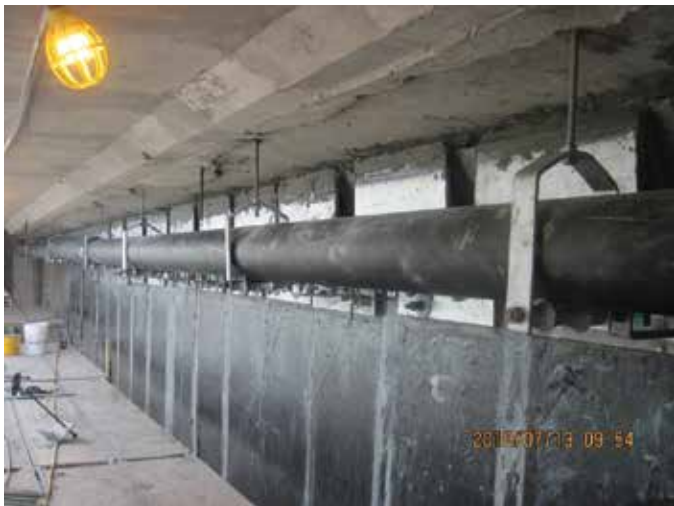
Fig. 14: External post-tensioning system

The EPT was provided to add the required flexure capacity for actual and assumed future girder deterioration and improved the girder shear capacity by adding axial beneficial compression (while not the main goal). The EPT was composed of two steel blocks with each carrying 22 x T15 greased sheath strands with multiple corrosion protection systems for high durability due to its primary function (Fig. 14 and 15).

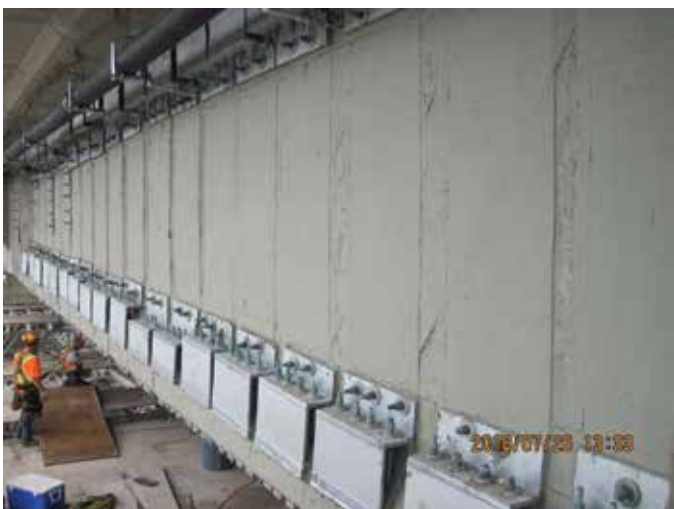
Fig. 15: External view of girder after completion of work

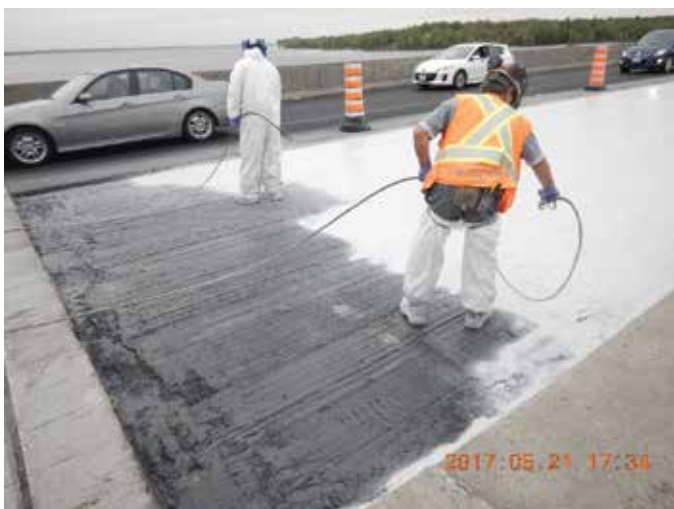
Fig. 16: Spray applied waterproofing deck membrane application

A liquid waterproofing membrane (Fig. 16) and new pavement were added to protect the new girder rehabilitation and avoid de-icing salts from penetrating the new CFRP repair from deck cracks and preventing premature concrete delamination and additional internal prestressing cable corrosion. This assures the required dry surface condition for the CFRP installation on the girder webs and near the top slab location.
