PARKING STRUCTURES CATEGORY

The Phoenician Resort— Post Tension Garage Repair

SCOTTSDALE, AZ

SUBMITTED BY TADJER-COHEN-EDELSON ASSOCIATES, INC.

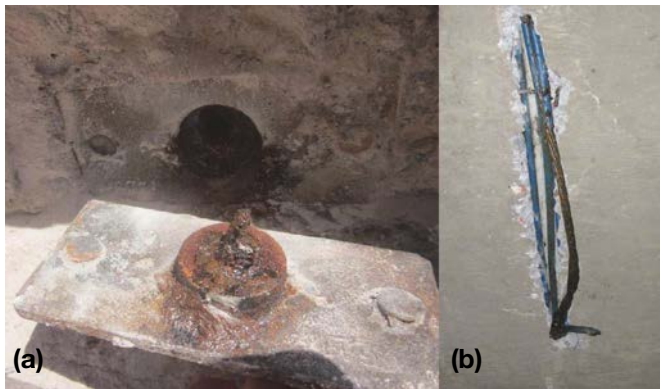
Prolonged water migration into the subgrade garage caused deterioration of post-tension components and conventionally reinforced concrete beams, columns and foundation walls in the structure. While the desert

climate in the Scottsdale area generates low annual rainfall, the landscaping irrigation system deposits water above the garage on a regular basis. Leakage occurred along the south end of the structure where the stressing end of the post-tension slab bears on the foundation wall. Leakage also occurred along the expansion joint prompting the hotel staff to install a network of collecting pans and drain lines below the garage ceiling to alleviate water stains on cars and dripping water on hotel guests below. The garage started experiencing ruptured post-tension tendons and large cracks on the bottom surface of the slab in recent years.

The structural issues prompted an engineering condition survey to evaluate the subgrade garage structure with findings used to develop a repair program. The survey included visual examination of the entire garage structure with exploratory openings within the overburden above the garage in order to ascertain the condition of the concealed structural and water resisting components. An exploration pit at the south end of the garage exposed a portion of the stressing end of the post-tension slab and top of the foundation wall. At this location, the existing surface-adhered “peel and stick” cold-applied sheet membrane was debonded and beyond its useful service life. The membrane conditions allowed water to reach and corrode the stressing anchors. Water also traveled within the protective sheathing causing corrosion and subsequent rupture of the post-tension tendons that was observed in the garage below (Fig. 3).

Fig. 3: (a) Corroded post-tension anchor, and (b) Ruptured tendon

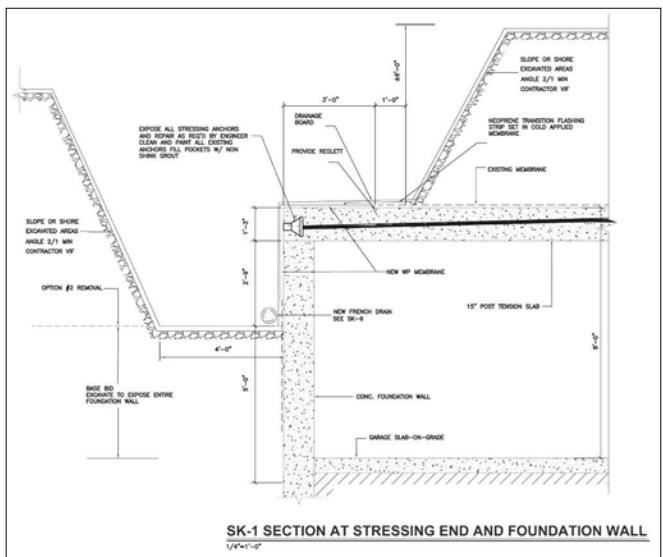
Fig. 4: Section detail at stressing end and foundation wall (repair drawing)

The project included removal of overburden to expose the stressing end of the slab and foundation wall (Fig. 4). The existing debonded sheet membrane and grout pockets were removed for engineer assessment of the stressing anchors, and components were repaired accordingly (Fig. 5). Corroded anchors required slab openings, locking off the existing tendon, replacement of the anchor, splicing

to the existing tendon, placing concrete, stressing, and placing new non-shrink grout at the stressing pockets prior to installing new hot applied reinforced membrane on the slab and foundation wall. By the end of the project, over 1,000 stressing anchors were exposed, evaluated and 364 repairs required. Due to the reconstruction of the adjacent swimming pools and spa facility, space to excavate and store soil was limited. In addition, storing soil above the garage utilizing shoring was not feasible due to the hotel using the garage for parking. Therefore, the excavation and repairs had to be performed in four consecutive phases.

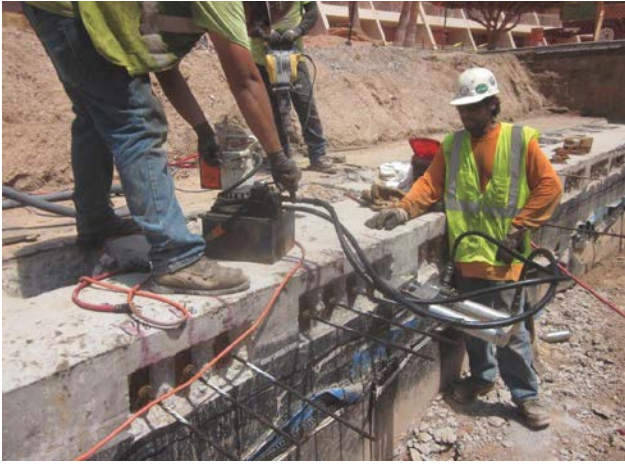
Fig. 5: Post-tension repairs in progress (stressing end)

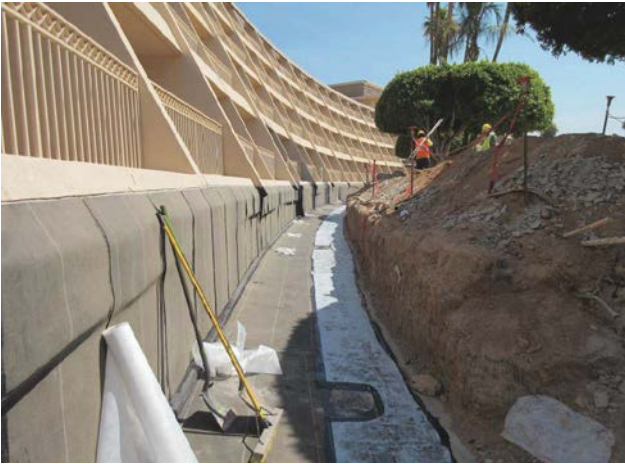
Fig. 6: New membrane and flashing along the expansion joint and building wall

The waterproofing repairs included new expansion joint seals and looped flashing sheets over the joint, and hot applied reinforced waterproofing membrane and counter flashings at the slab and building wall (Fig. 6). Upon completion of waterproofing repairs, a drainage layer, expanded polystyrene (foam) blocks, and a 2.5 ft (0.8 m) layer of soil were placed over the slab (Fig. 7). The foam blocks were used to reduce the load on the structure and provide easier access to the expansion joint for future serviceability.

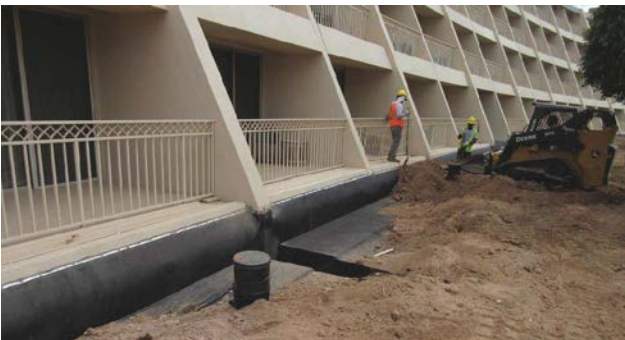
Fig. 7: Foam blocks and backfilling in progress after completion of waterproofing repairs along the expansion joint

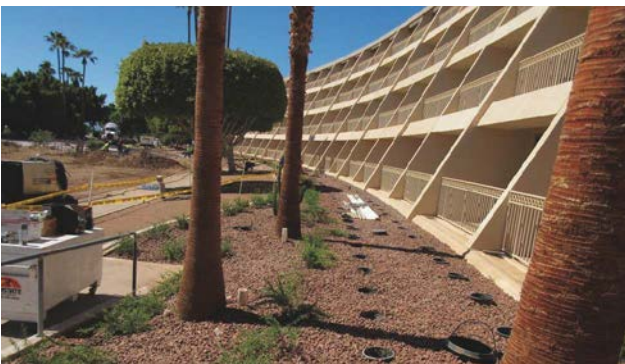
Fig. 8: Completion of repairs with new landscaping in front of the hotel building

Various challenges were addressed during the repair project and included restraints from site conditions, strict schedule requirements for completion within a four-month period, the magnitude of repairs, scope complexity, and unforeseen conditions. The completed project is shown in Figure 8. ■
