## HISTORIC CATEGORY

# Unity Temple Restoration

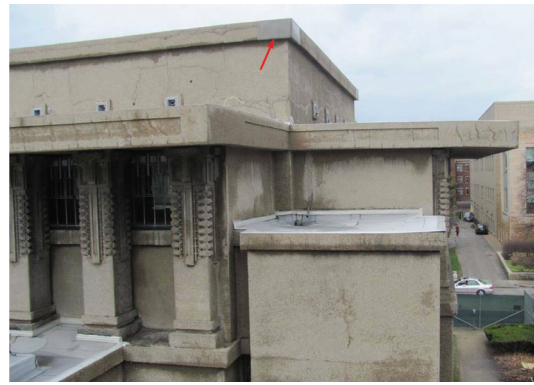
Fig. 2: Concrete cracking and deterioration on exterior walls and cantilevered roof slabs—loose spall at corner of parapet wall (arrow) was removed and covered to address potential falling hazard prior to restoration

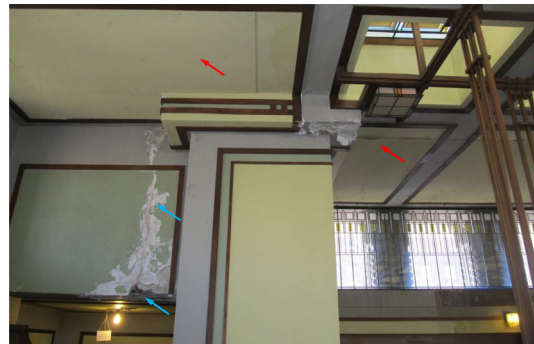
Fig. 3: Concrete deterioration of concrete beam (blue arrows) and water damage to plaster finish at interior of Unity Temple Sanctuary—roof slab underside delaminations were removed and covered with plywood (red arrows) to address potential falling hazards prior to restoration

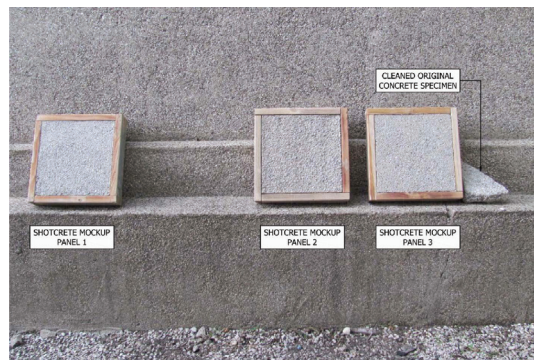
Fig. 4: Field mockup shotcrete panels compared to cleaned original concrete specimen

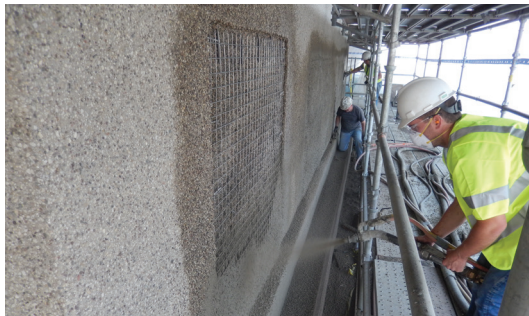
Fig. 6: Localized exterior wall repair using wet-process shotcrete

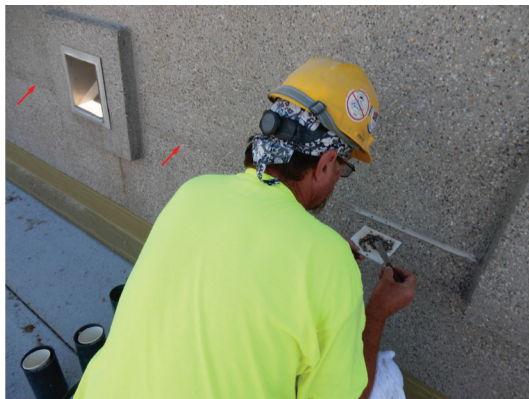
Fig. 7: Routed and sealed construction joint repair (arrows point to completed joint repair)—crack repair was similar

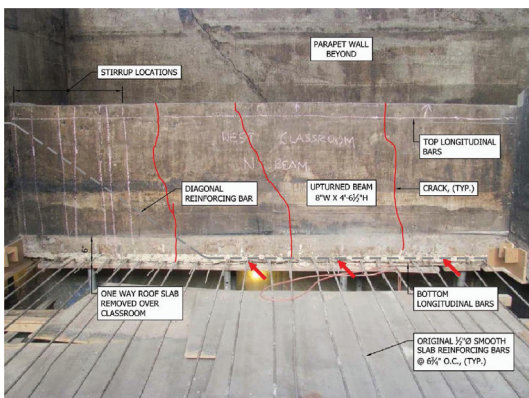
Fig. 8: Unity House classroom after roof slab removal (red arrows point to horizontal splitting above longitudinal bars of upturned beam in zone without stirrups)
