NTH Consultants, Ltd.

Rehabilitation of Raw Water Conduit and Pedestrian Tunnel

**INTERNATIONAL CONCRETE REPAIR INSTITUTE
2014 Spring Convention - Infrastructure Repair**

March 19, 2014

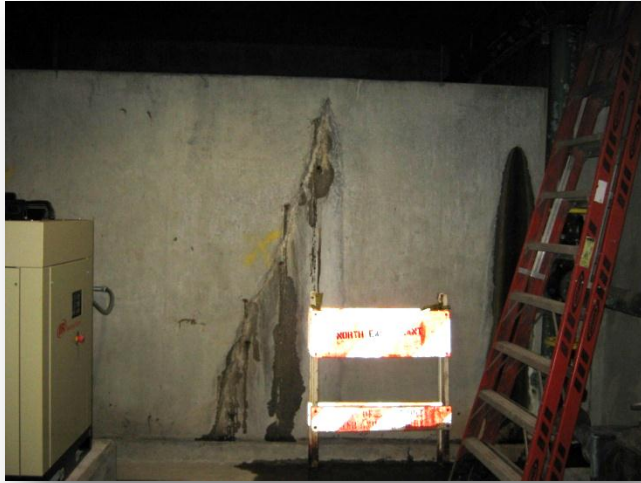
- Visible cracks in walls and ceiling in Chemical Building
- Water leakage through cracks
- Other areas not visible without dewatering system

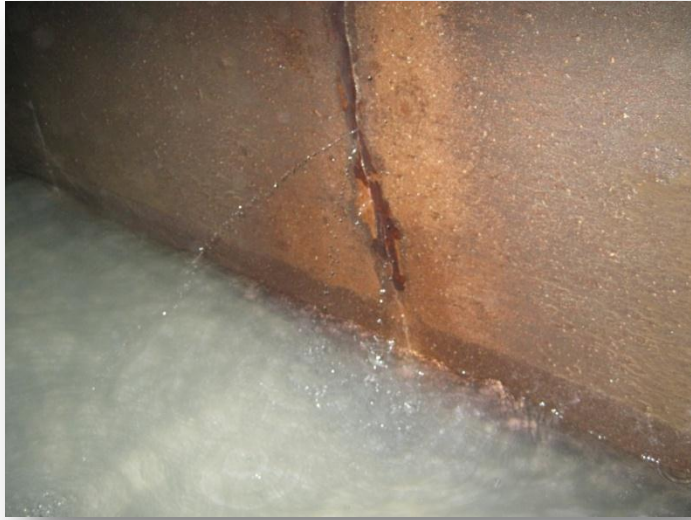
- No Delamination Observed

- Compressive Strength 7300 psi
- Tensile strength of Steel 60 ksi

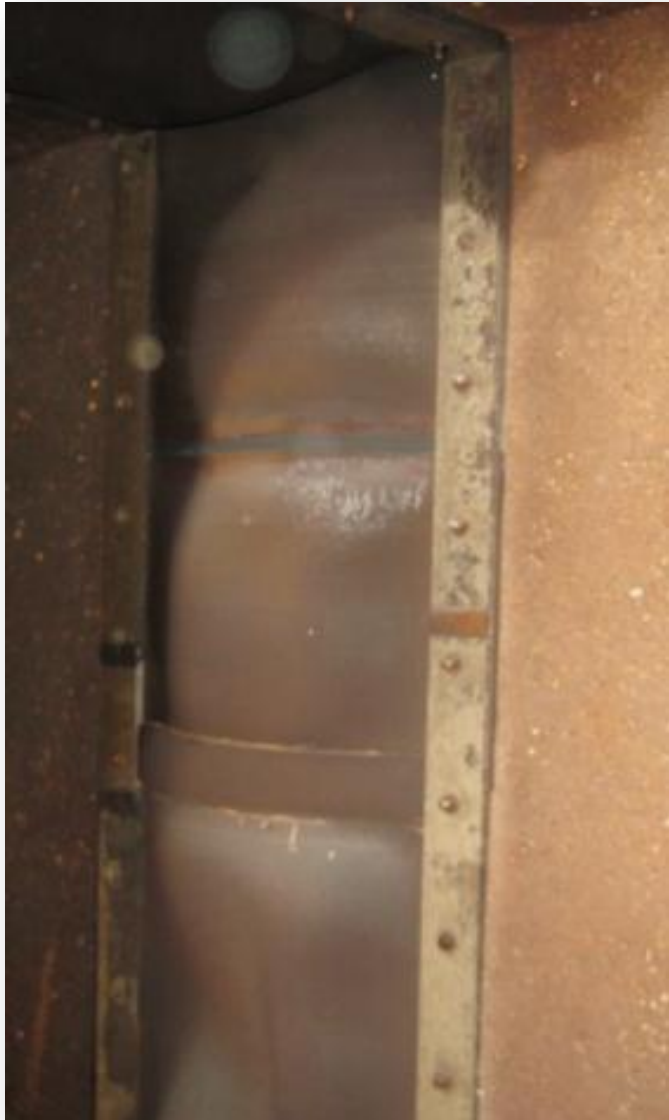
- Fairly Good Condition
- Offset joints at Low Lift Bldg.
- Defects mainly in Chemical Bldg.
- Grout missing at some joints
- Visible Cracks and Fractures

- 1 Gushing & 1 Running leak
- Dripping & weeping leaks
- Previously sealed fractures were reopened and leaking
- Rubber seals sound but distressed – bars placed to hold in place

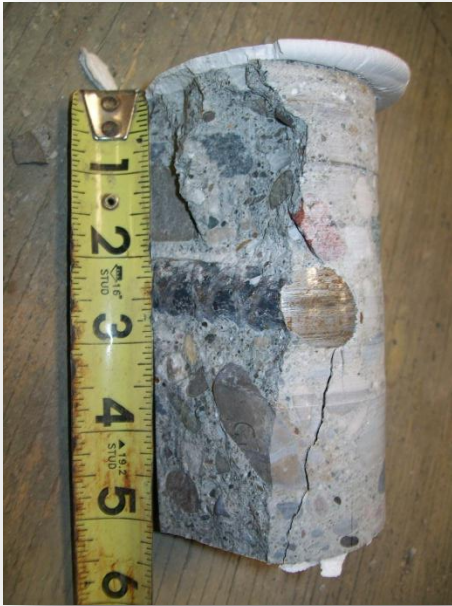
- W/C ratio – 0.33 to 0.35 for CIP, 0.35 to 0.37 for steel plate pipe
- No air entrainment
- Water –soluble chloride 0.03 to 0.04 % (well within ACI range)
- Cement paste friable, soft and degraded at surface
- Carbonation to 5/16-inch at surface

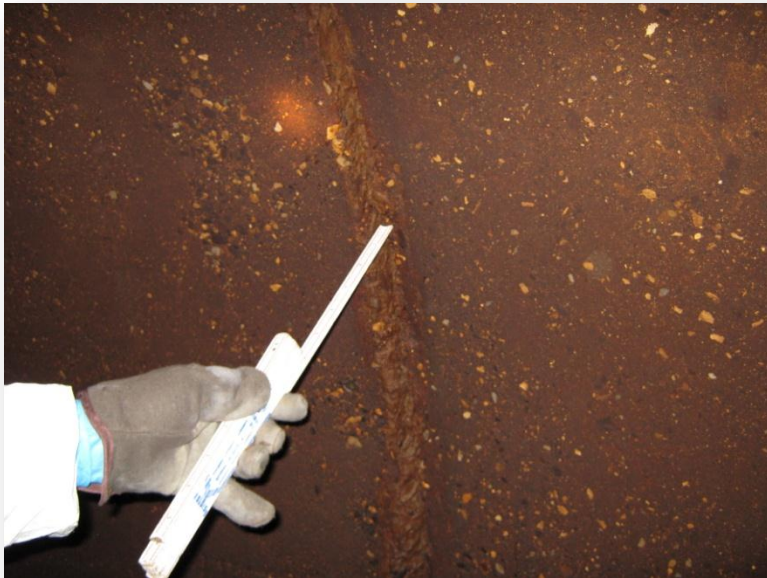
- Conduits Structurally sound
- Cracking due to thermal movement
- Continued infiltration will impact durability

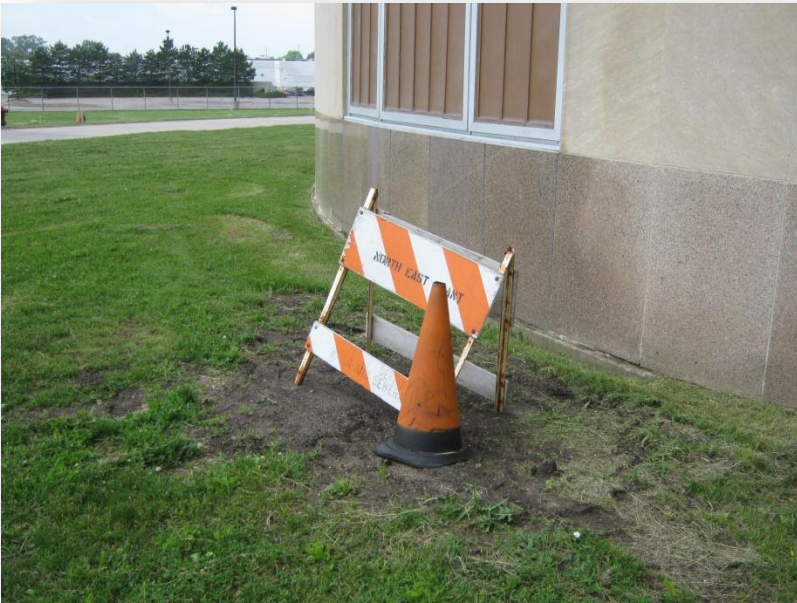
- Sinkhole developed near Low Lift Bldg. after returning East Conduit to service
- Owner re-drained East Conduit, replaced plug on drain line
- Owner filled sinkhole at surface
- NTH revisited site, performed supplemental GPR survey

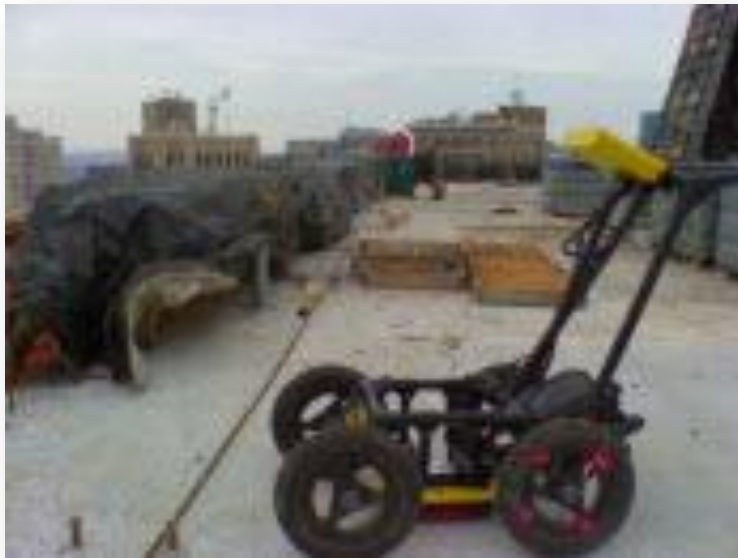
- Several anomalies detected
- Sloping reflectors and soil pocket
- No indication of voids
- Anomalies match construction features shown on plans

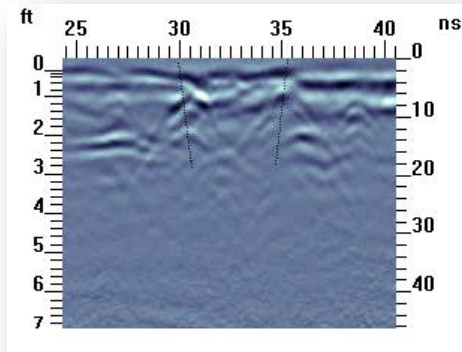
Line 1

GPR Line Adjacent to Sinkhole,
Lines Indicate Limits of Observed Sinkhole
Effects

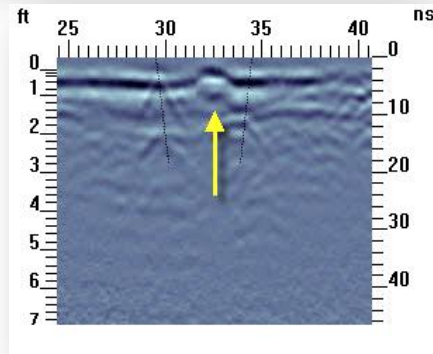
Line 2

GPR Line Above Sinkhole (Surface Feature),
Arrow Indicates Small Depression
Observed at Ground Surface

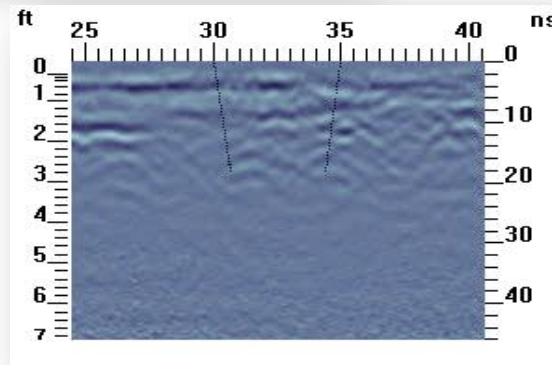
Line 3

GPR Line Adjacent to Sinkhole,
Anomaly Barely Discernable

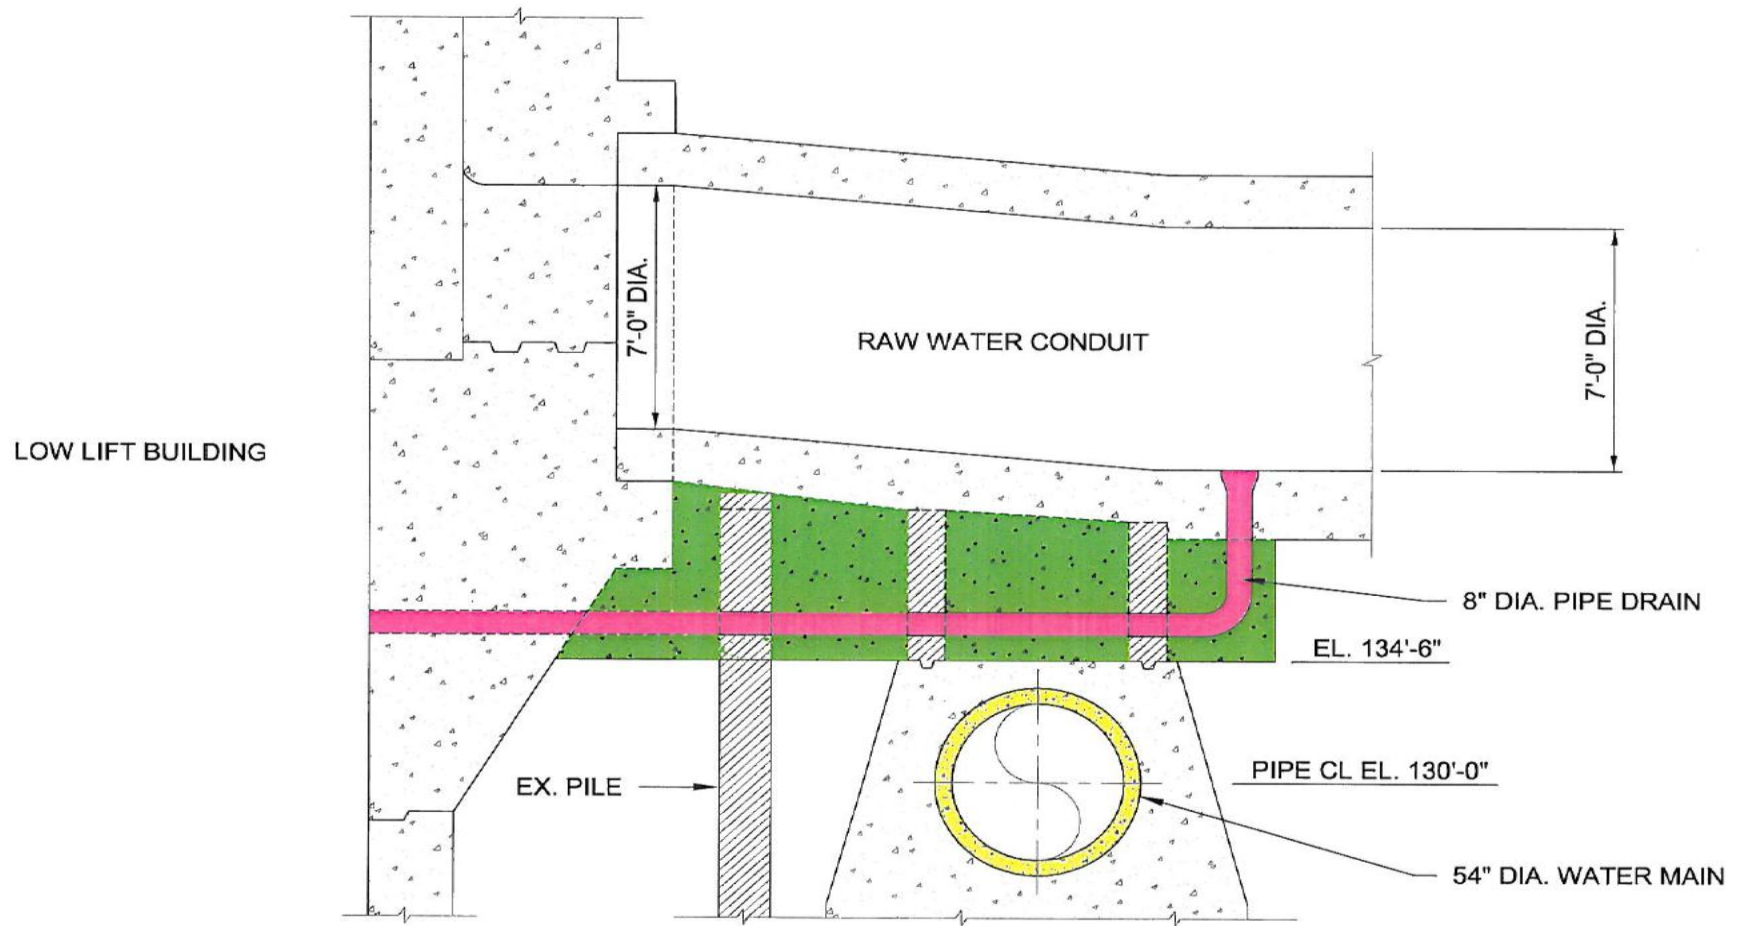
Raw Water Conduit at Low Lift Building – area of sinkhole

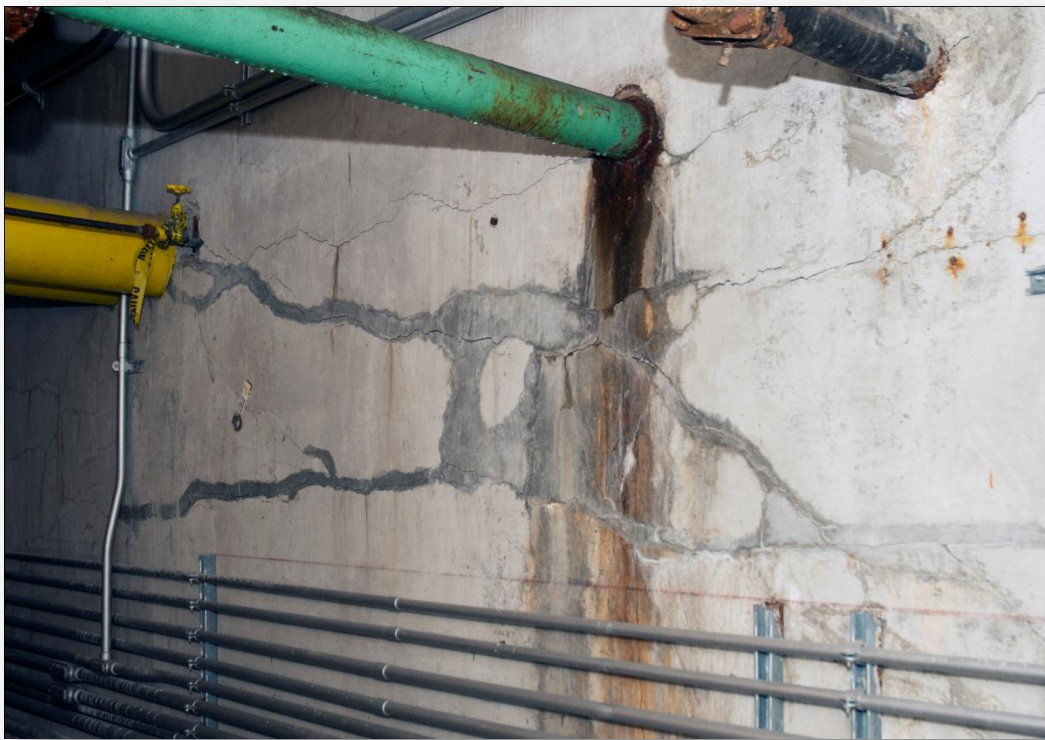
Distress discovered while looking at exterior of East Conduit

- Fractures in wall
- Bowing of concrete
- Delamination in floor near Chemical Bld.
- Leak in Wall at Chemical Bld.

- Install new wall section
- Grout fractures/cracks
- Repair spalls/delaminations
