Repair of Concrete Utility Poles With the Use of Migrating Corrosion Inhibitors

Ashraf (Ash) Hasania Nov. 2018

Concrete Lighting Poles

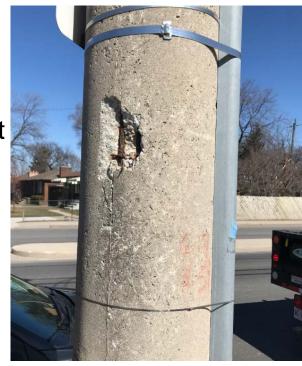
Recent Conditions

- Lots of cracking
- Visible signs of corrosion (spalling/ stains)
- Rusted exposed rebars and helical reinforcement
- Some poles have actually failed

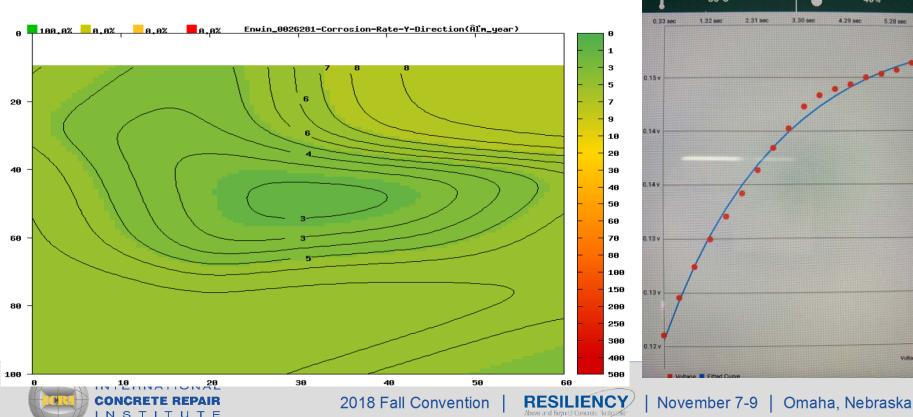
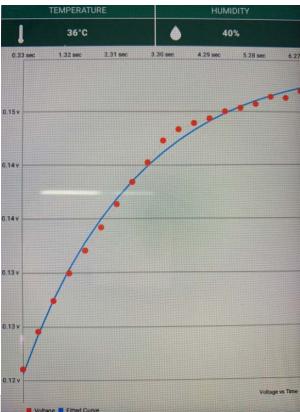
Results (Pole 1)

Х	Υ	Current Y	Rp(Y)	Corr Rate(Y)	Conc Res (Y)	Temp	Humidity	R ² (Y)
60	100	1.68E-01	61678	4.9	363	42	31%	0.99
60	60	1.49E-01	48838	6.2	353	38	35%	0.98
50	18	1.35E-01	33728	8.9	252	37	36%	0.97
40	75	2.67E-01	45474	6.6	201	36	37%	1
40	50	1.49E-01	145674	2.1	401	36	40%	1
40	20	1.24E-01	36305	8.3	221	36	38%	0.99
20	20	2.18E-01	85292	3.5	276	36	41%	1
0	10	1.28E-01	52387	5.8	415	36	38%	0.95
0	50	1.18E-01	44917	6.7	548	36	39%	0.99
0	80	1.42E-01	46566	6.5	451	35	39%	0.98
	Average		60086	5.95	348	37	37%	0.985

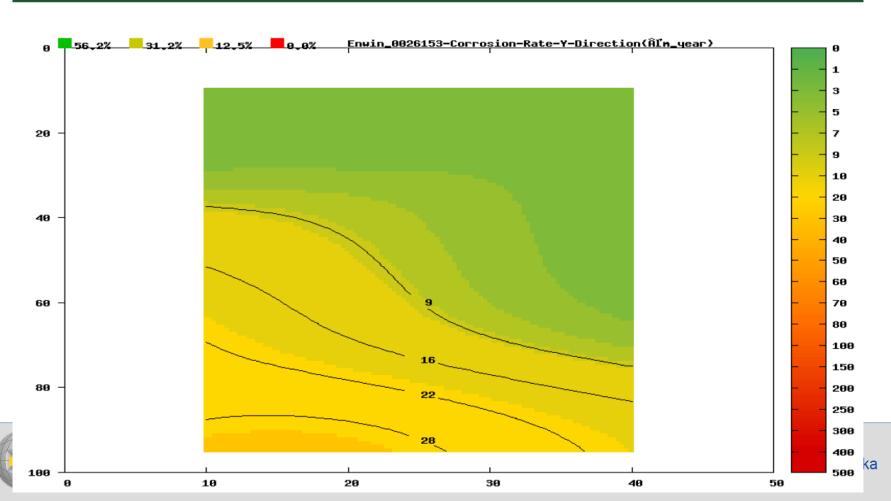
CORROSION RATE Y-DIRECTION CONTOUR MAP

Х	Υ	Current Y	Rp(Y)	Corr Rate(Y)	Conc Res (Y)	Temp	Humidity	R ² (Y)
10	90	4.76E-01	14734	20	182	22	85%	0.92
10	80	3.09E-01	15097	20	197	22	86%	0.96
10	60	3.42E-01	7480	40	116	22	85%	0.99
10	50	2.79E-01	30946	9.7	116	22	85%	1
10	20	1.75E-01	82871	3.6	477	22	86%	0.99
10	10	1.26E-01	77191	3.9	377	22	86%	0.99
20	50	1.15E-01	55809	5.4	819	22	87%	0.97
30	95	2.44E-01	29372	10	343	22	88%	1
20	95	3.25E-01	4667	65	168	22	89%	0.94
20	80	3.84E-01	10273	29	186	22	89%	0.97
20	60	1.82E-01	44620	6.8	737	22	88%	0.99
30	60	1.24E-01	91916	3.3	957	22	88%	0.99
30	90	3.53E-01	15142	20	168	22	88%	0.99
30	75	1.89E-01	73655	4.1	792	22	89%	0.99
40	50	1.83E-01	84805	3.6	492	22	88%	1
40	60	2.10E-01	86878	3.5	977	22	88%	0.98
	Average		45341	15.5	444	22	87%	0.98

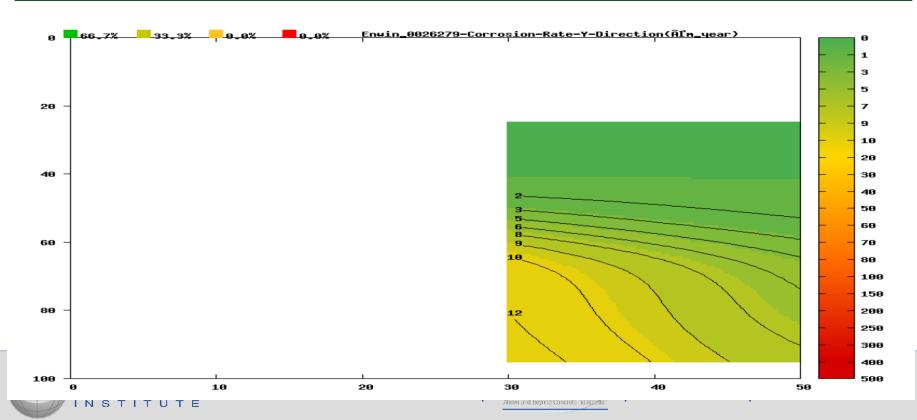
CORROSION RATE Y-DIRECTION CONTOUR MAP

Х	Υ	Current Y	Rp(Y)	Corr Rate(Y)	Conc Res (Y)	Temp	Humidity	R ² (Y)
50	90	3.63E-01	39644	7.6	1095	22	88%	0.95
50	75	1.64E-01	918348	0.33	1568	22	89%	0.9
50	50	1.40E-01	309868	0.97	1196	22	88%	1
30	95	3.93E-01	22377	13	271	22	89%	0.96
40	75	2.13E-01	20304	15	204	22	89%	0.81
40	25	1.05E-01	388795	0.78	6903	22	89%	0.87
Average		283223	6.3	1873	22	89%	0.915

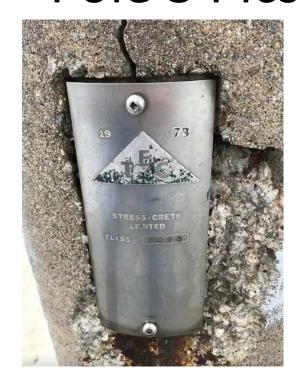
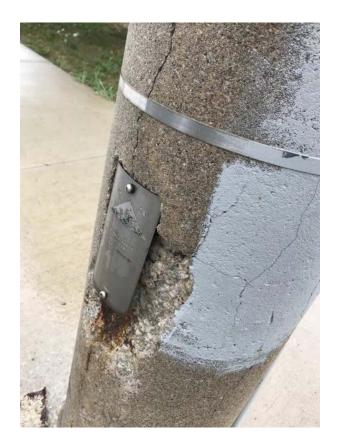
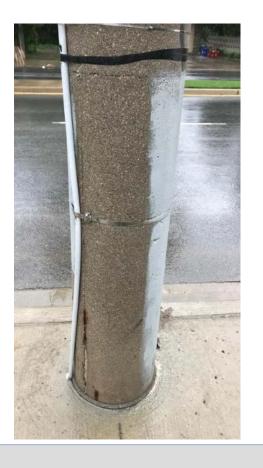
Pole 3 Pics

- Low corrosion rates despite the visible corrosion damage
- Reasons??
- Geometry, weather influence on readings?
