Supplemental Post-Tensioning for Concrete Dome Repairs

Travis Marman, Cody Mitchell, Josh Brewster

Vector Construction, Inc.
Fargo, ND

Simpson Gumpertz & Heger
Chicago, IL

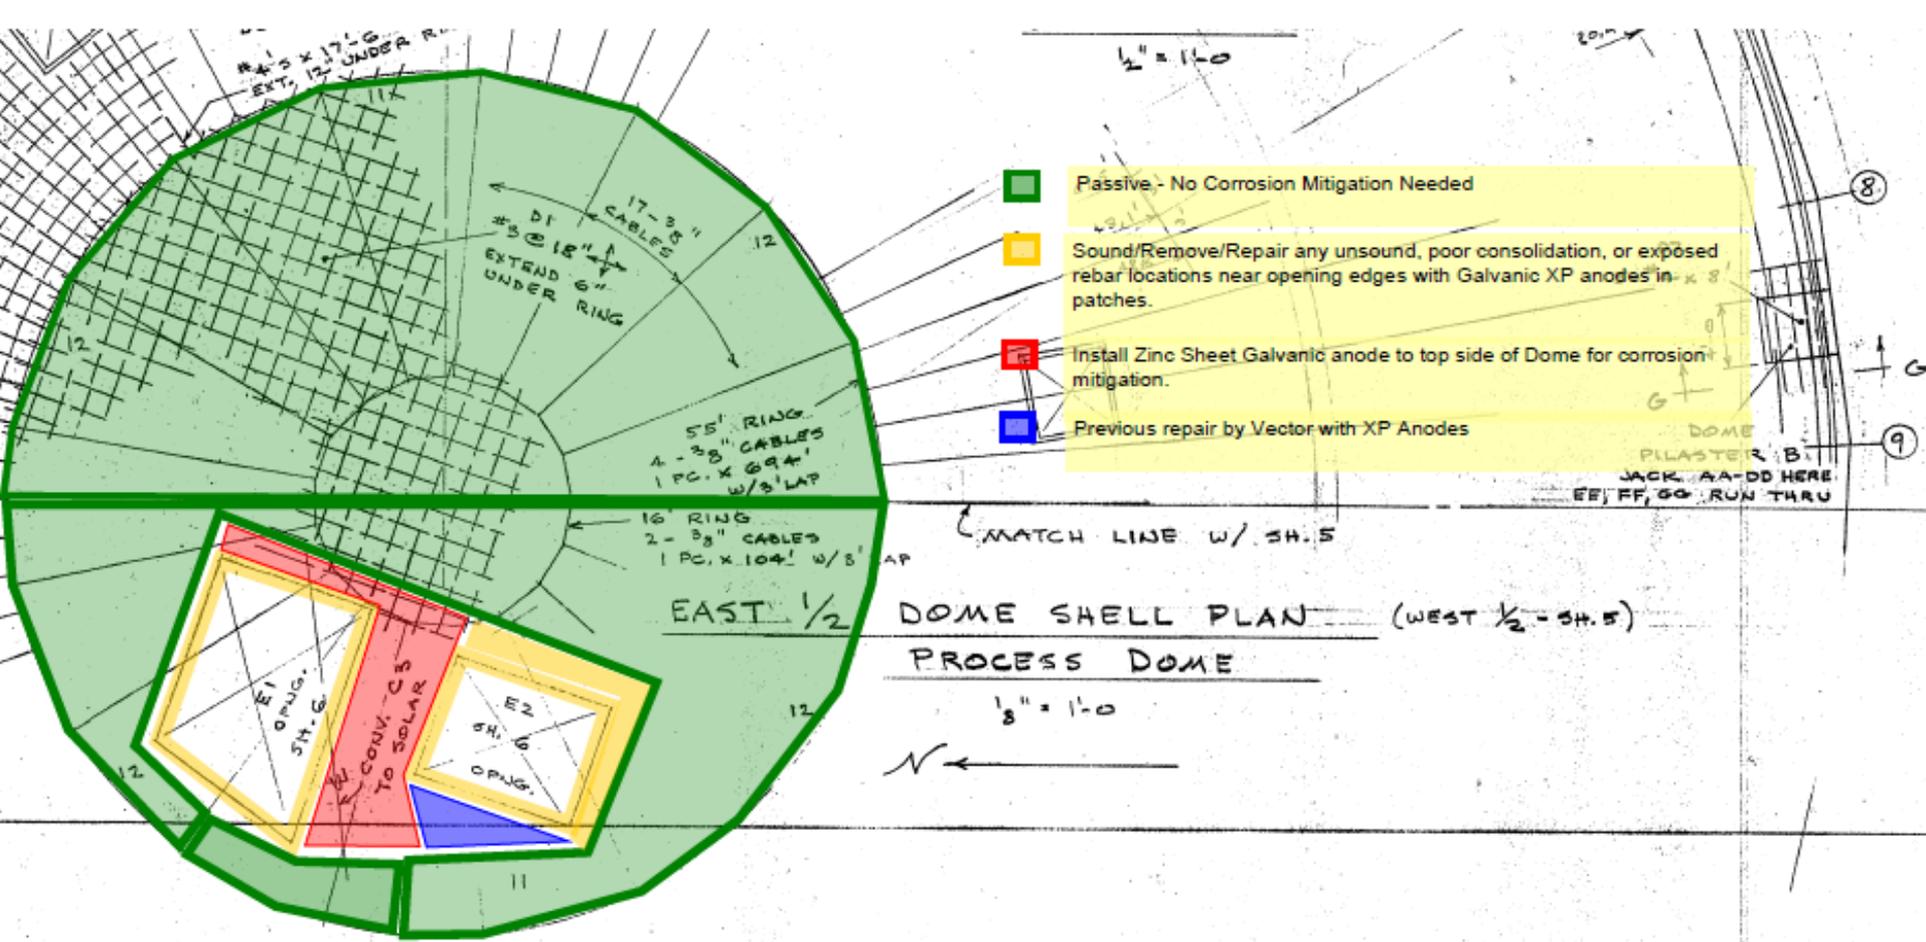
- The majority of corrosion potentials taken at the top of the dome showed very passive conditions at the reinforcing steel. There were a select few localized active areas of corrosion indicated in the area between the two openings. This area is exposed from above and below with no waterproofing on top and is exposed to the humidity from outside the top penthouse. This entire area will be treated with a corrosion mitigation system to prevent against future corrosion.
