**ICRI 2014 Fall Convention,
Kansas City, MO**

**University of Missouri Health Care
Parking Garage Structural Repairs,
Columbia, MO**

Richard McGuire, P.E.,

Structural Engineering Associates Inc.

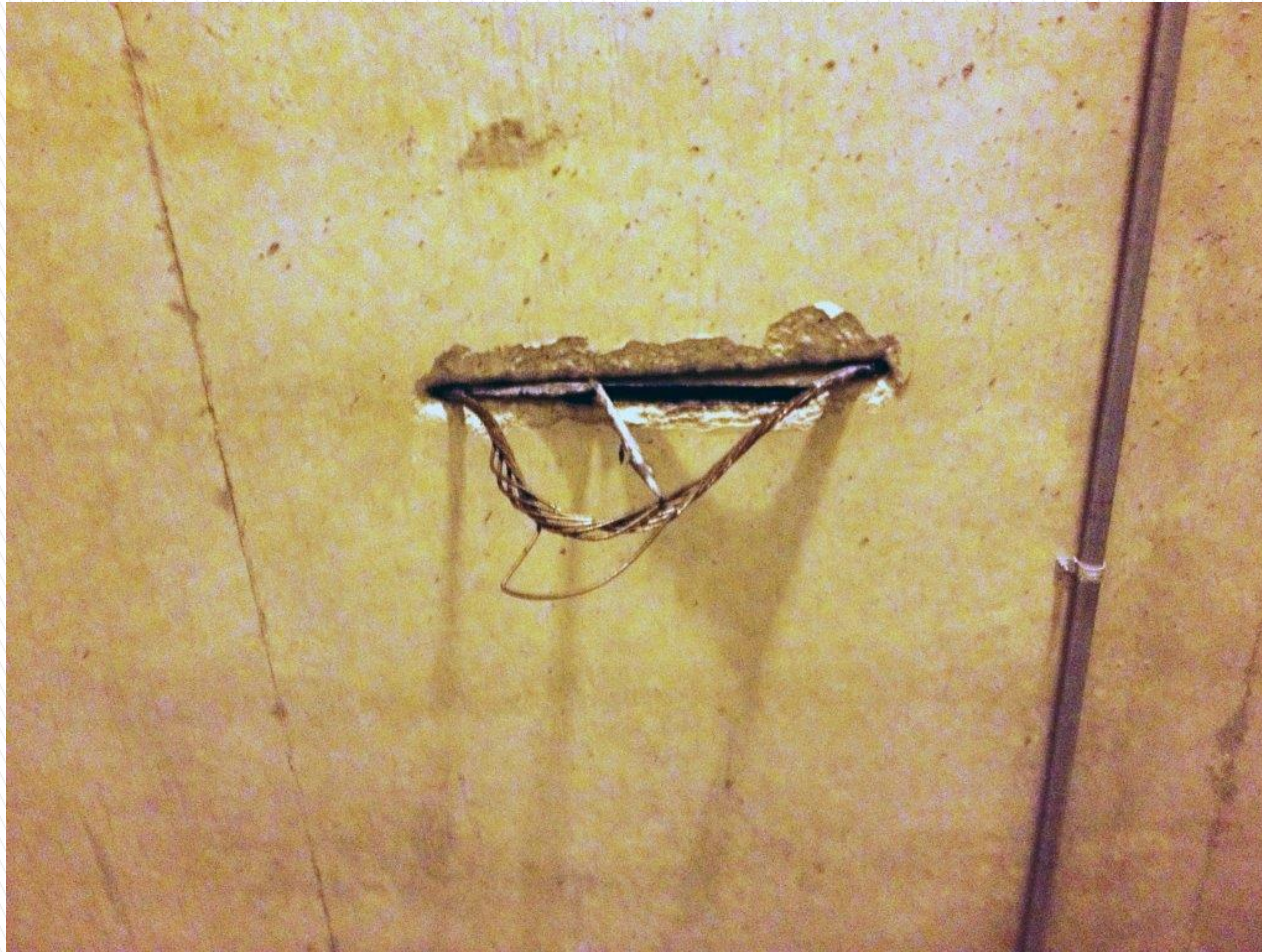
Strand eruption triggered initial investigation

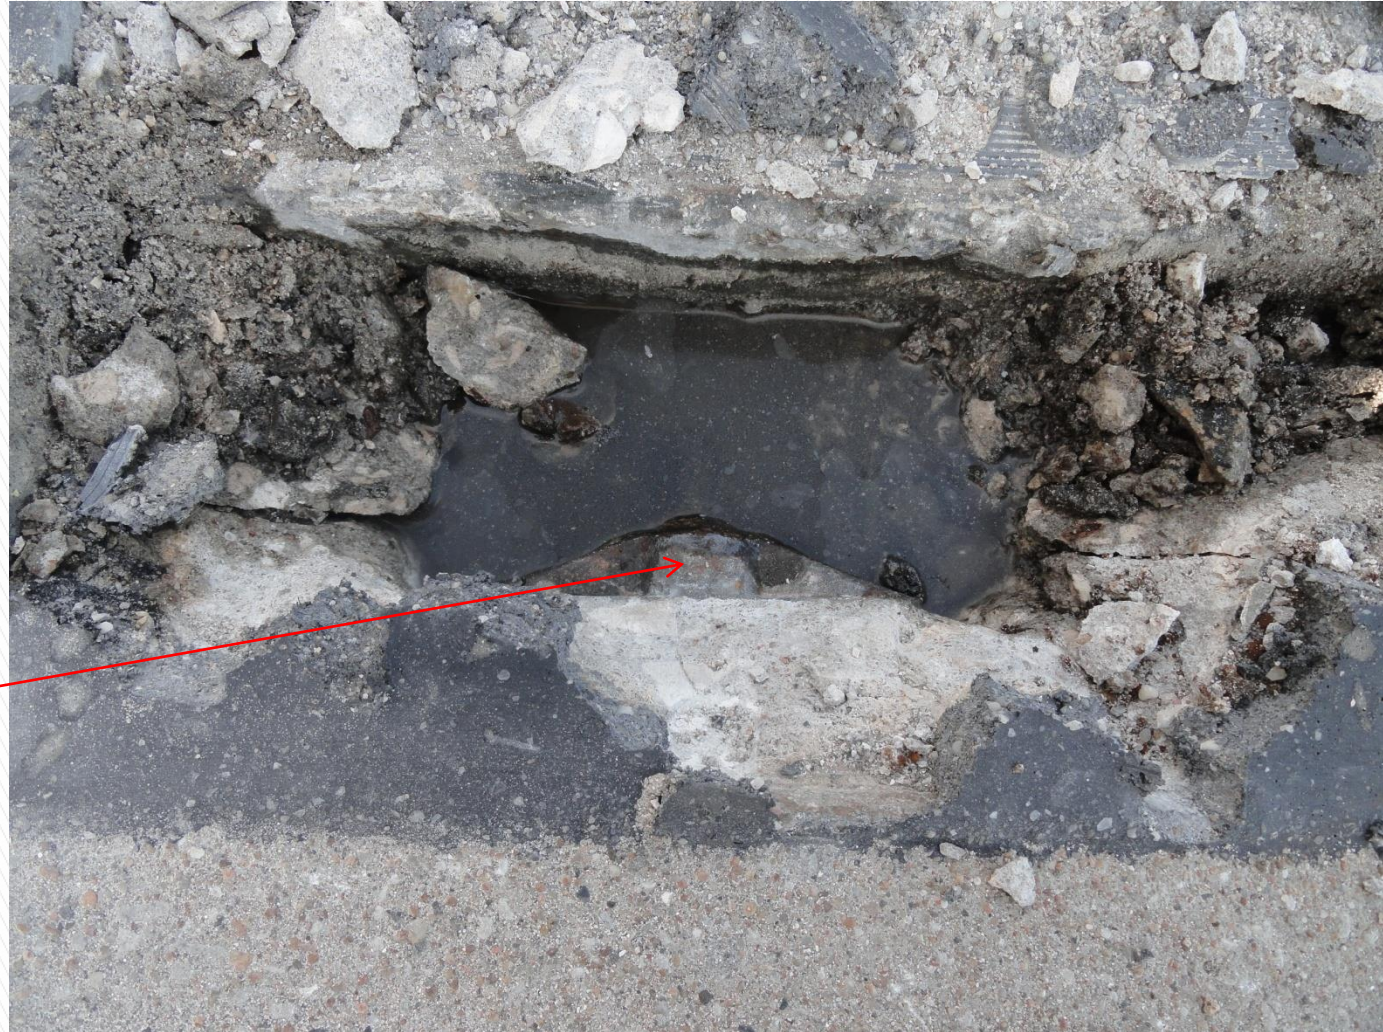
Visual Inspection of Live Anchors at P/T Slab Expansion Joints

Wedge Anchor

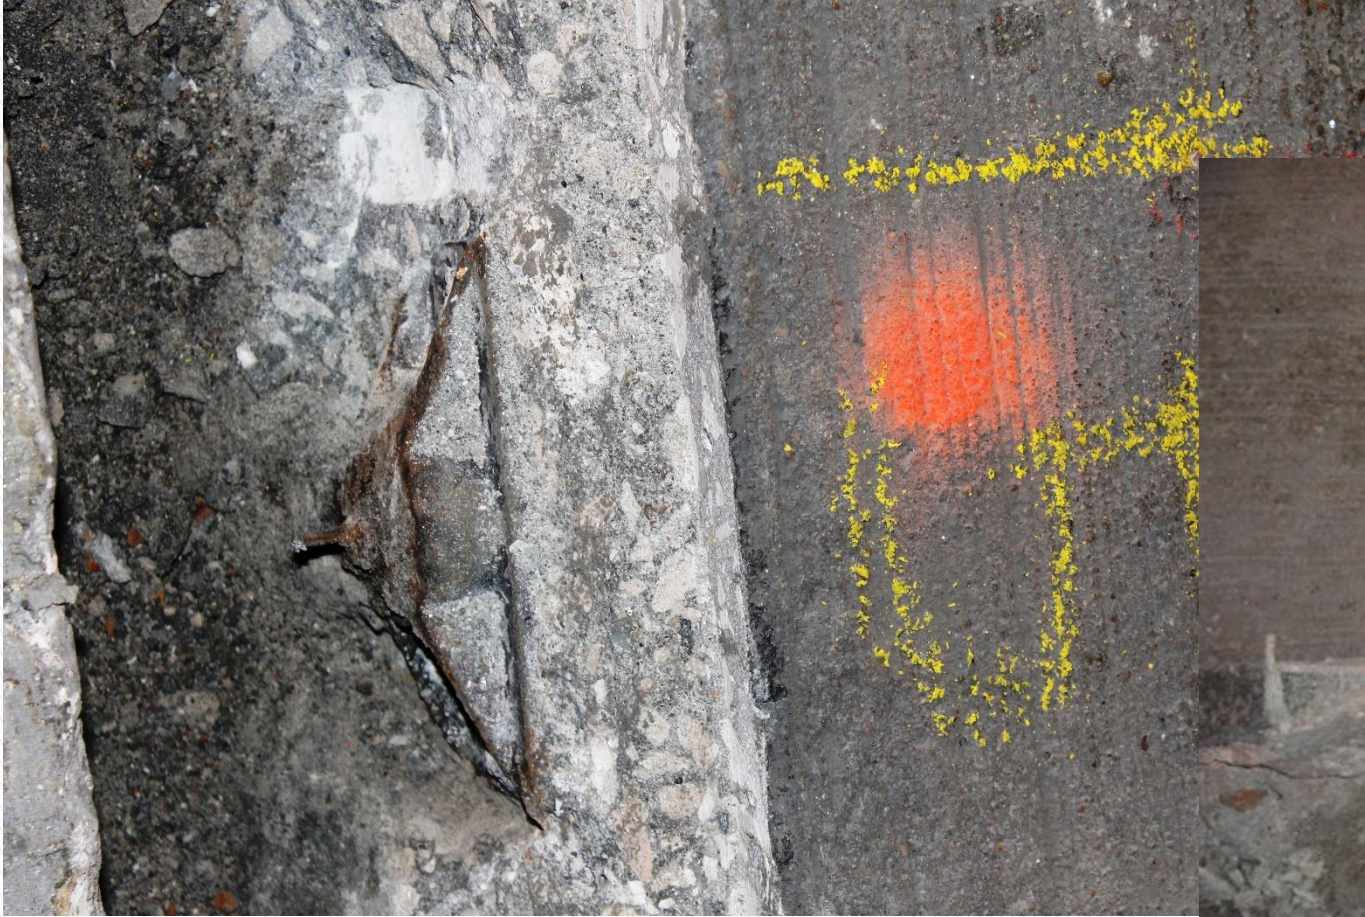
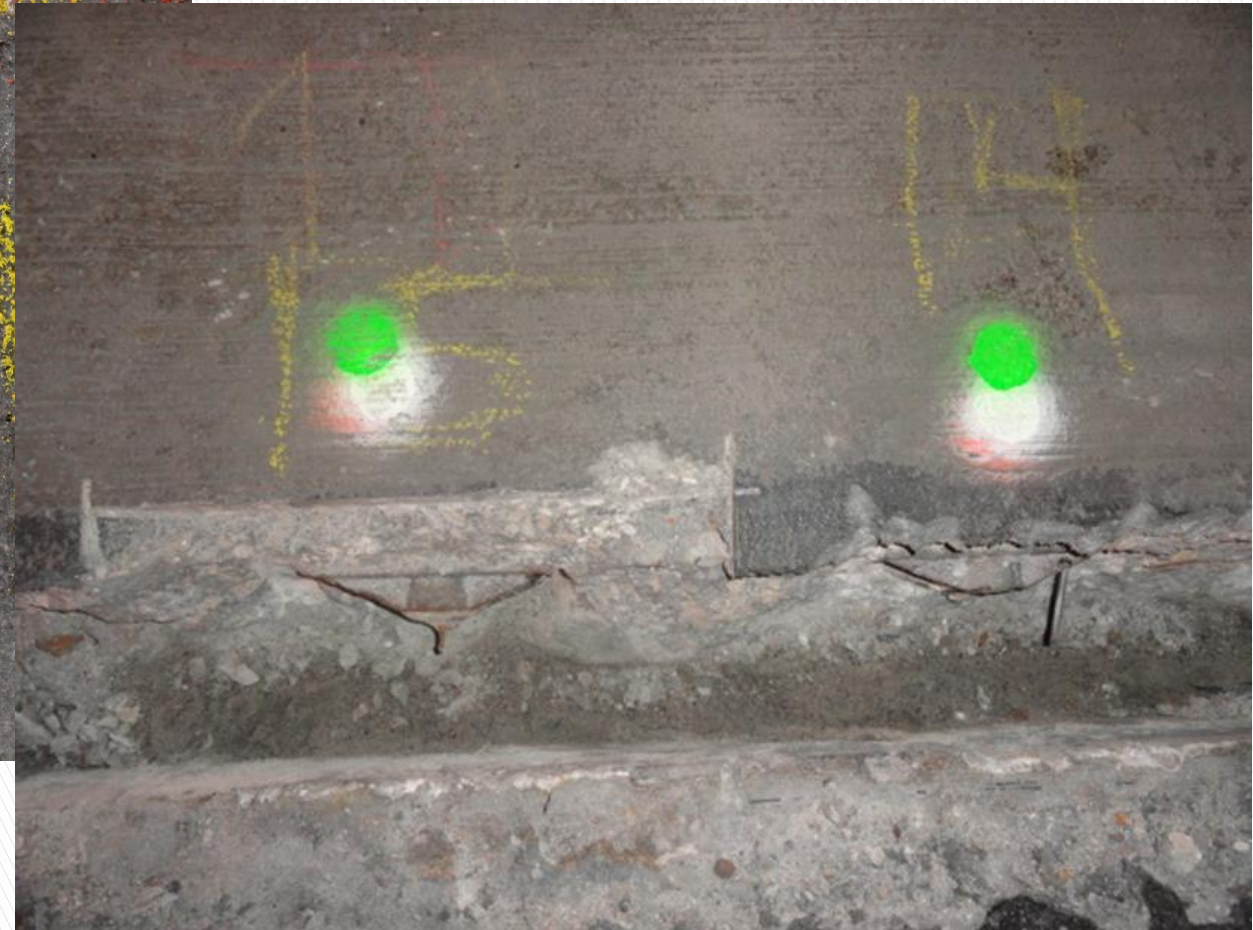
Invasive Exploratory at Live Anchors

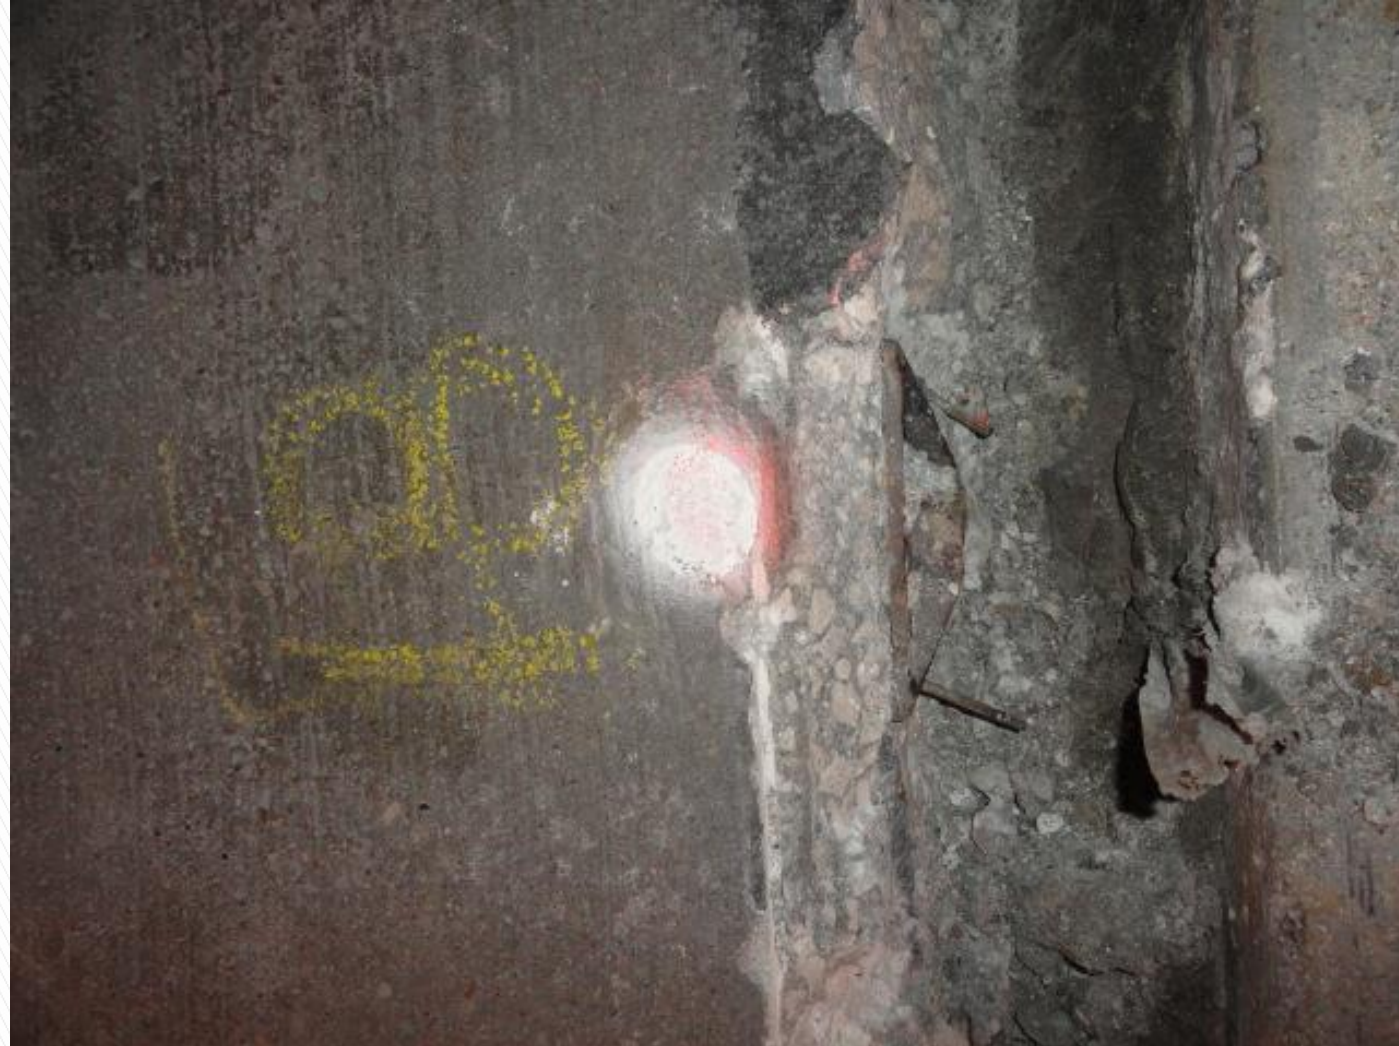
Concrete excavation and visual inspections

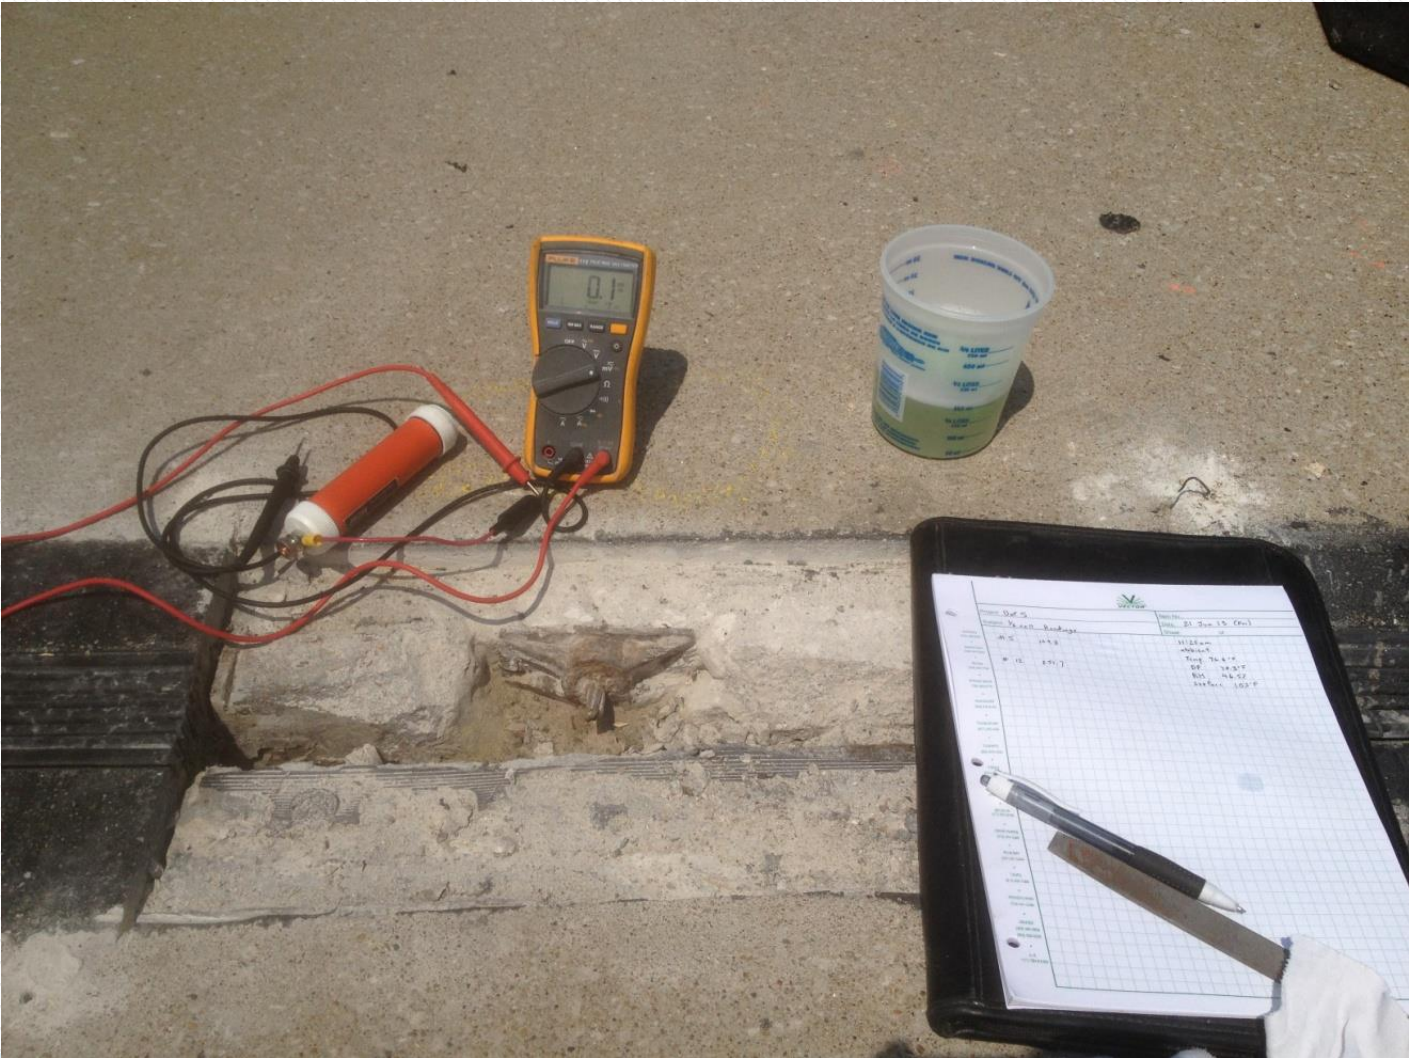
- Chlorides levels in the elevated slabs, most > 400 ppm at 1" depth
 - Half-cell potential tests at all exposed anchorages, results indicated approx. 30% had active corrosion values < 350 mV

P/T Live Anchorage Half-cell Corrosion Potential Evaluation

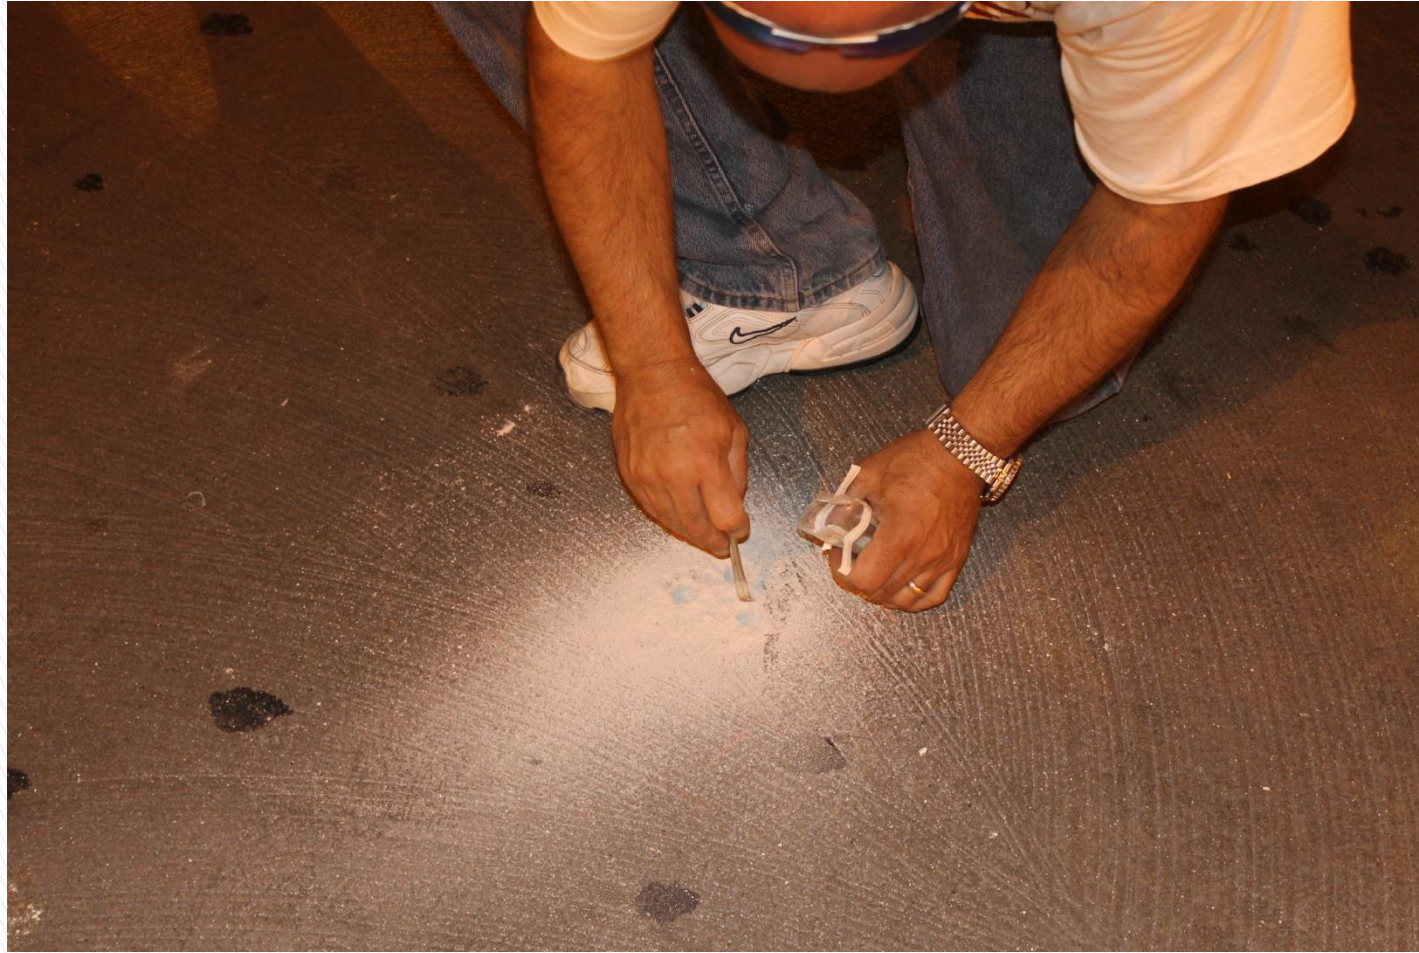
Chlorides contamination testing of p/t slabs

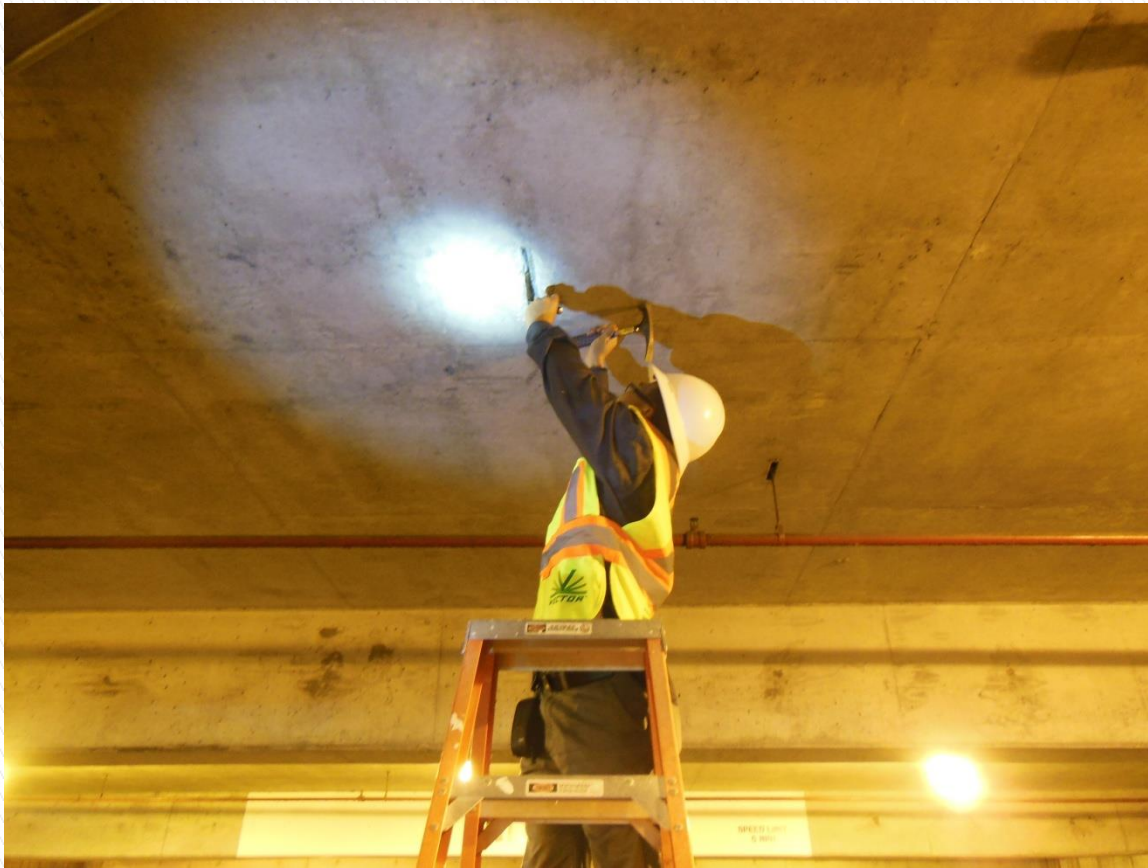
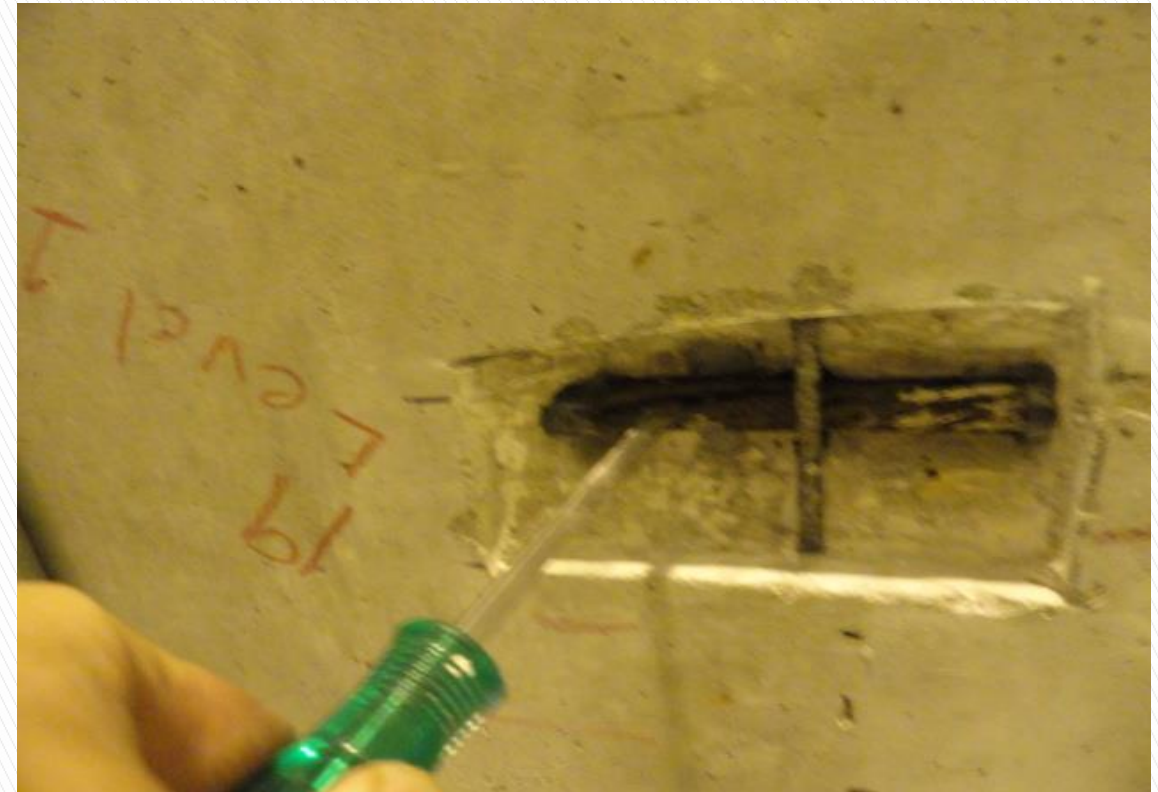
Screwdriver Penetration Tests of Tendons

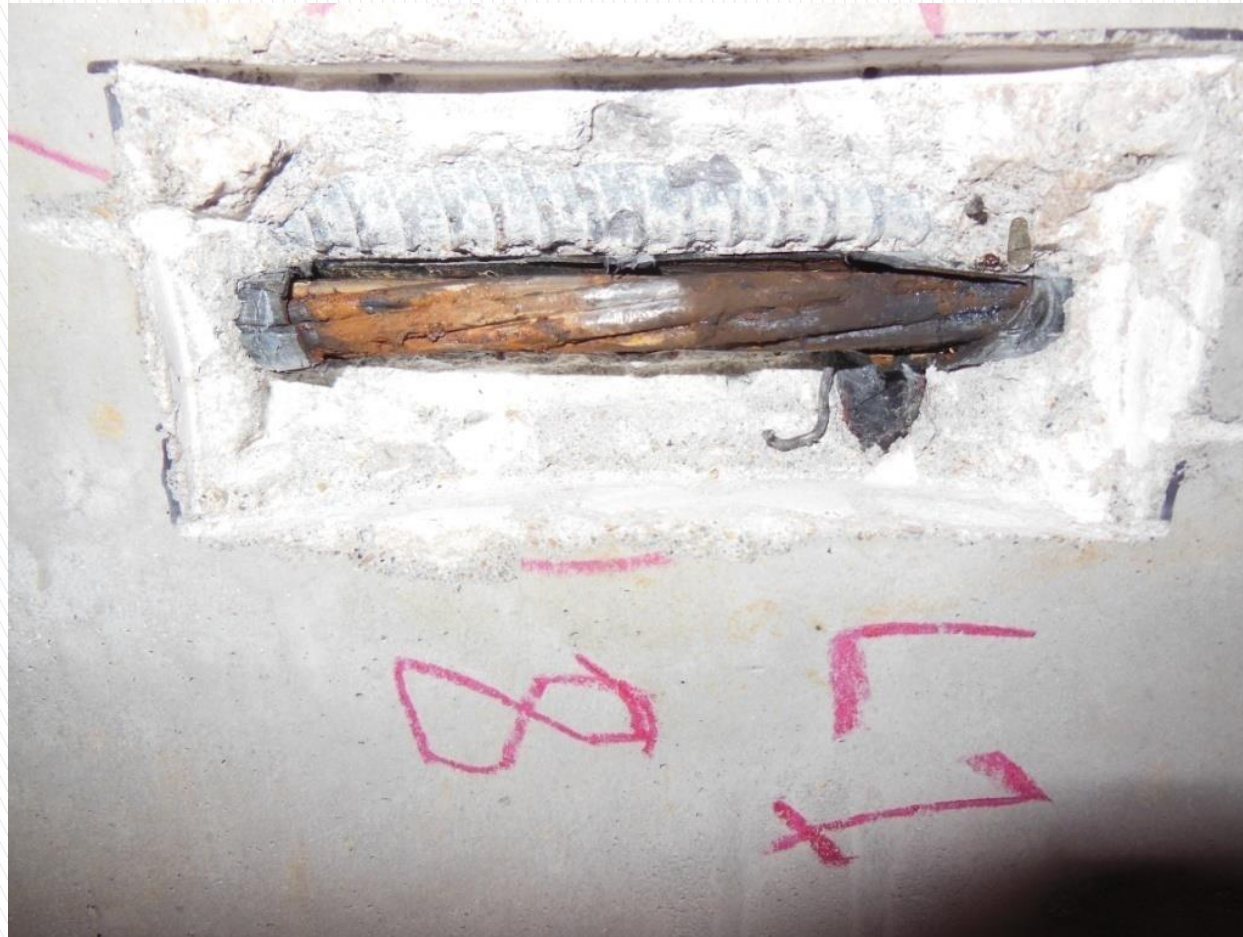
Exposed P/T Tendon for Screwdriver Penetration Testing, Corrosion and Grease Condition Grading

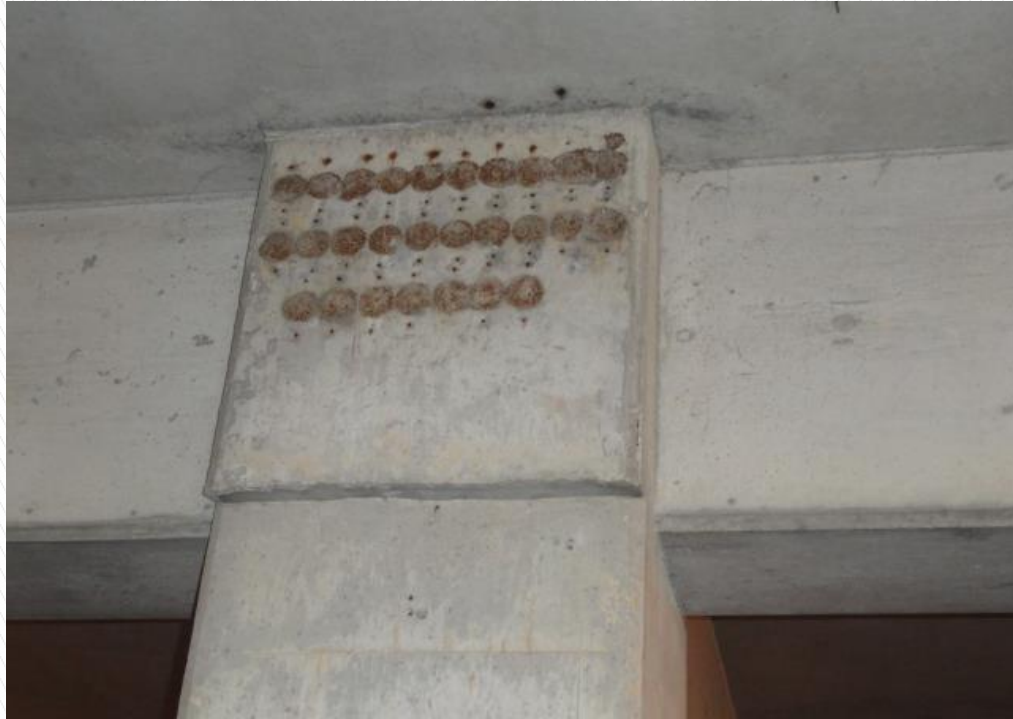
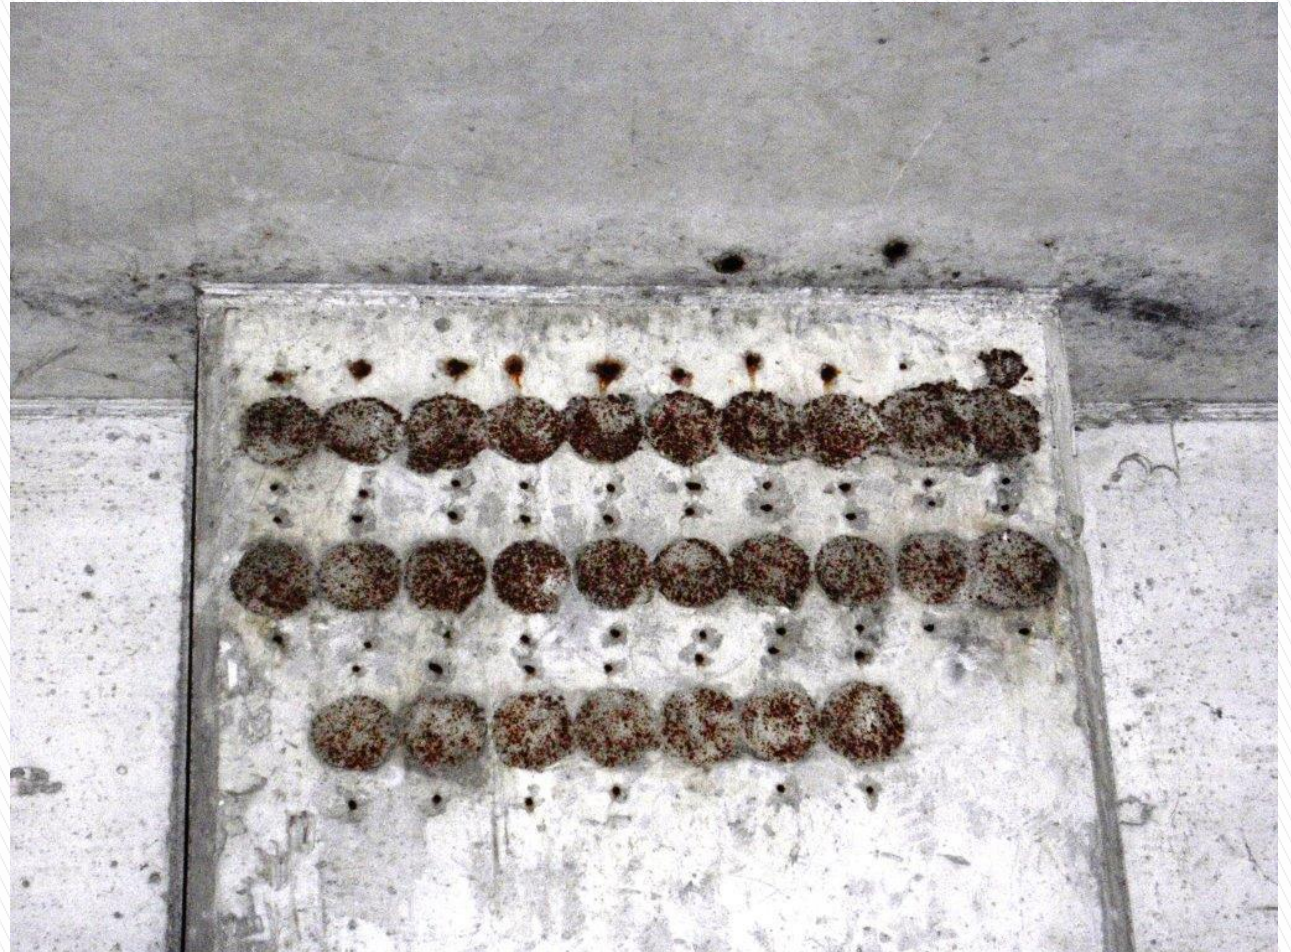
Visual Inspections of Anchor Grout Pockets at P/T Beams and Slab Edges

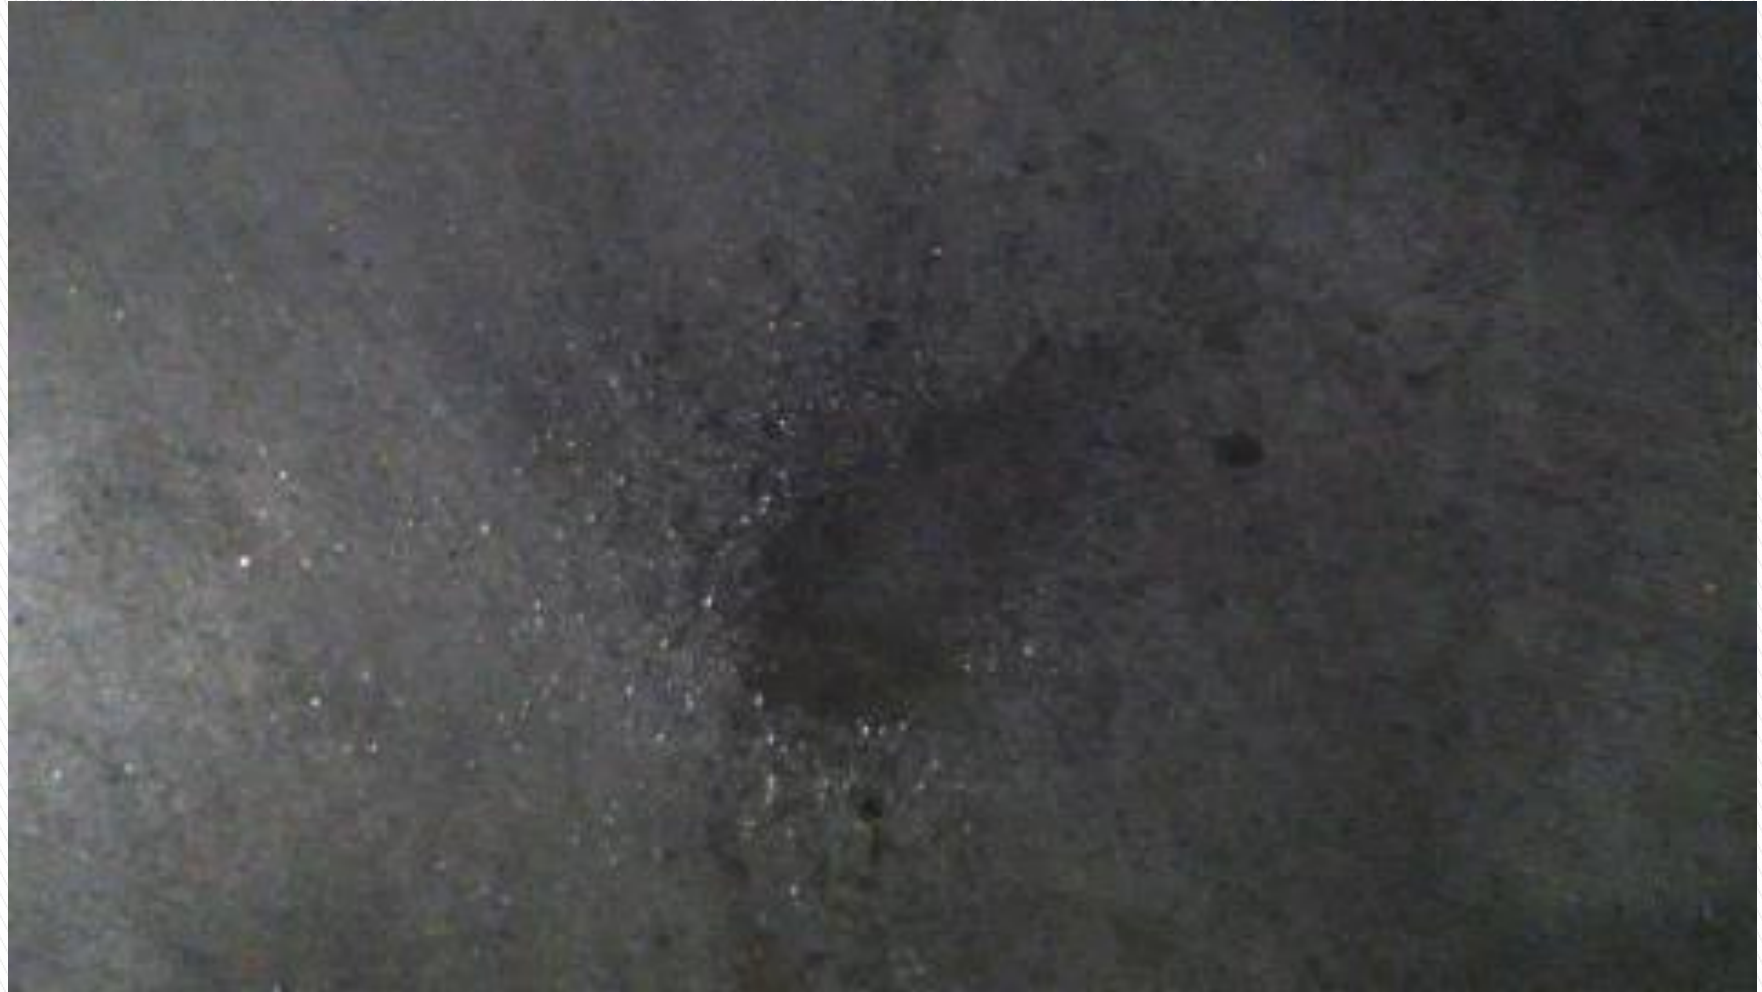
Water bubbling from tendon during Initial drying
