**ADDING
SUPPLEMENTAL SHEAR
CAPACITY IN BEAMS
USING DOWELS**

Presented by Steven M. Talafous, P.E.

A heavily used public parking structure
in the Minneapolis-St. Paul
metropolitan area:

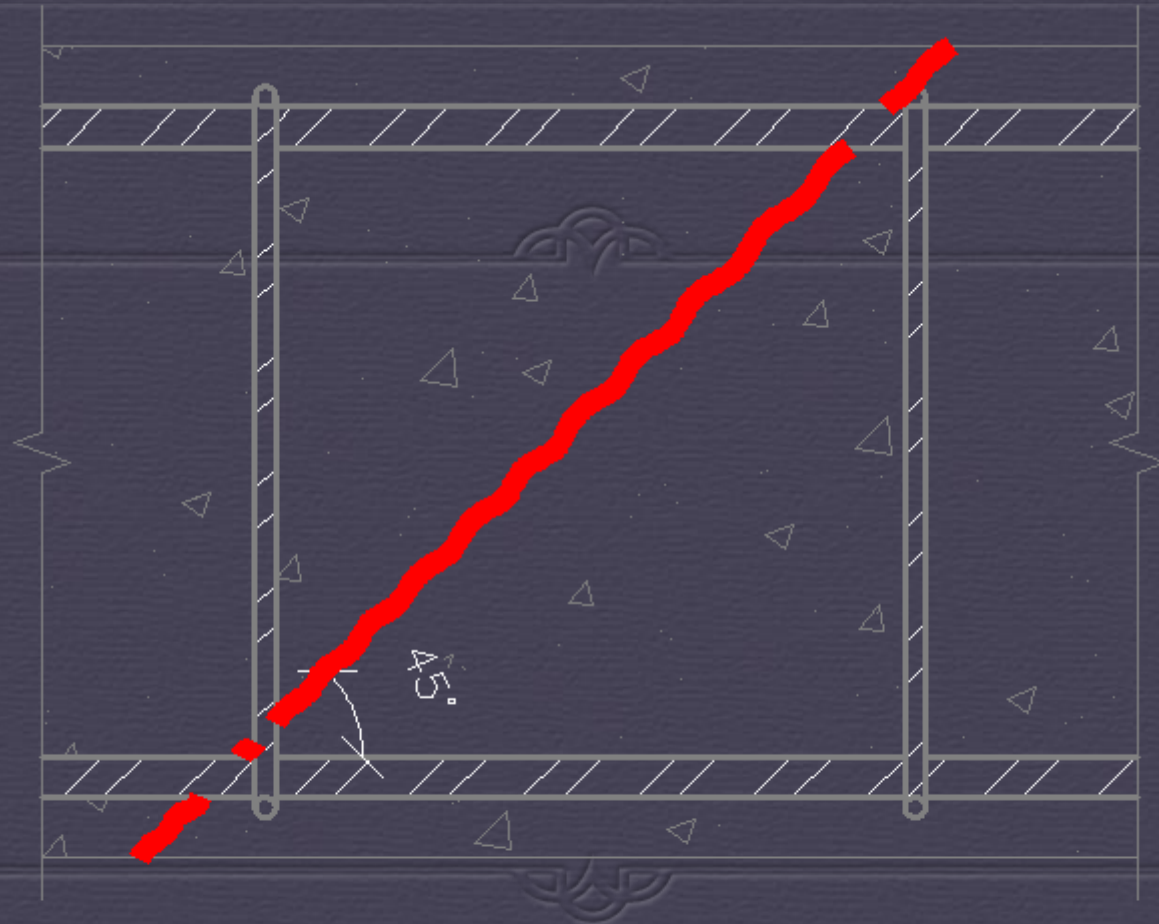
CRACKING UNDER LOADING

TYP. BEAM WITH THEORETICAL SHEAR CRACK
(STIRRUP SPACING TOO GREAT)

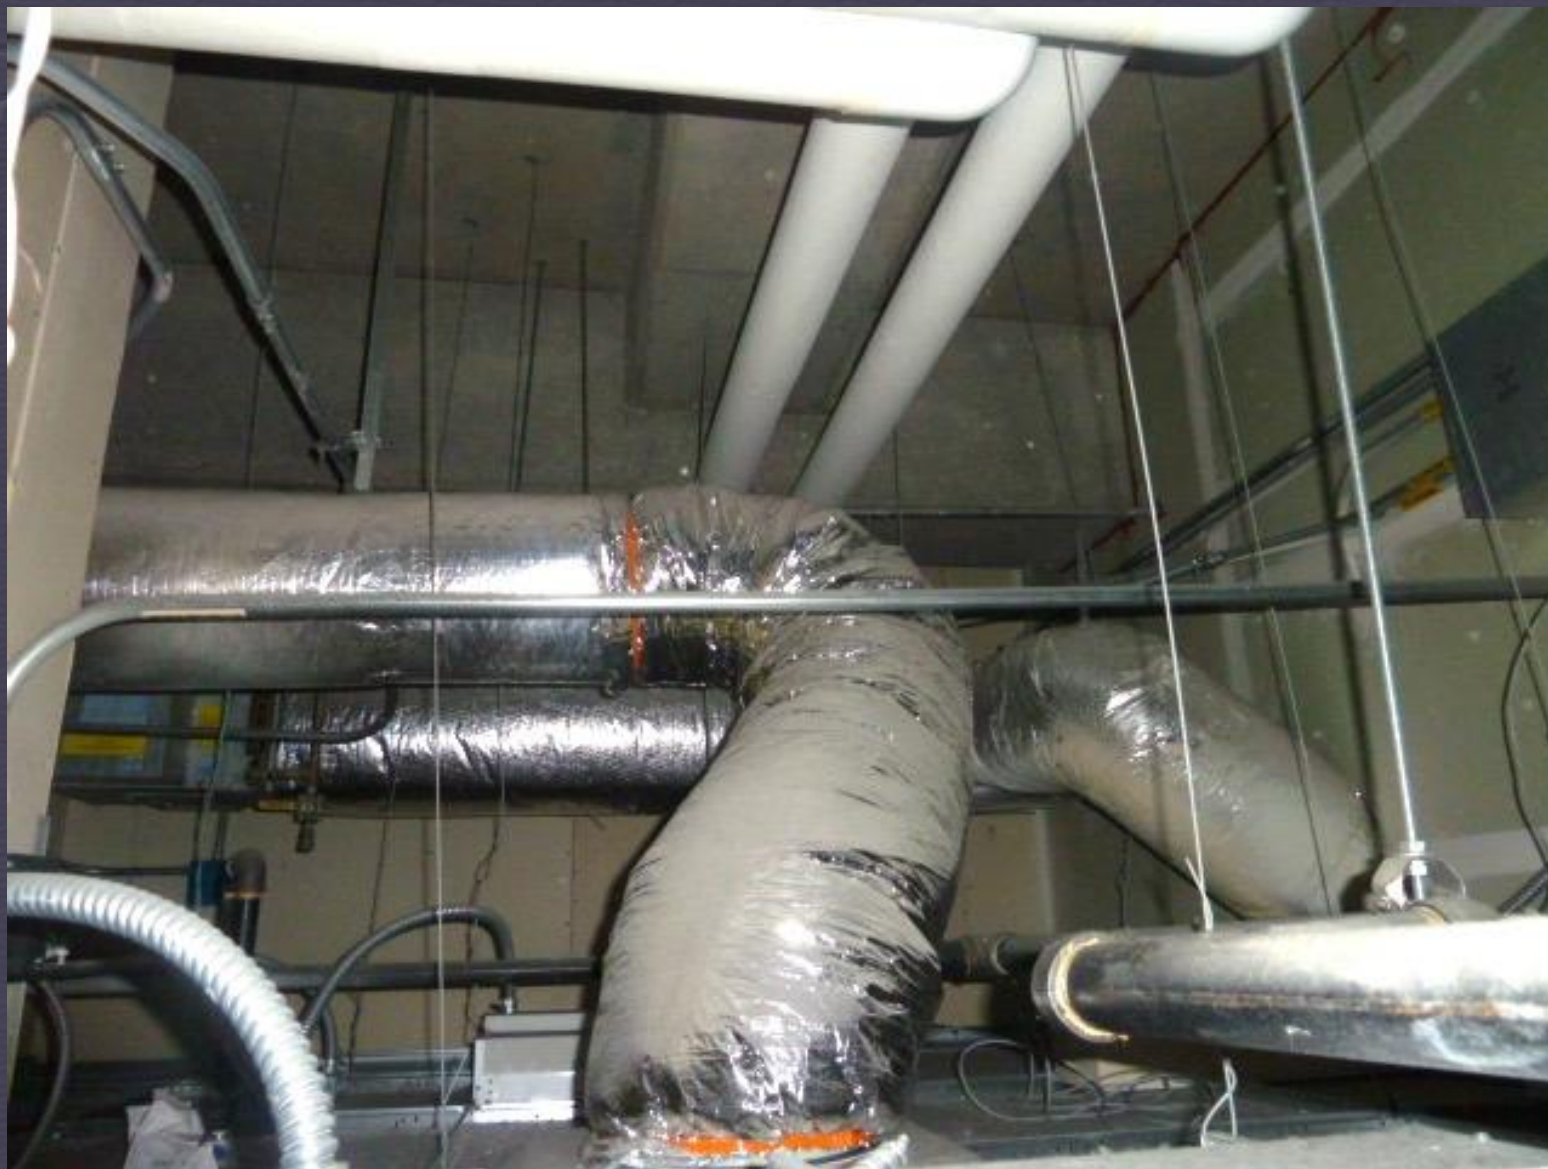
Congested areas below beams
