RENO NV LEEWENS CORPORATION

SPOKANE (WA) GREENE STREET BRIDGE LOAD RATING REPAIR

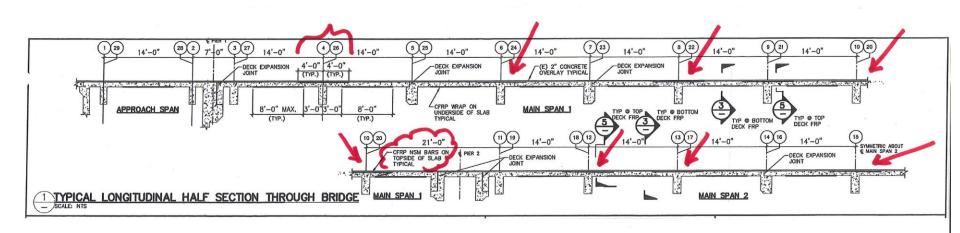
• NEAR SURFACE MOUNTED CARBON FIBER REINFORCING BAR ON TOP SIDE OF DECK

ON TOP OF THE BRIDGE DECK PLACE 8 FOOT LONG 1/2" (#4) DIAMETER CARBON FIBER BAR INTO 3/4" WIDE SLOTS CENTERED OVER THE BEAMS BELOW AT ONE FOOT ON CENTER WITH THE 8 FOOT LENGTH IN THE DIRECTION OF TRAFFIC. FILL SLOT.

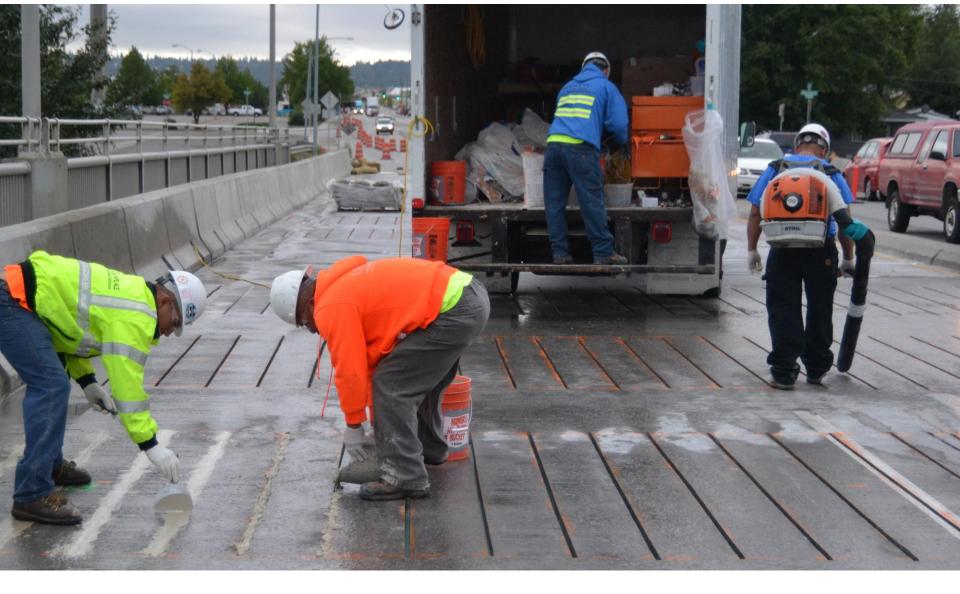
THE GREEN IN THE BOTTOM OF THE SLOT IS CURED EPOXY OVER THE CARBON FIBER BAR.

SURFACES WETTED, THEN BLOWN DRY OF FREE WATER FOR CEMENTITIOUS GROUT FILL OF TOPPING SLAB.

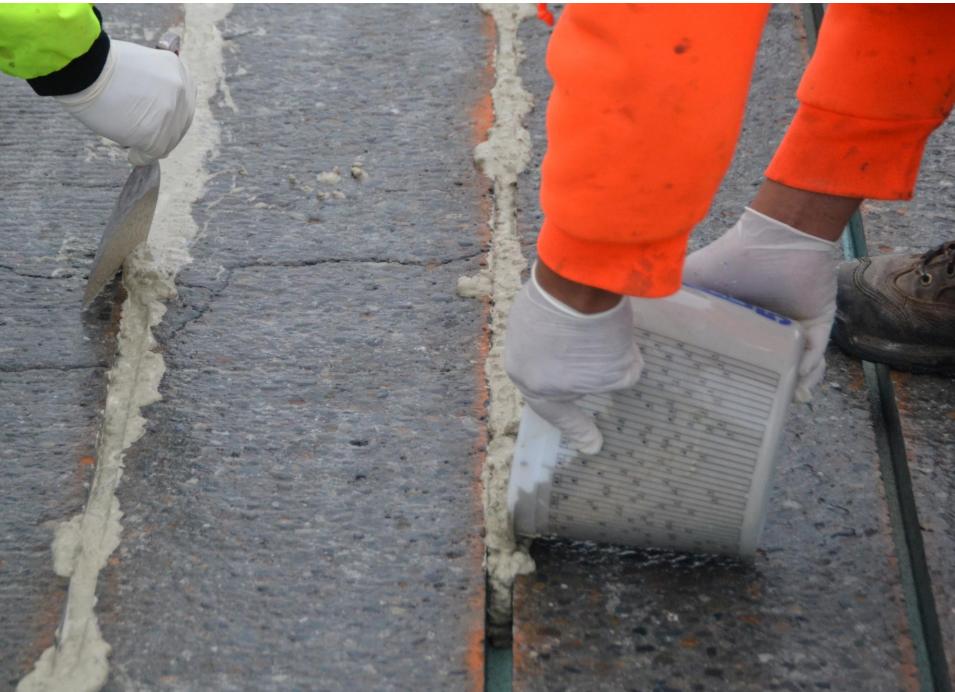
FILLED SLOTS BEFORE TRAFFIC

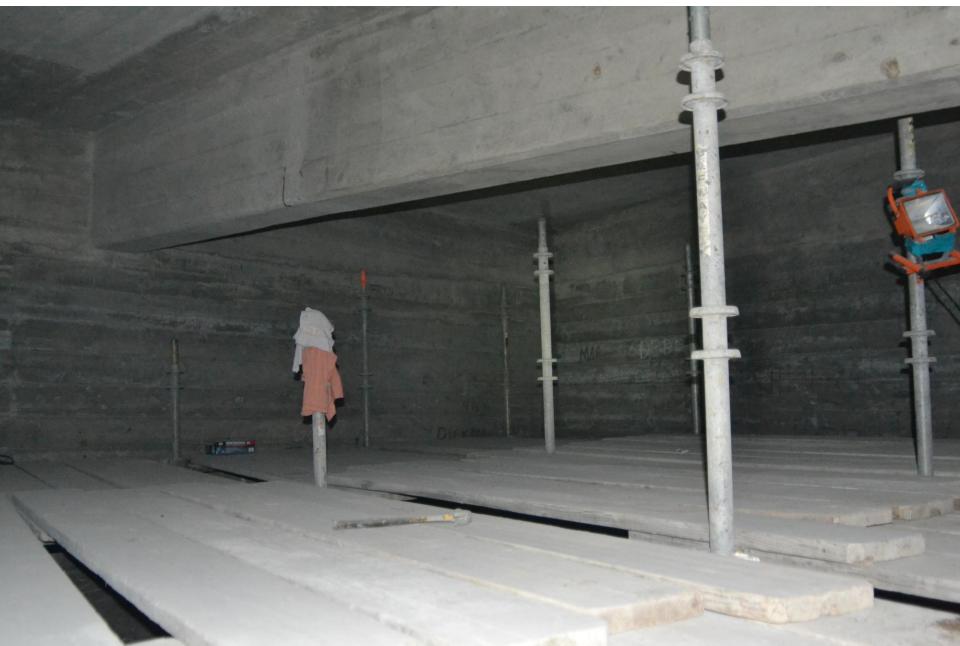
UNDERNEATH THE BRIDGE DECK, CRACKS ARE UNCOVERED.

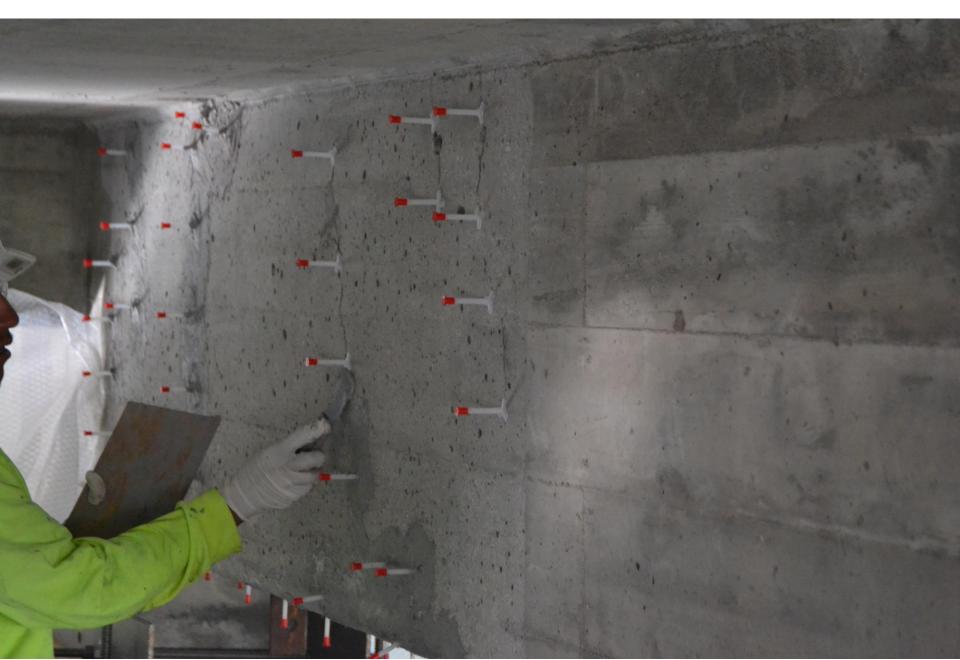
QUANTITY OF CRACKING VARIED FROM BEAM TO BEAM AND IN BRIDGE DECK.

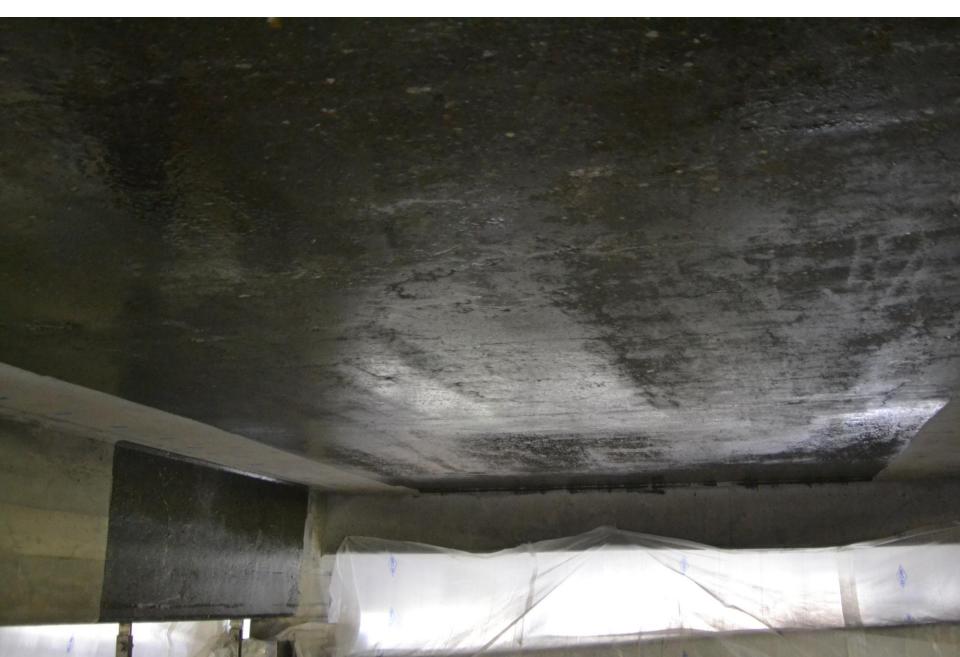
PREPARED AND PRIMED CONCRETE WITH INJECTED CRACK
