# Restoration of the Corning Centerway Bridge

**Joseph Logan, PE, Principal**  
**Fisher Associates, PE, LS, LA, DPC**

# Centerway Arch Bridge

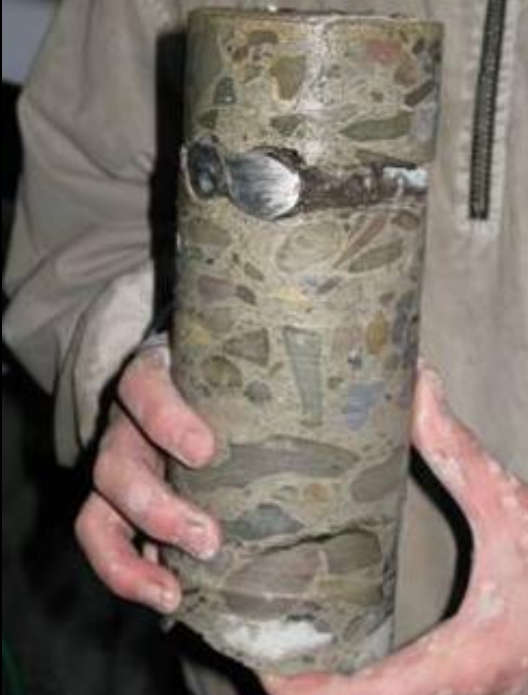
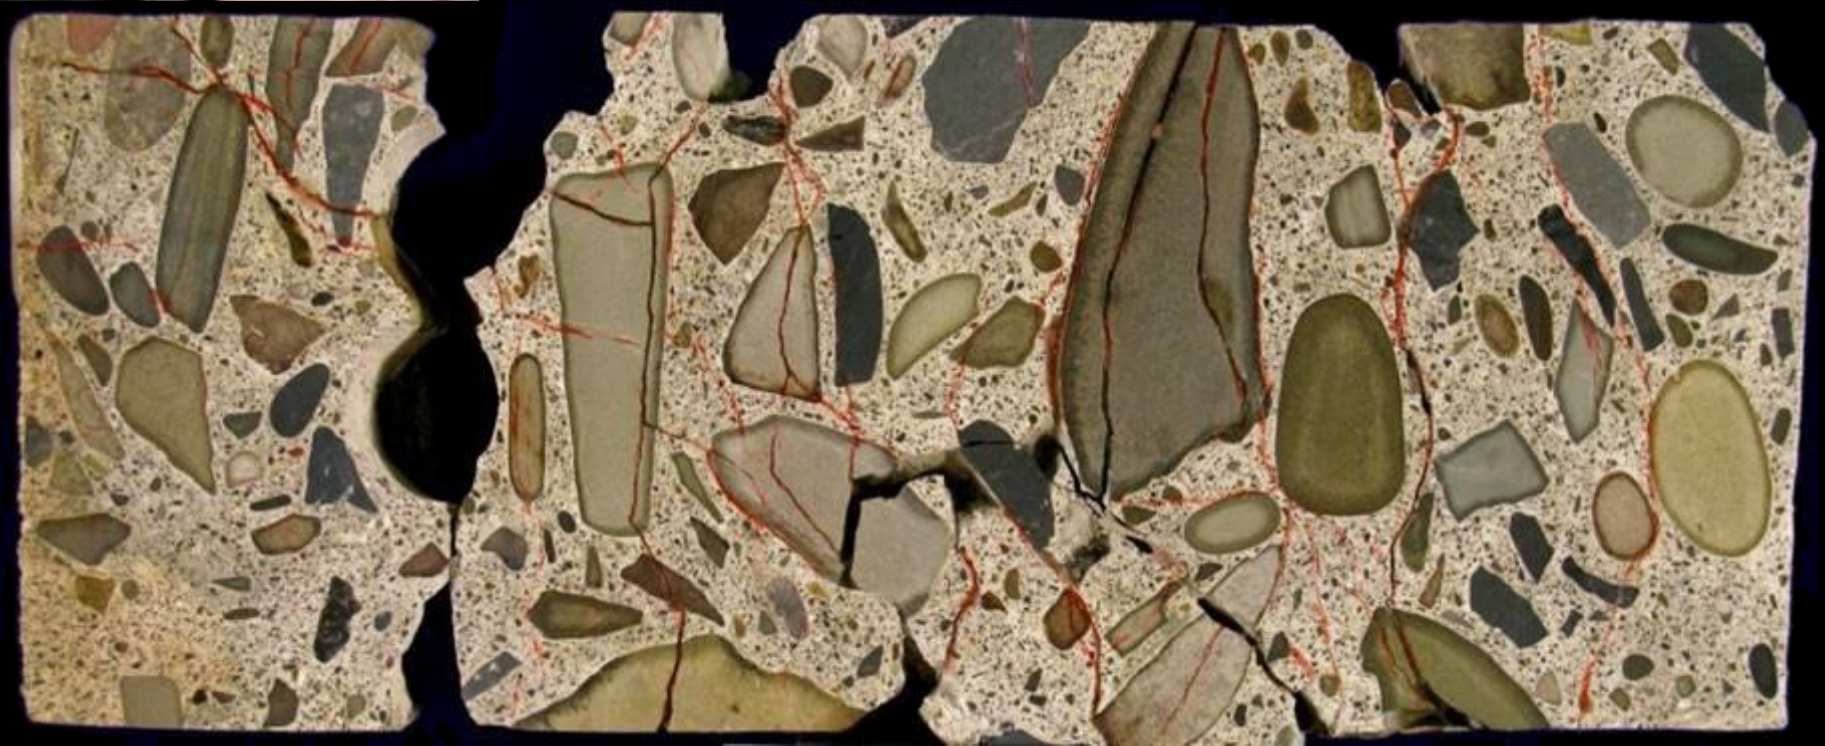
# ASR In Petrograph Section

- Cracking
- Gel Formation/Aggregate Discoloration

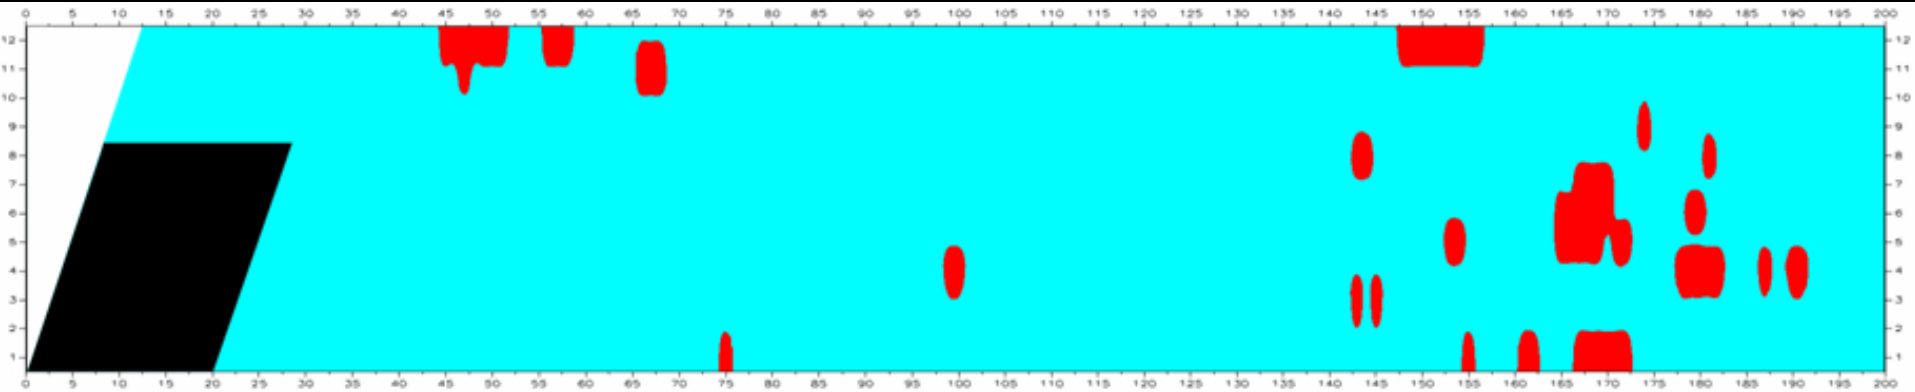
Delaminations/Voids

Surface Scaling  
Conditions verified by concrete cores

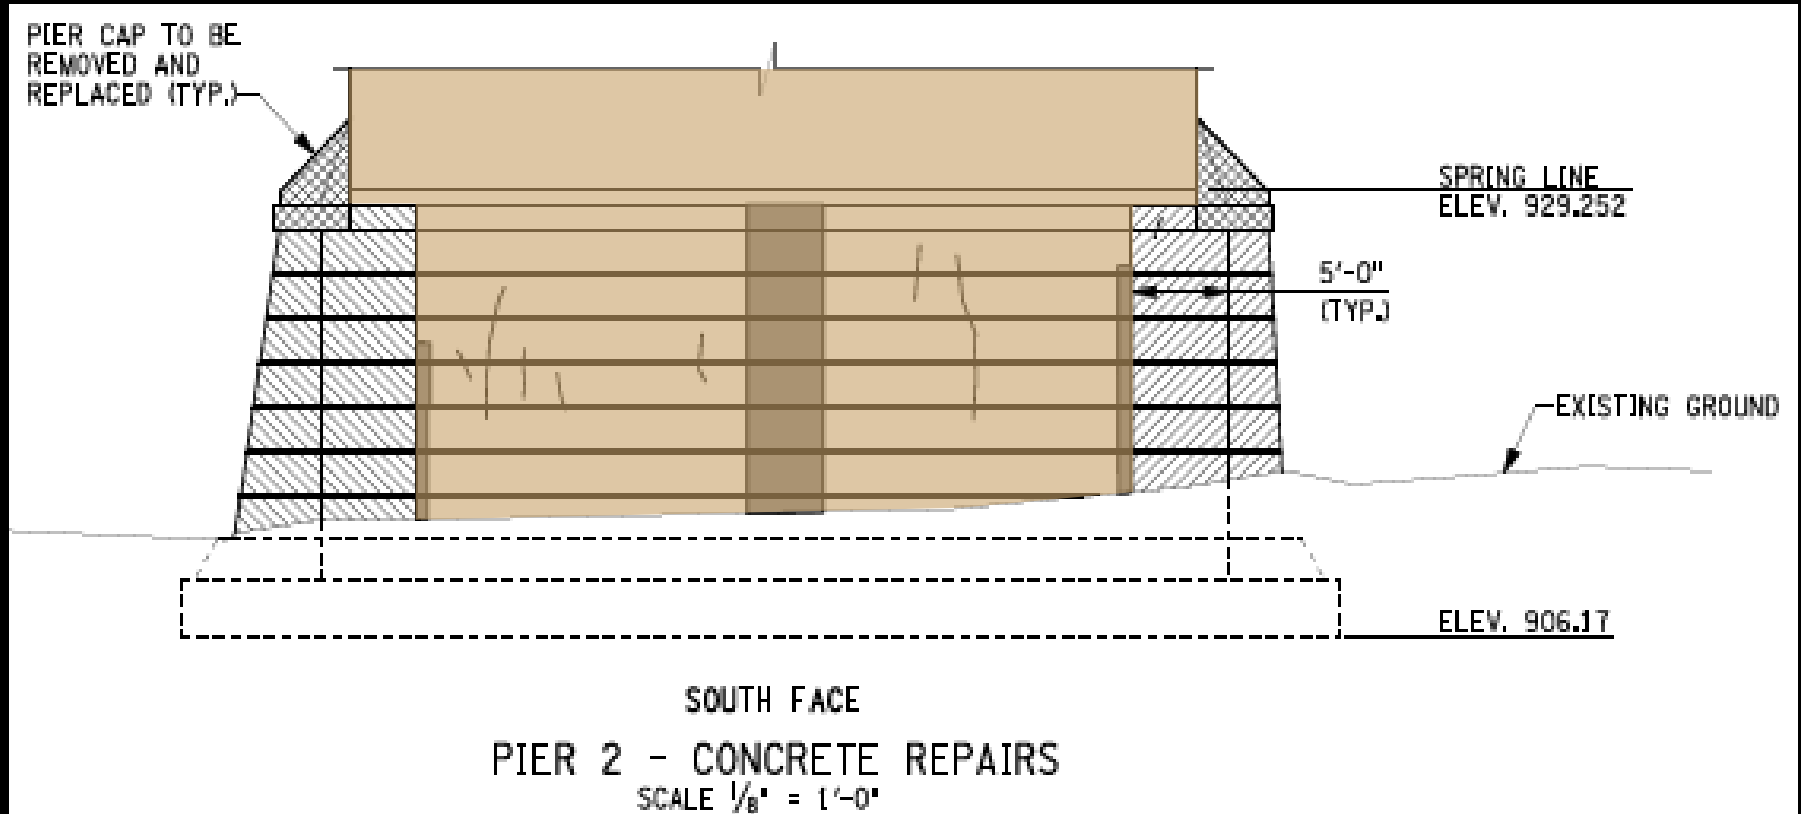
## Piers and Abutments

- Concrete in Abutments, Wingwalls, and Spandrel Walls show spalling, advanced concrete degradation due to moisture retention from coating applied in 1989 due to Alkali-Silica Reaction (ASR).
- Concrete Arches were not coated, but exhibited advanced ASR, cracking, and some delamination.
- Complete loss of integrity from ASR.  
Restoration/overlay is not feasible due to condition.

- Rehabilitation at upstream/downstream ends due to spalling/cracking of surface.
- Repair cracks and perform partial depth concrete repairs; seal surfaces.
