Advanced Pile Encapsulation

Solutions for the Repair and Protection
of Underwater Structures

Hazem Jadallah

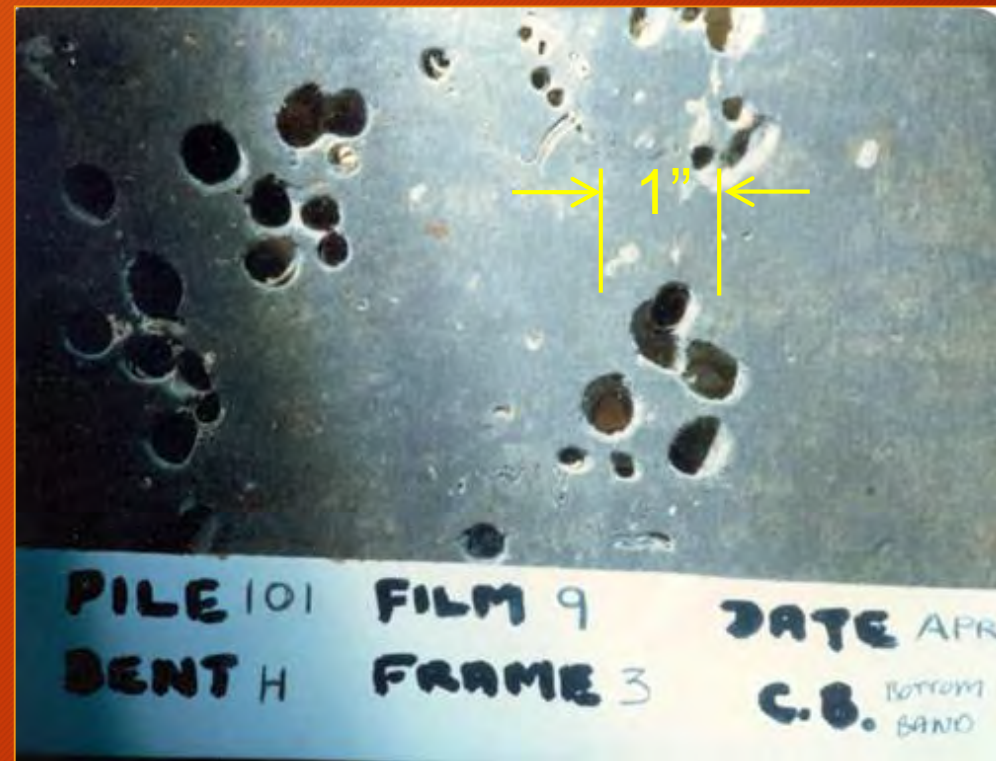
- Routine inspection in 1983 (3 years after construction) revealed severe marine borer attack
- 616 piles affected

- The 616 piles were encapsulated using the advanced pile encapsulation technique in 1984

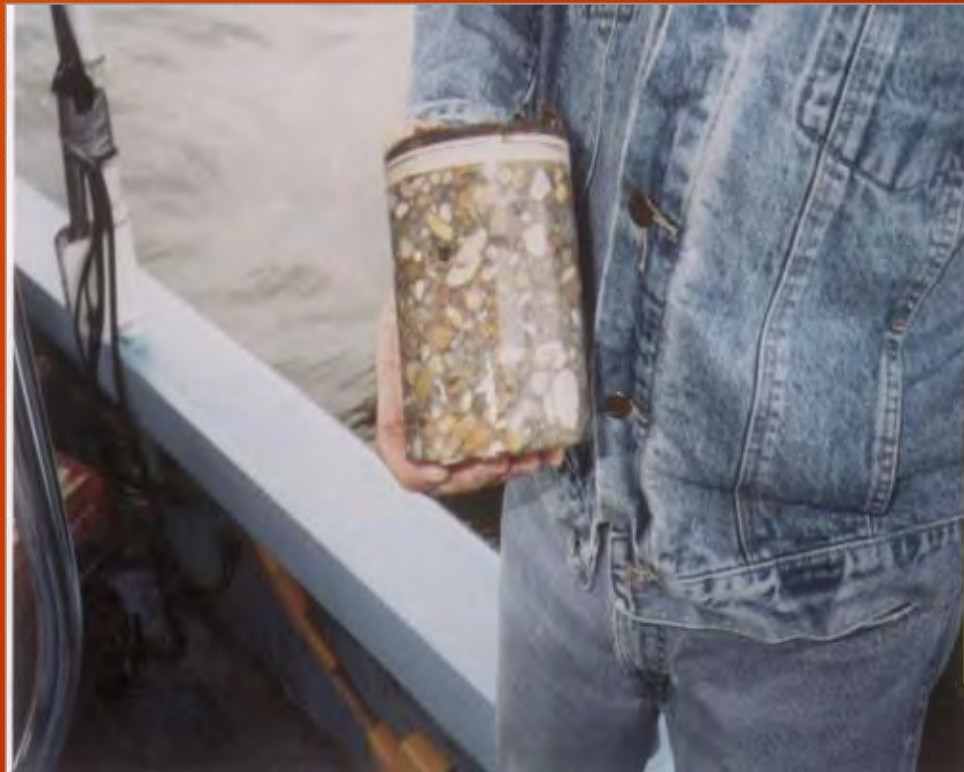
- Core sample

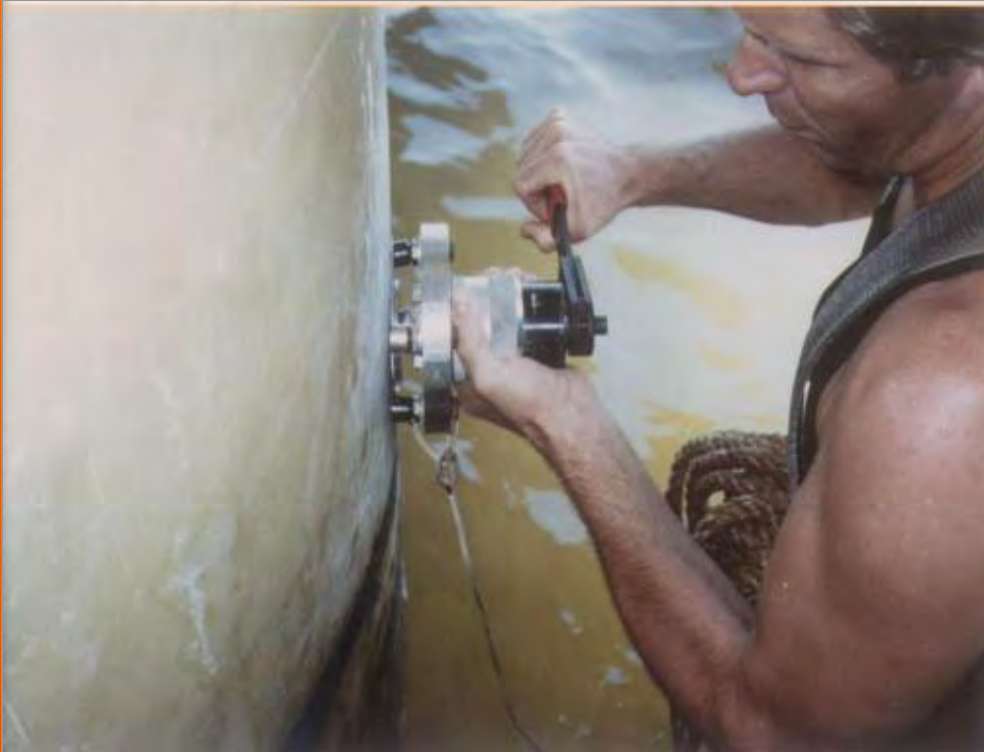
- Bond testing 13-year old encapsulations

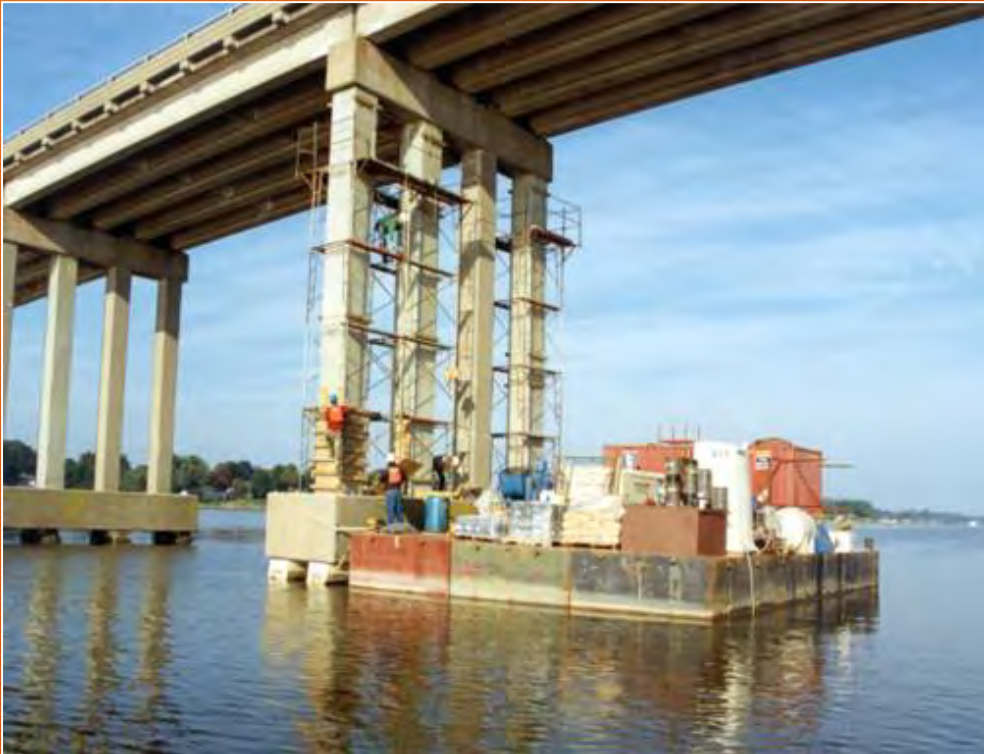
- 1993
- RC Piers Showing Corrosion and Spalling
- Encapsulations all Above Water

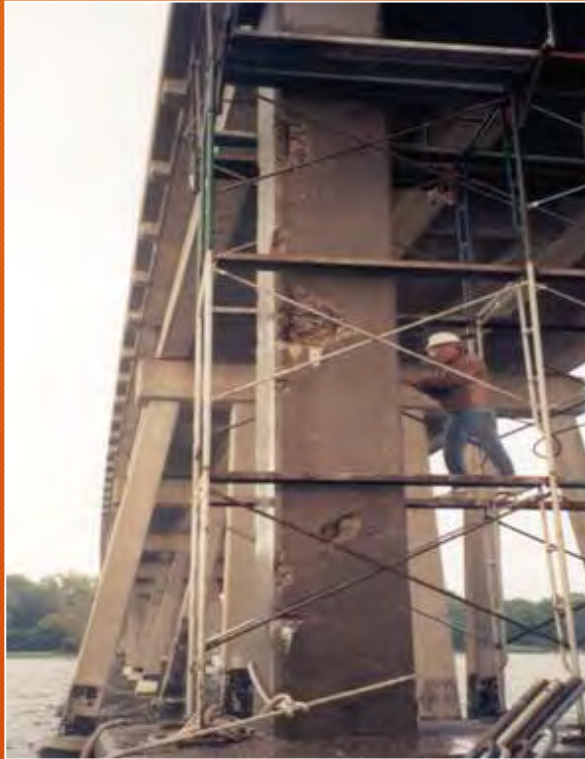
- 1993
- RC Piers Showing Corrosion and Spalling
- Encapsulations all Above Water

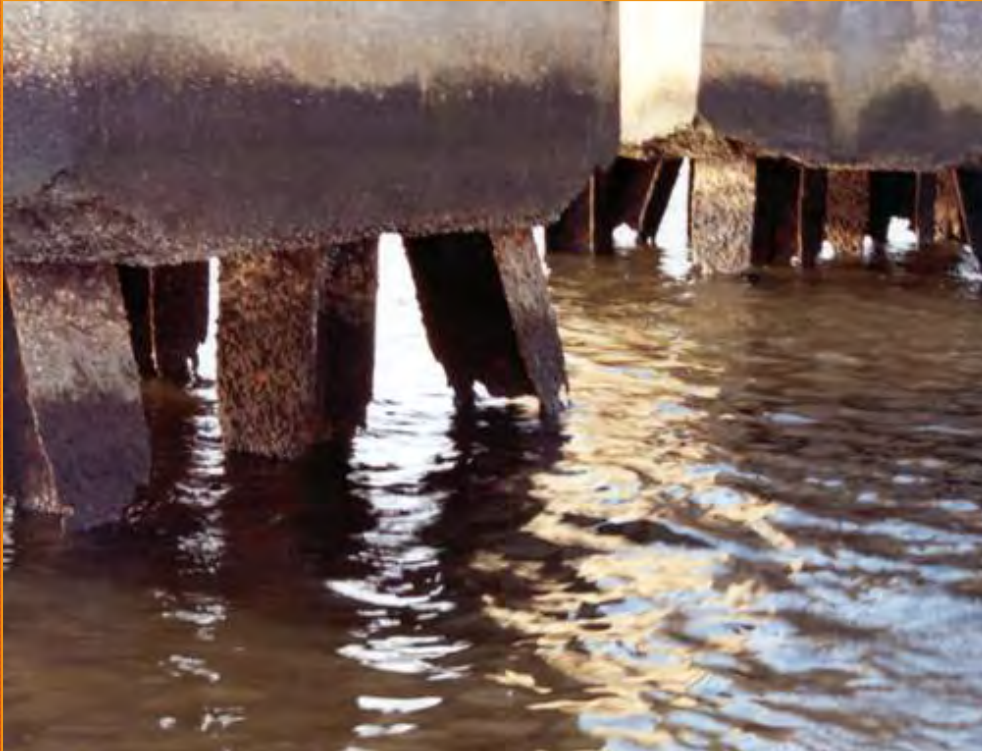
- Badly deteriorated H-Piles

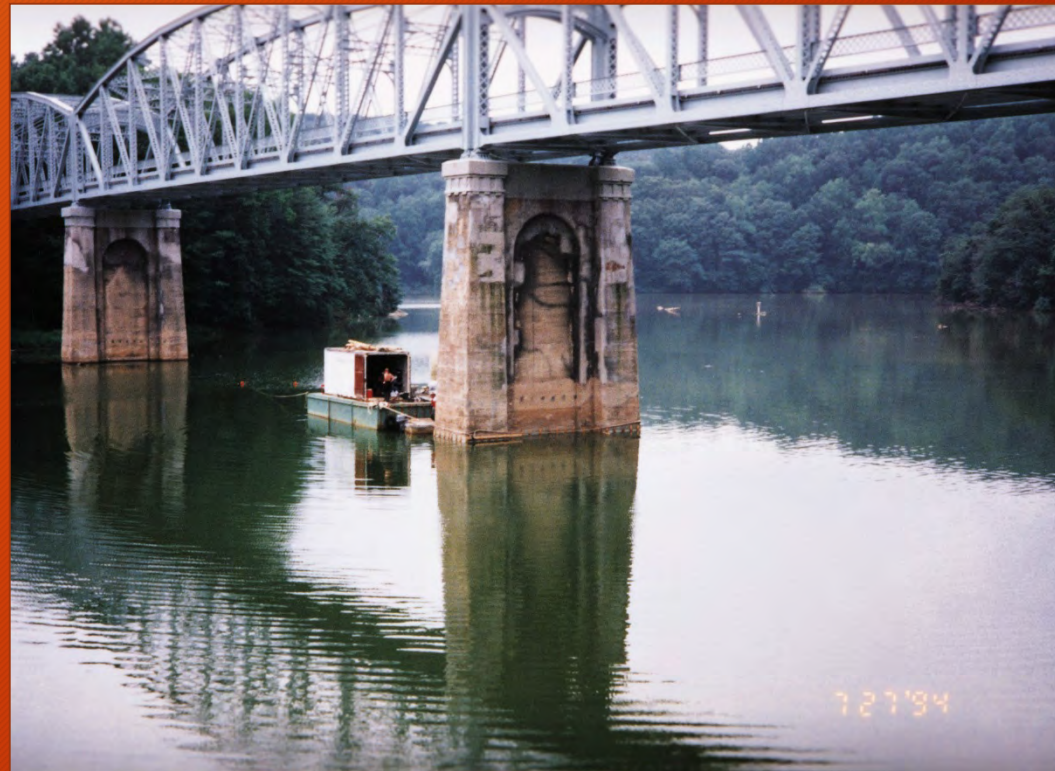
Deteriorated piers

- Large concrete pier

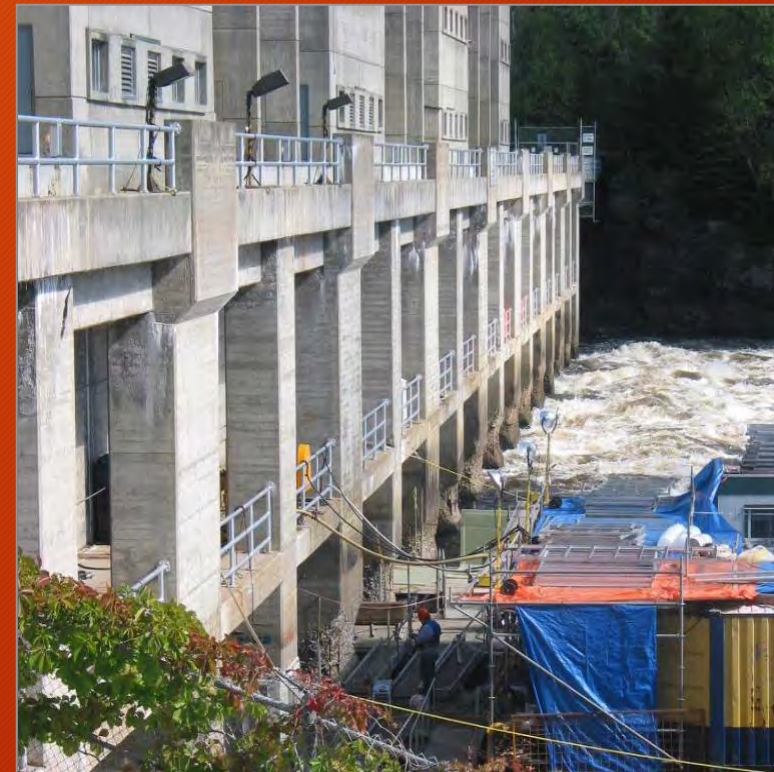
- Structure built in 1940's
- Damage to tailrace from scour and abrasion

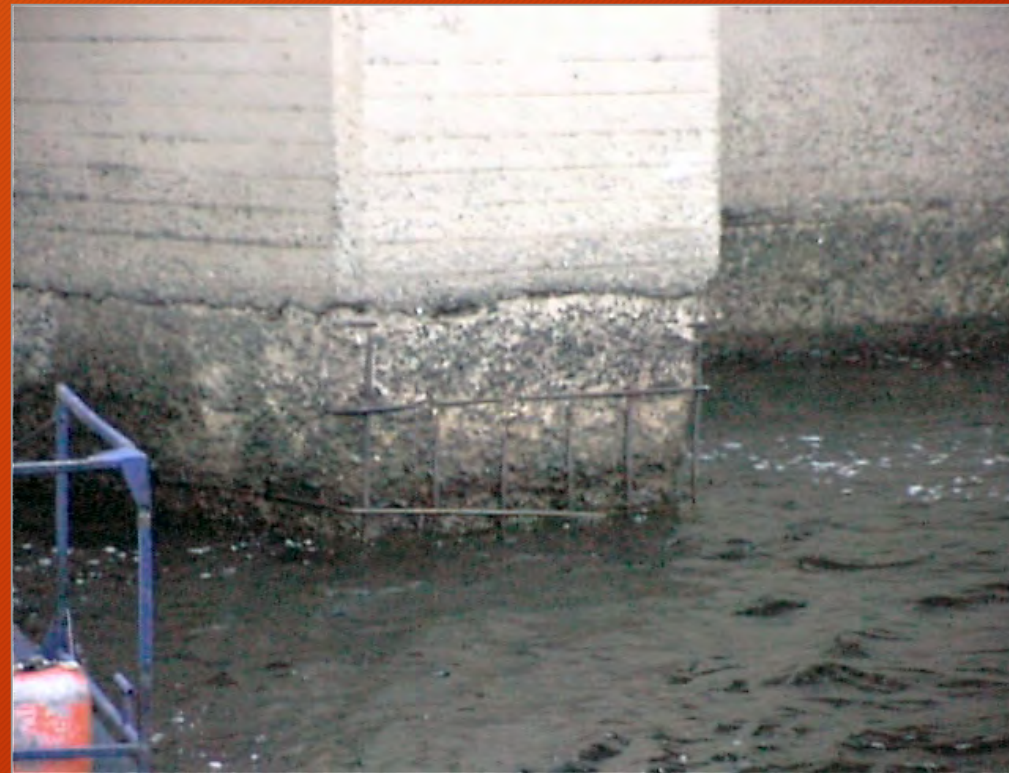
- Damage to Piers
 - Loss of section
 - 12" to 18" of section loss in some instances
 - Reinforcing steel exposed

- Restore loss of section
- Protect against future abrasion damage
- Protect the downstream ecosystem
- Minimize dam shutdown time to less than 10-days

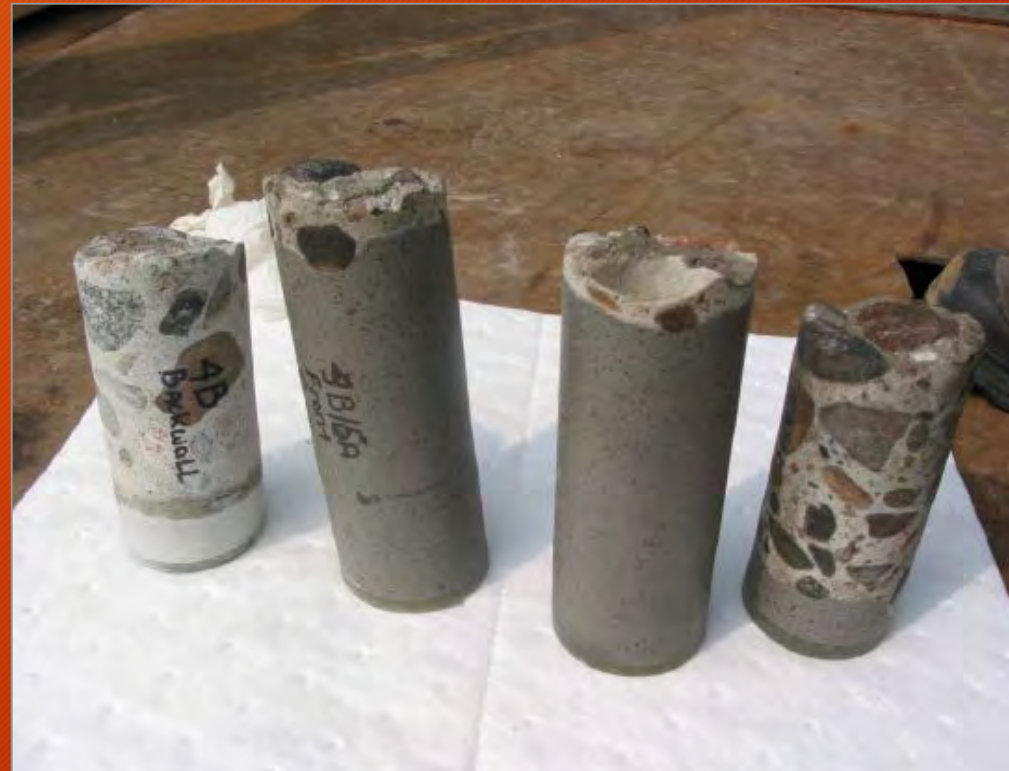
- Excellent bond to backwall
- Good grout consolidation
- No cracking in grout from exotherm

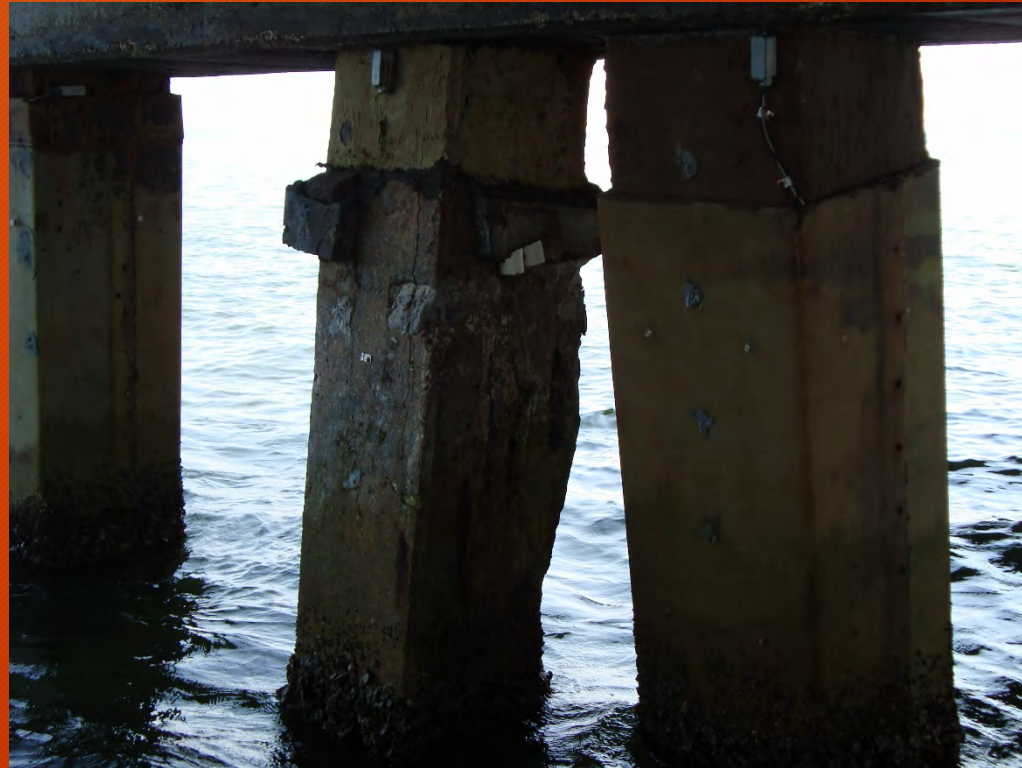
- Condition Survey
- First Encapsulated in 1987

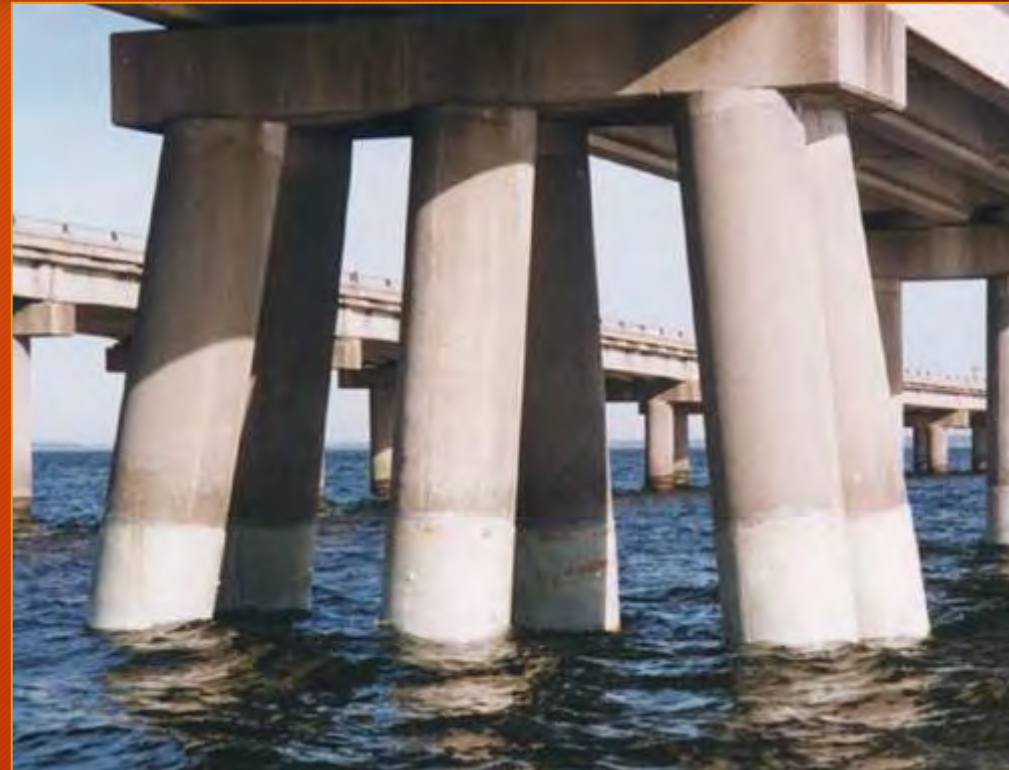
The repair and protection via Advanced Pile Encapsulation remains in place and continues to provided protection without any maintenance
