Carbon Fiber Reinforced Polymer (CFRP) Systems Prove Effective for Drinking Water Pipe Repairs

HJ3 Composite Technologies

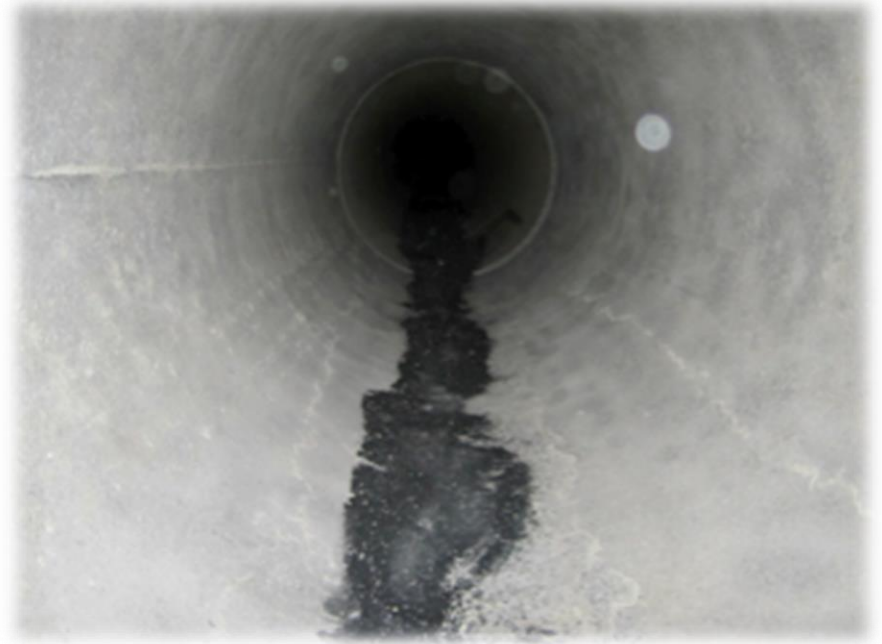
PROJECT #1 REPAIR OVERVIEW: 54 INCH PIPE

- Three 20 foot sections
 - Lock-joint
 - 2 Access manholes
2,200 LNFT apart

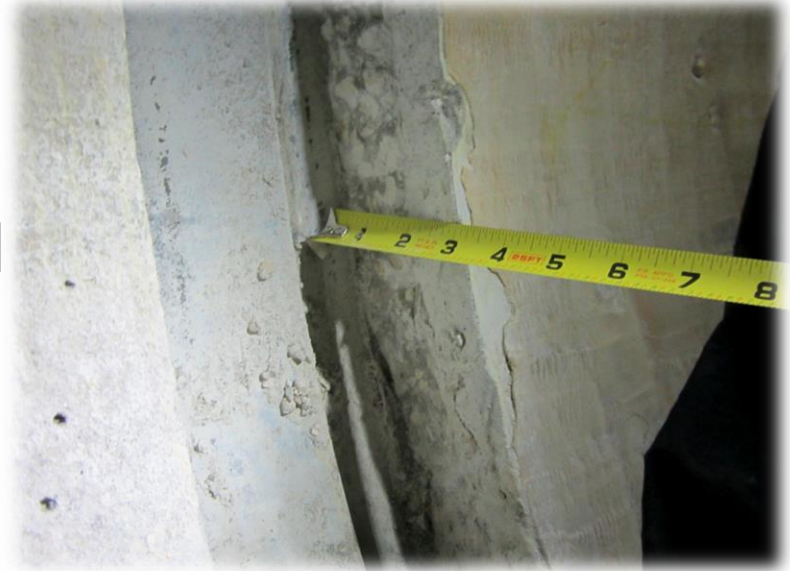
- Condition Assessment:
 - Acoustic test
 - ACI-546 “Concrete Repair Guide” standards referenced for crack repairs
 - Visual inspection found joints had lost 50-75% of circumferential grout covers

- Surface:
 - High pressure sandblasting
 - Minimum ICRI 03732 CSP#3 Concrete Surface Profile
 - Moisture and dust test
 - Steel cylinder prepared to SSPC SP-10/NACE #2 Near White Metal with hand tools
