October 17, 2023
ICRI 2023 Fall Convention

Rehabilitation of O'Hare International Airport Parking Garage

**Predrag L. Popovic
Dunja Vla**
Wiss, Janney, Elstner Associates, Inc.

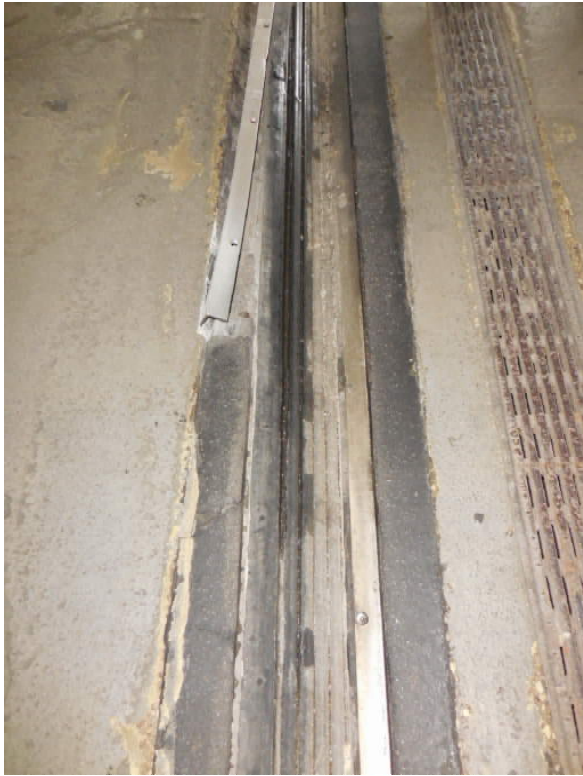
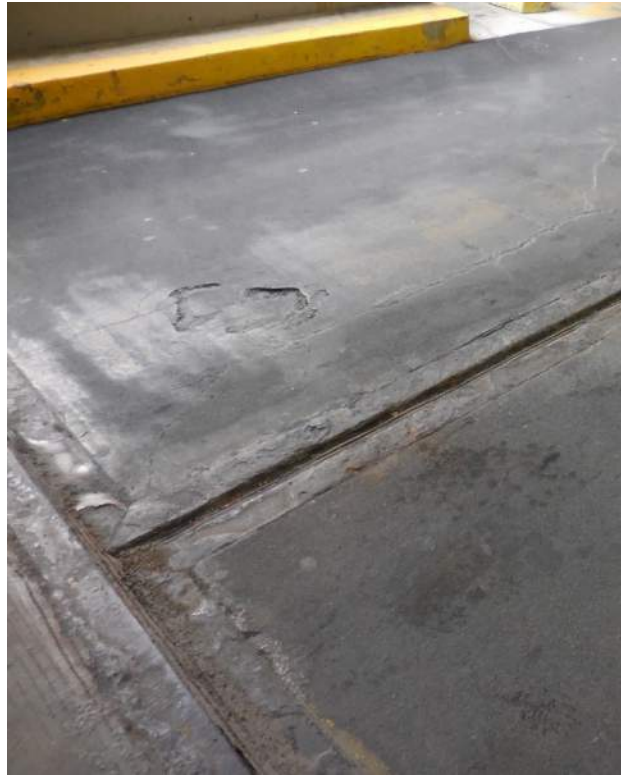
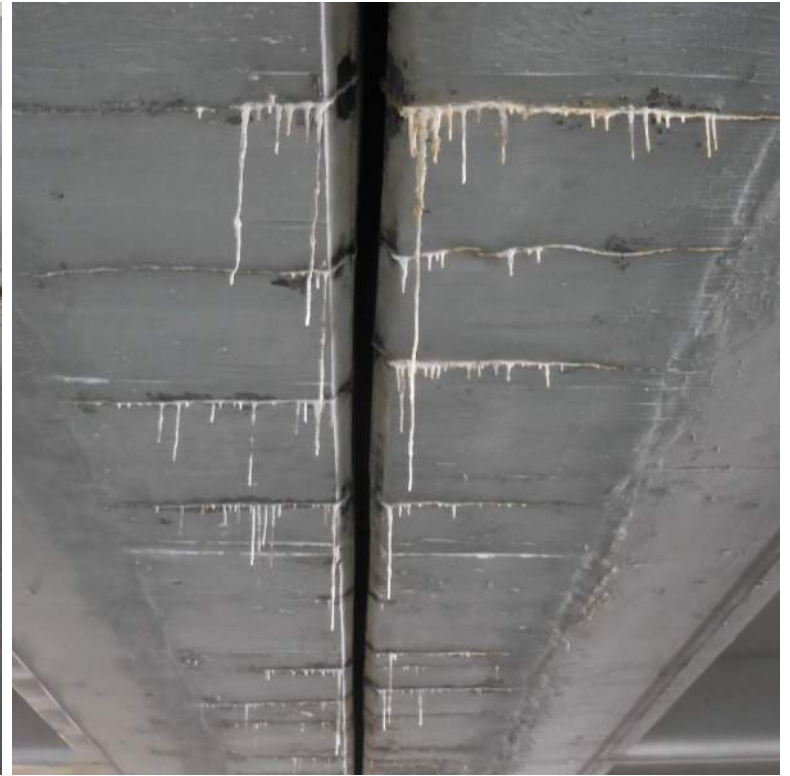
Condition Assessment – Expansion Joints

- 150,000 sq ft of top surface delaminations (~6%)
- 5,000 sq ft of topping slab replacement
- 6,000 sq ft of vertical and overhead repairs
- 3,500 sq ft of concrete repairs on exterior surfaces
- 100% of expansion joint seals had failed
- Expansion joint block supports were failing
- Worn and debonding traffic coating

- Concrete and PT repairs
- Replace expansion joint seals
- Repair PT column
- Traffic coating repairs
- Replacement of drains
- Expansion joint block replacement
- Painting and repair of steel spandrel panels

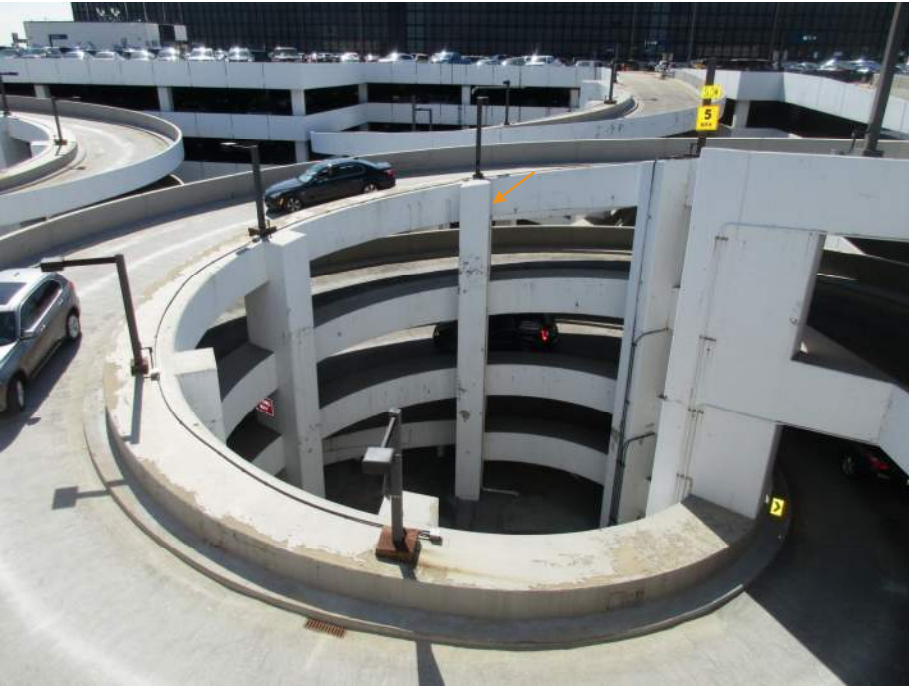
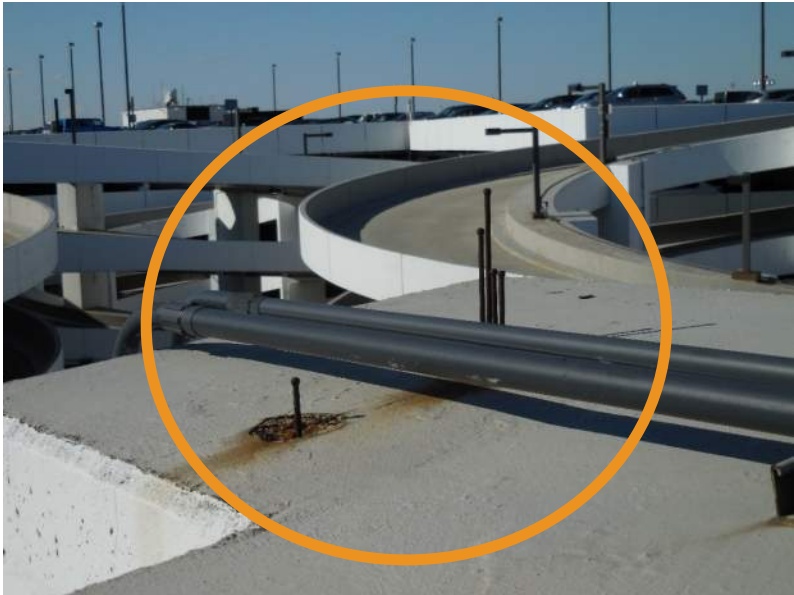
External PT Column Repair

- Original PT
 - 3 tendons with 42 wires each
 - ~1,000,000 lbs of PT force
 - At least 10 wires were failed, unknown condition of remaining wires
 - Difficult access to investigate
 - Continued deterioration
- External PT Repair
 - (13) 0.6 in. diameter 7-wire strands in each new tendon
 - (12) 1 ¼ in. diameter Dywidag bars in anchor blocks to transfer new force
