# Concrete Façade Restoration, South Boston Waterfront, Boston, MA

369 Congress Street, Boston, MA

Gorman Richardson Lewis Architects, Inc.

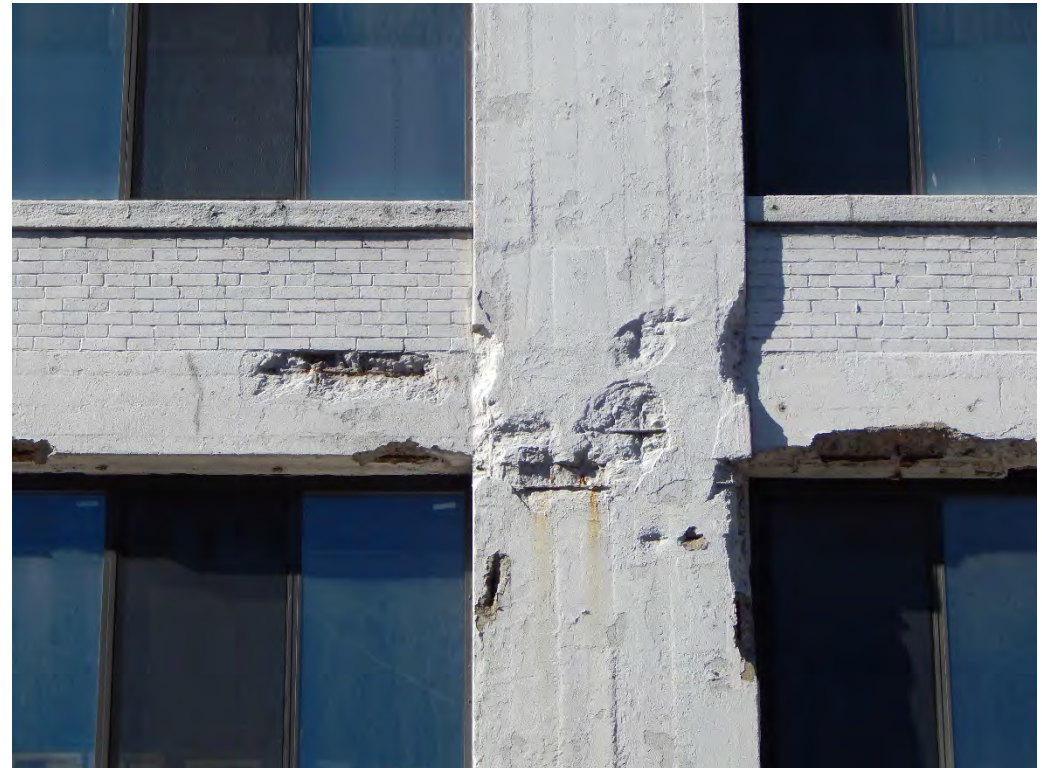
At Right: Close-up view, typical spalling conditions throughout the building.

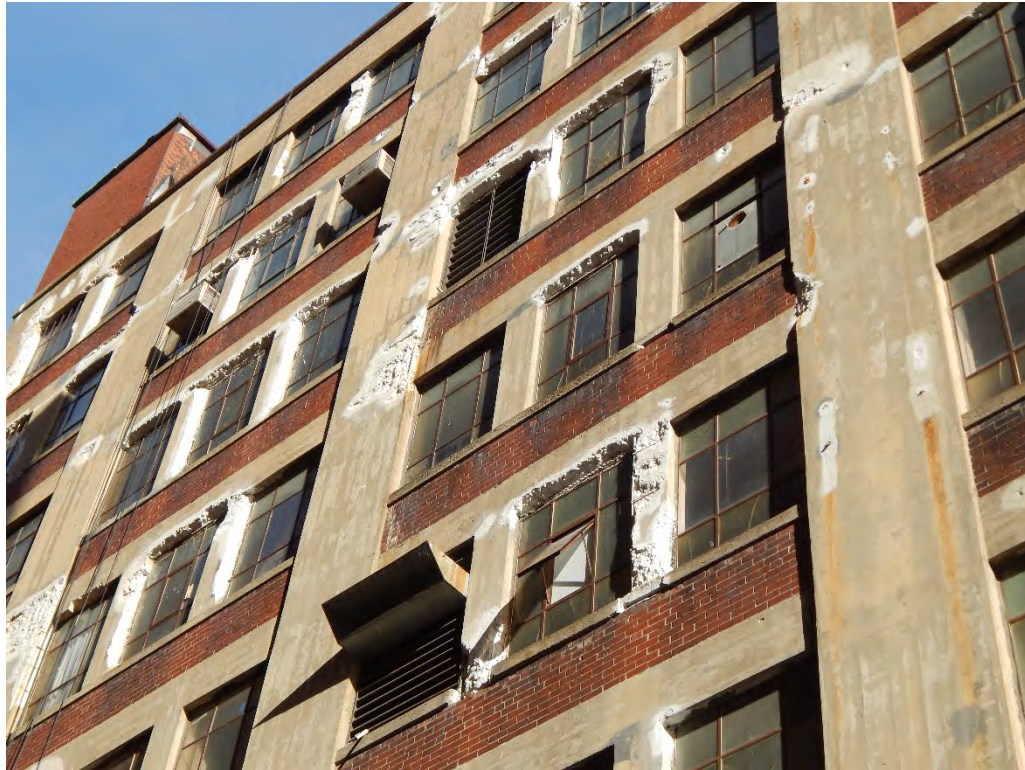
At Left: Partial view of the South (rear) Elevations and associated spall areas.

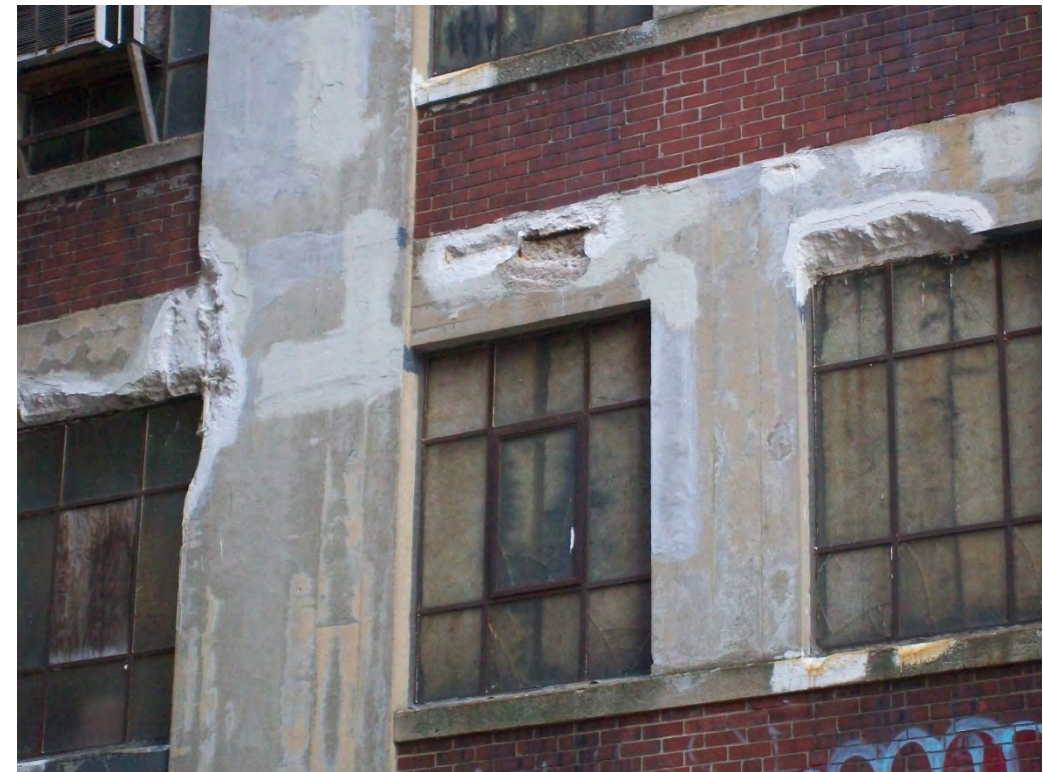
At Right: Close-up view, typical spalling conditions throughout the building.

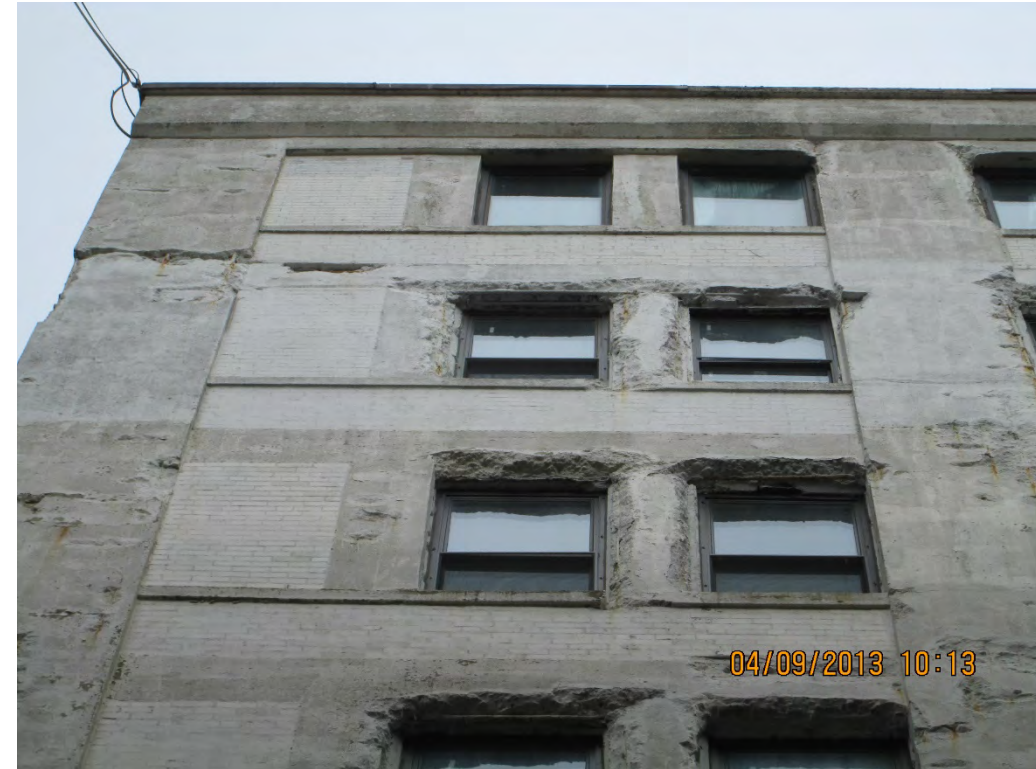
At Right: Representative spall locations.

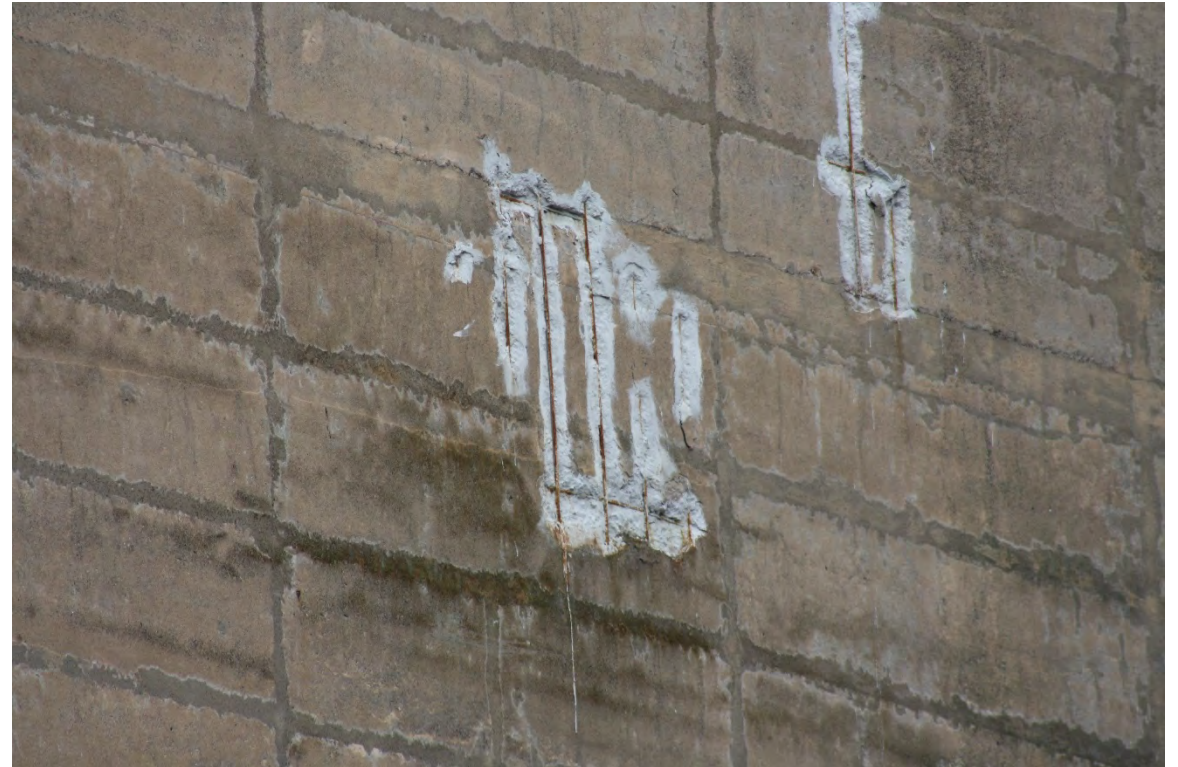
At Right: Representative spall locations.

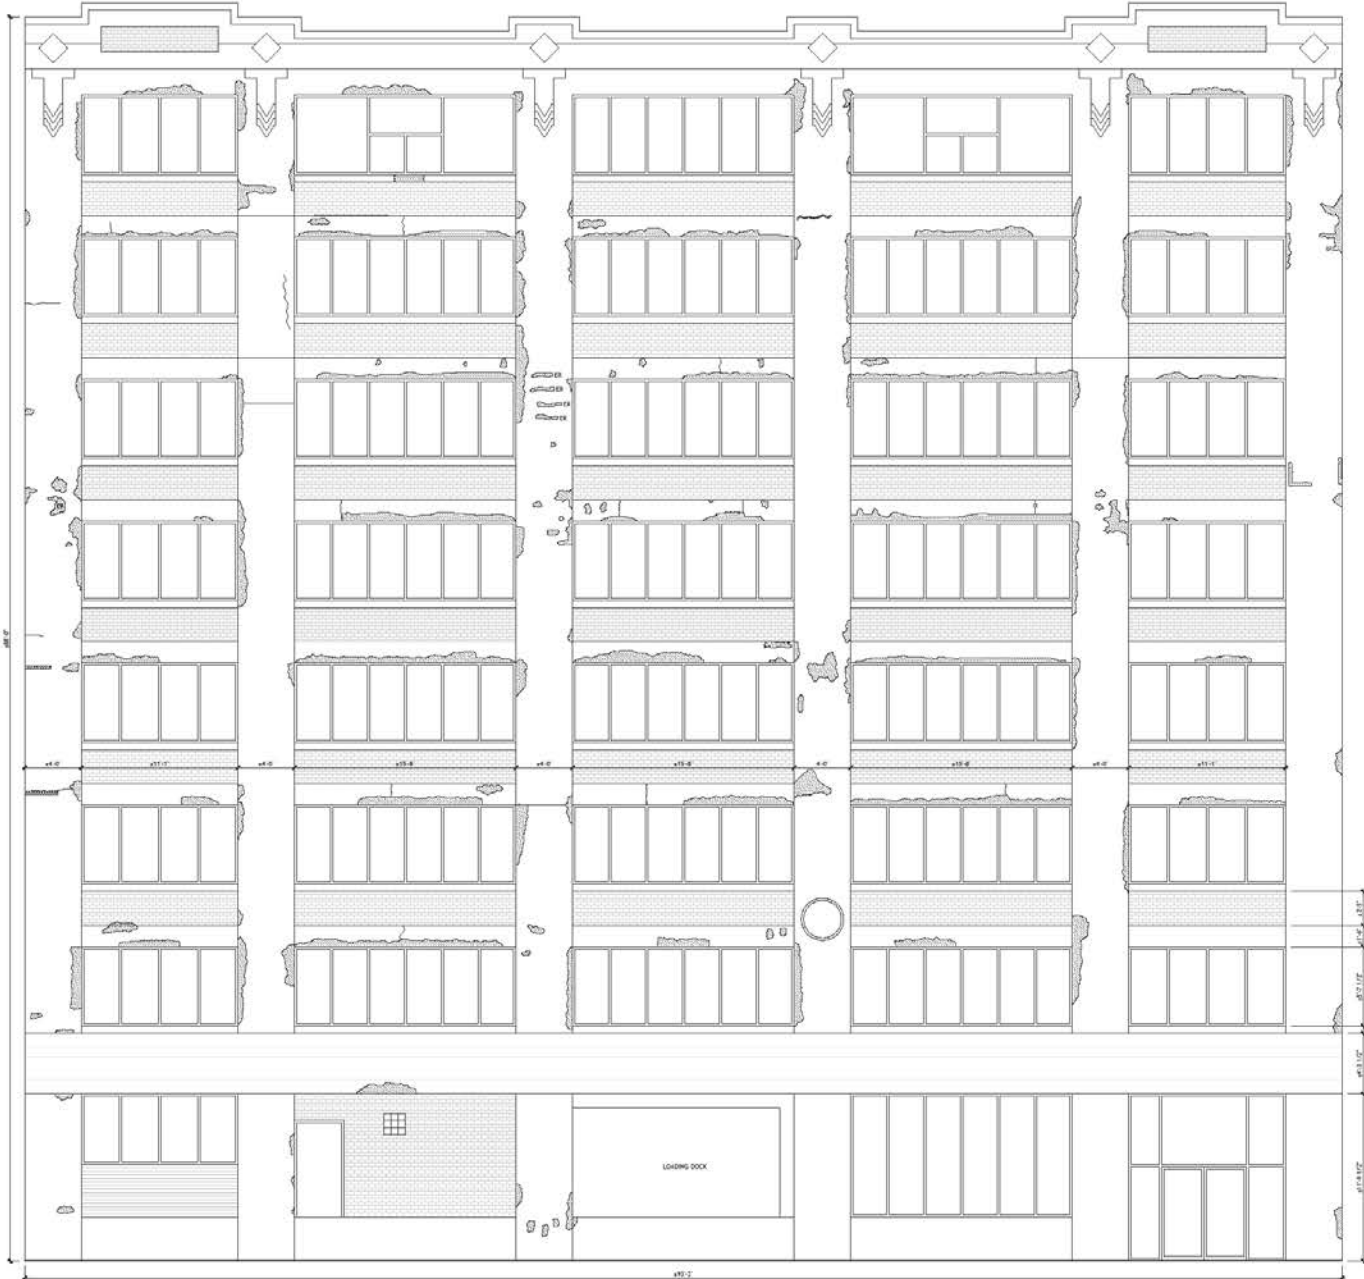
**NORTH ELEVATION**

**1 NORTH ELEVATION**  
SCALE: 1/8" = 1'-0"  
CONGRESS STREET

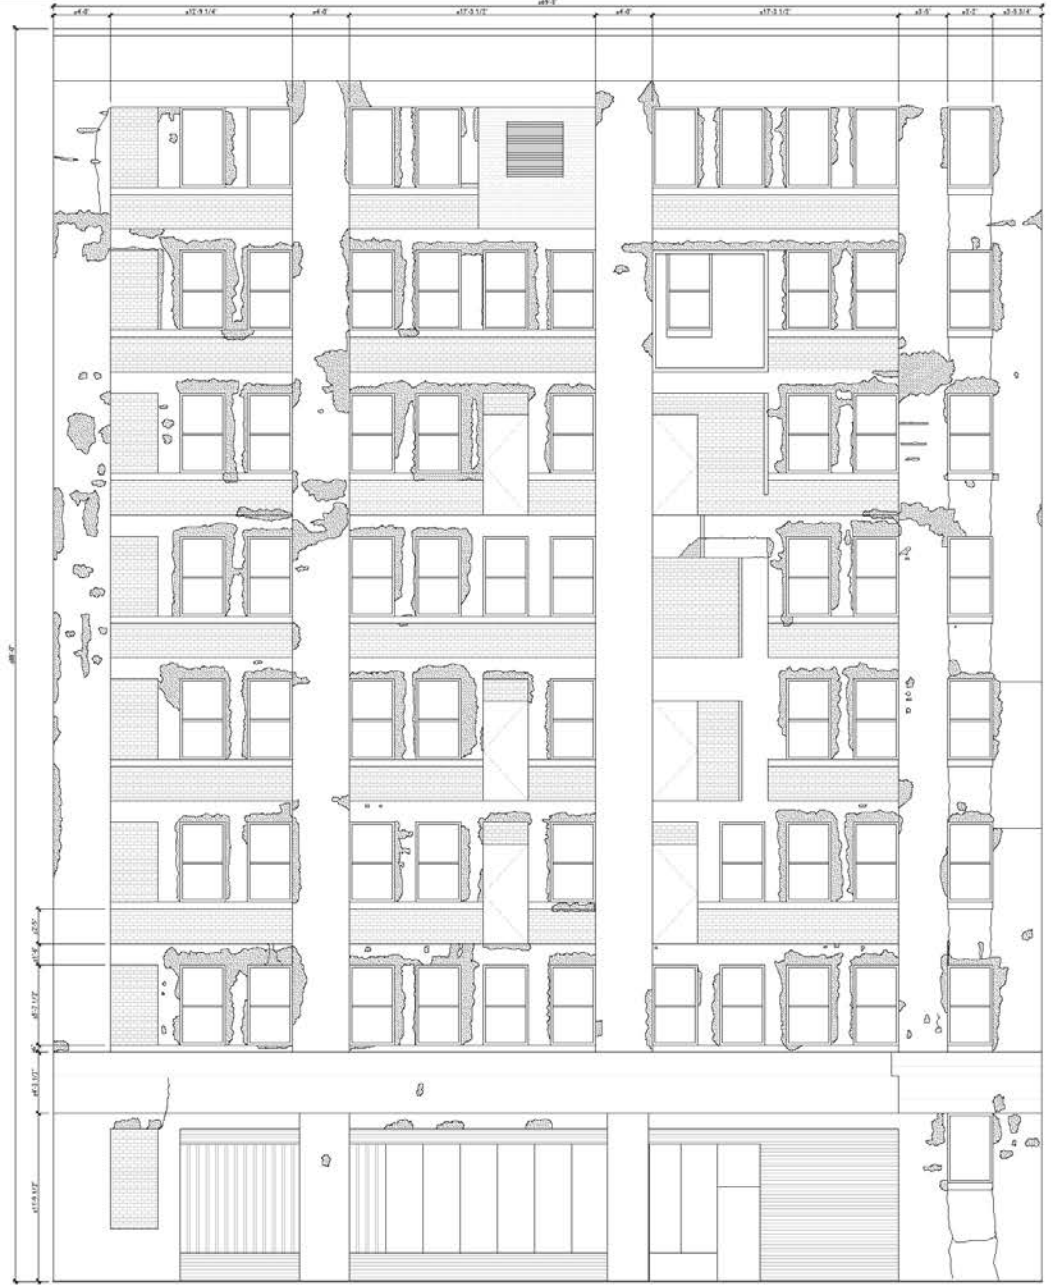
**EAST  
ELEVATION**

**2 EAST ELEVATION**  
SCALE: 1/4" = 1'-0" LEFT ALLEY

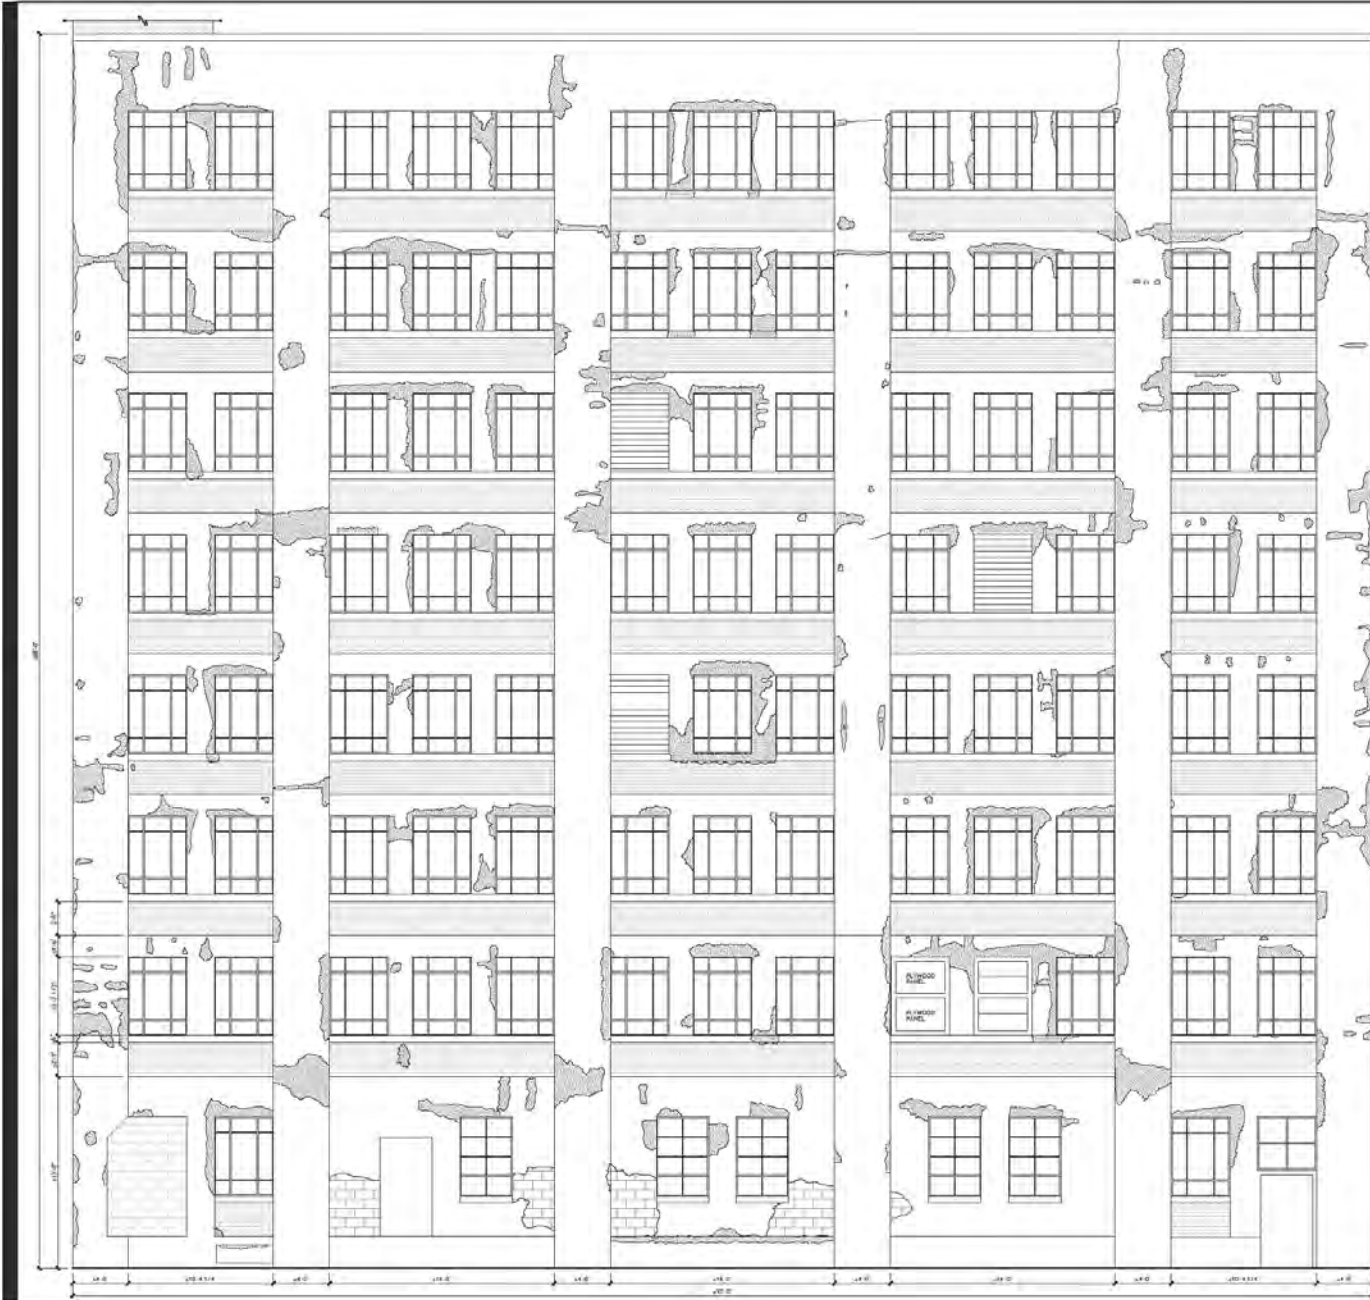
**SOUTH  
ELEVATION**

**3** SOUTH ELEVATION BACK ALLEY

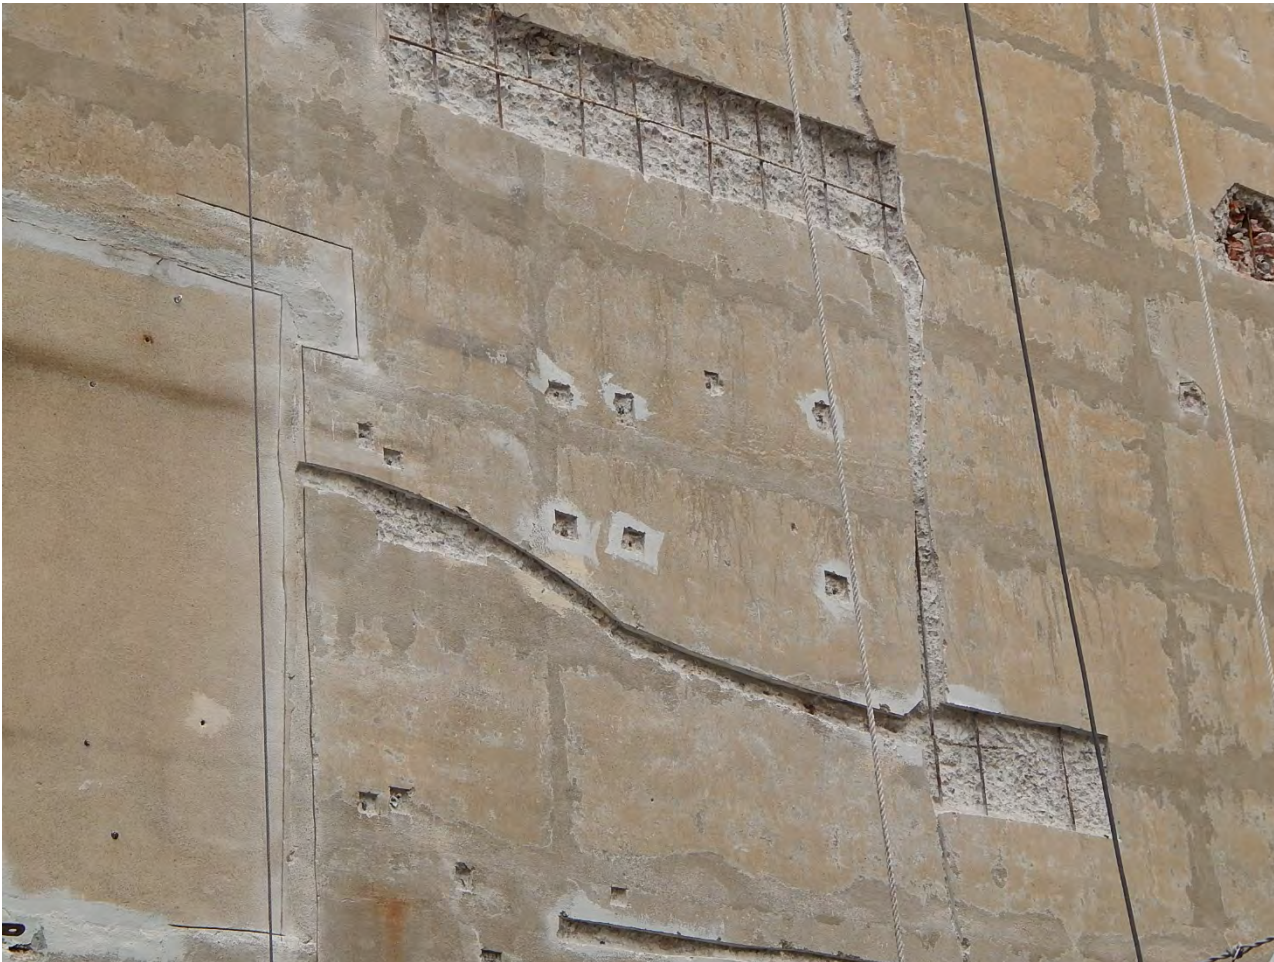
West Elevation: Exposed reinforcing steel, as a result of removing loose concrete. Overall, steel was more intact than anticipated.

Ultimately, some repairs were made; often, existing reinforcing was supported back to structure.

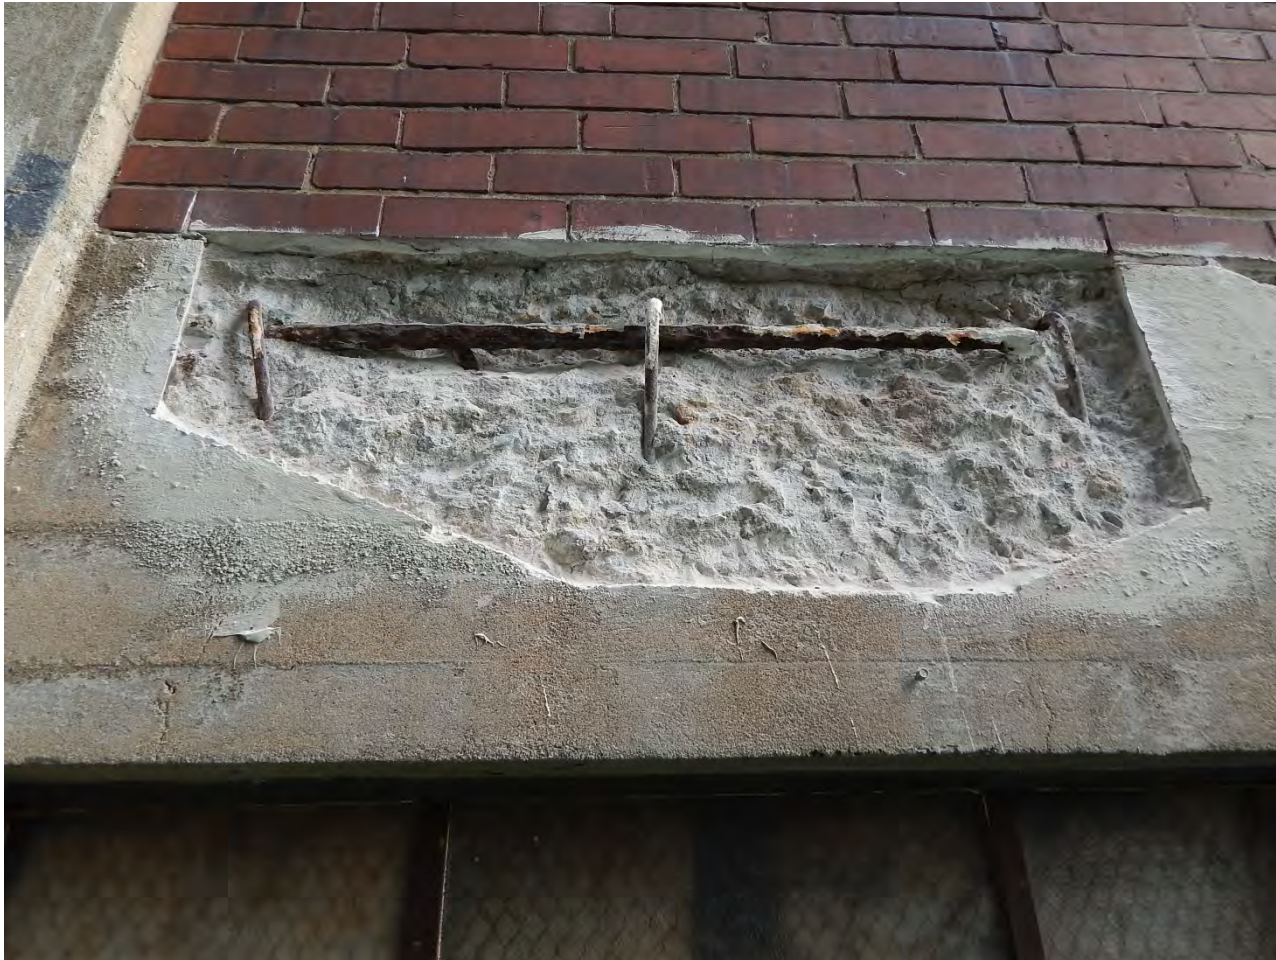
South (rear) Elevation:  
Typical spalled area,  
after removal of loose  
concrete. As noted,  
overall reinforcing steel  
was not "as bad" as one  
may anticipate, although  
at times it was cut short.

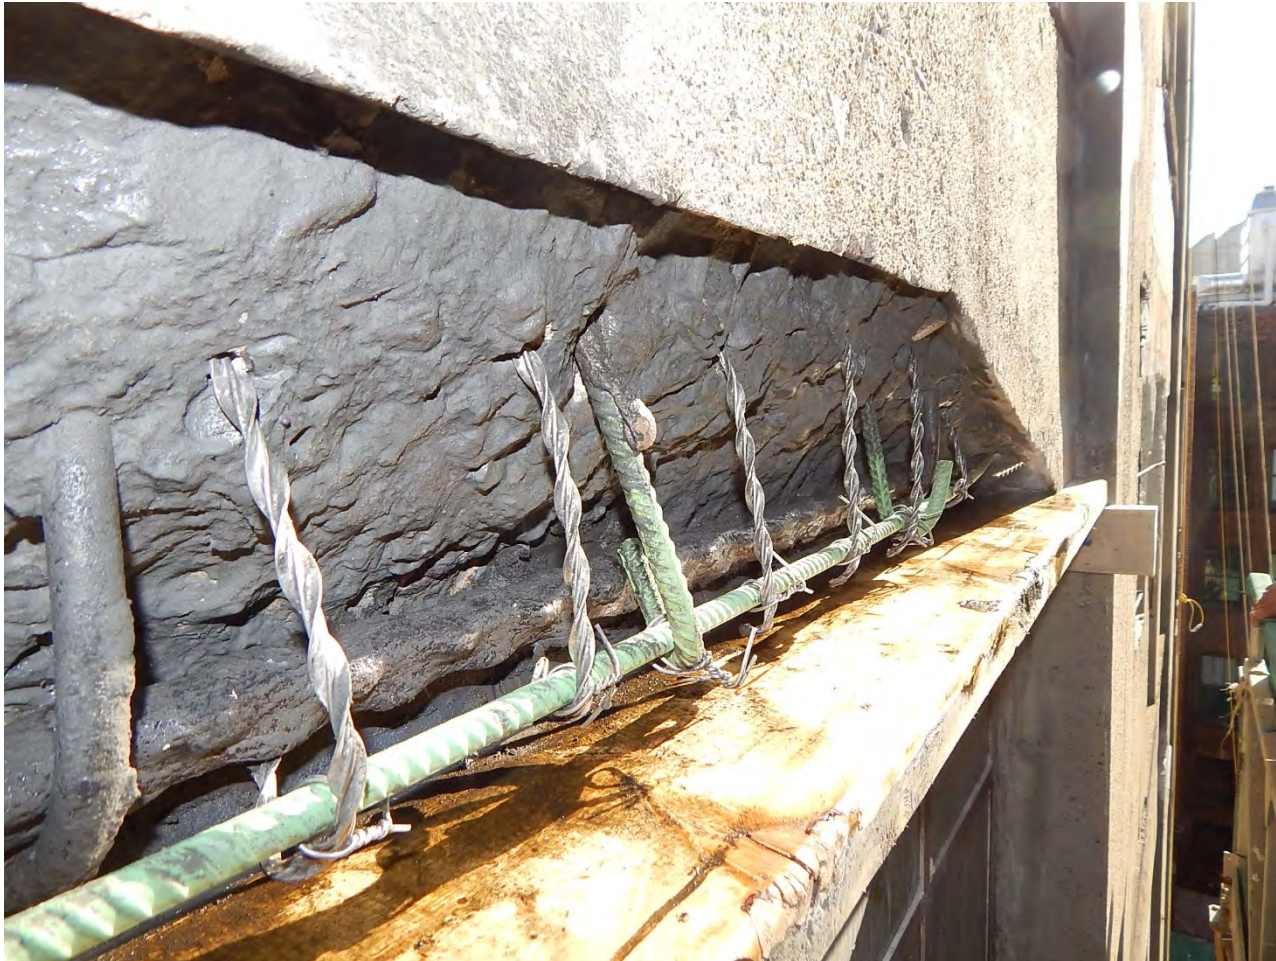
South (rear) Elevation: A new horizontal bar was placed to help “grab” the concrete, tied back to structure using what affectionately became know as “candy-canes” .

Candy canes were at times reinforcing steel, or the spiral anchors.

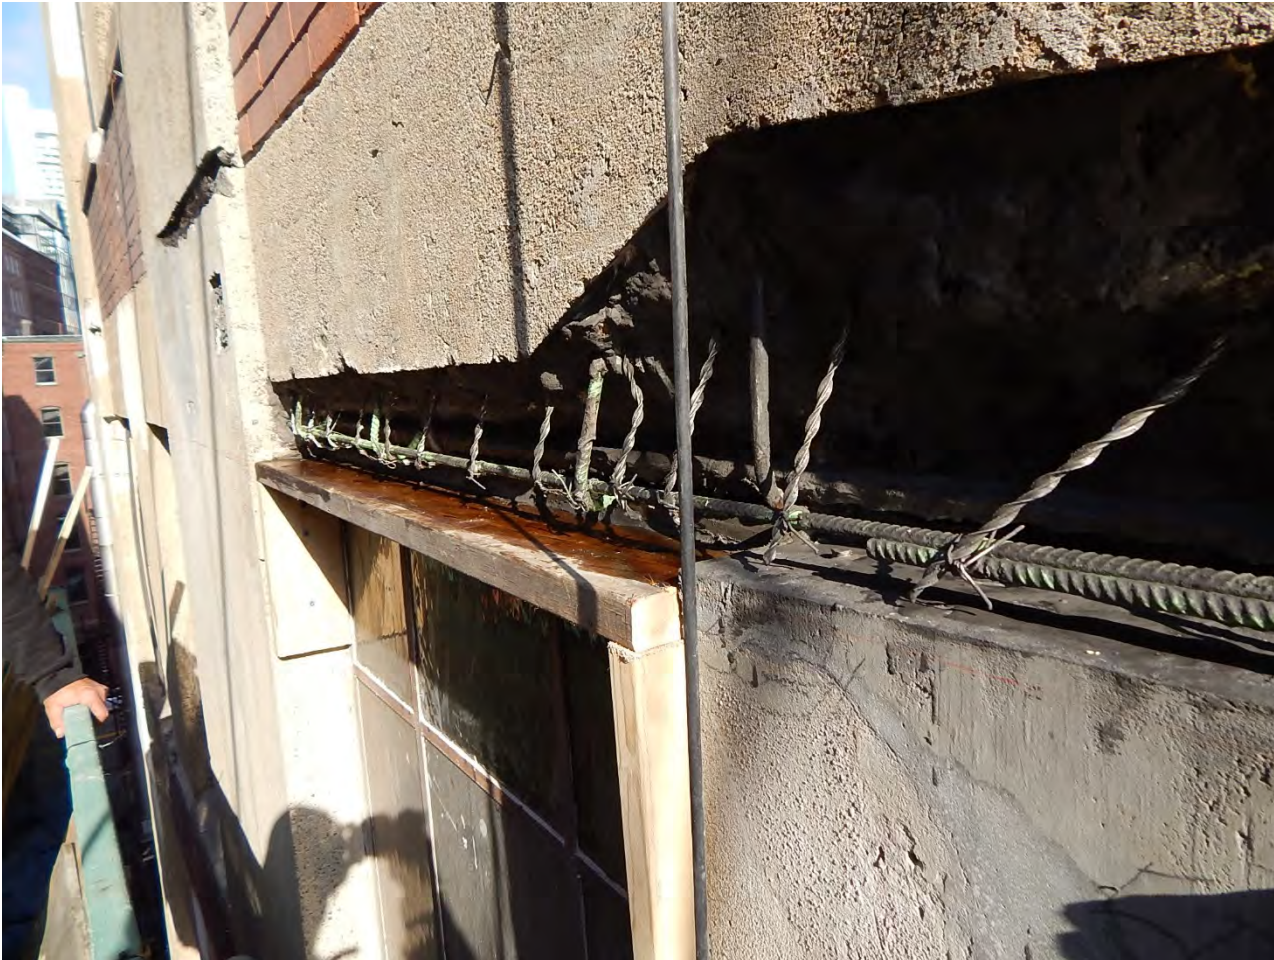
South (rear) Elevation: A new horizontal bar was placed, tied back to structure using what affectionately became know as “candy-canes”.

Candy canes were at times reinforcing steel, or the spiral anchors.

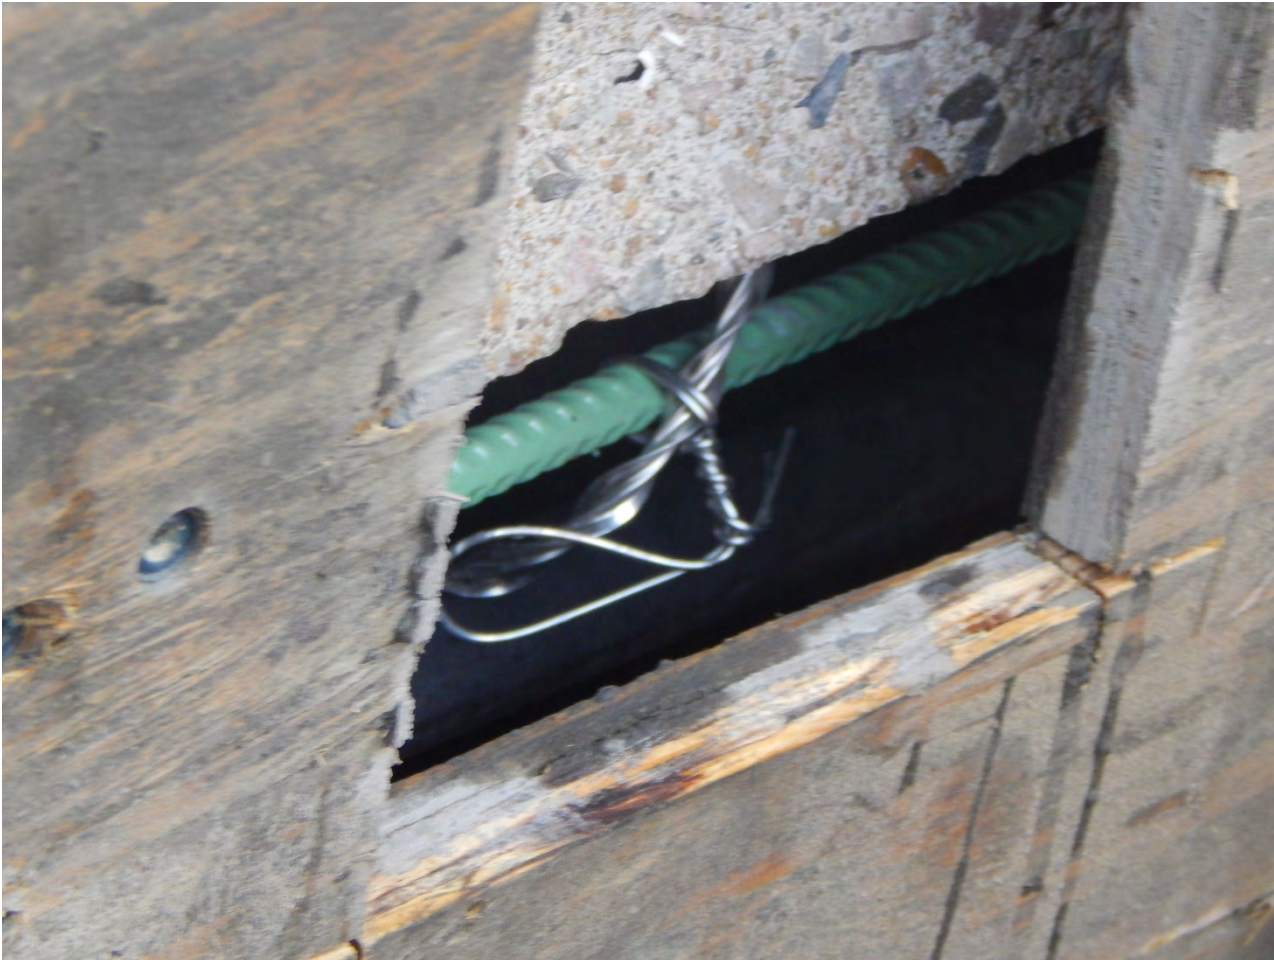
East (rear) Elevation:  
Typical reinforcing steel provided as it was missing. As noted, steel was in “better” condition than anticipated; but, one issue was often reinforcing was altogether missing.

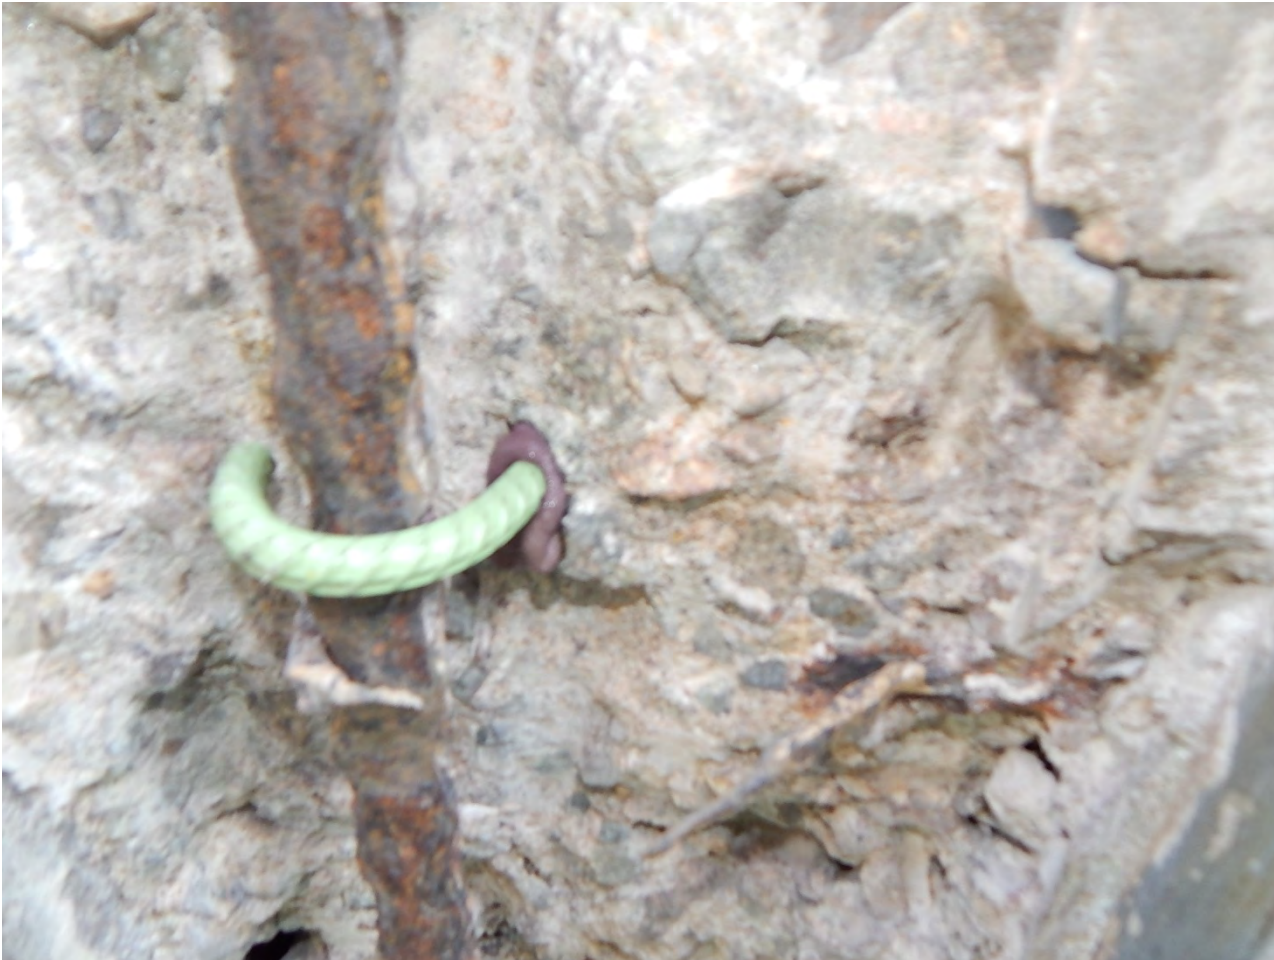
South (rear) Elevation:  
Typical spalled area,  
after removal of loose  
concrete. A "candy  
cane", epoxy-anchored  
to support vertical  
reinforcing steel.

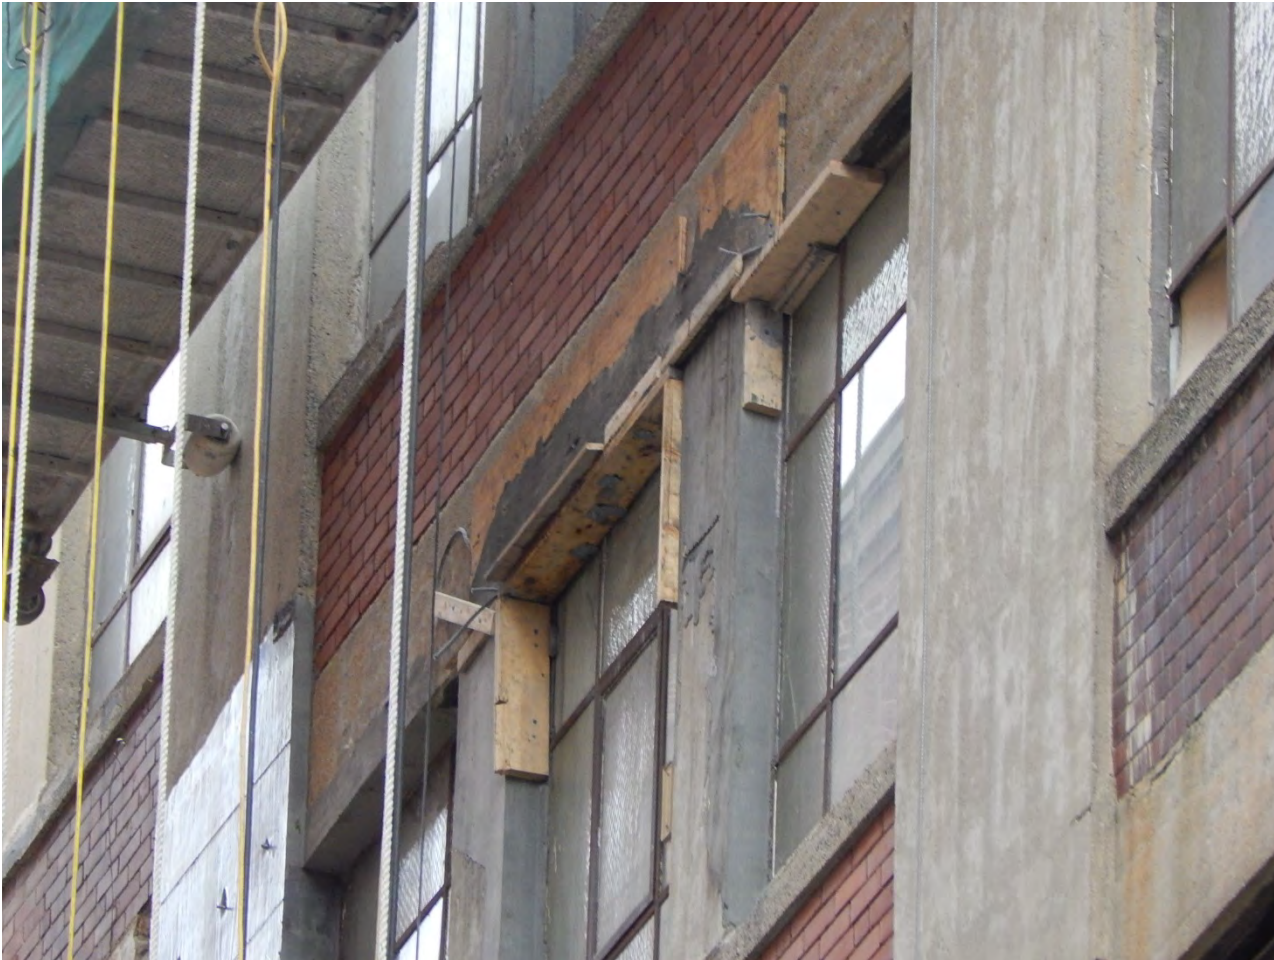
**South (rear) Elevation:**  
After reinforcing repairs, forms were constructed for support of concrete repair material. The form work was intricate around windows, as at times spalls would undermine window frames.

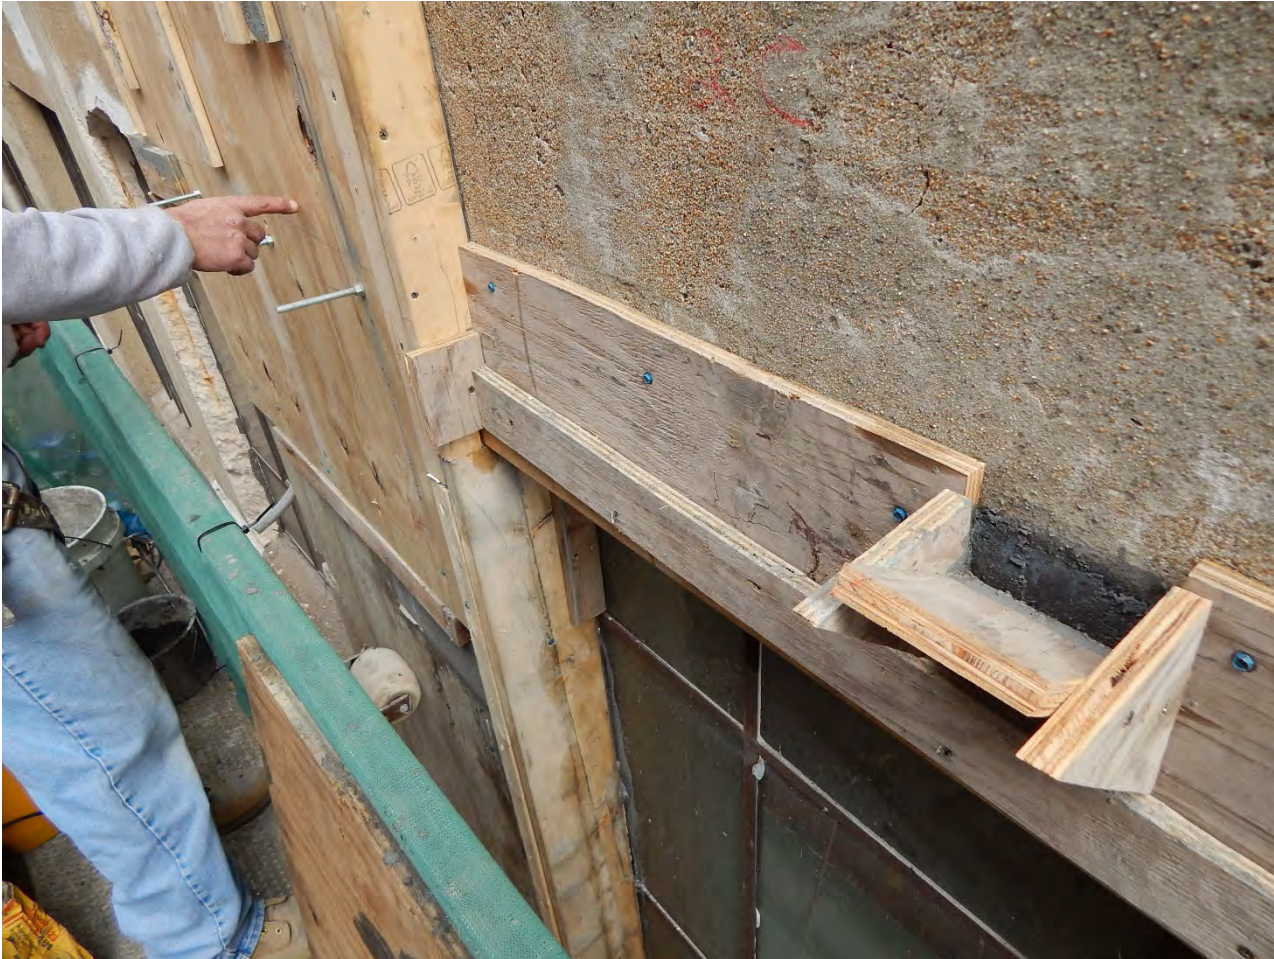
South (rear) Elevation:  
Form work at a window  
head-to-column, with  
“port” for the pour.

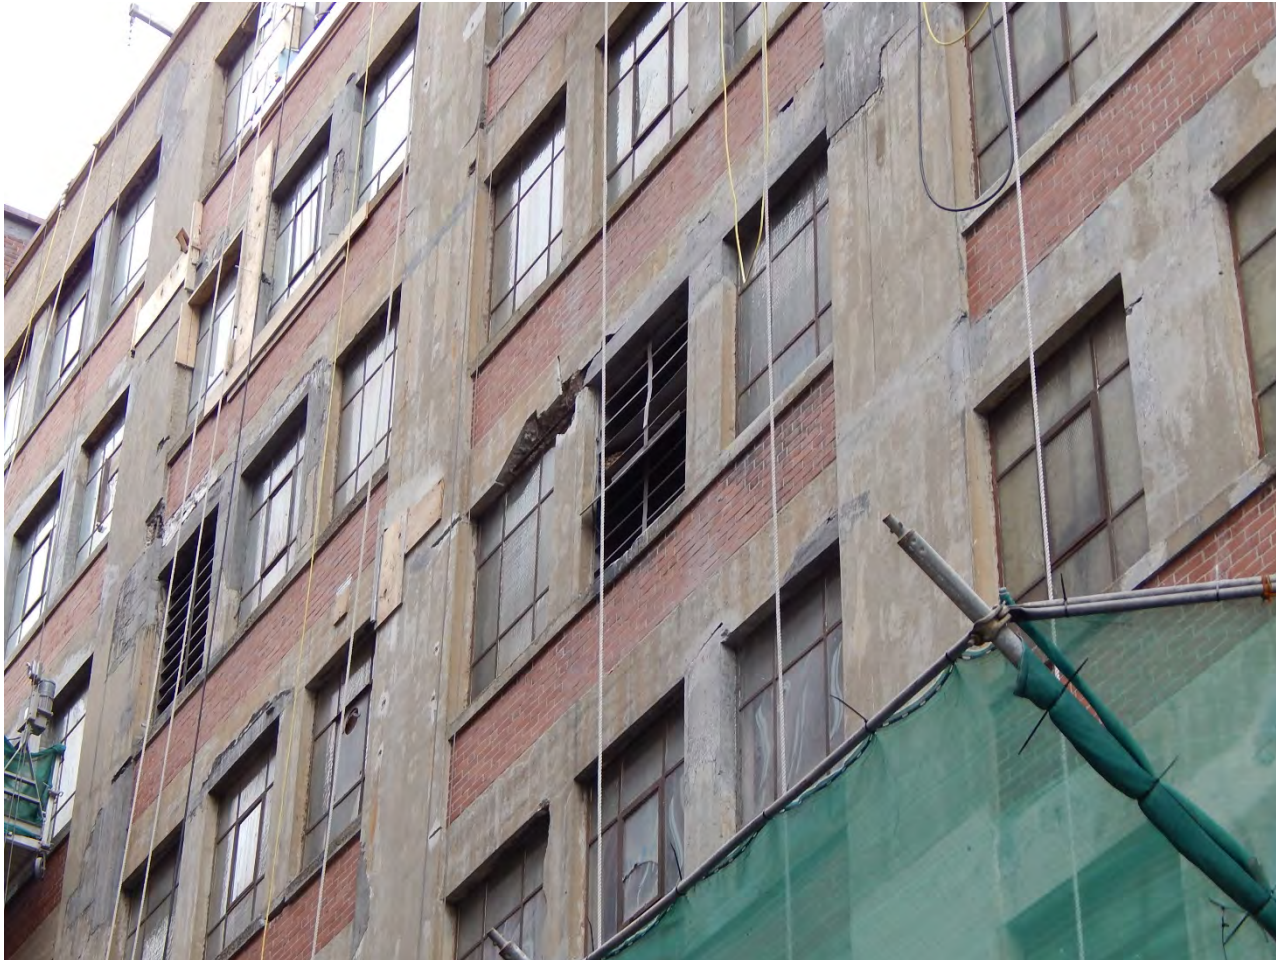
South (rear) Elevation:  
Work in progress --- some forms in process, with some areas forms were removed. Here, patched areas are shown before they were rubbed.

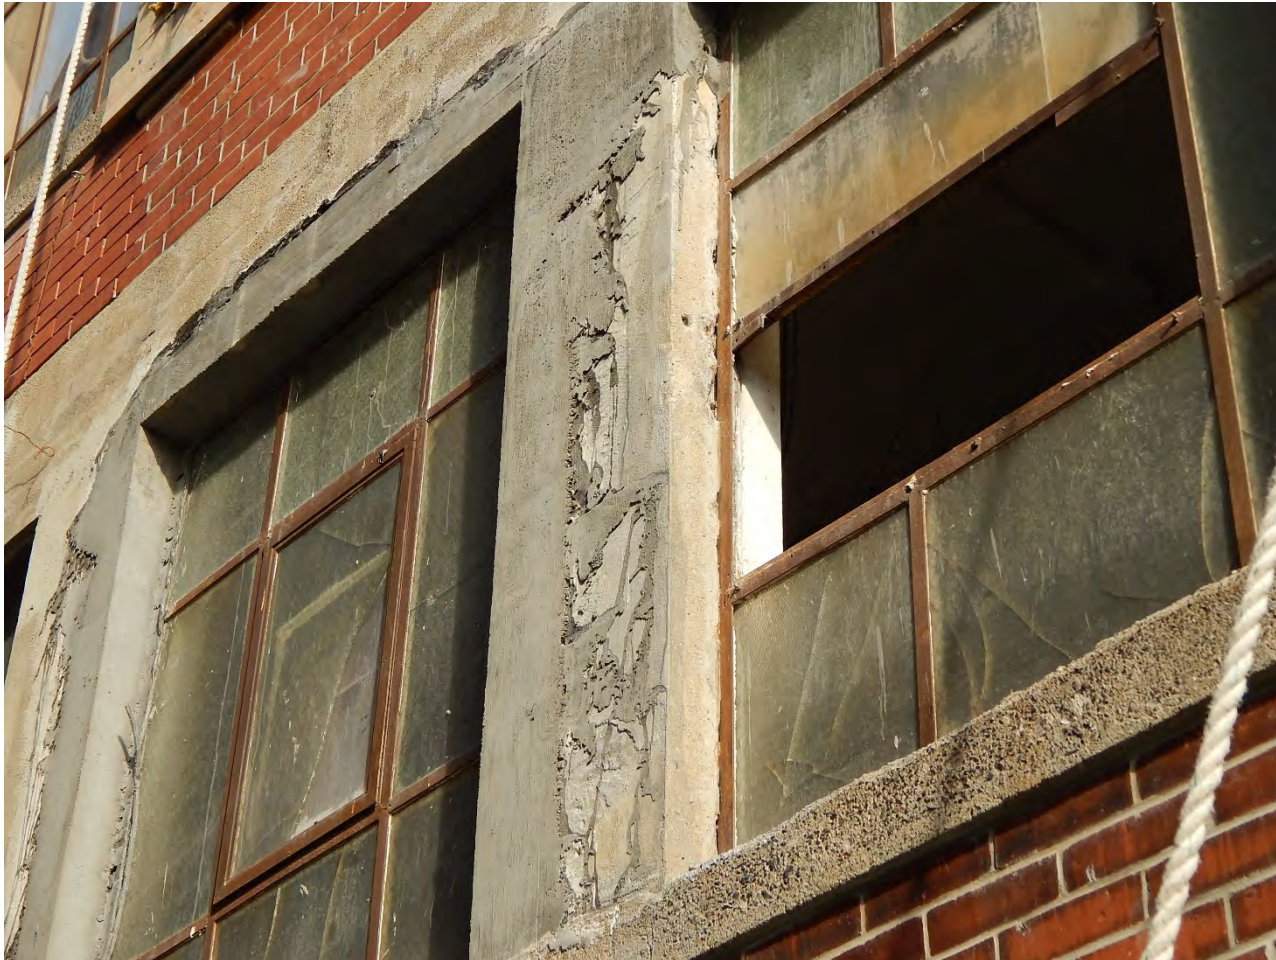
South (rear) Elevation:  
This is among the first areas of repair. Initial impressions were not favorable; but, stone rubbing did well to blend the patch areas into older existing concrete.

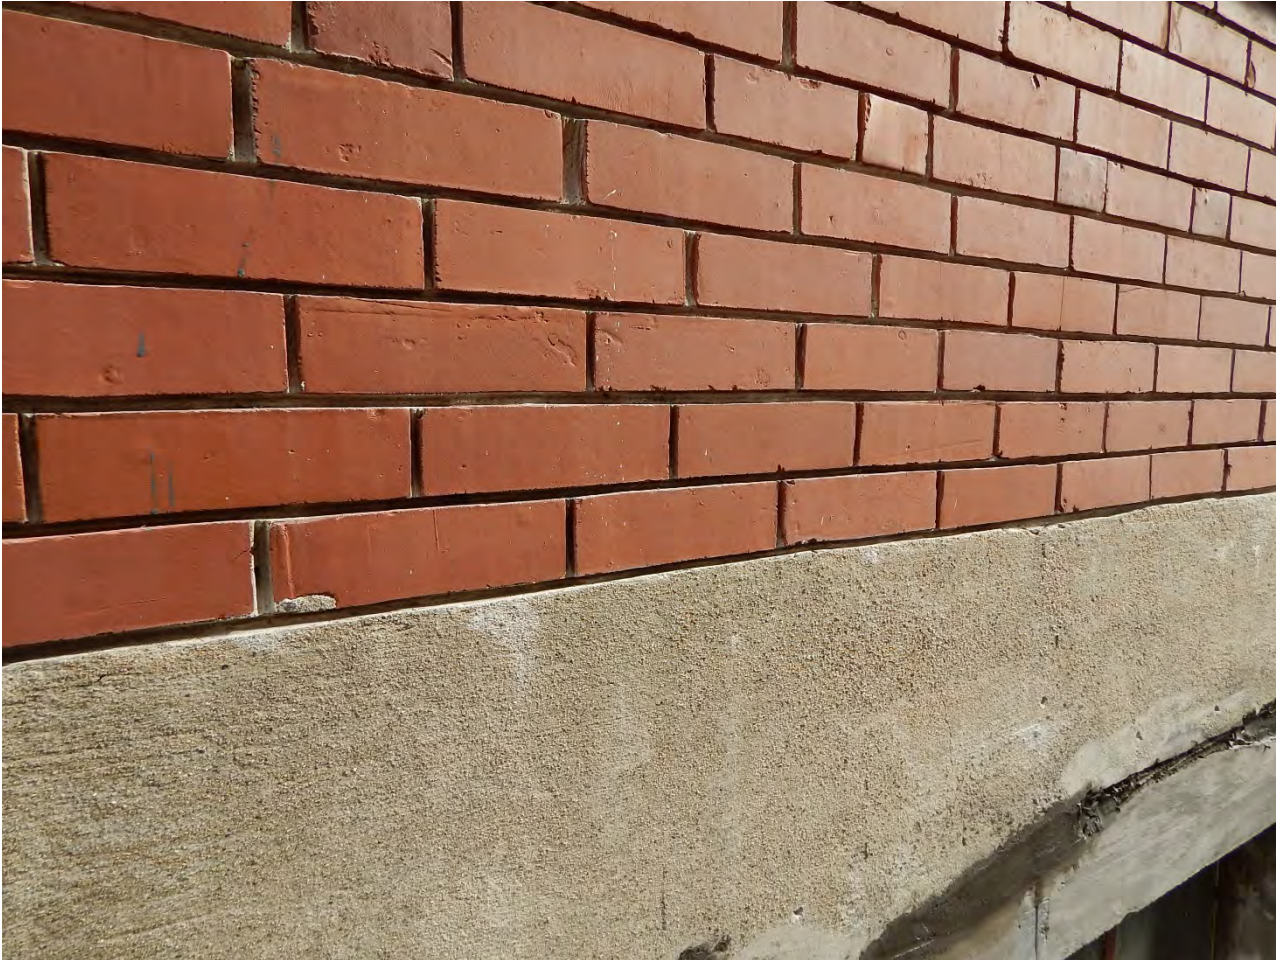
East (left) Elevation:  
Among the more pleasant  
“surprises” was the  
integrity and appearance  
of the brick once the  
coatings were removed.
