# Concrete Façade Restoration, South Boston Waterfront, Boston, MA

369 Congress Street, Boston, MA

Gorman Richardson Lewis Architects, Inc.

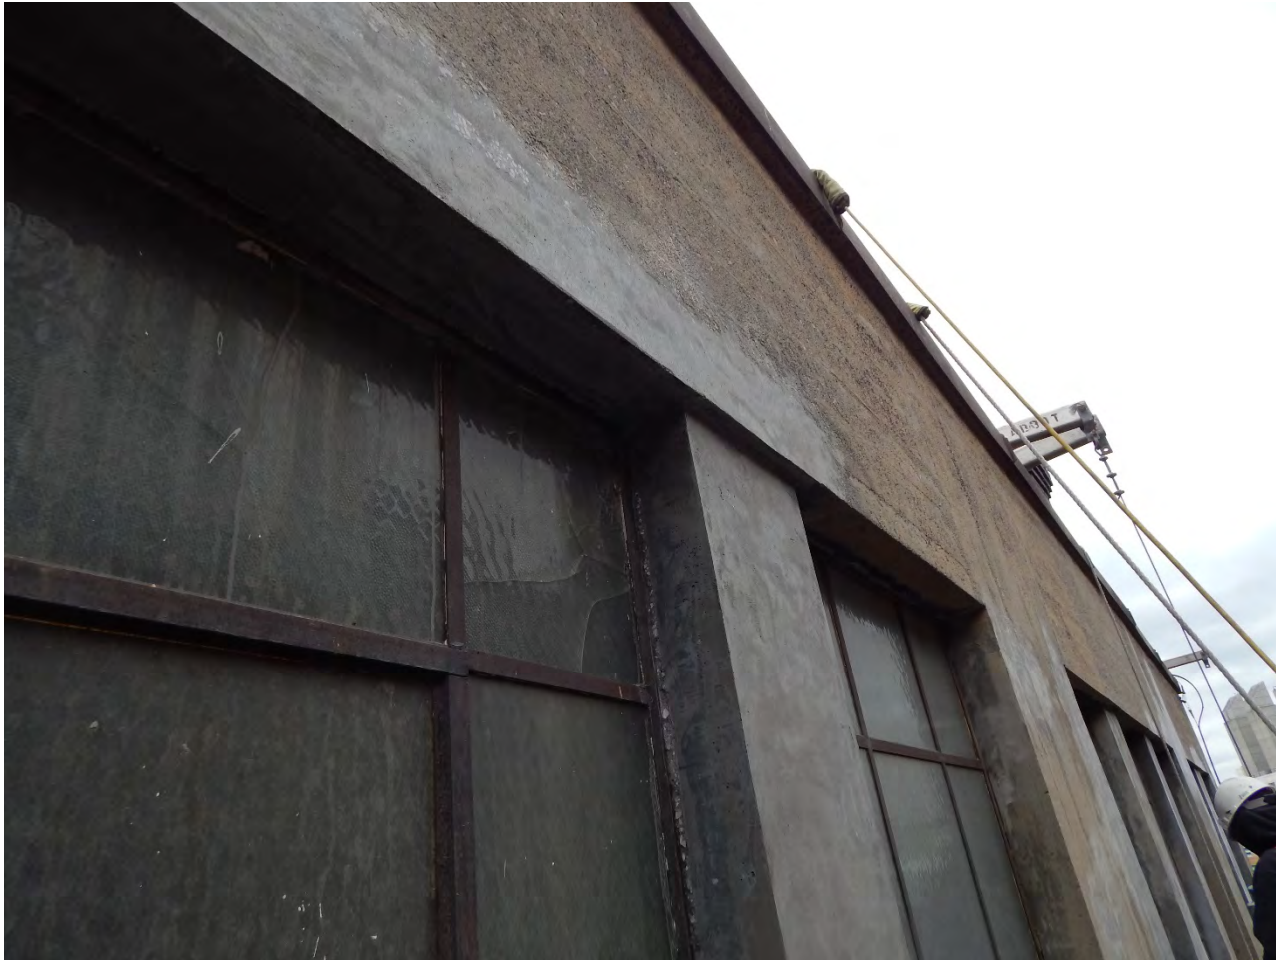
South (rear) Elevation:  
Form work removed,  
after some initial stone  
rubbing. Texture would  
have been very difficult  
to match; but, the  
patches did blend fairly  
well overall.

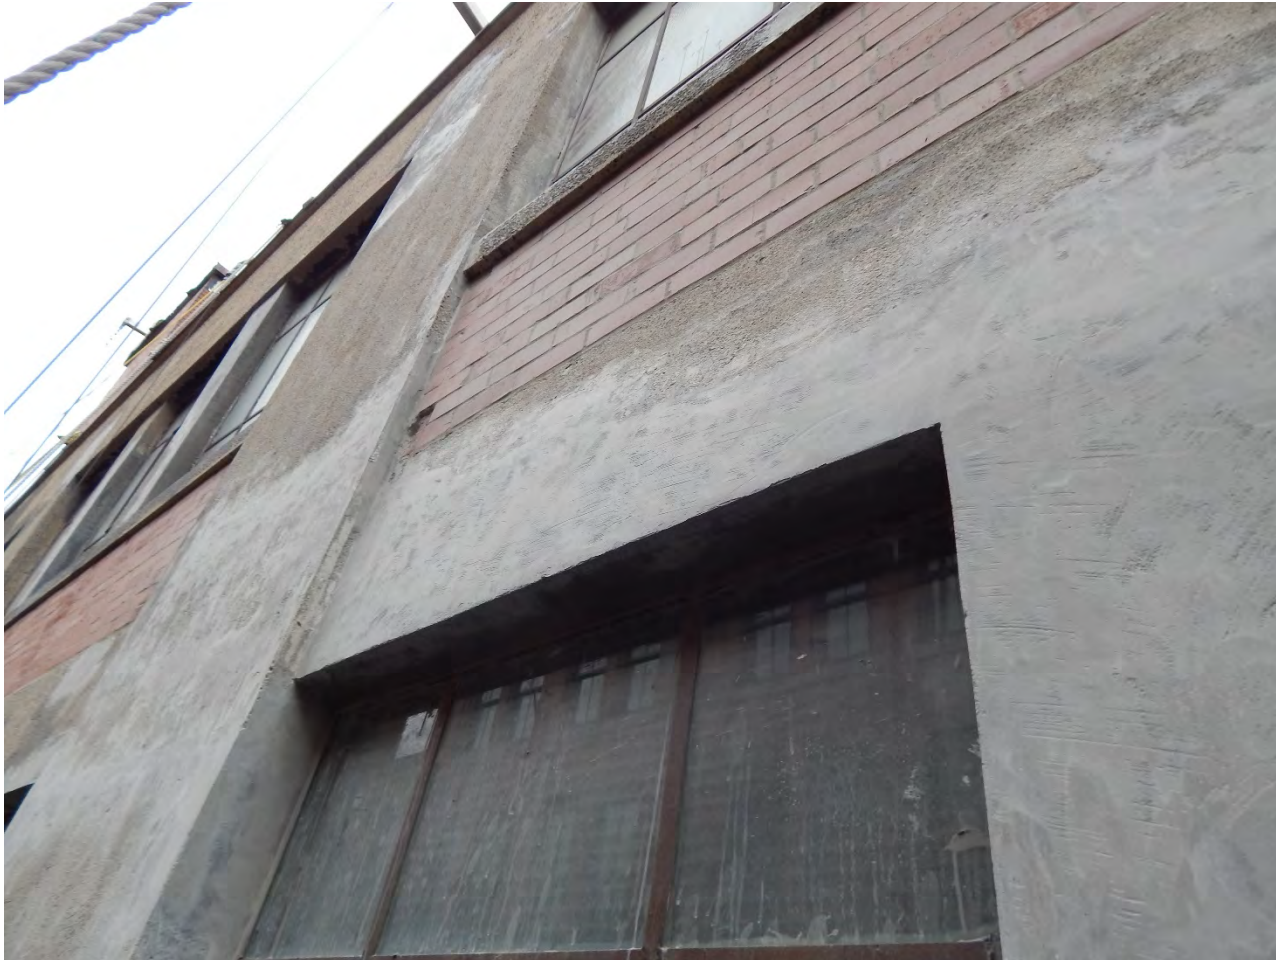
South (rear) Elevation:  
Form work removed,  
after some initial stone  
rubbing. Texture would  
have been very difficult  
to match; but, the  
patches did blend fairly  
well overall.

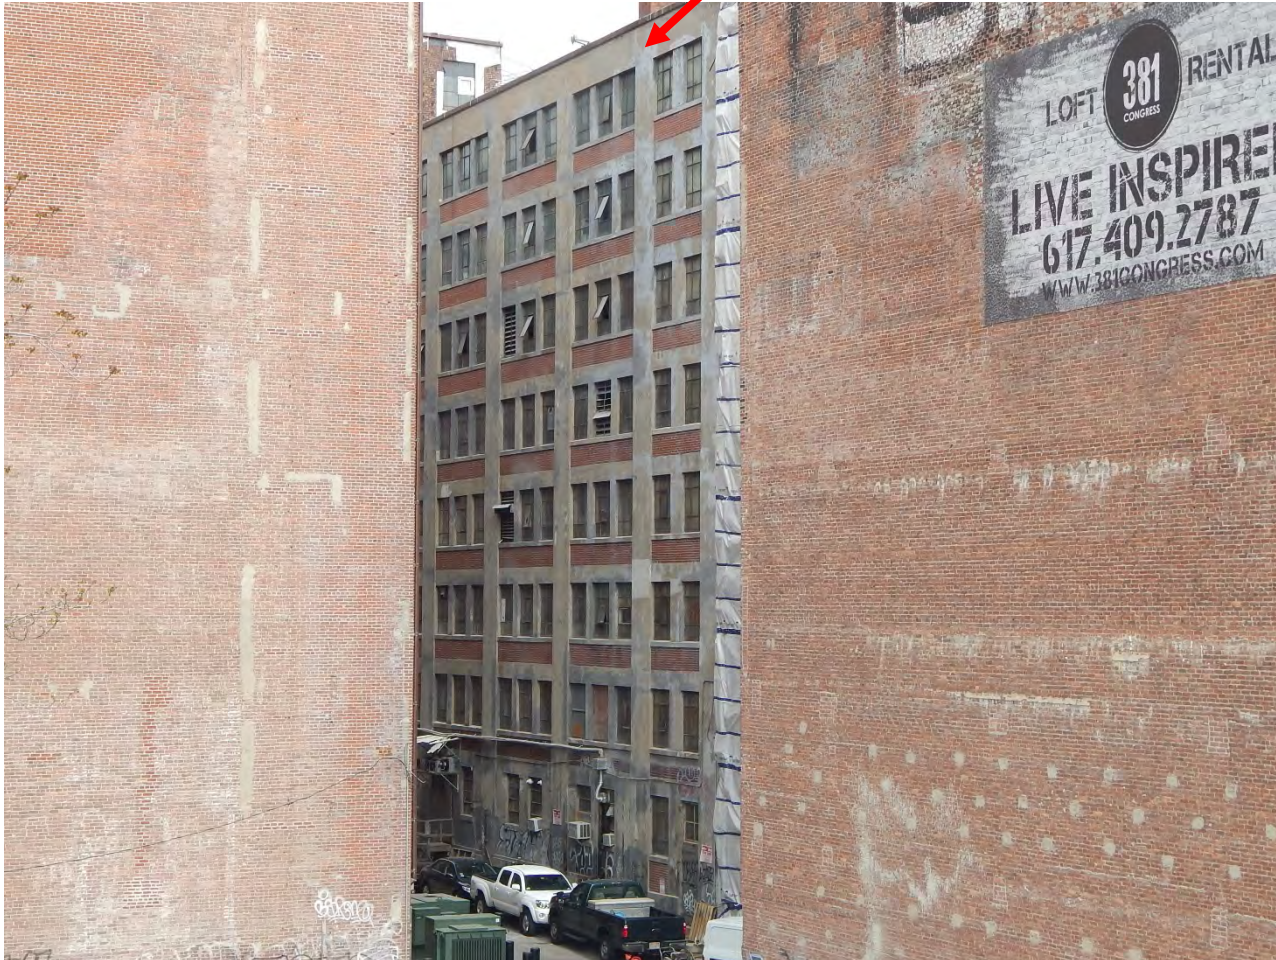
**South (rear) Elevation:**  
Area complete, prior to coating. The lower floor was done last, as there was some stucco repair; but, the Team waited owing to the risk of graffiti. The Owner had security monitoring installed in the meantime.

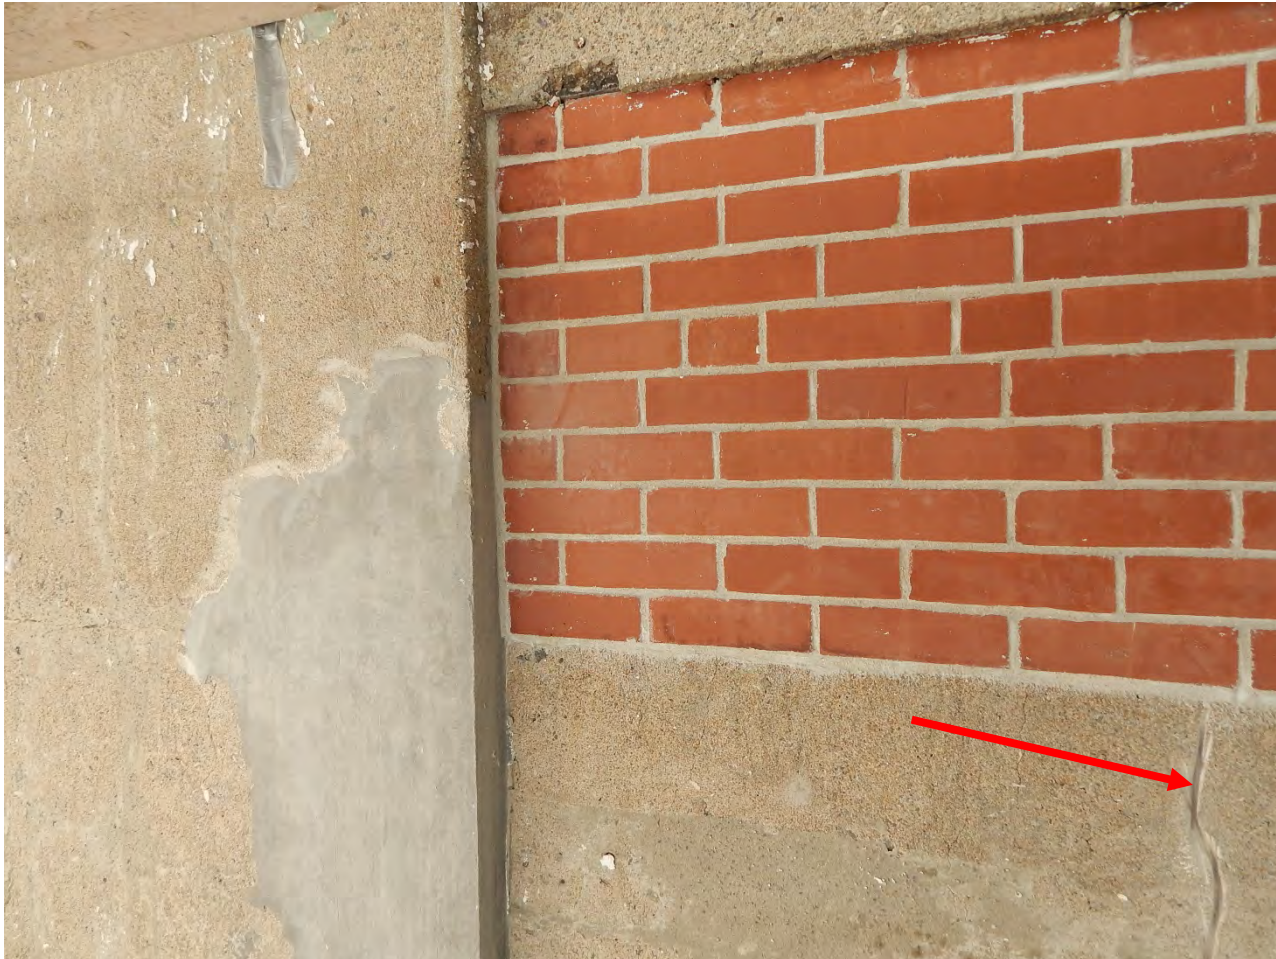
North (front) Elevation:  
Brick masonry after  
pointing, with a patch  
area at the column,  
“rubbed” in. Note,  
there was some crack  
repair at a few areas.

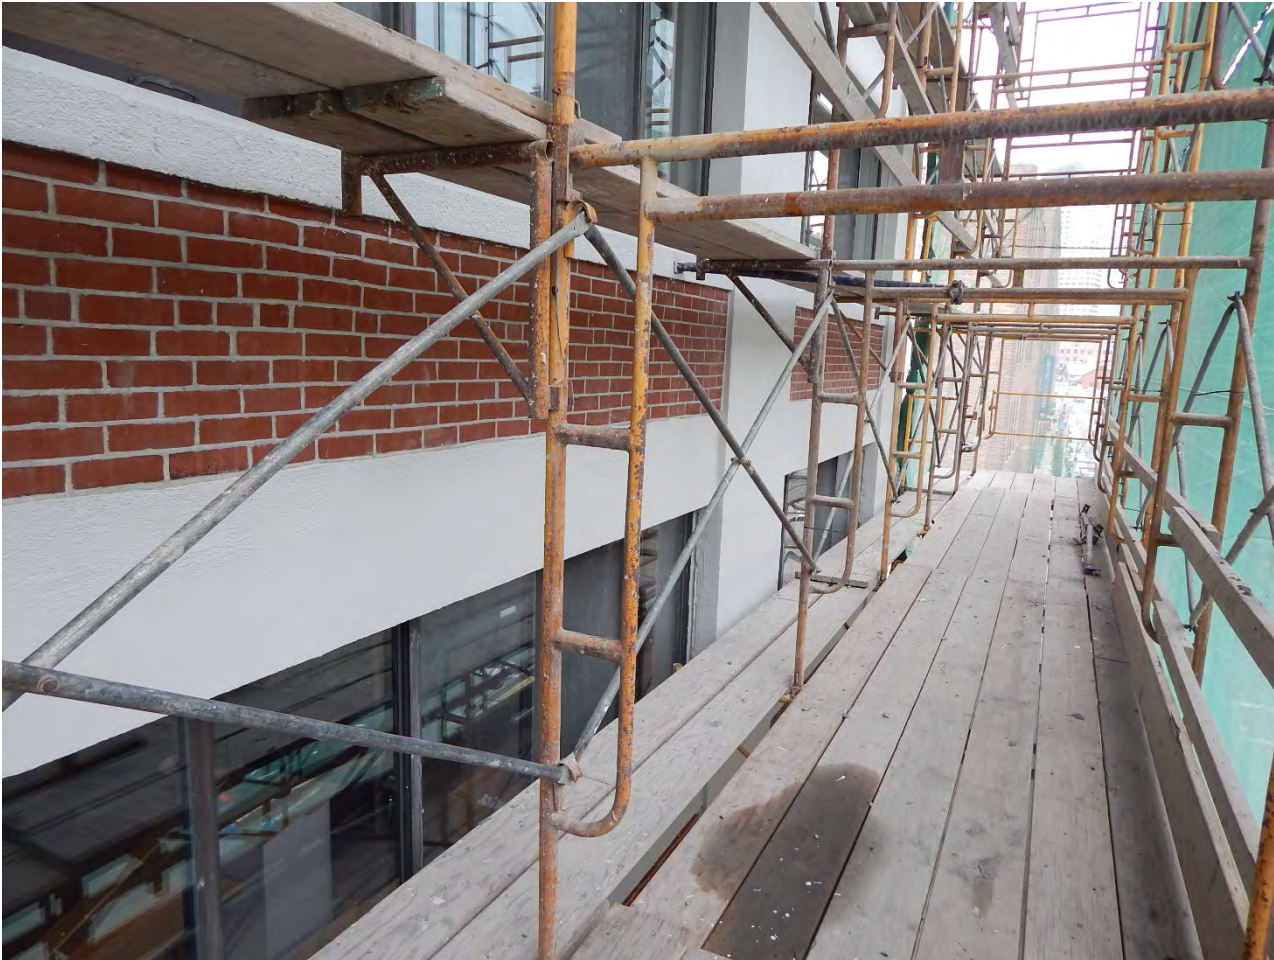
North (front) Elevation:  
Eventually, concrete  
work is finished; and the  
coating applied. The  
final product began to  
emerge.

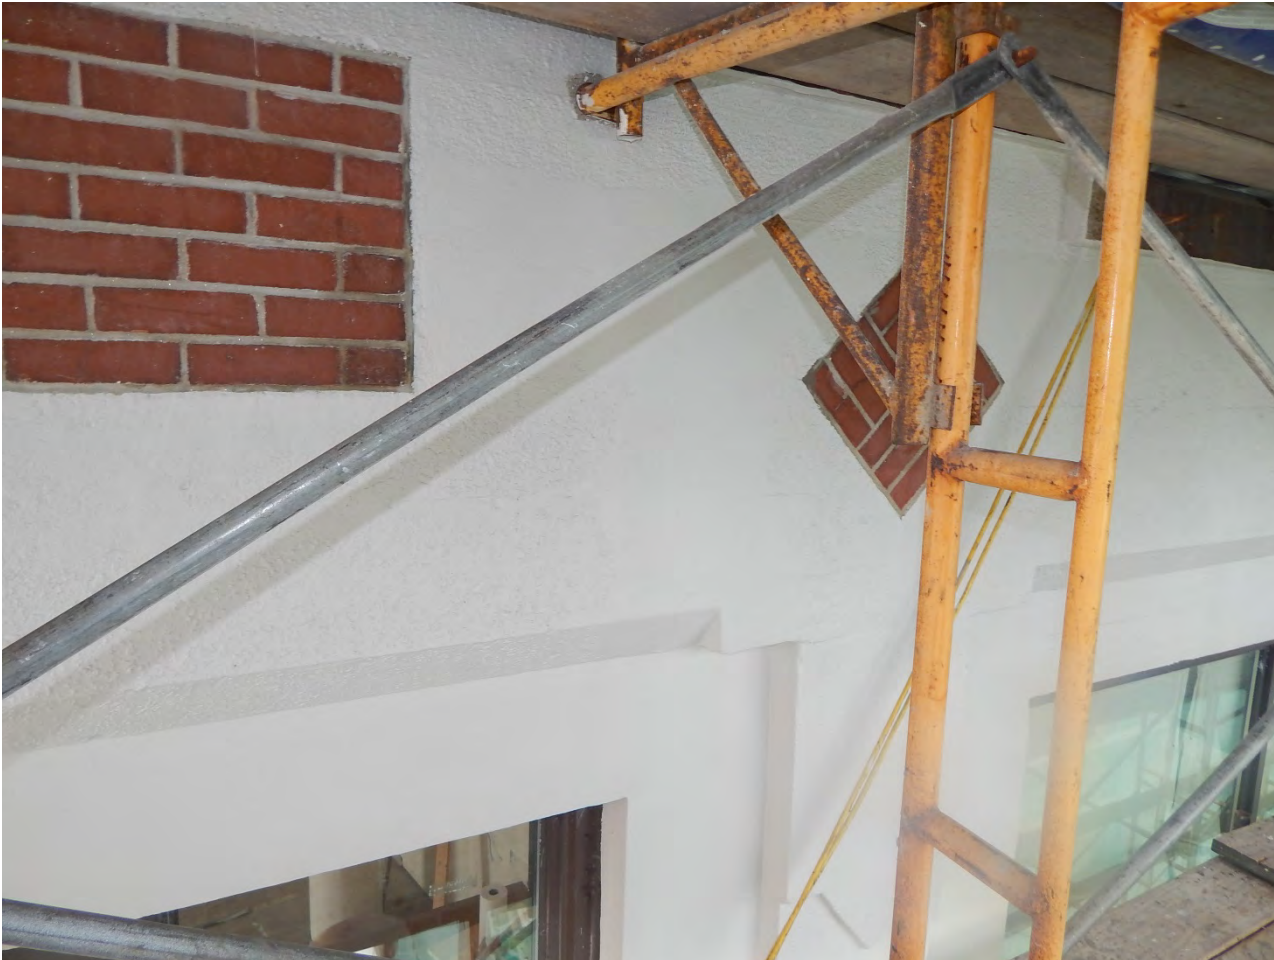
North (front) Elevation:  
Eventually, concrete  
work is finished; and the  
coating applied. The  
final product began to  
emerge.

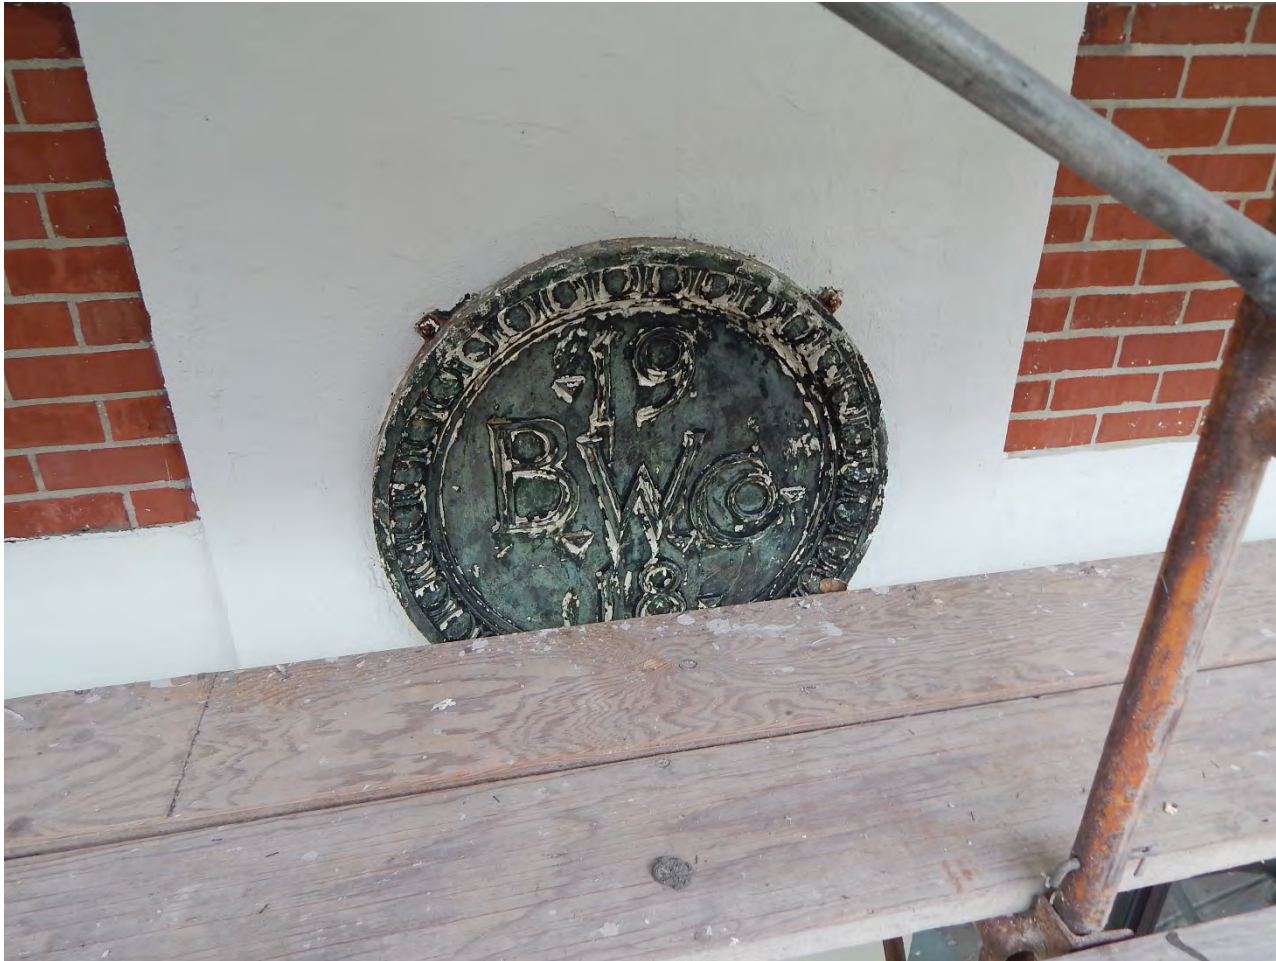
North (front) Elevation:  
Last; but, by no means  
least, the medallion was  
stripped on site. It was  
then taken down, further  
cleaned at “the shop”  
and reinstalled and left  
to patina, as one of  
several plans proposed  
that was preferred by  
the City.

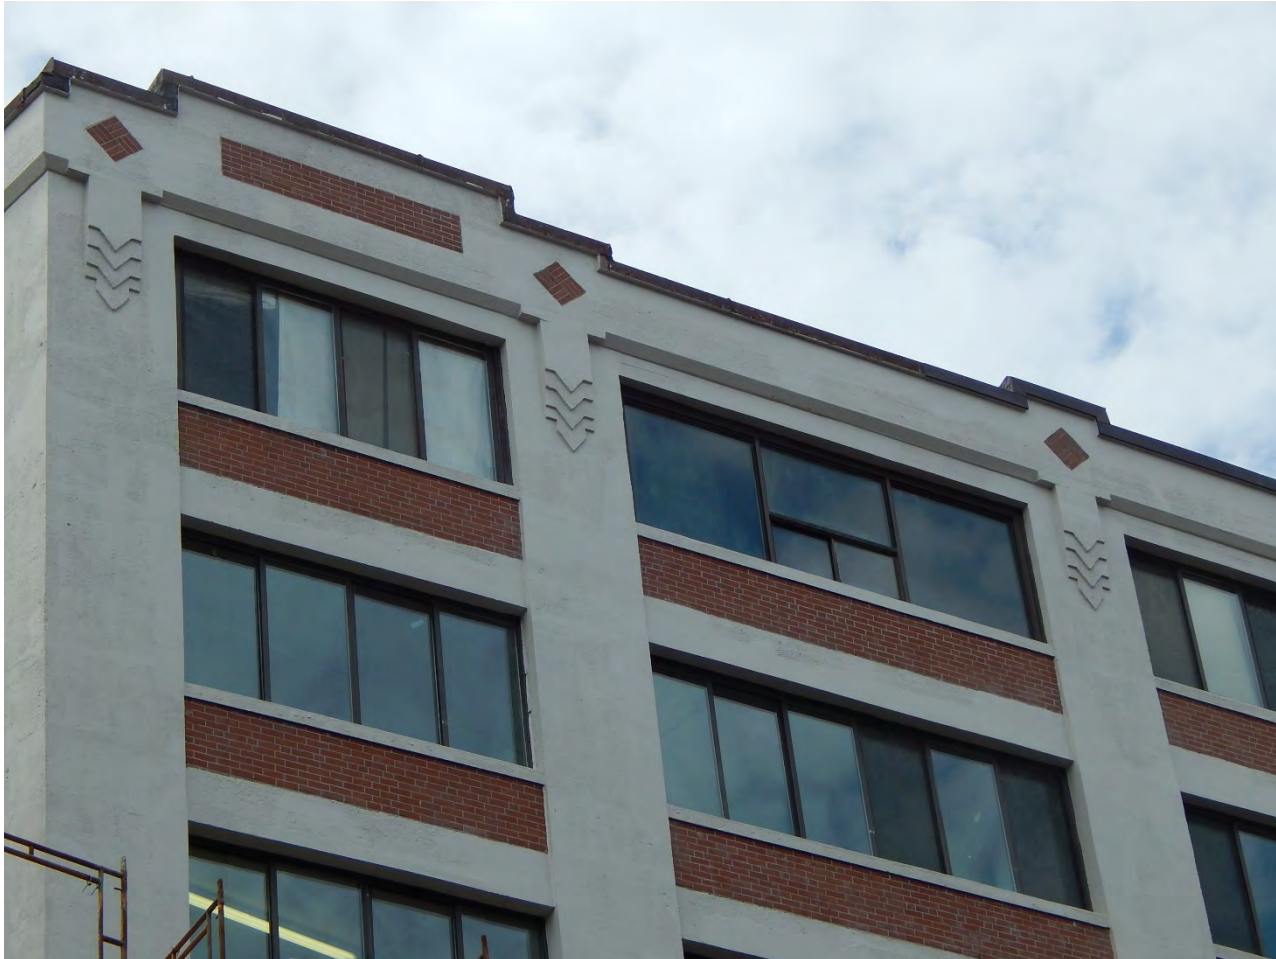
North (front) Elevation:  
The details long-forgotten (the “Classical influence”) reemerge and provide some character.
