# Arizona Veterans Memorial Coliseum Roof Repairs

*ICRI Award of Merit 2009*

Dennis Wipf P.E.

Gervasio & Assoc. Inc.  
Consulting Engineers  
Phoenix, AZ

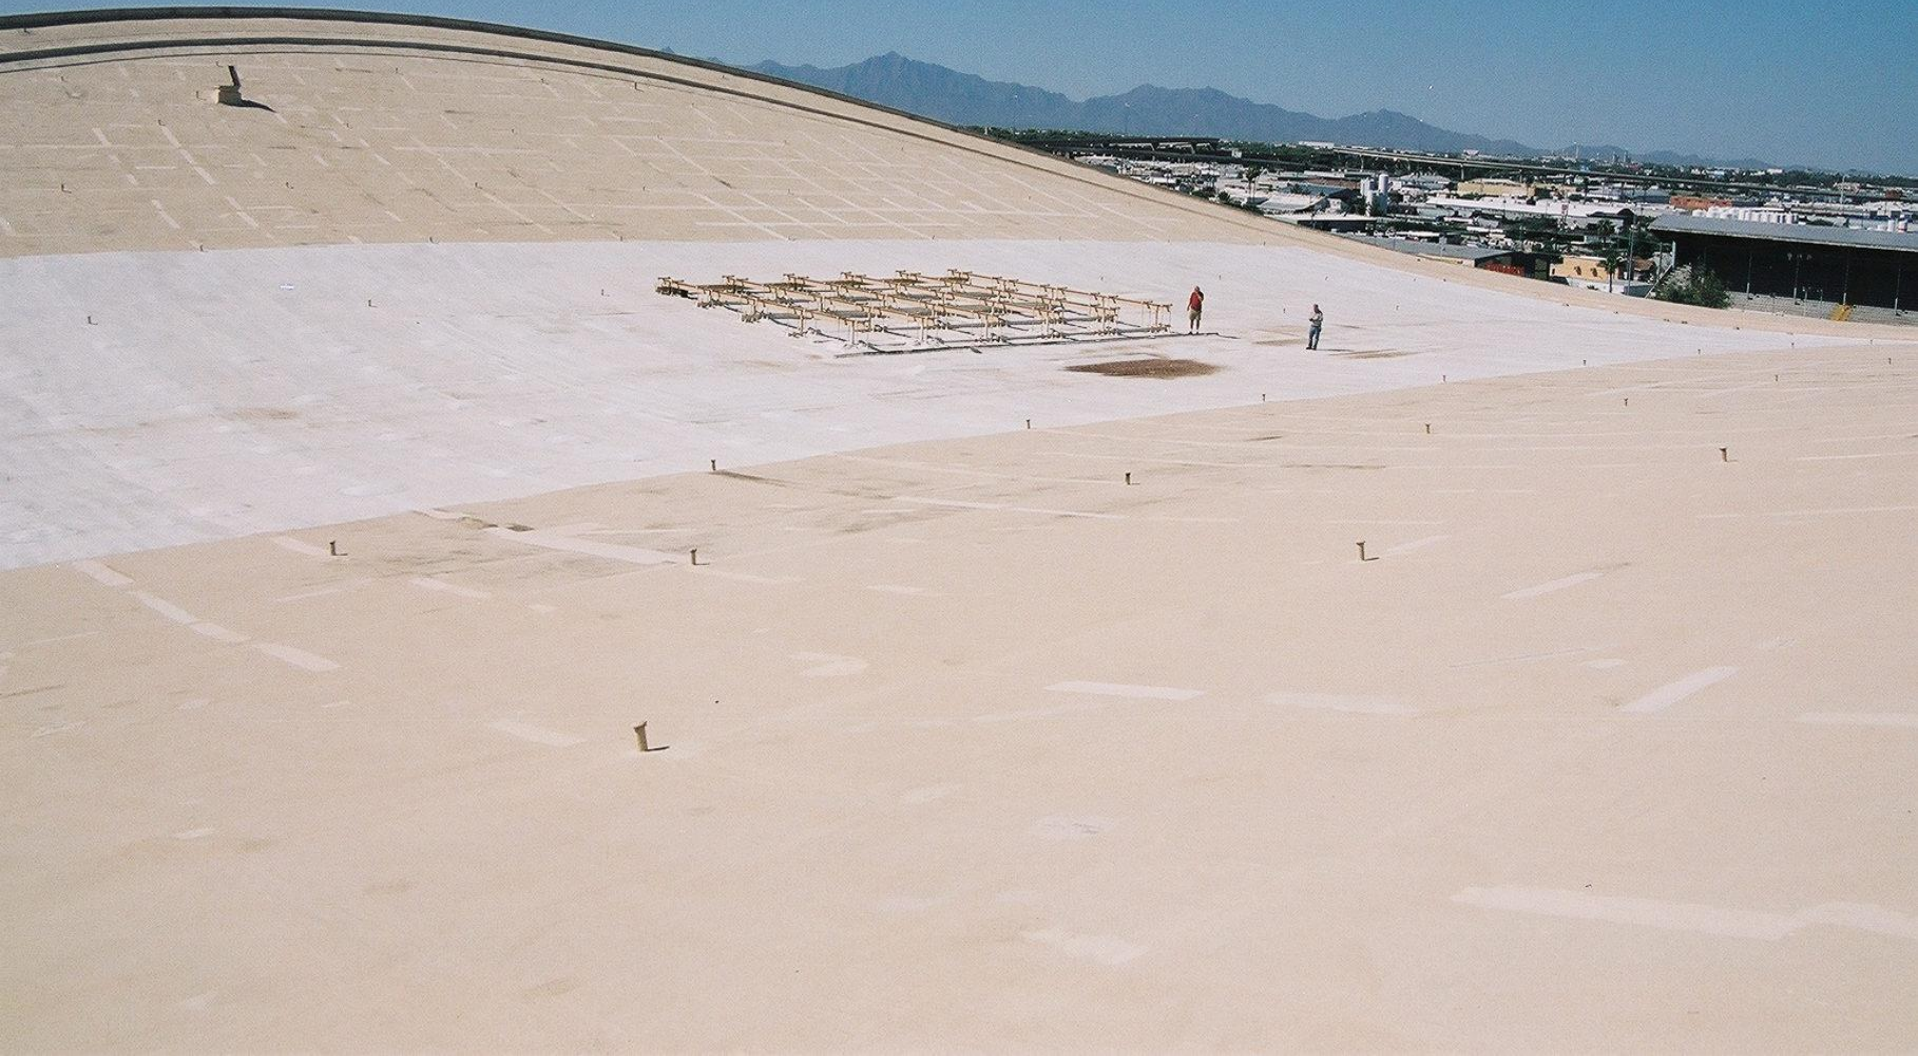
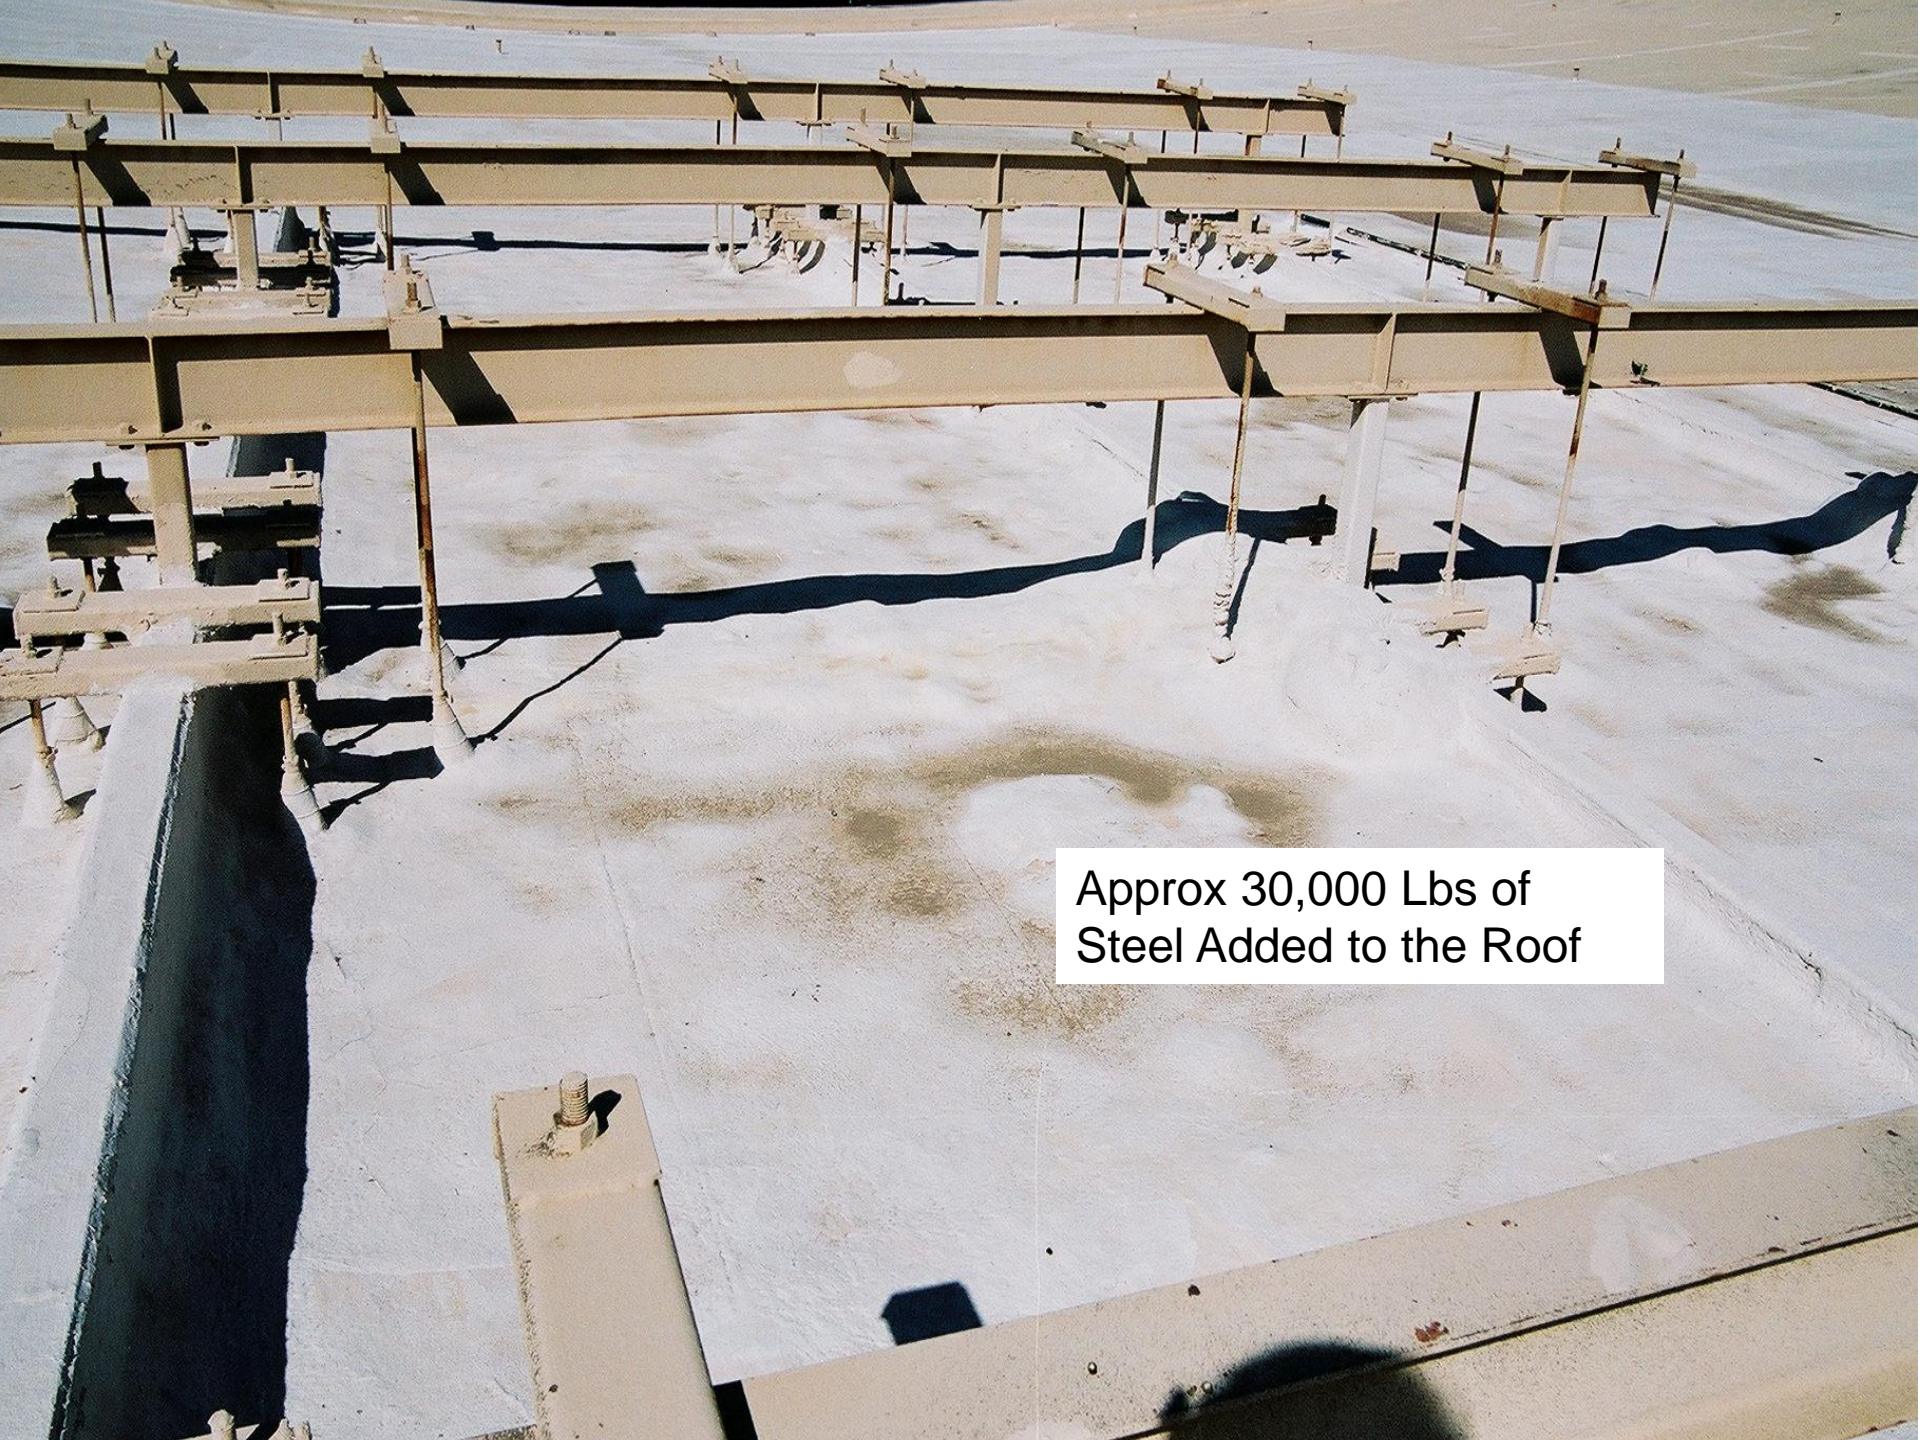
- ▶ A “dip” is discovered in the roof.
- ▶ Cause: ??????
- ▶ Solution: Put steel beams across the roof and “jack” up the dip.
- ▶ ***Maybe Not Such a Good Idea***

Approx 30,000 Lbs of  
Steel Added to the Roof

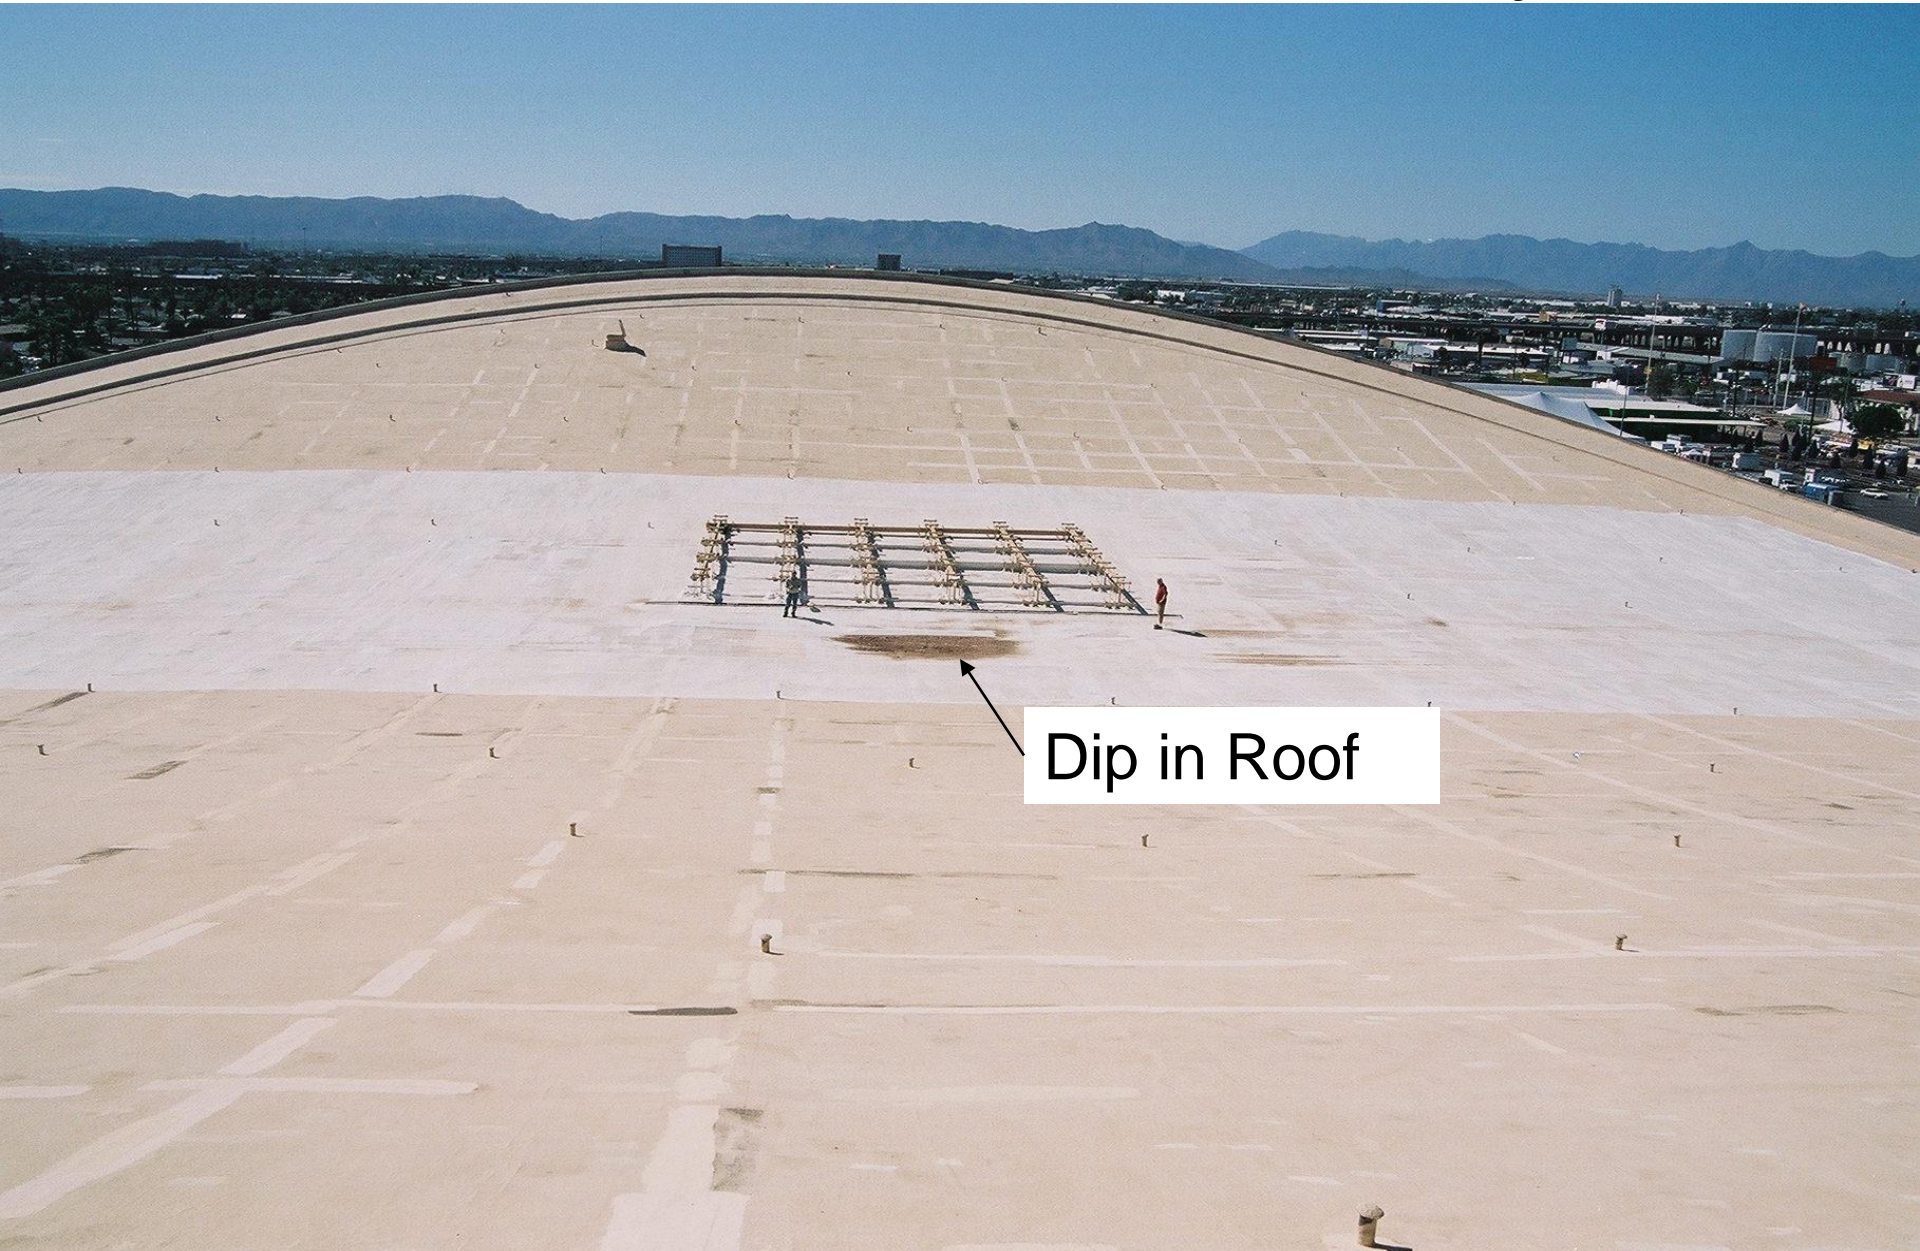
Dip in Roof

Corrosion?????

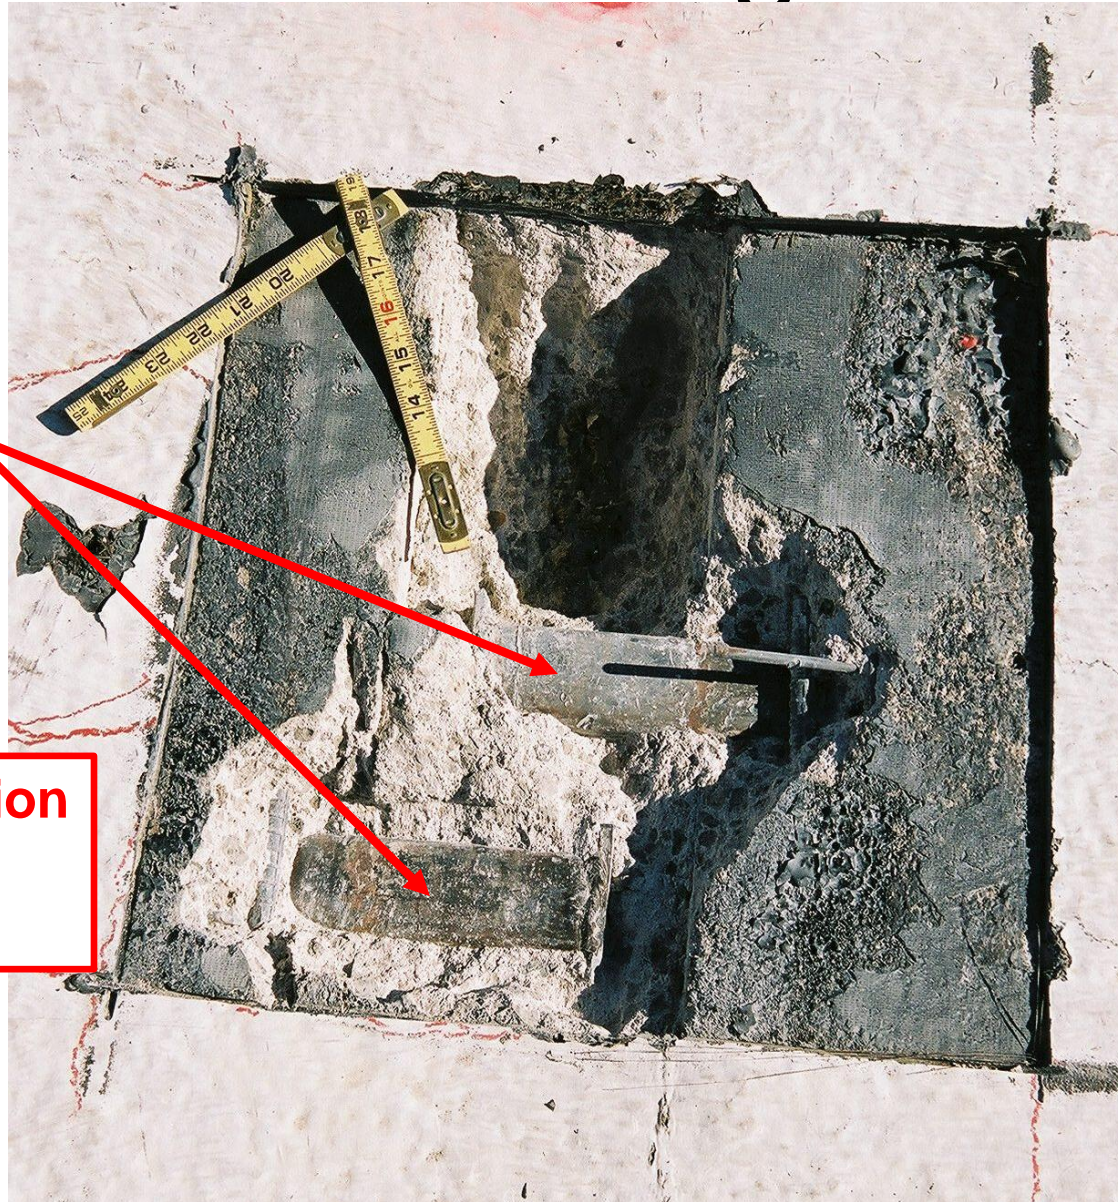
Steel Tube  
Brackets that  
hook over cables  
to support the roof  
panels.

**Not much Corrosion**

**Not Failed!**

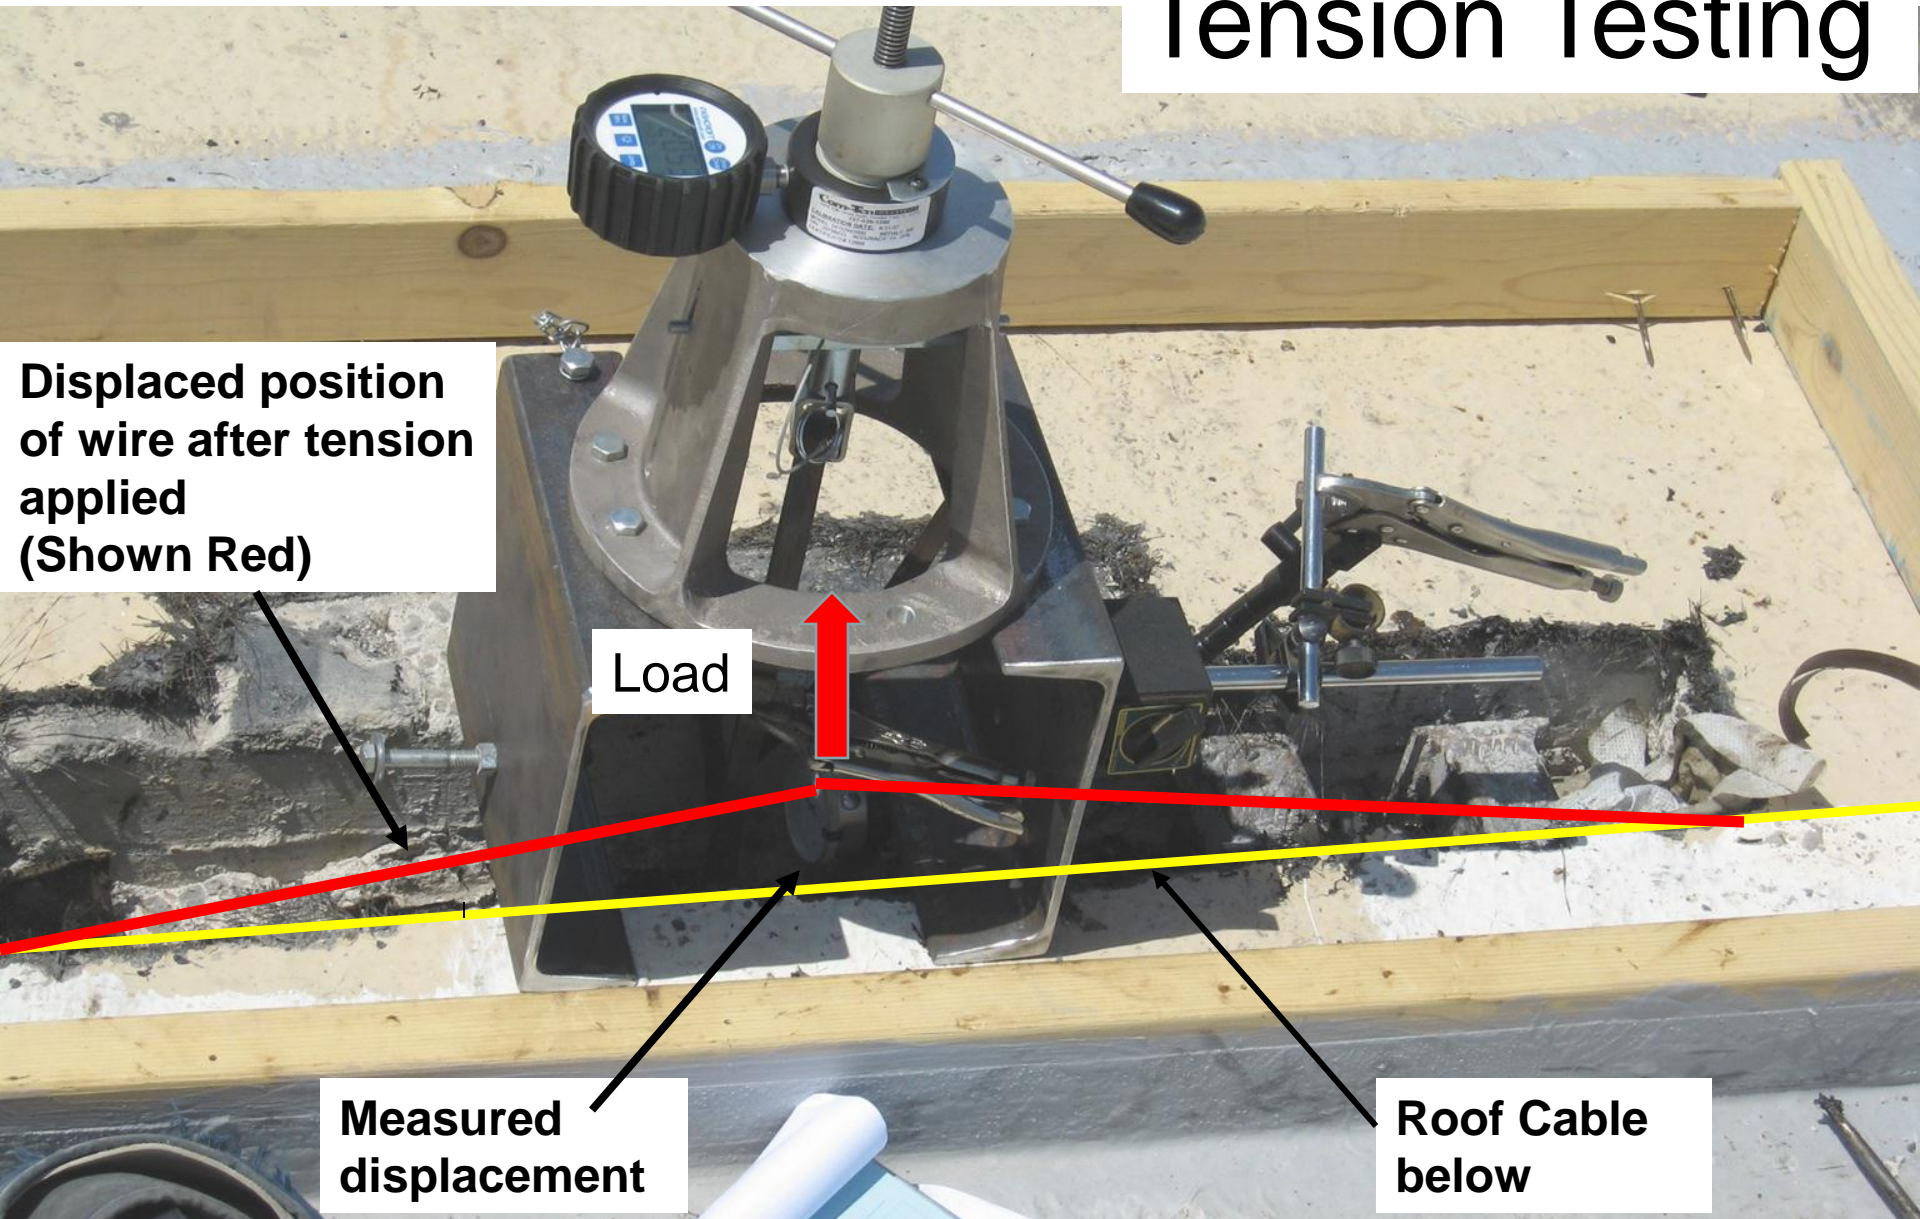
Individual wire tension testing. Pull off testing equipment used to pull up on individual wire strand of cable. Dial Indicator measured displacement (below tension tester). This was used to confirm tension or failure of the cables.

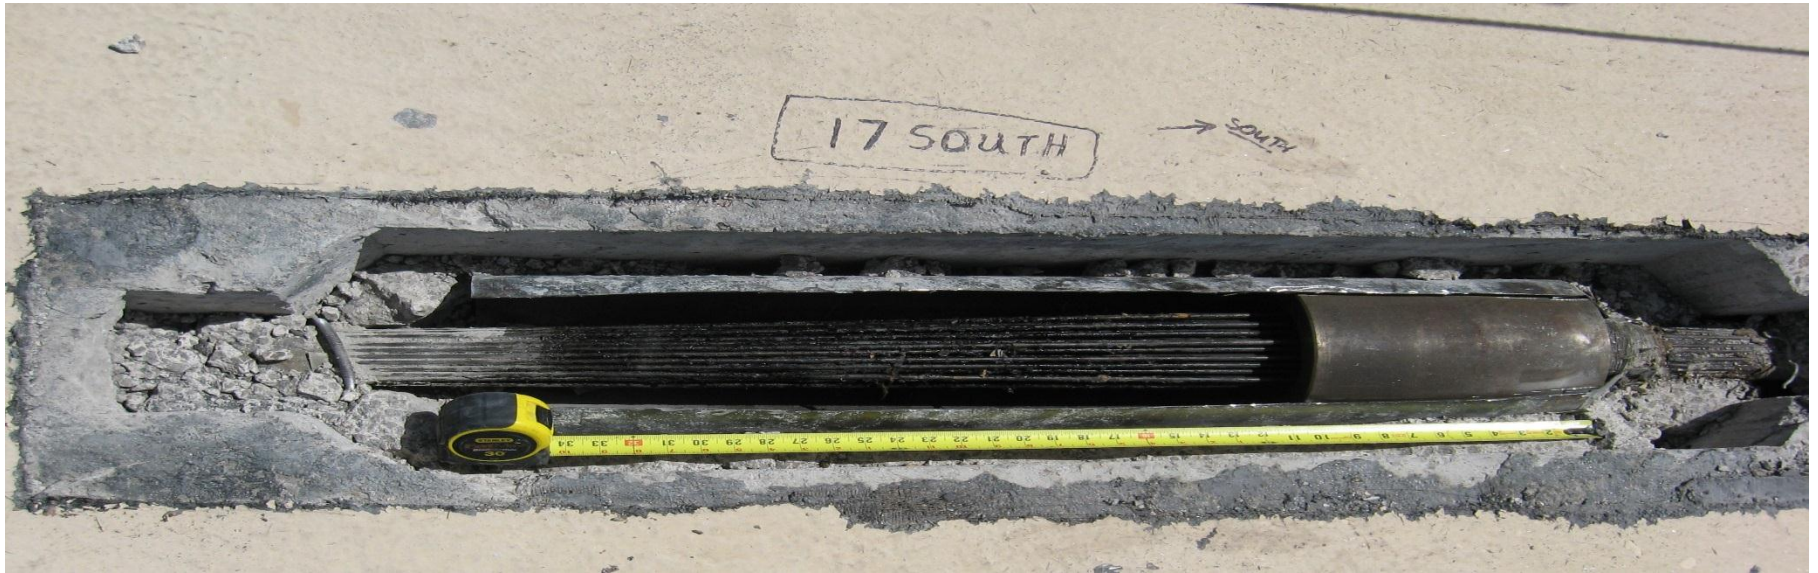
**Photo #3 (above)** shows cable coupling in normal position, with straight parallel wires. This occurred at the un-failed end.

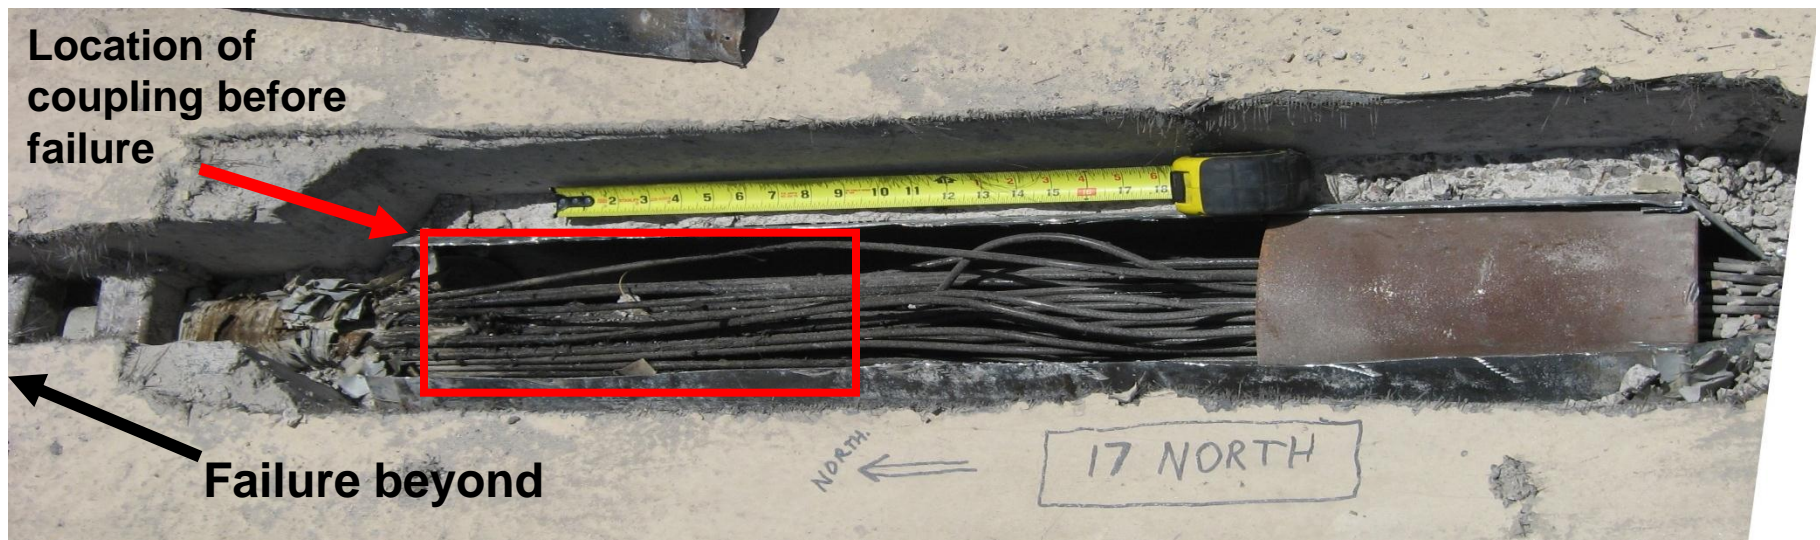
**Photo #4 (below)** shows cable after failure at end anchorage, with wires deformed due to recoil from the failure and loss of 420,000 pounds post tensioned force. This occurred at the end with the failure.

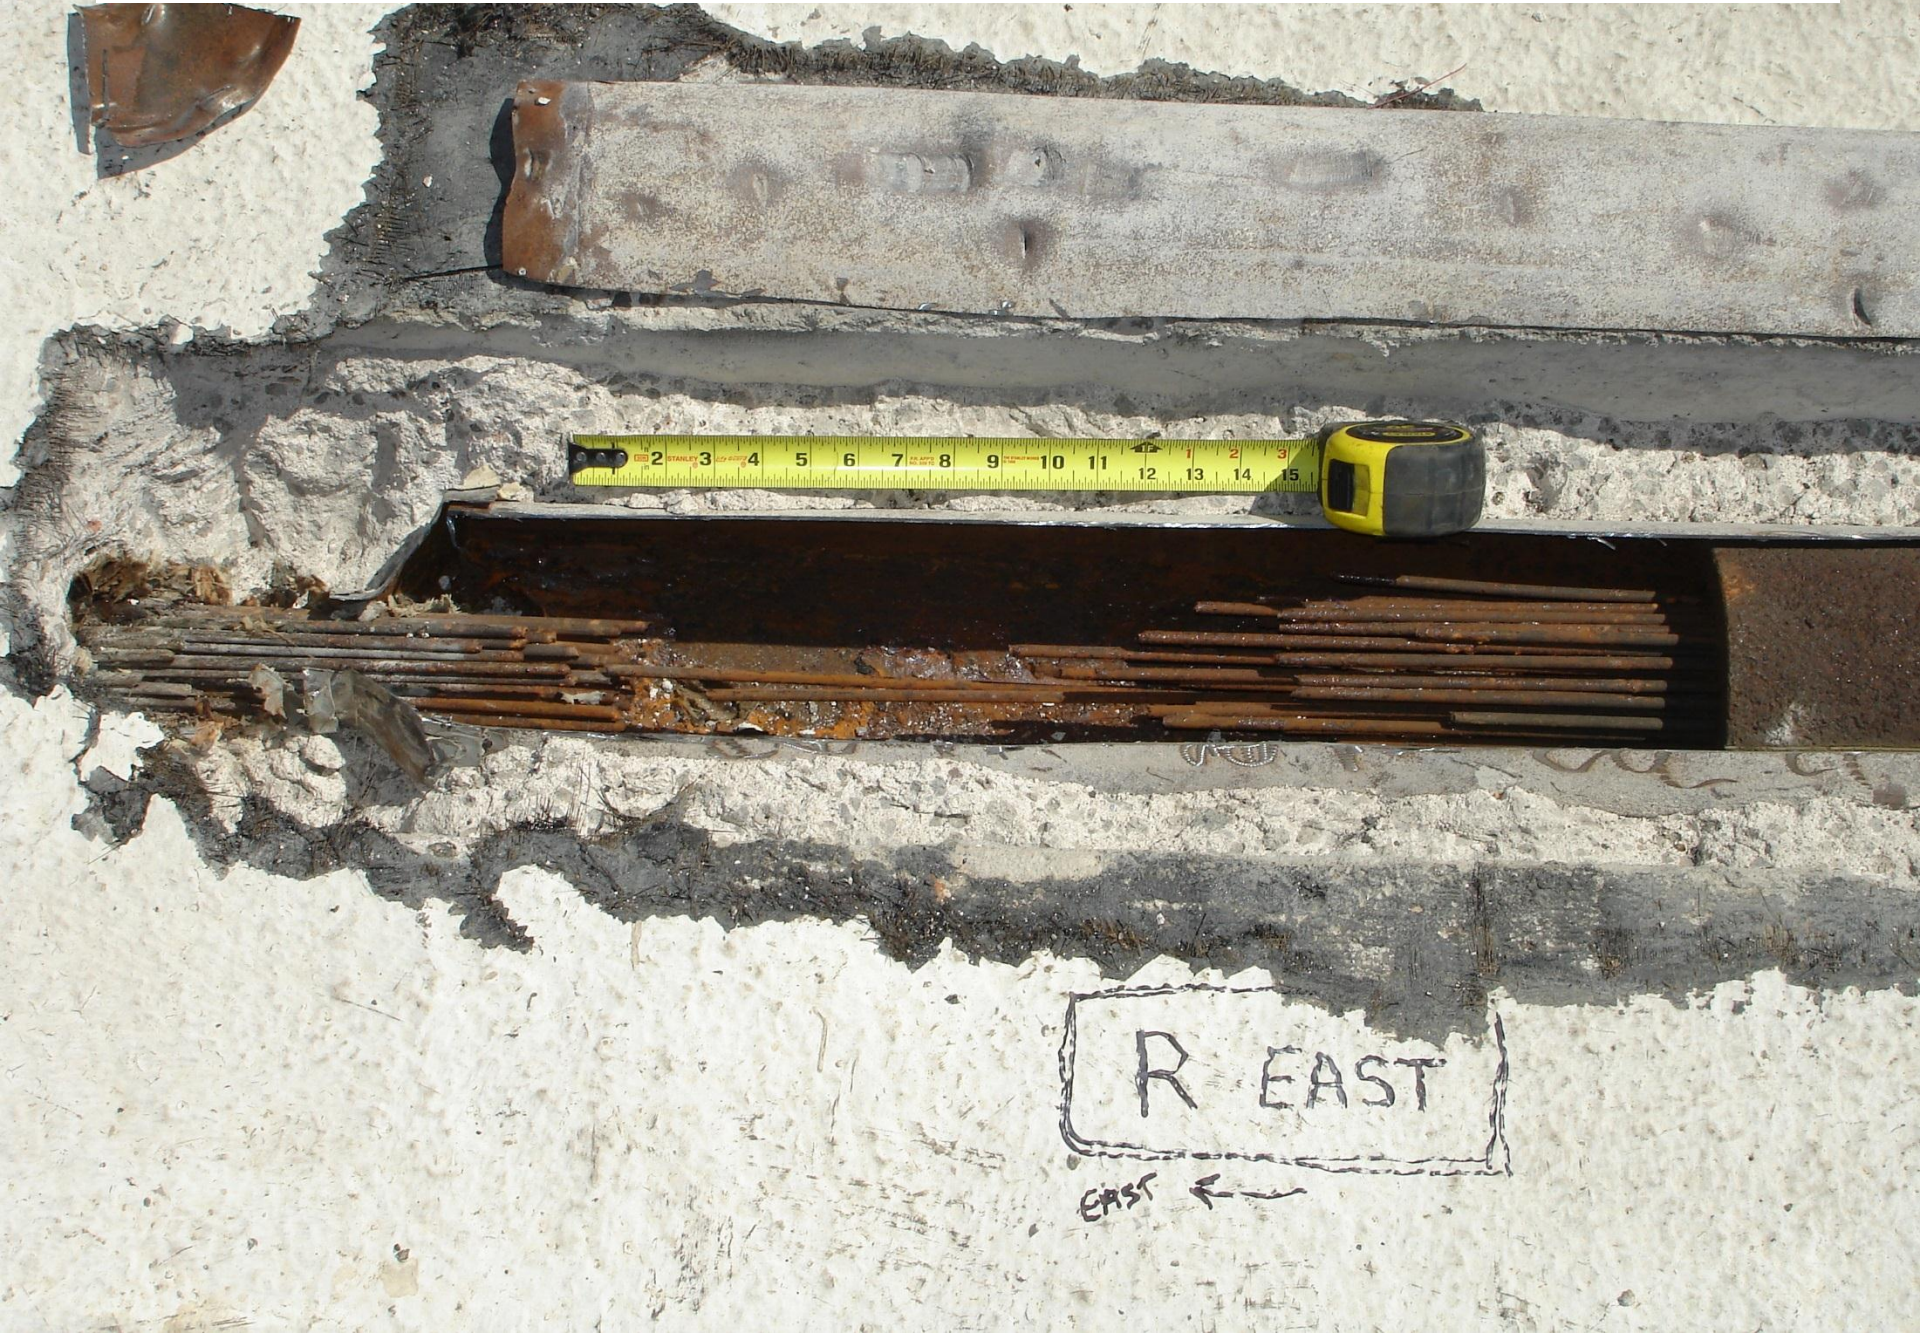
# The Only Tendon Failed because of Roof Leaks

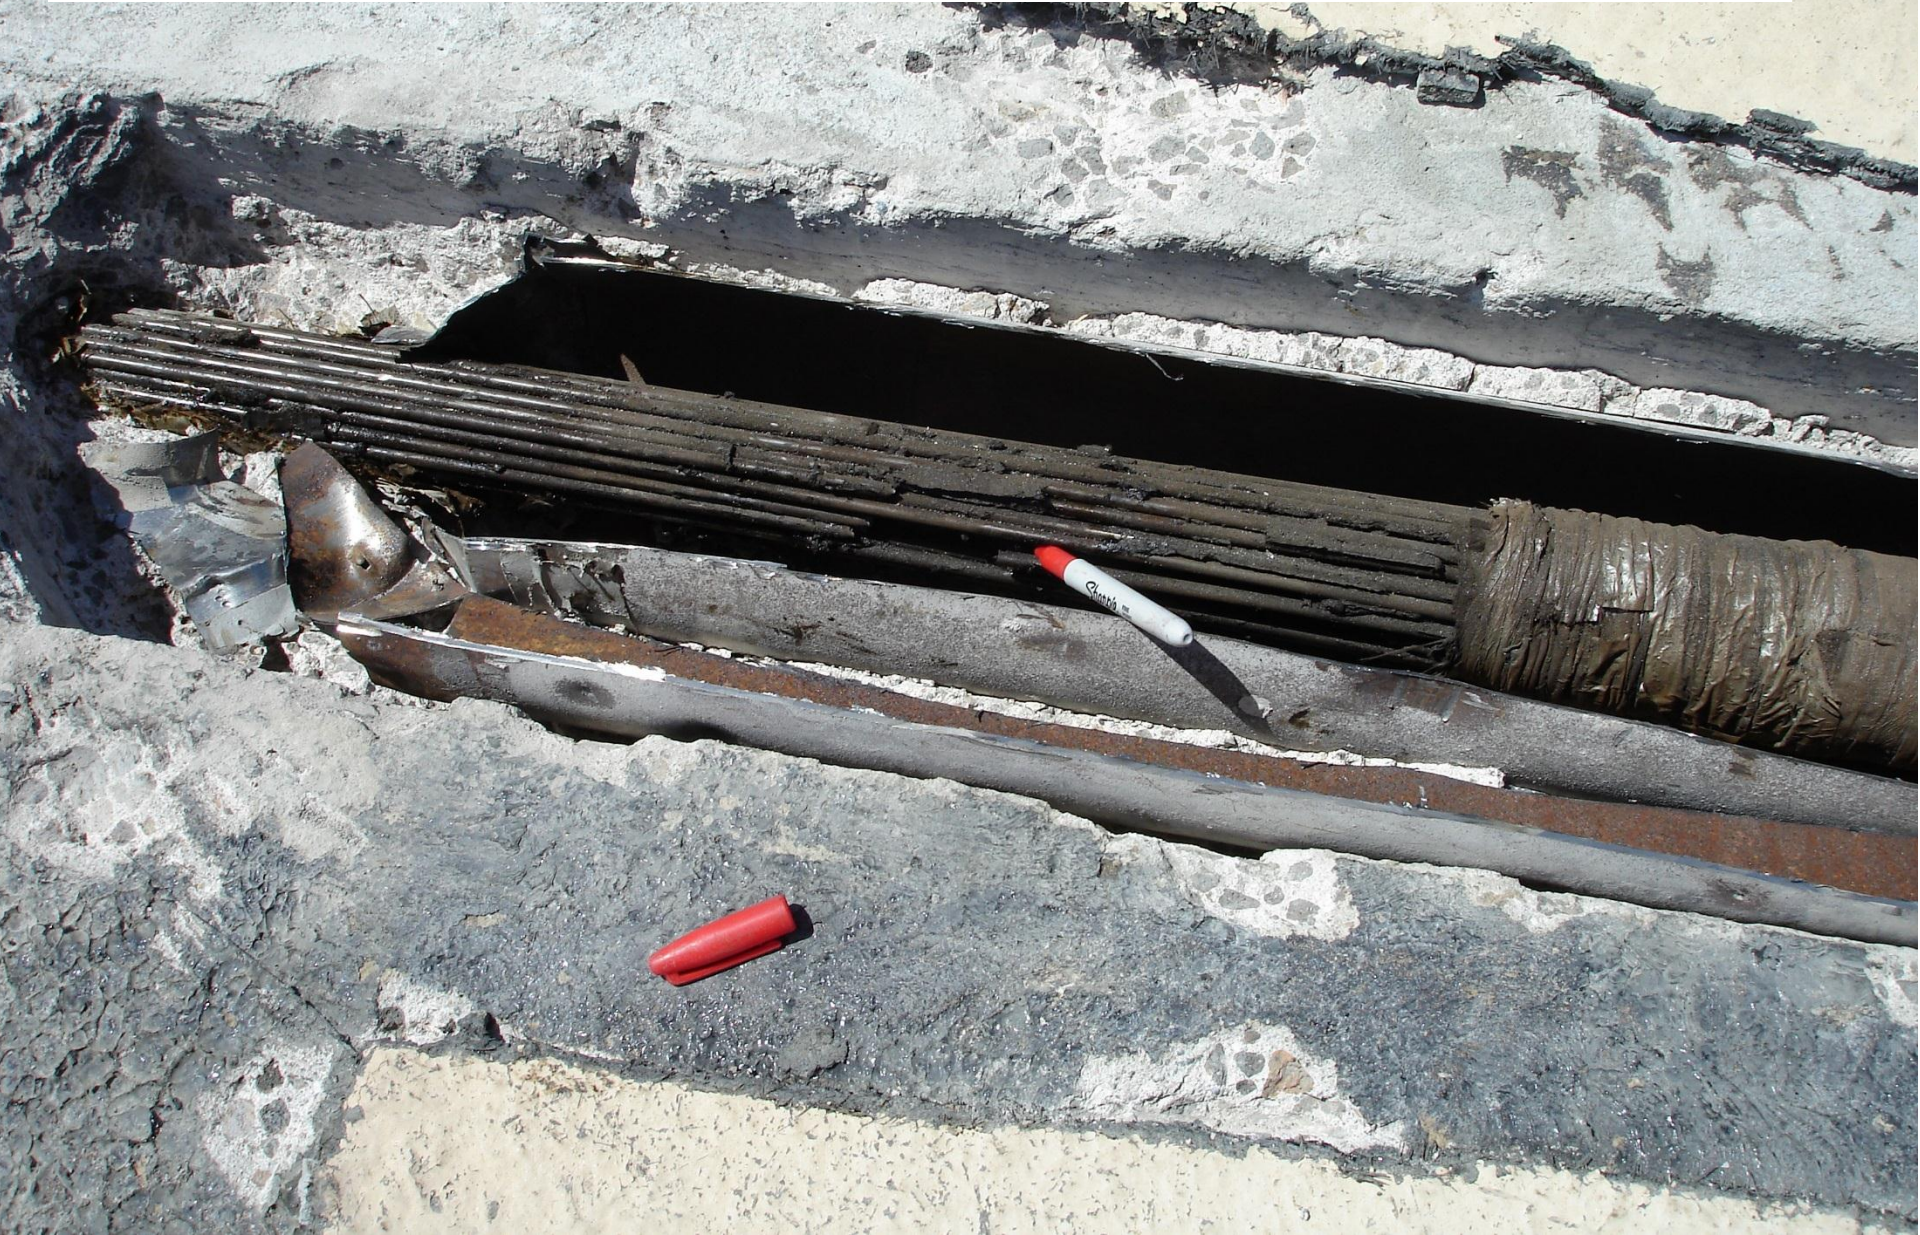
Failures Due to Tension Overload – Failure of Wires at End Anchorage Caused these Wires to be Overloaded
