Restoration and Monitoring of a Thin Lightweight Reinforced Concrete Parking Slab

Project - Pegasus Apartments

Outline

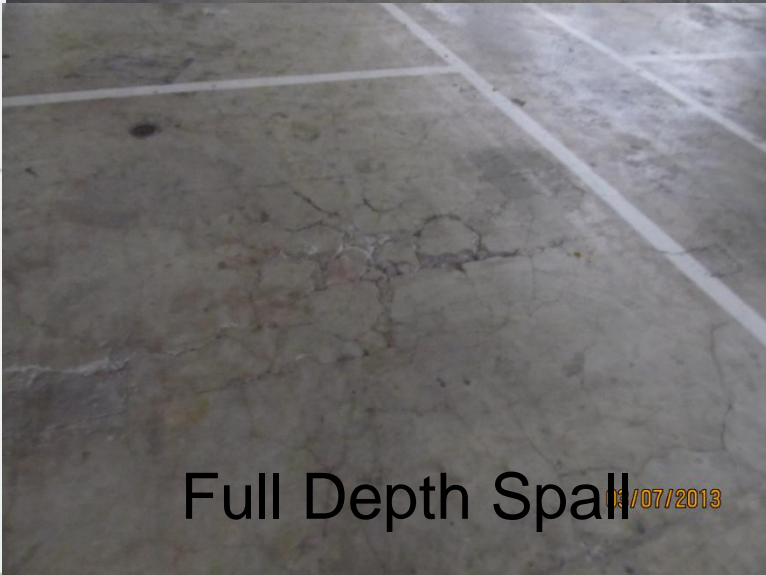
03/07/2013

Full Depth Spall

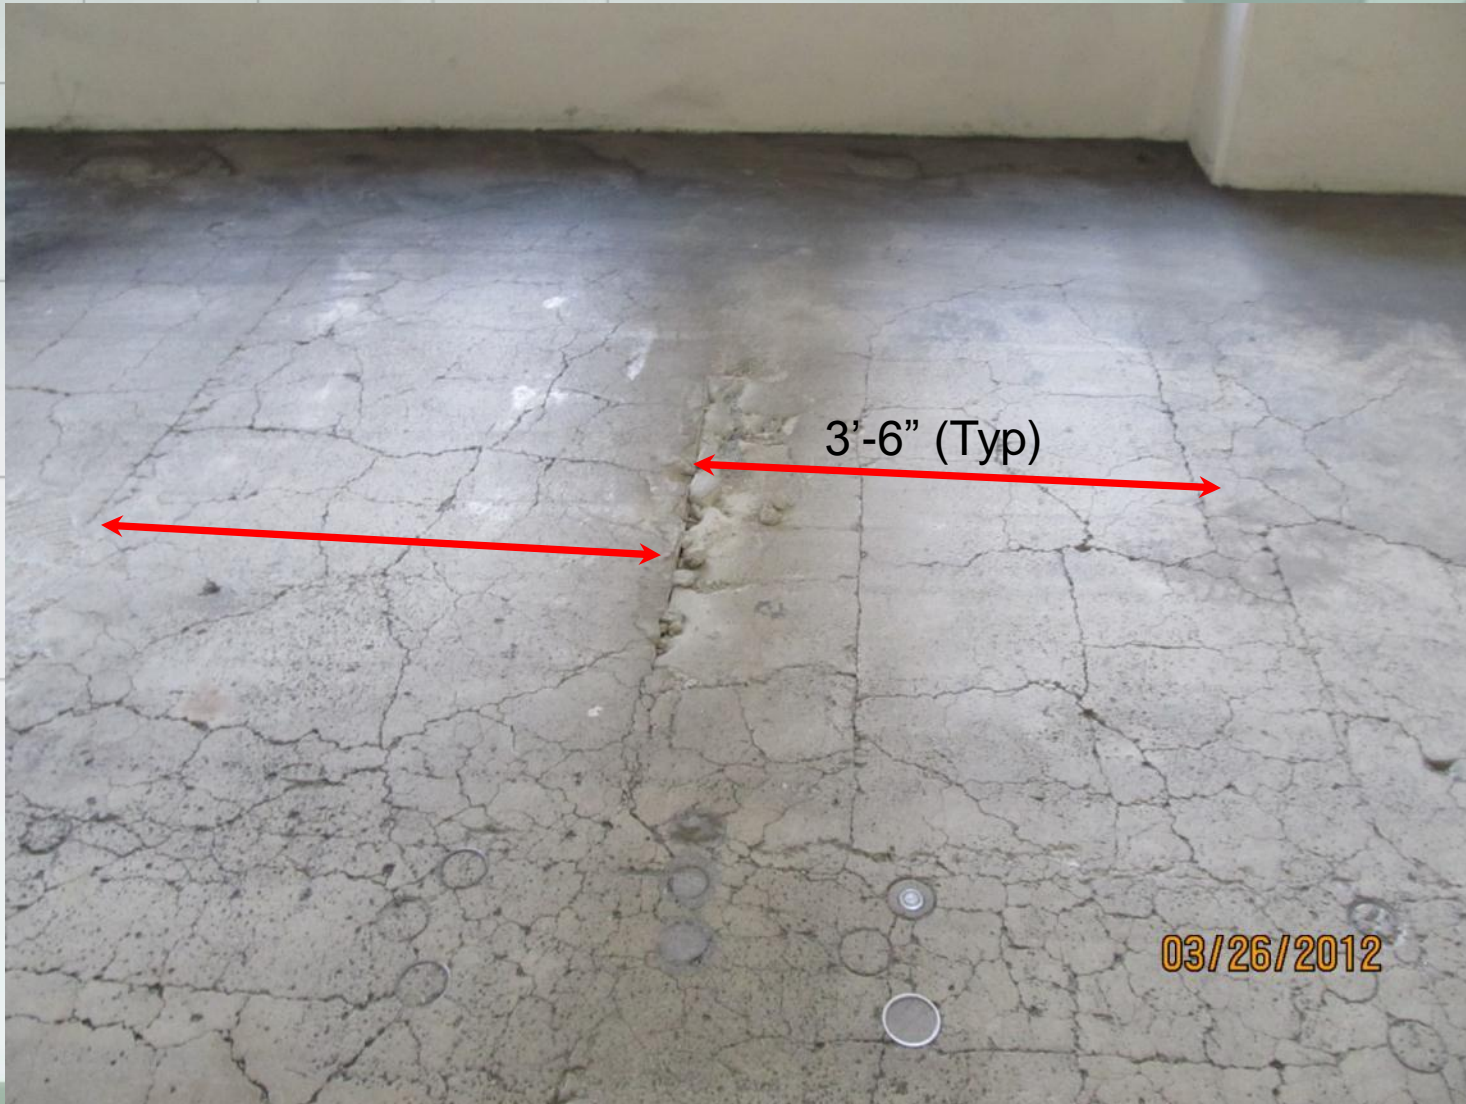
Slab Cracking Caused by Wheel Loads

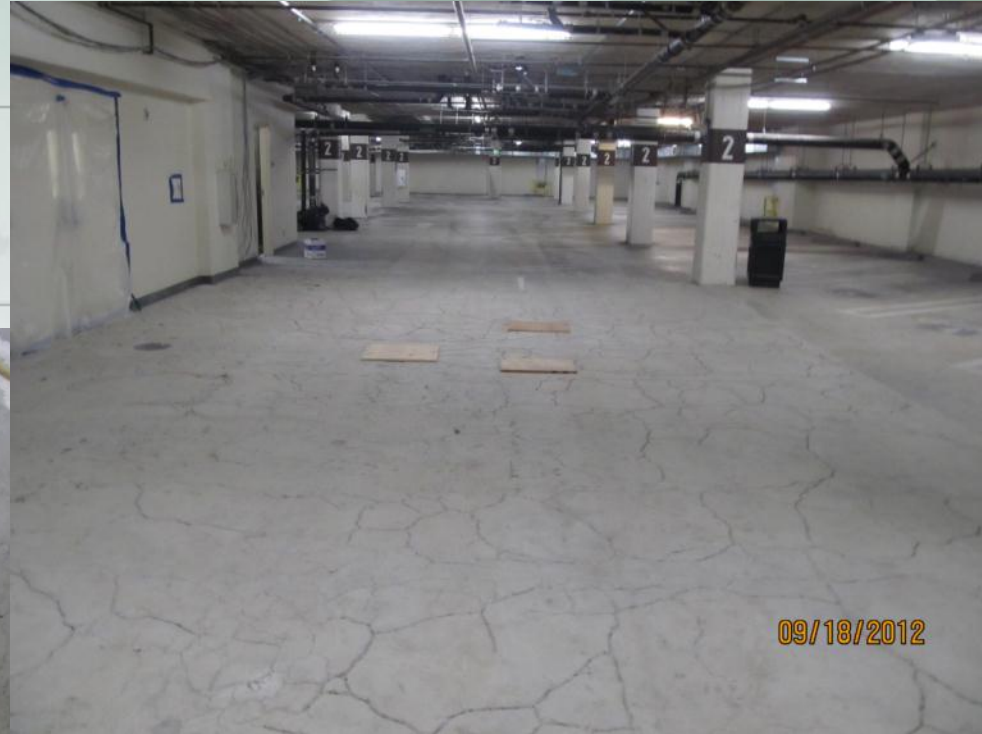
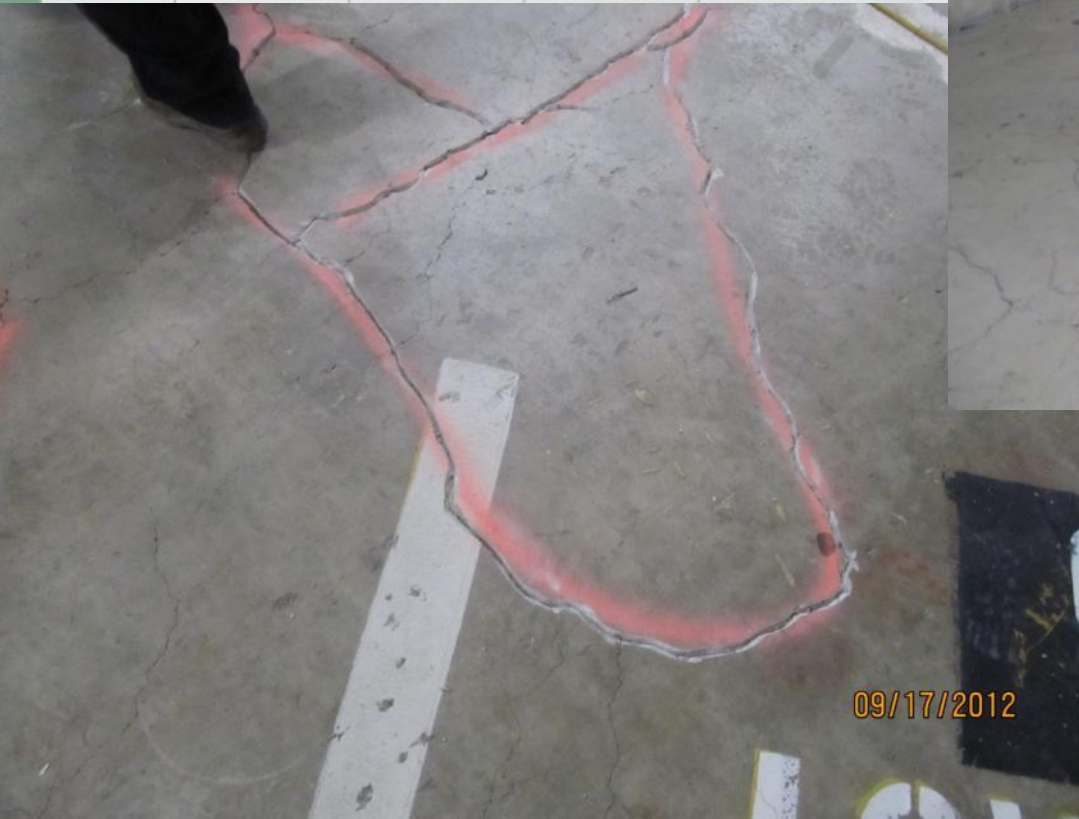
Crack Repair

- Rout & fill cracks
> 1/32"
