# “From Textbook to Practice: Case History of Failure and Repair of an Underground Wastewater Vault”

Structural Diagnostics Services  
Walter P Moore

October 13, 2011

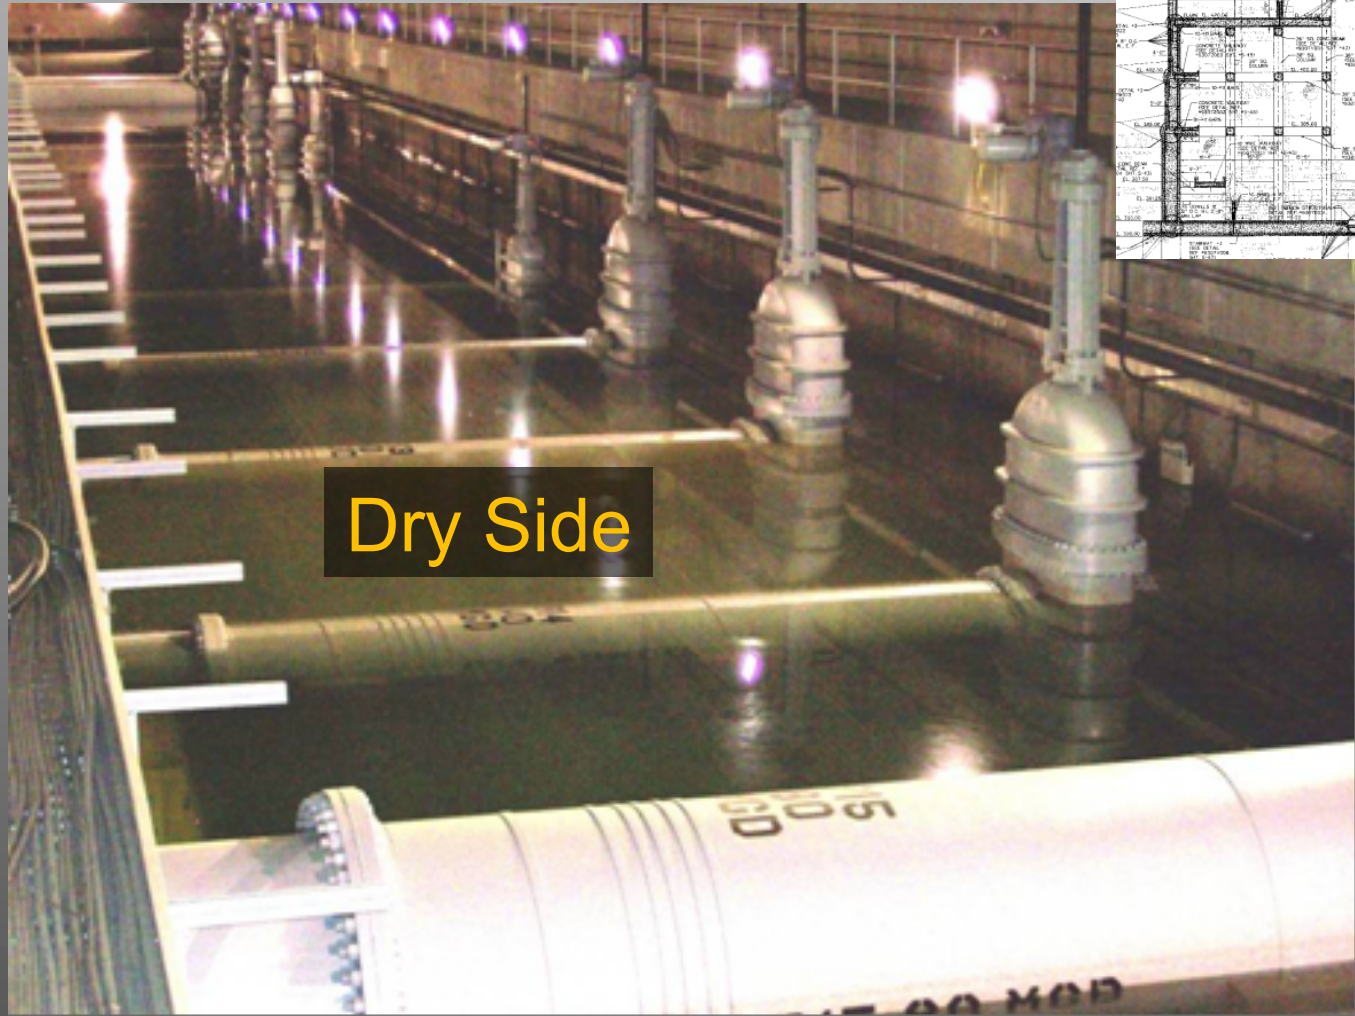
Groundwater flooded the dry side of the vault.

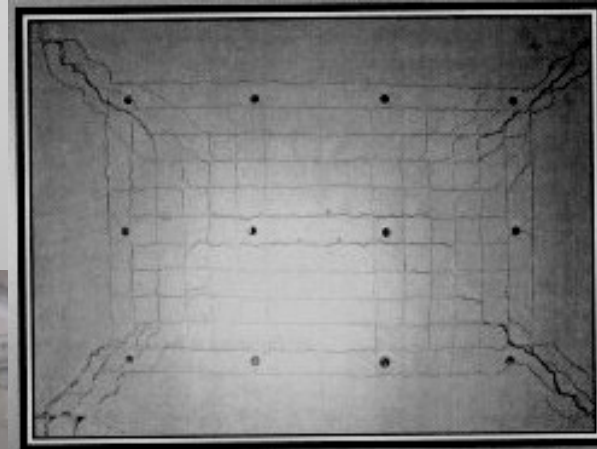
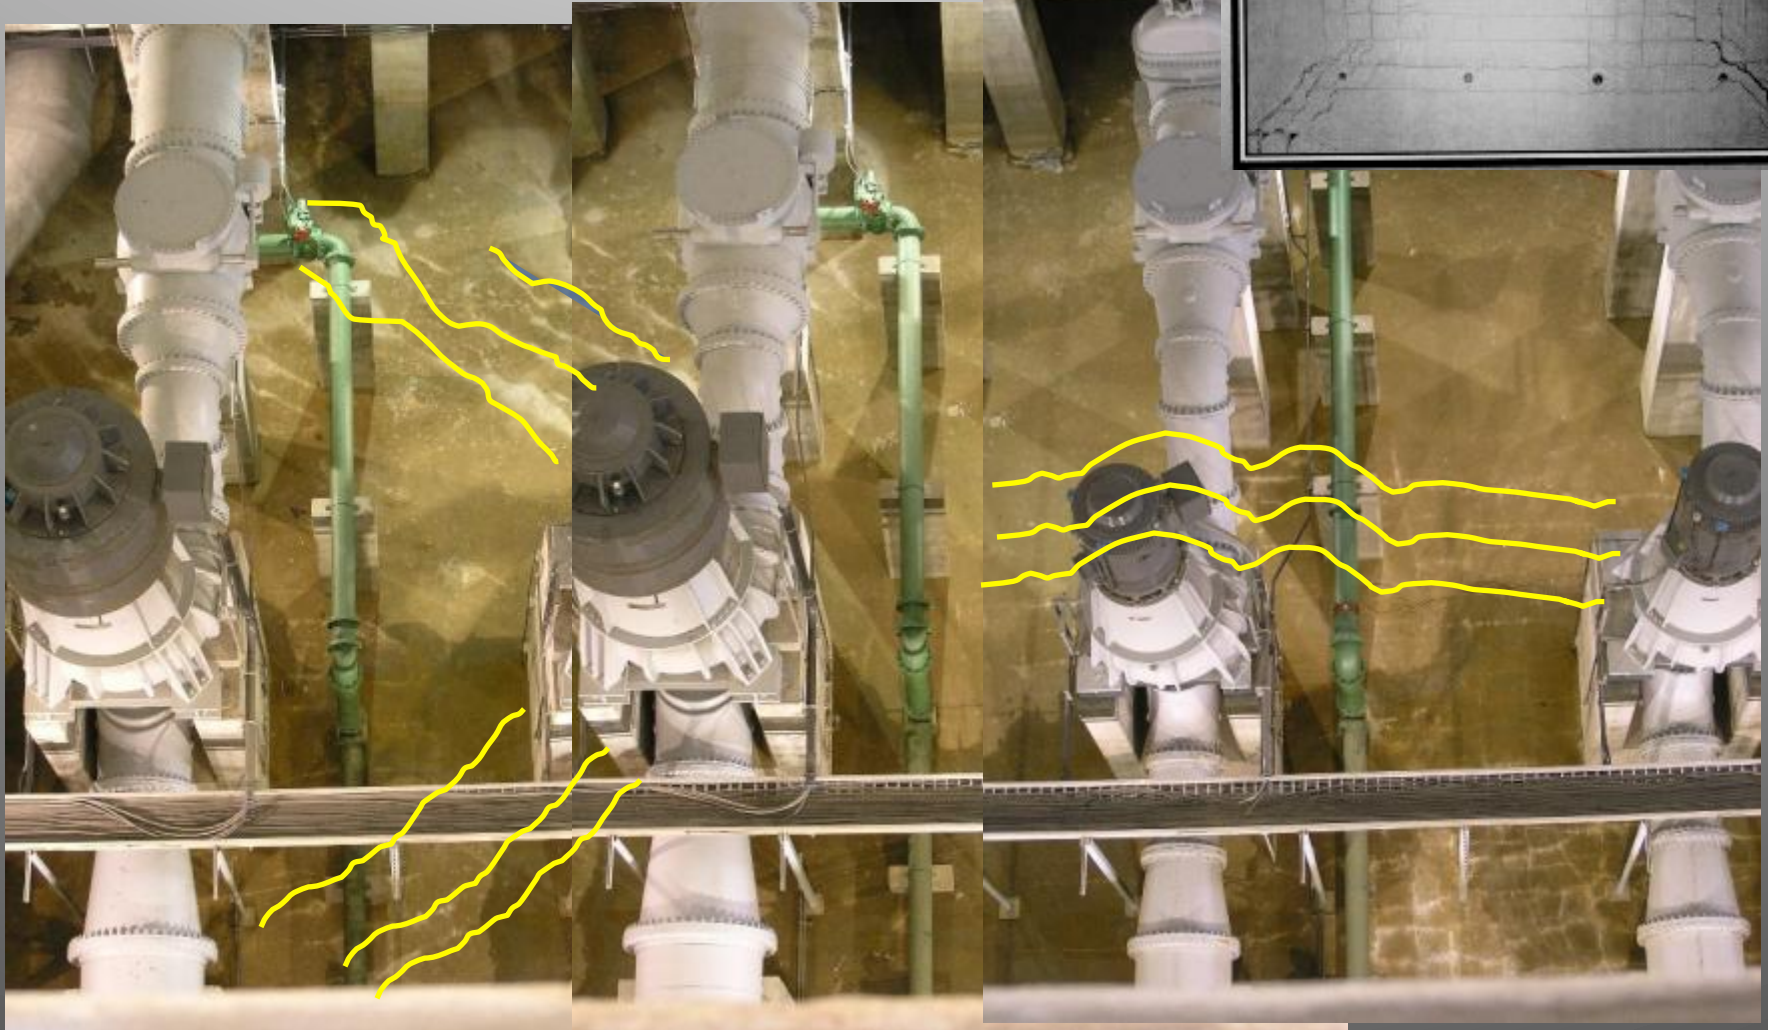
- Slab cracks noted in top face of slab.
- Crack patterns consistent with yield line pattern seen in uniformly loaded slabs.
  - Diagonal cracks at corners.
  - Cracks parallel to edges in middle.

Yield Line Flexural Failure in Slab in Dry Side  
(Compare with text book example)

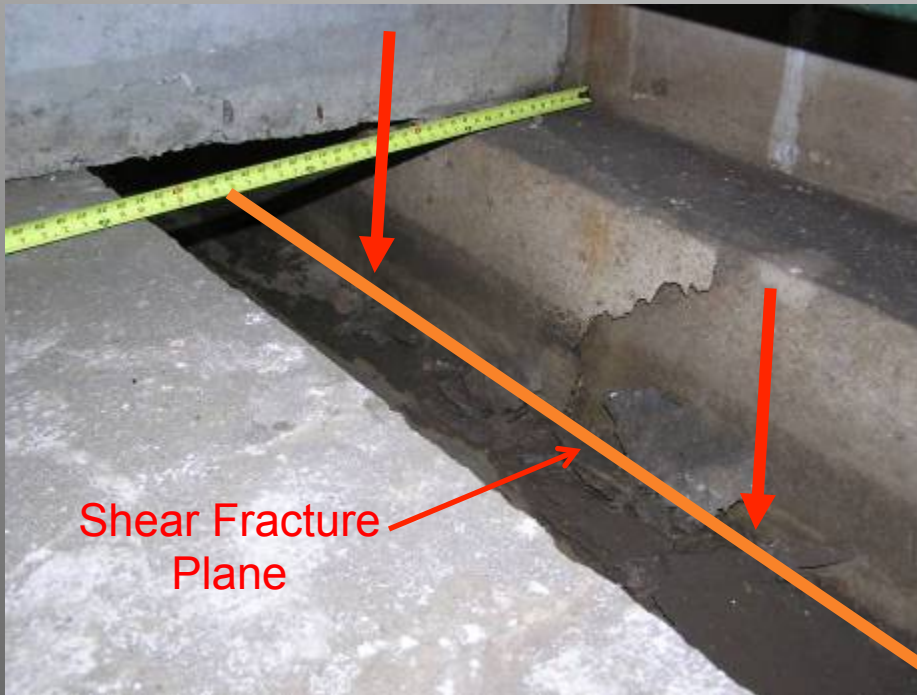
- Mat slab fractured at trench.
- **Shear failure**
- 1.5" floor level difference across fracture plane.
- Probable yielding of reinforcing at fracture plane.

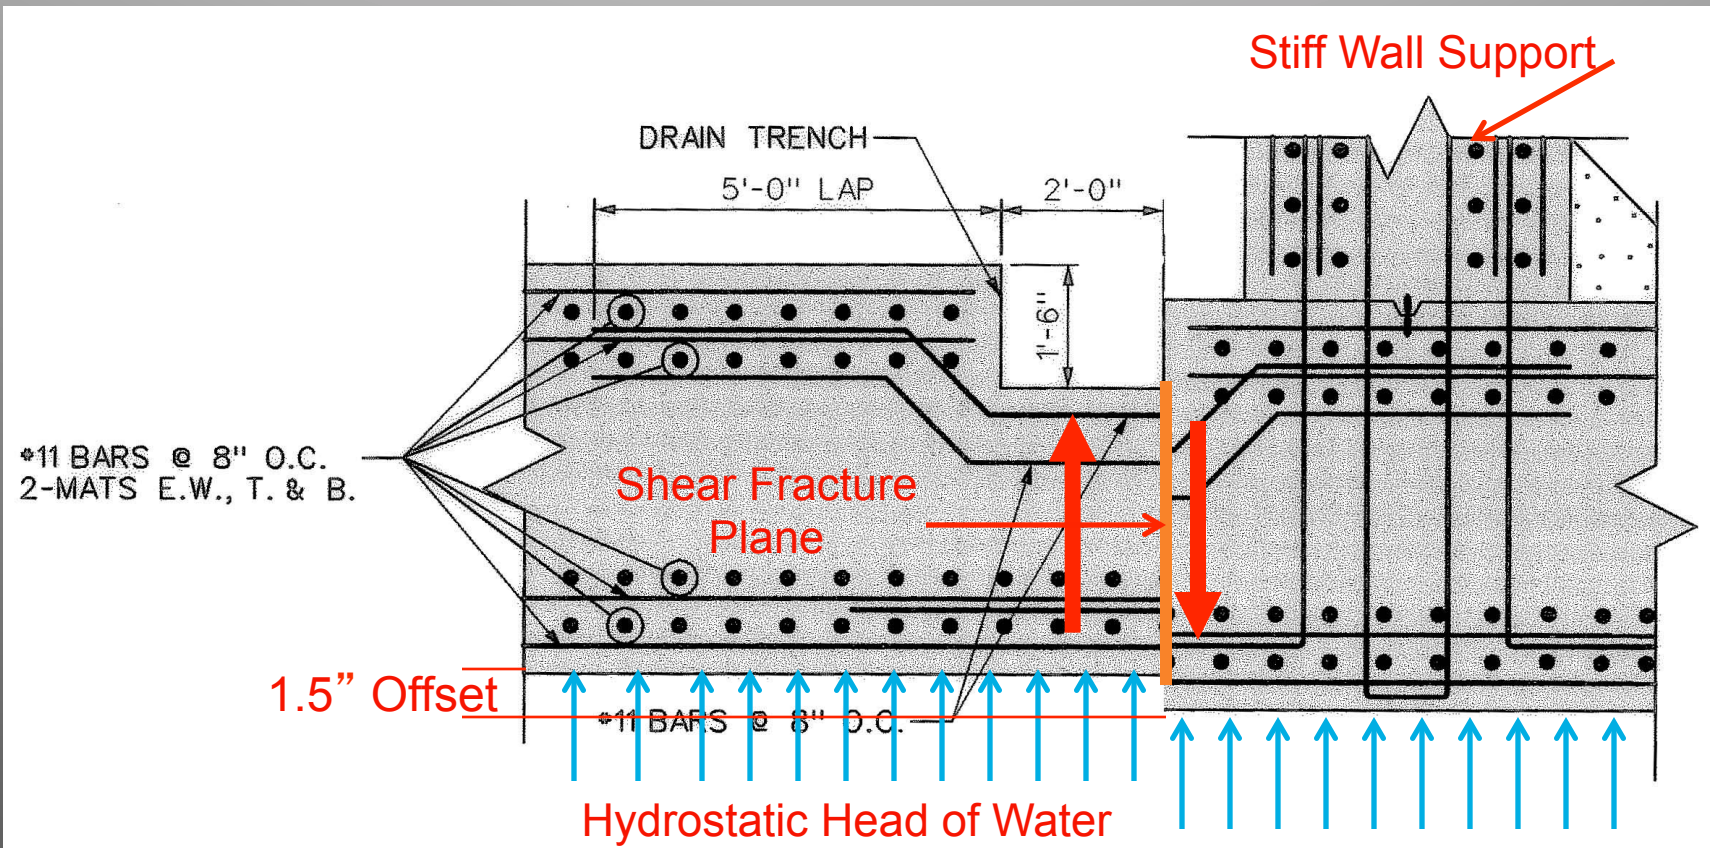
Shear Failure at Reduced (Weak) Section

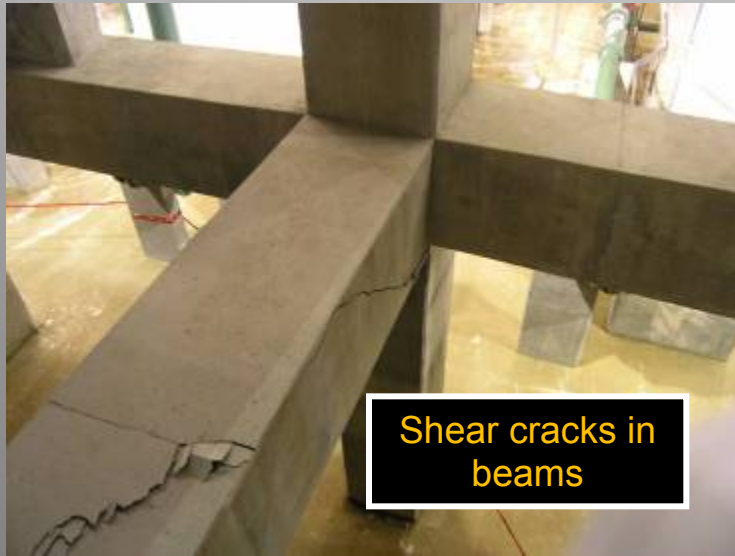
Shear cracks in beams

- Observations on 3' x3' Beams and Columns supporting Chute.
  - Spalls at base of columns.
  - Shear cracks in beams perpendicular to chute axis.
    - Crack widths ranged from hairline to more than 2".

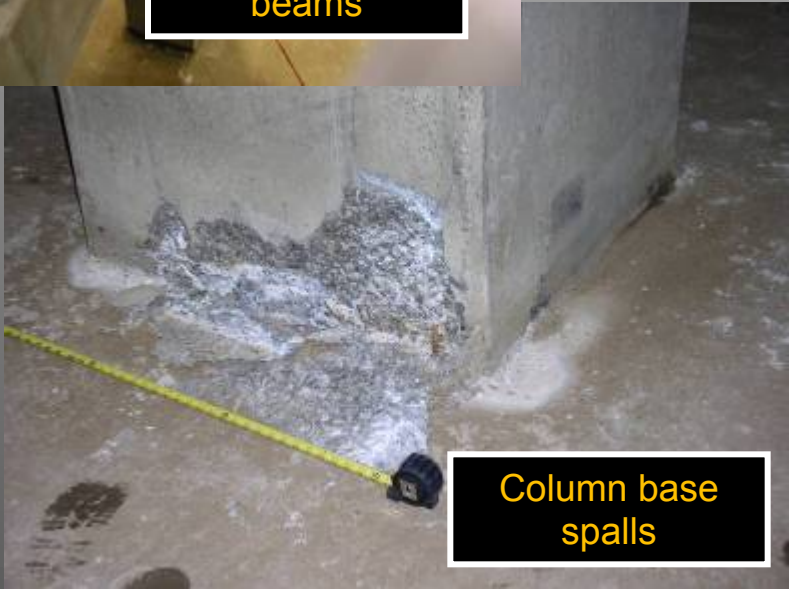
Column base spalls

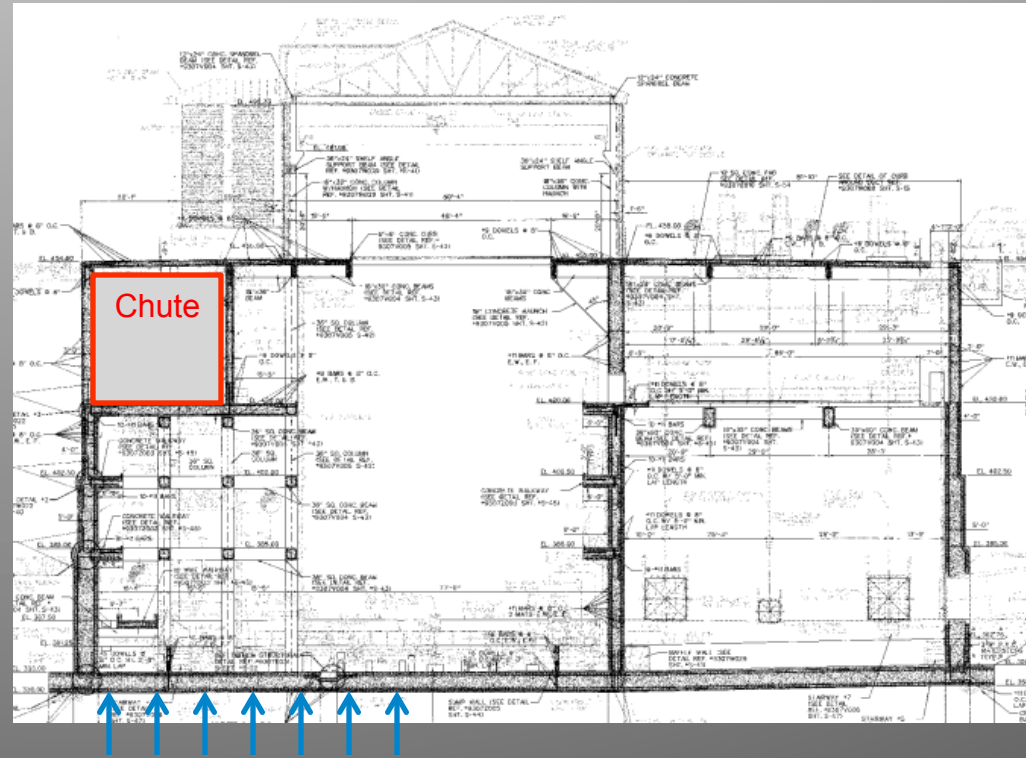
Chute in Vault Subjected to Torsion Due to Upward Force in Mat Slab on Chute Support Frame

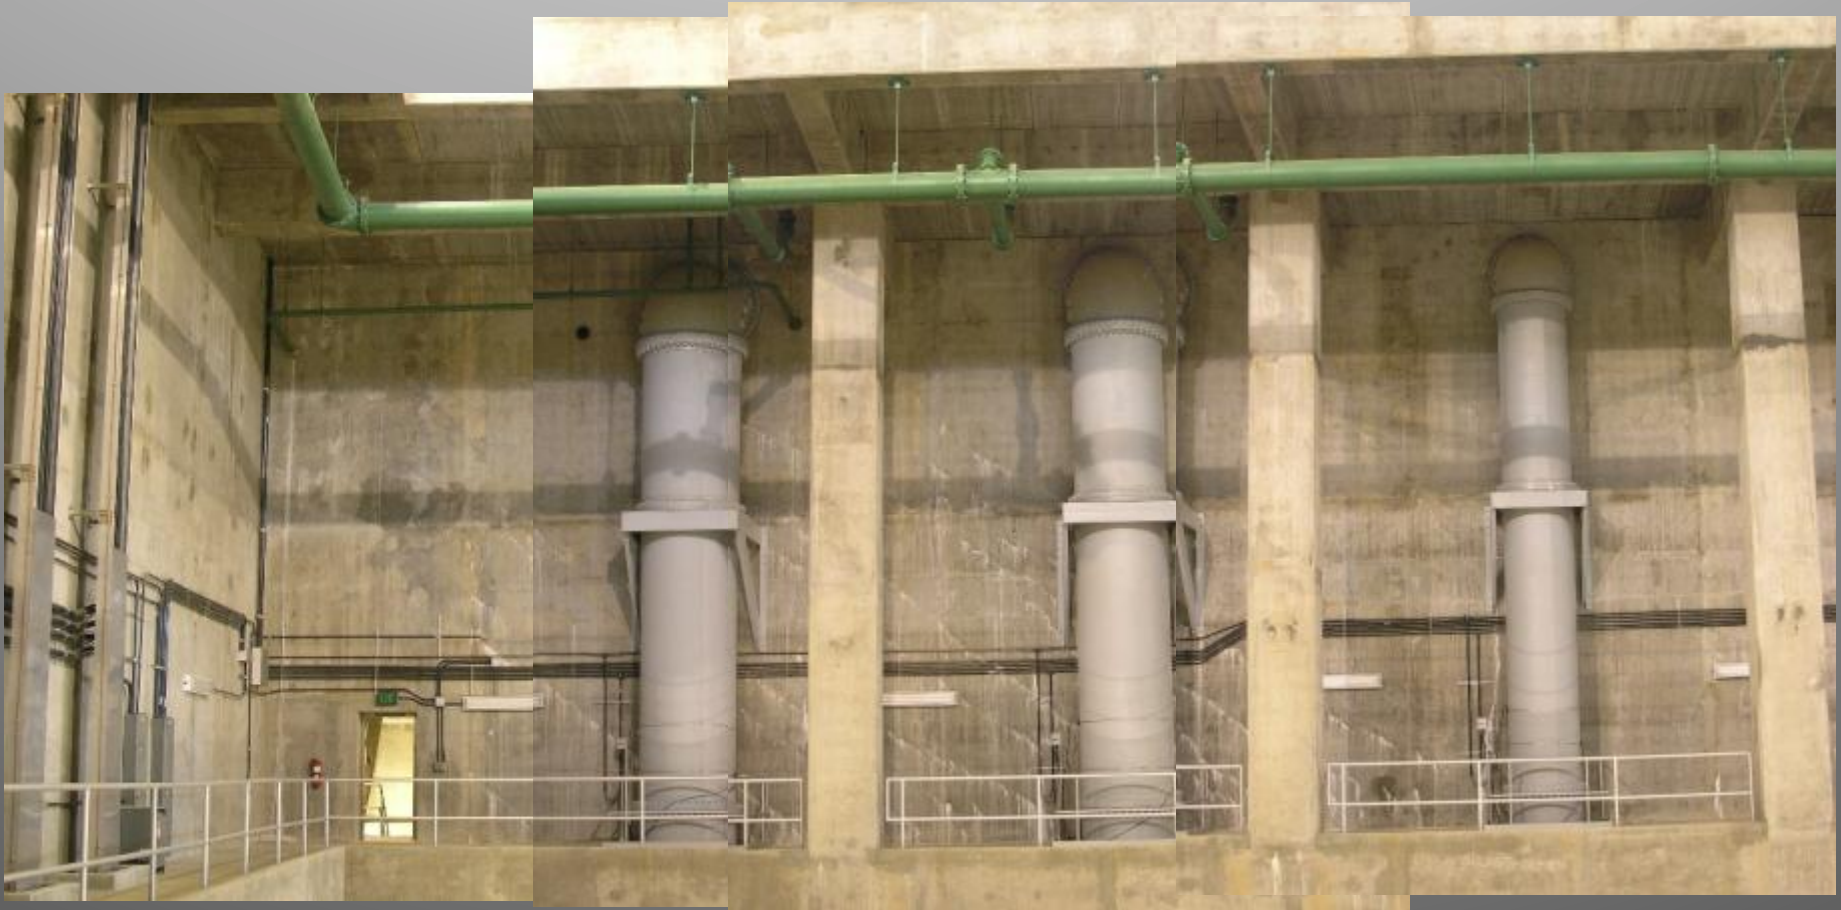
## Torsion Cracking of Chute Side Wall

- Chute is a hollow square section measuring 35' X 35' .
- Diagonal cracks found on sides and bottom at both ends (points of restraint).
- Crack patterns similar to torsion cracking of a hollow tube.

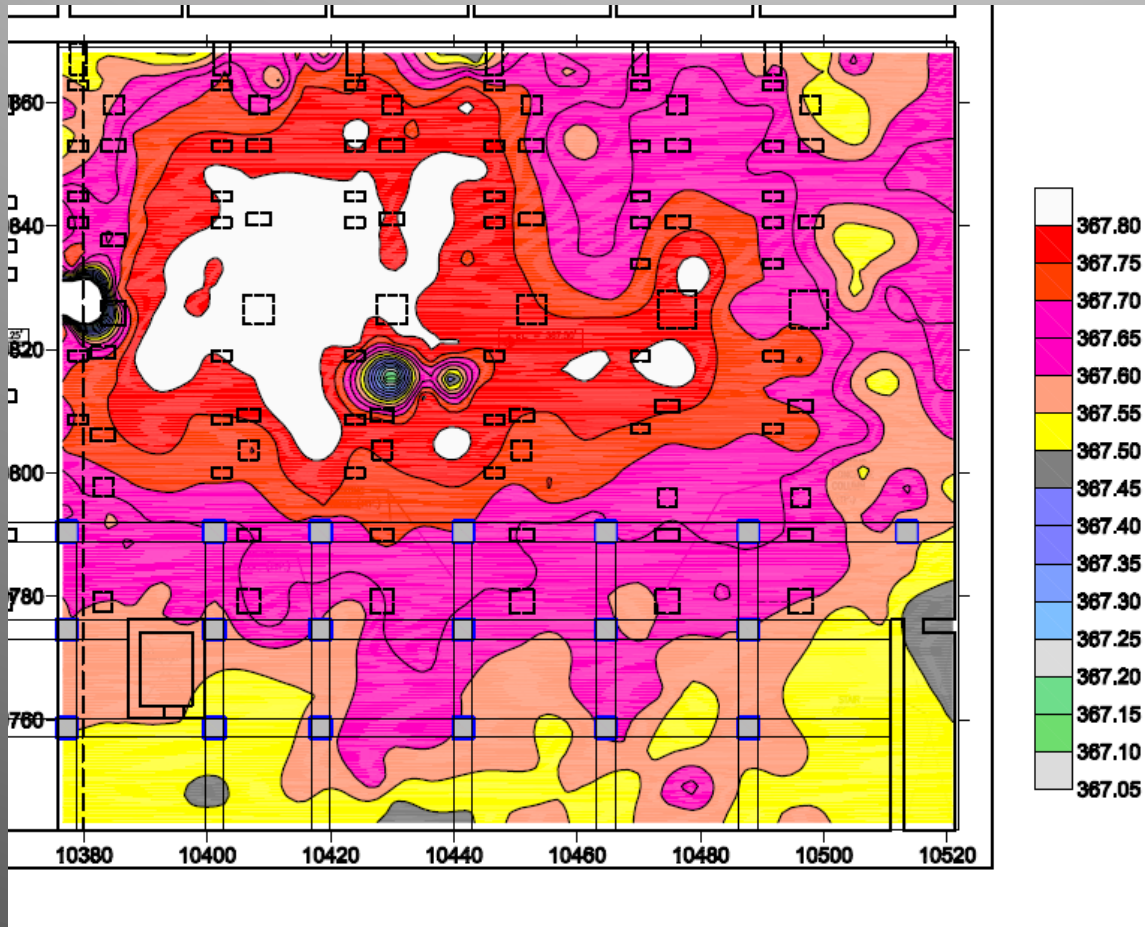
- 4"-6" of floor level variations from reference floor level.
- 1"-2" permanent heave on dry side.

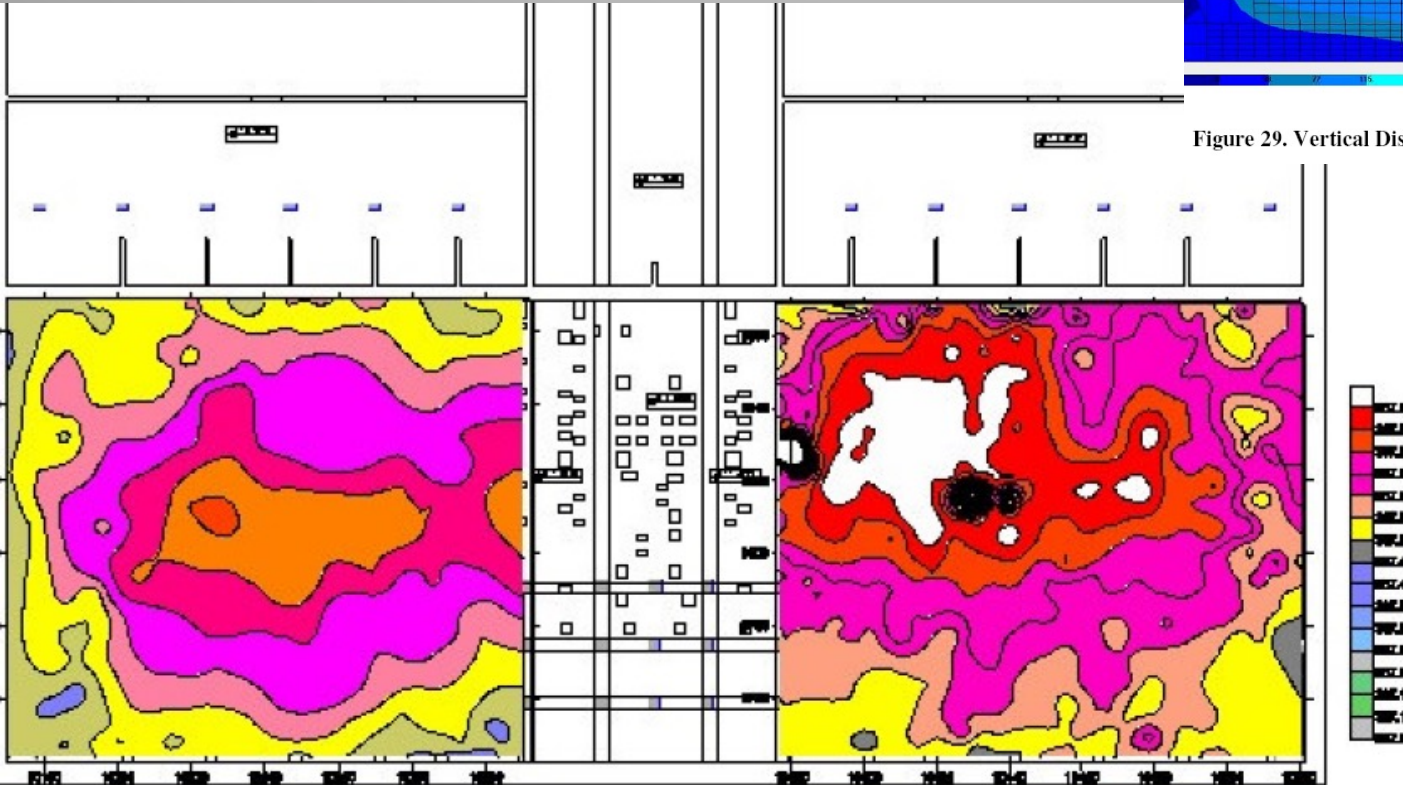
Figure 30. Measured Heave Contours of the Mat slab (See Appendix A)
