# Structural Assessment Key to Returning Historic Union Depot to an Active Transportation Hub

ICRI 2012 Spring Convention  
Quebec City, QC, Canada

Kevin A. Michols, PE, SE

Wiss, Janney, Elstner Associates, Inc.

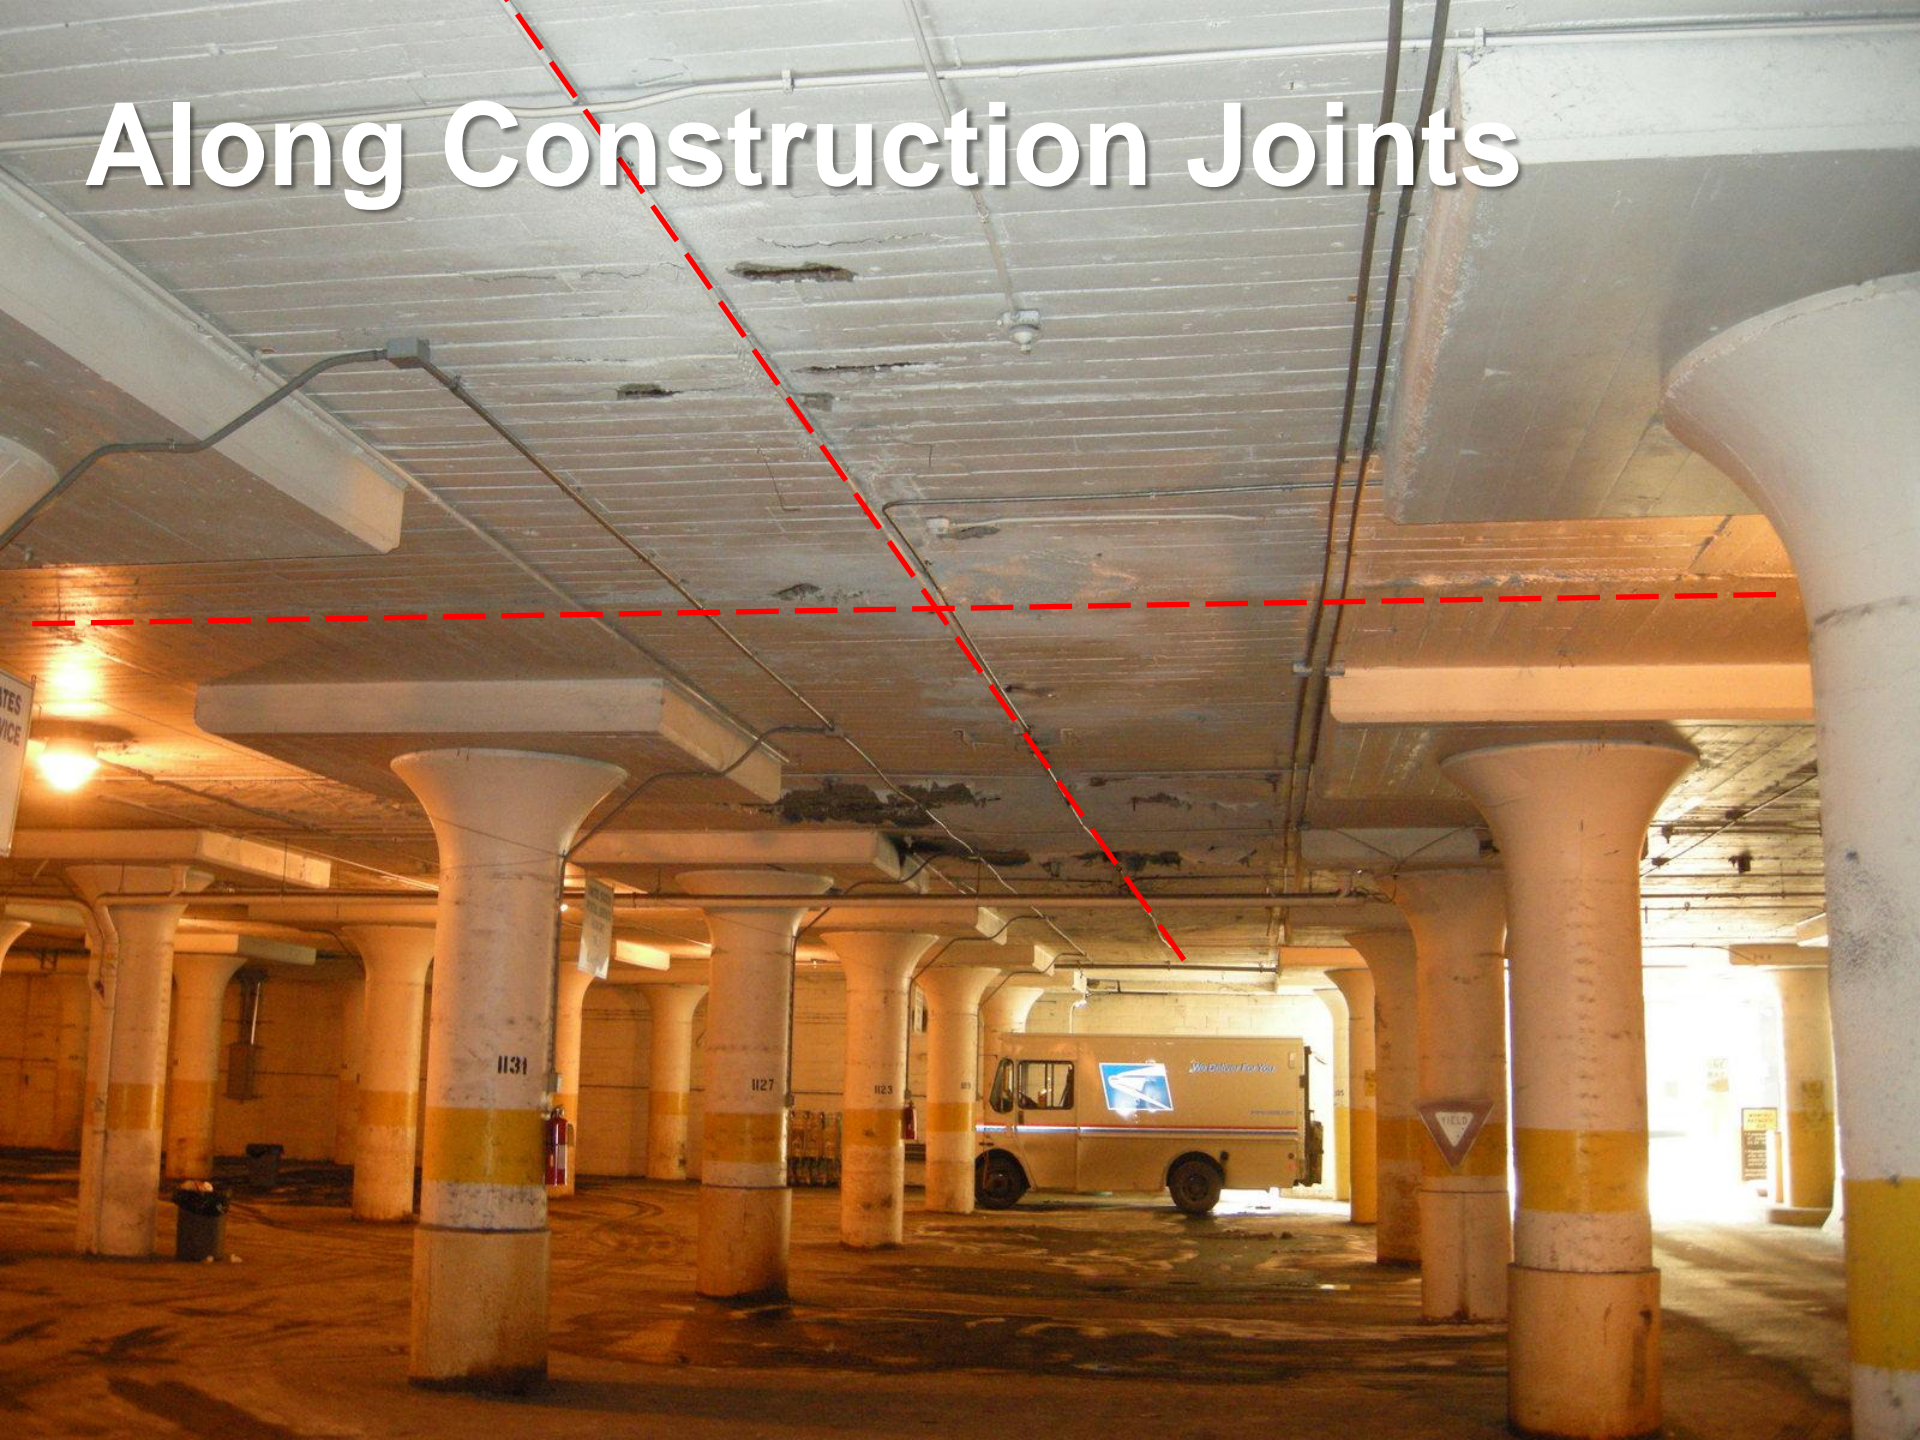
# Along Construction Joints

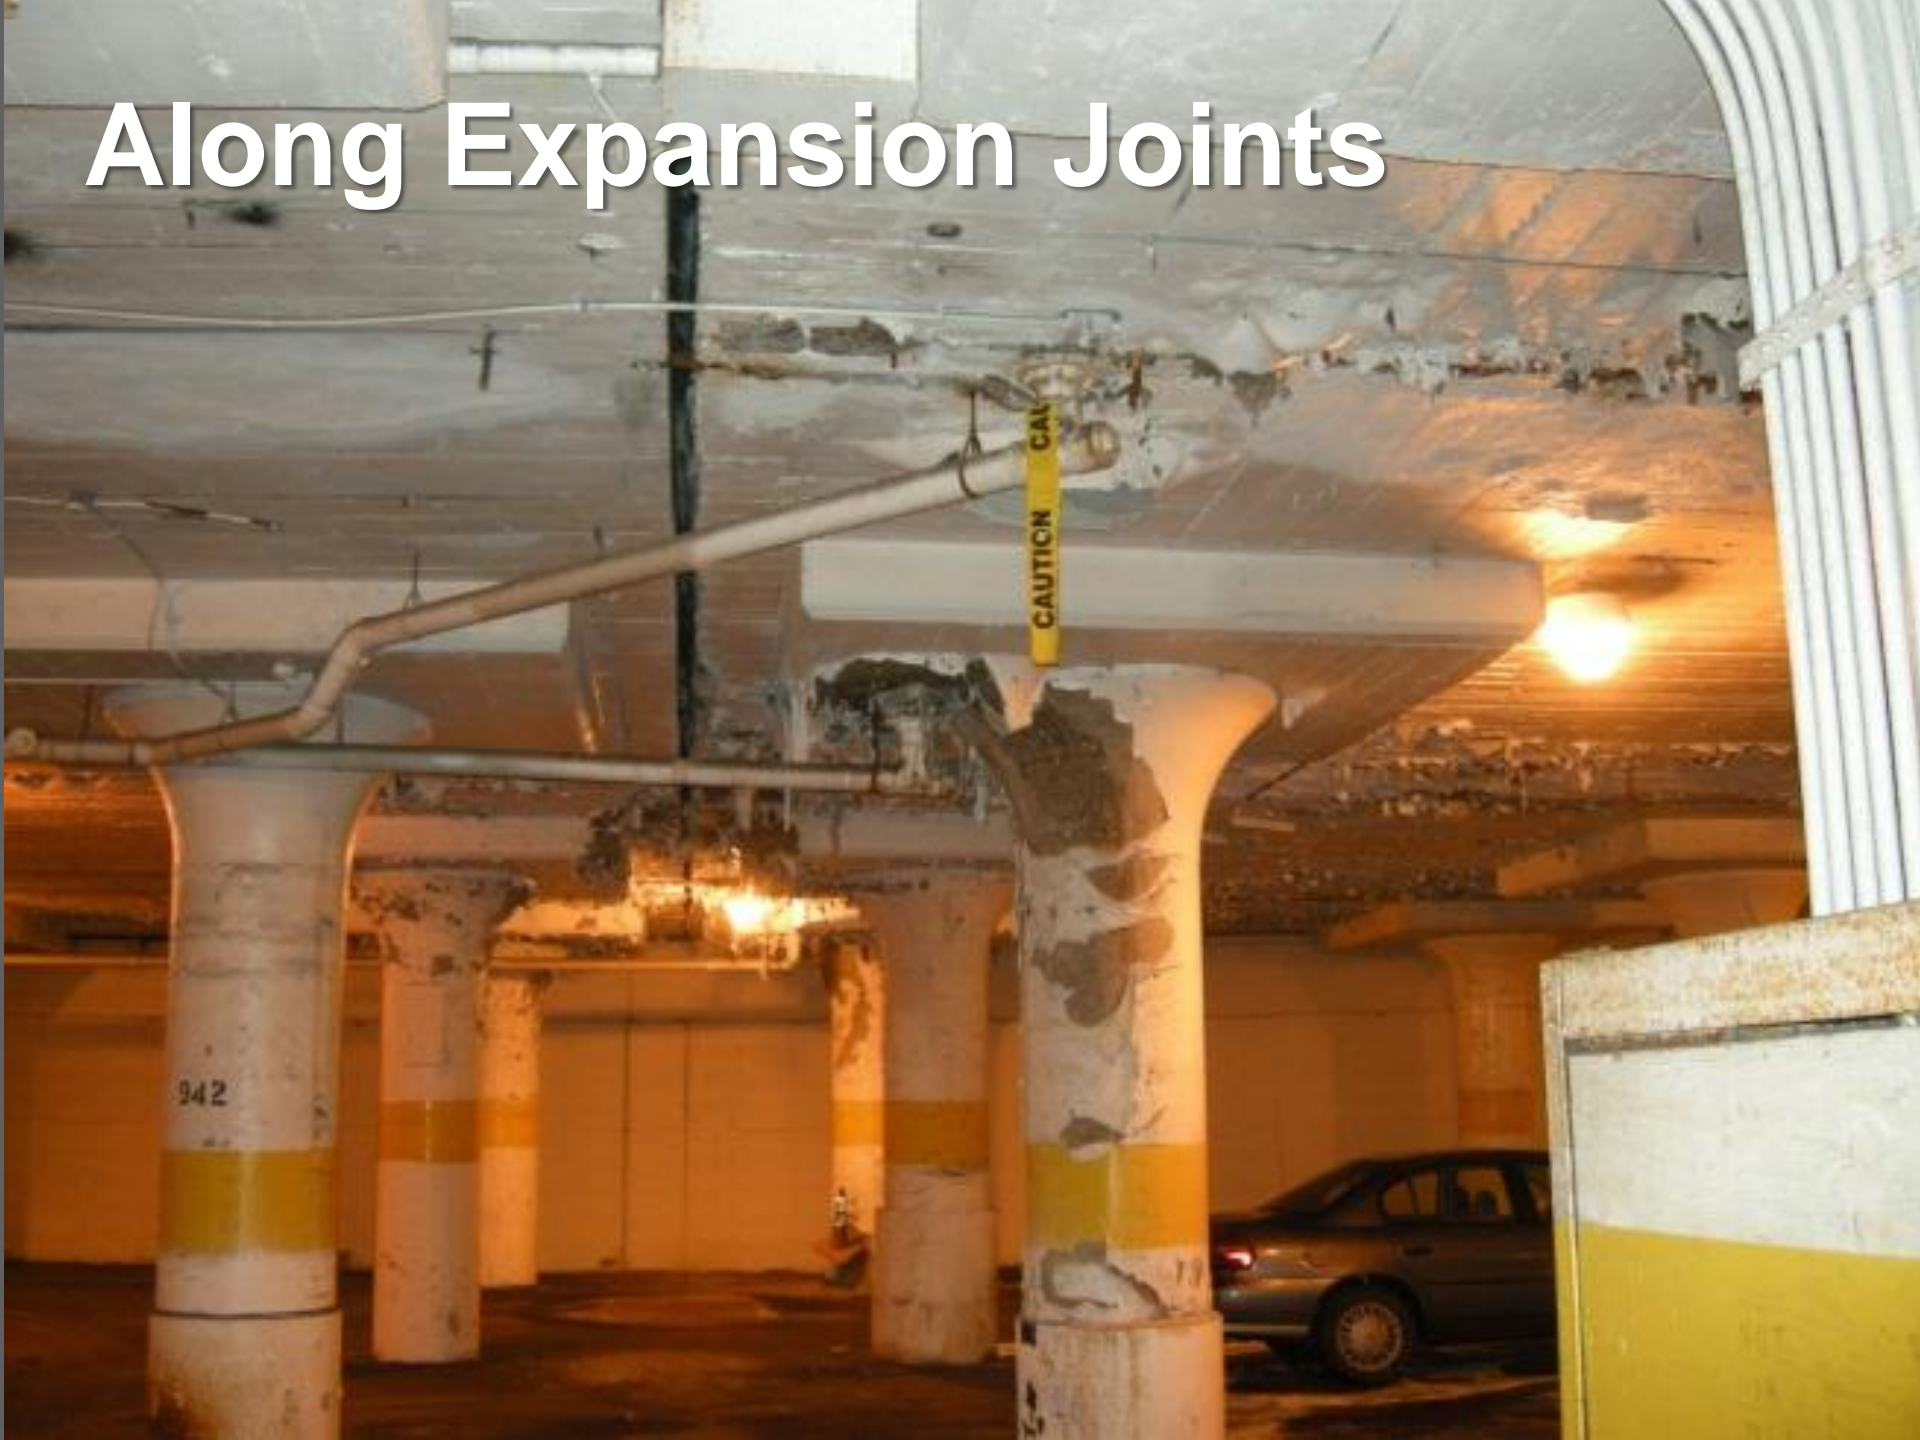
# Along Expansion Joints

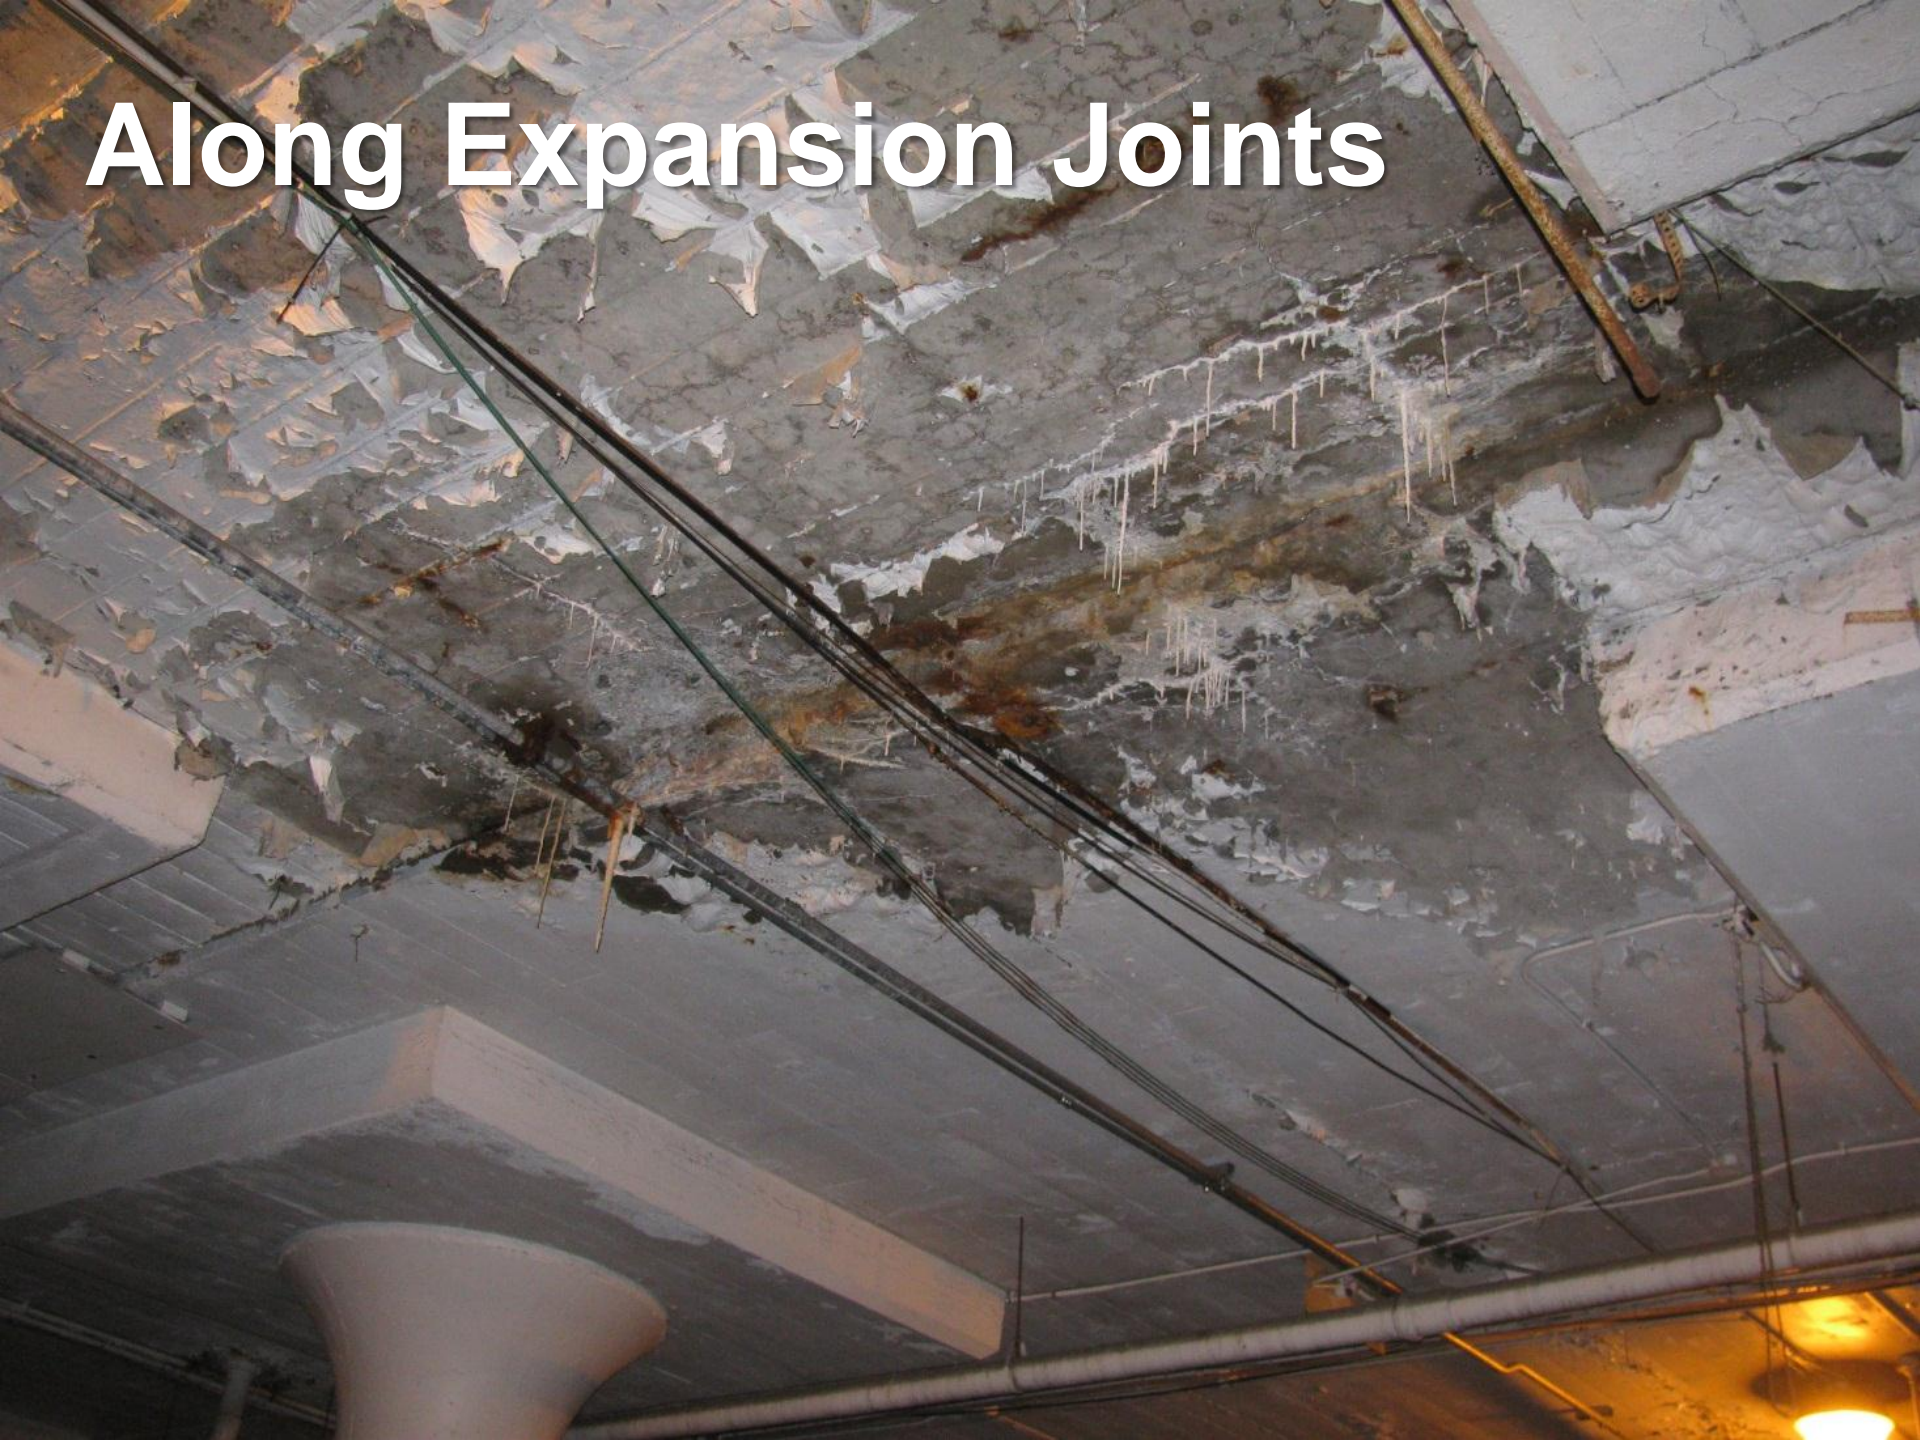
# Along Expansion Joints

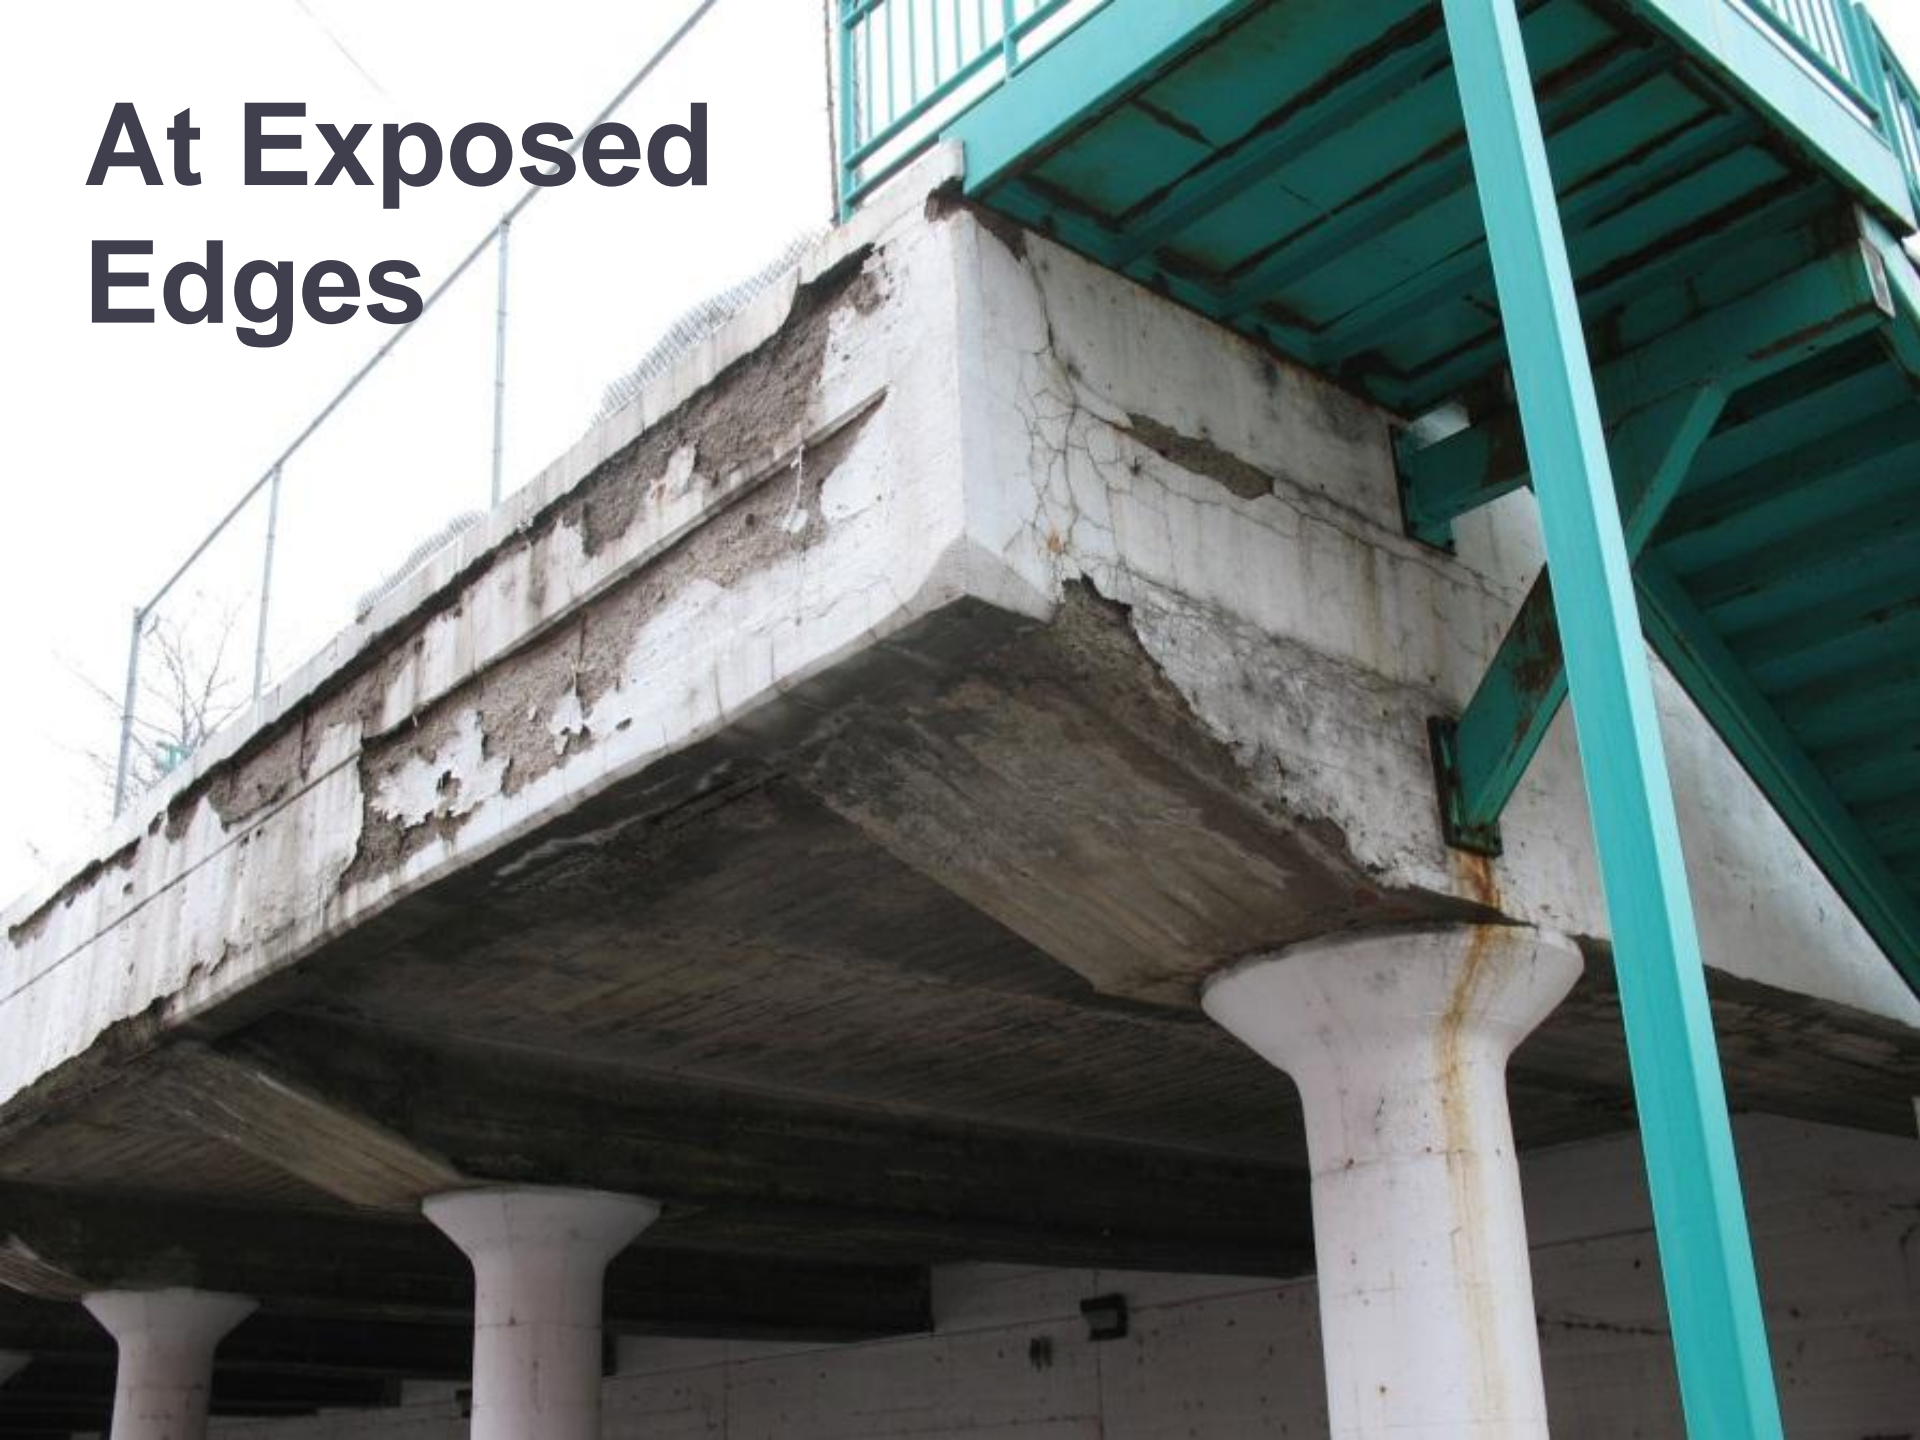
# At Exposed Edges

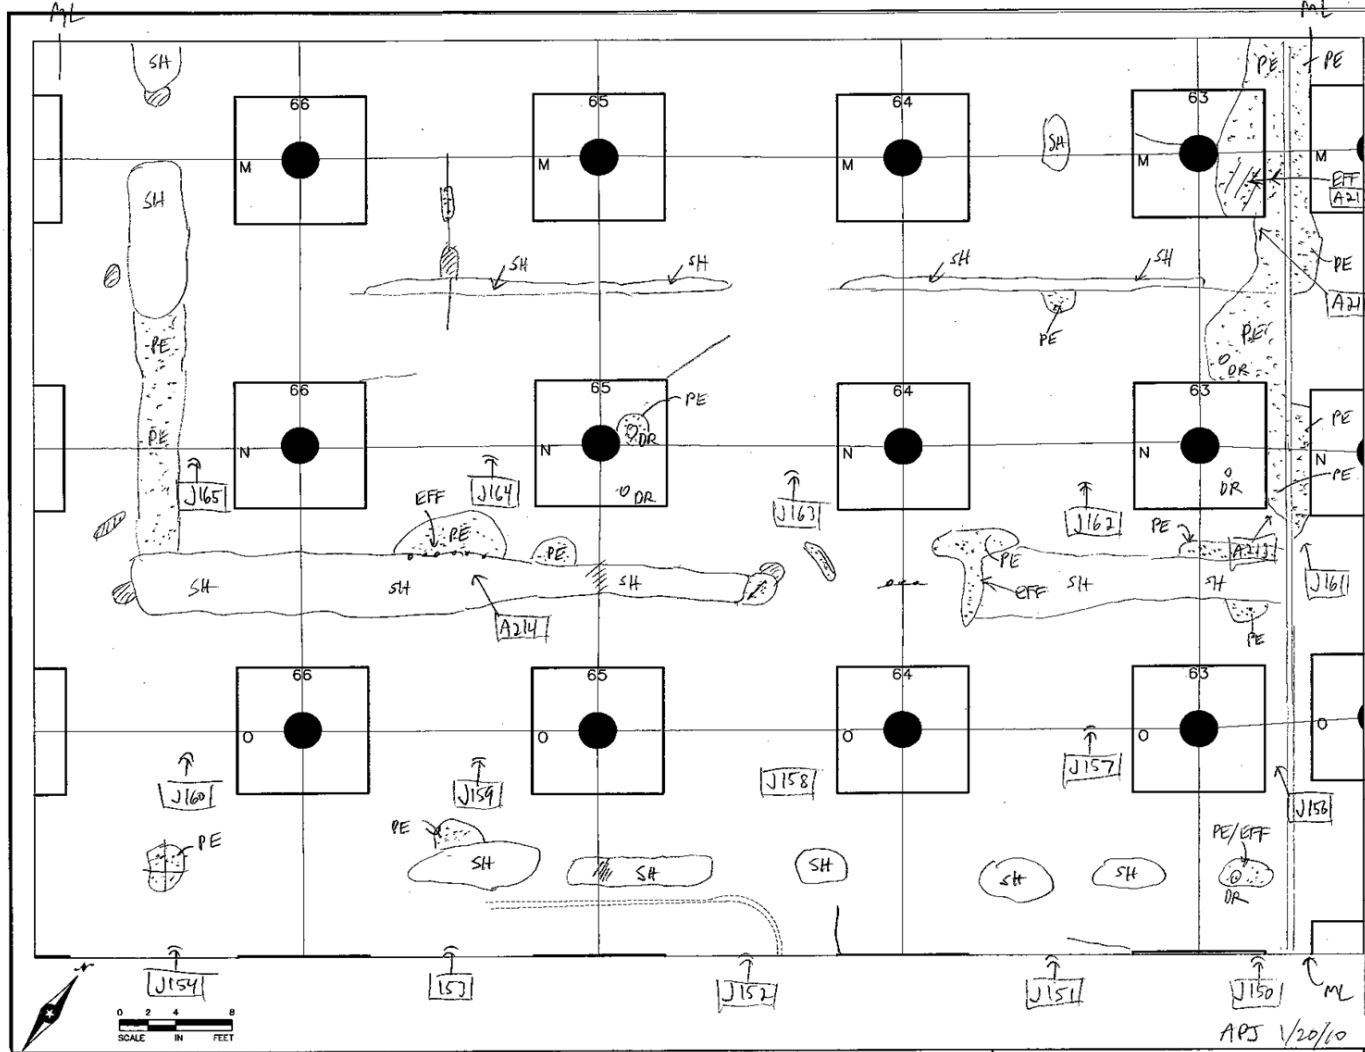
SHEET NO.  
 GL-47

COLUMN ID:	CONDITION NOTES:
M66	SJ
M65	SJ
M64	SJ
M63	SJ
N66	SJ
N65	SJ, PE - 1 SF @ DR
N64	SJ
N63	SJ
O66	SJ
O65	SJ, D - 2 SF
O64	SJ
O63	SJ

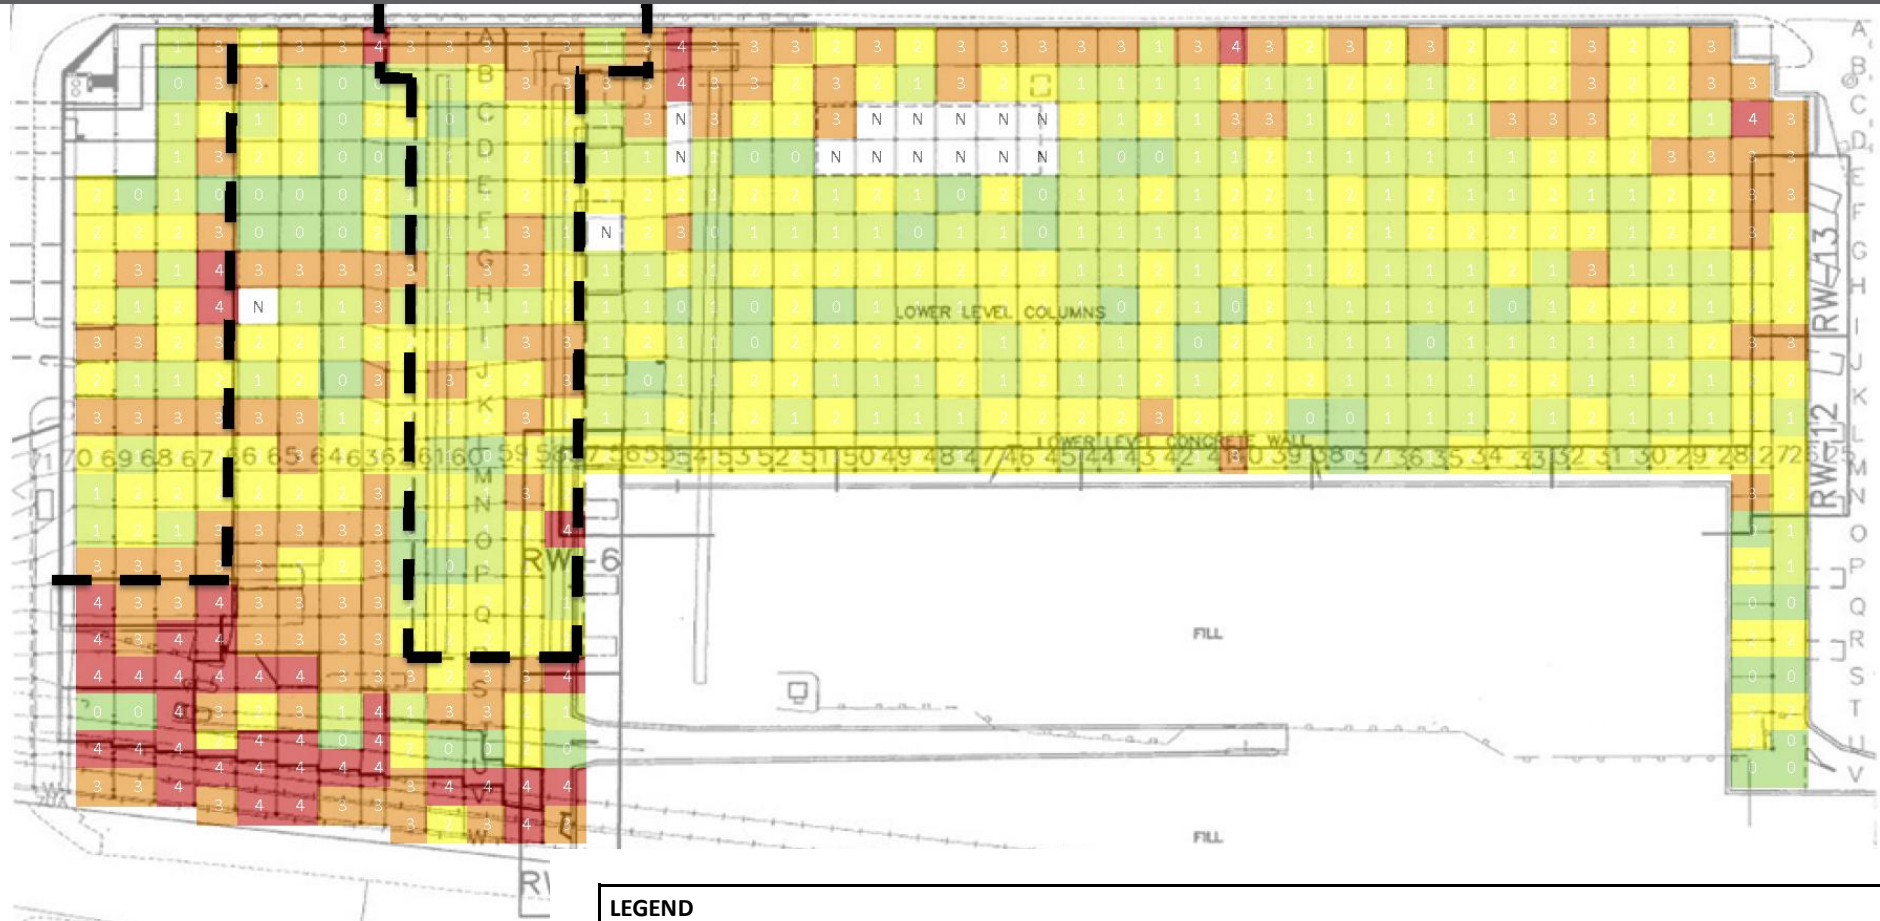
# Visual Rating-Deck Underside

- Documented concrete condition in every bay
  - Types of deterioration, degrees of each, visual quantities of each
  - 100% visual mapping of deterioration
- Visual condition rating for all bays (0 to 4, with 4 being worst)

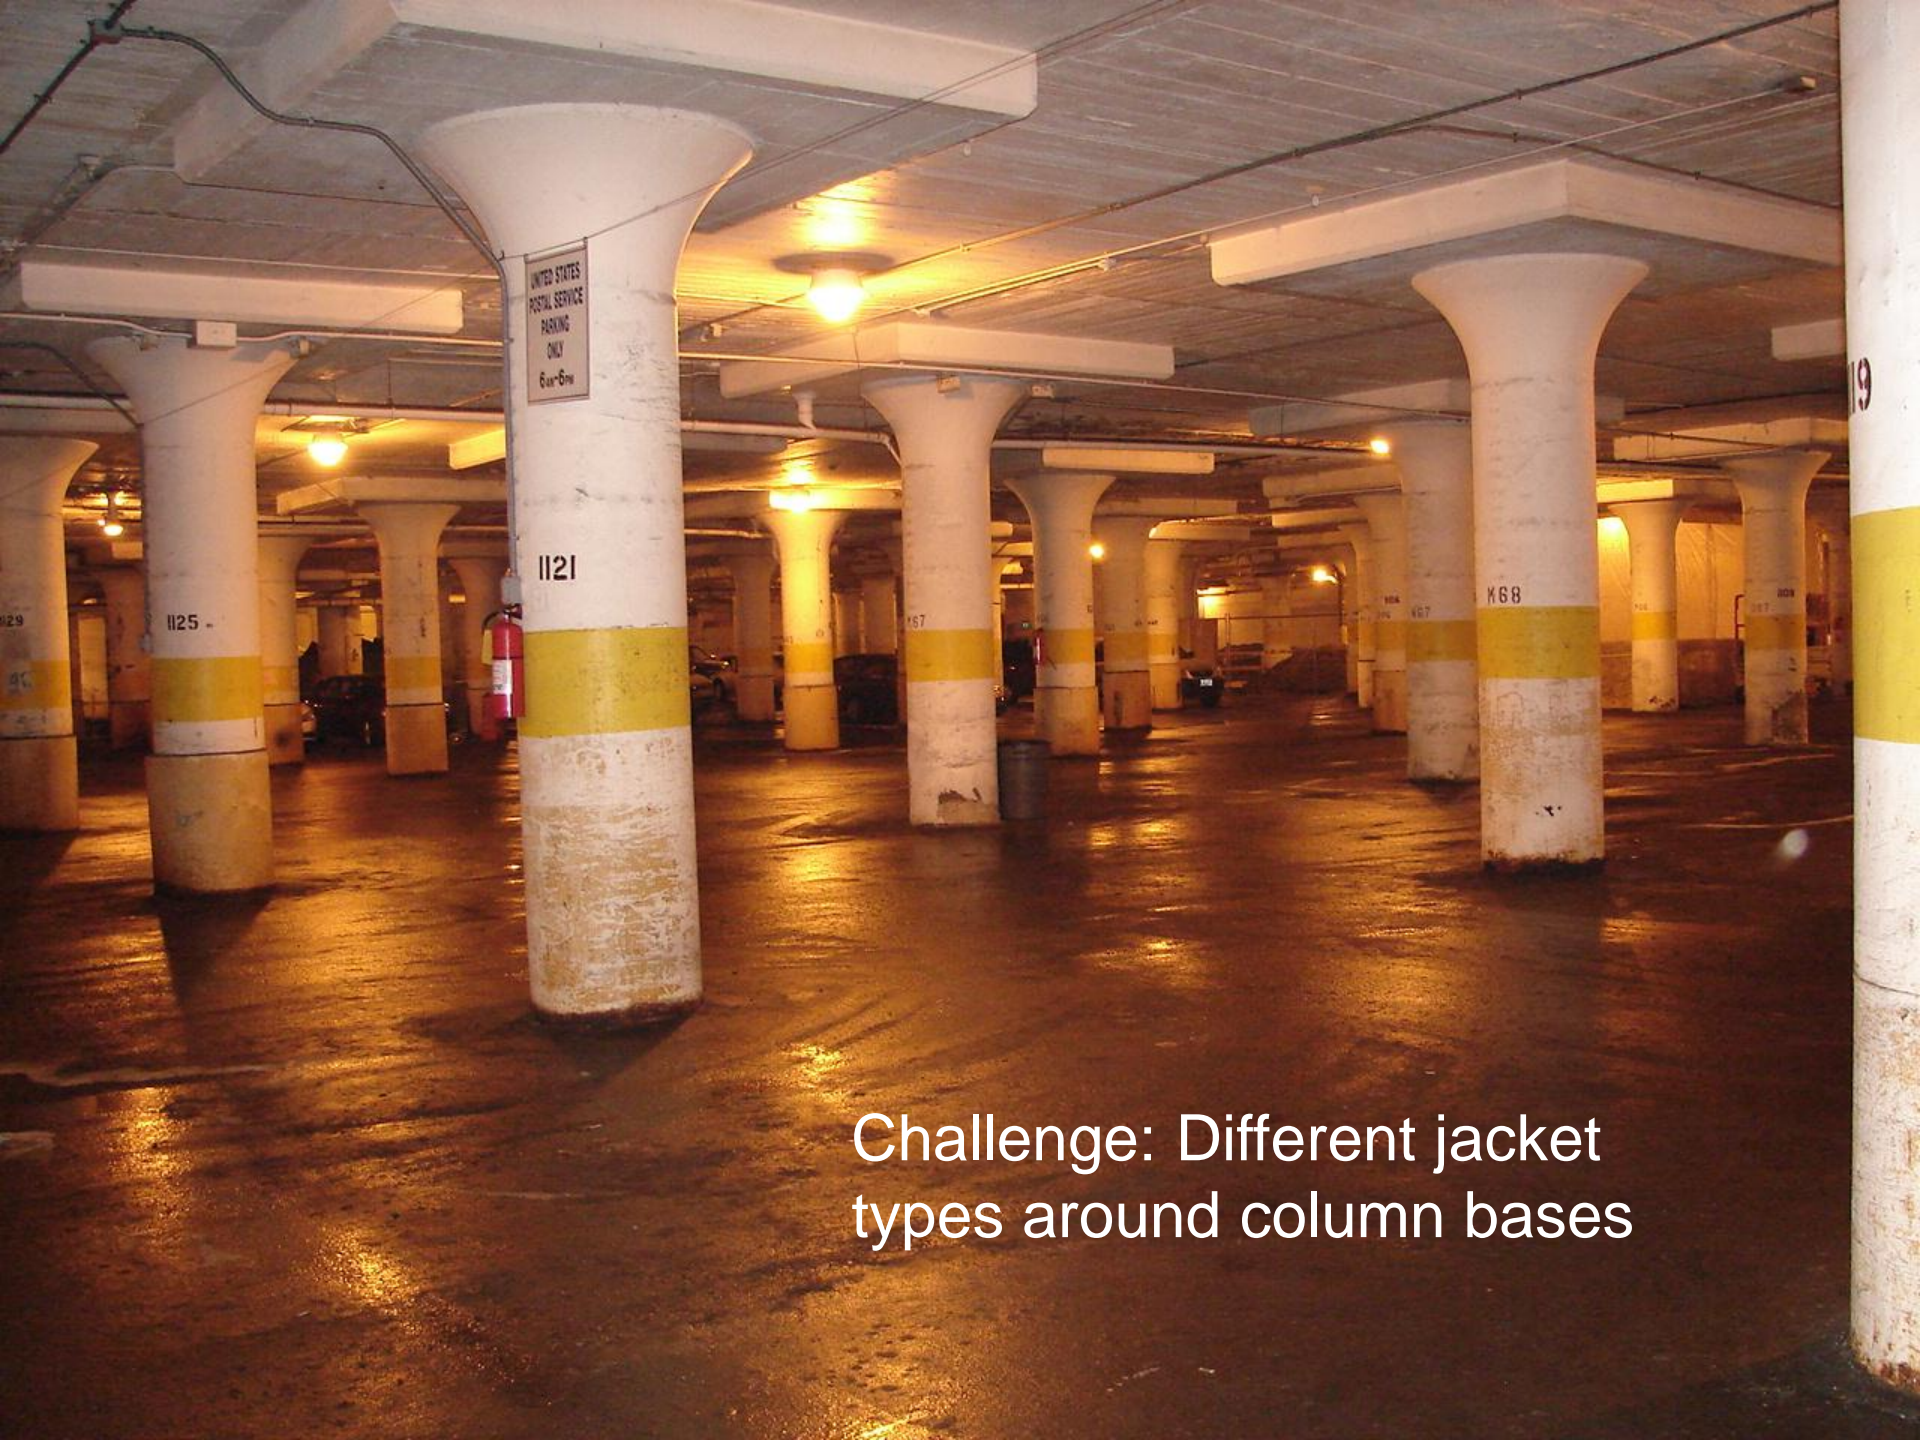
Challenge: Different jacket types around column bases
