Marble Bluff Dam Spillway Concrete Repairs

Westin Joy, P.E.

U.S. Department of the Interior
Bureau of Reclamation

Marble Bluff Dam

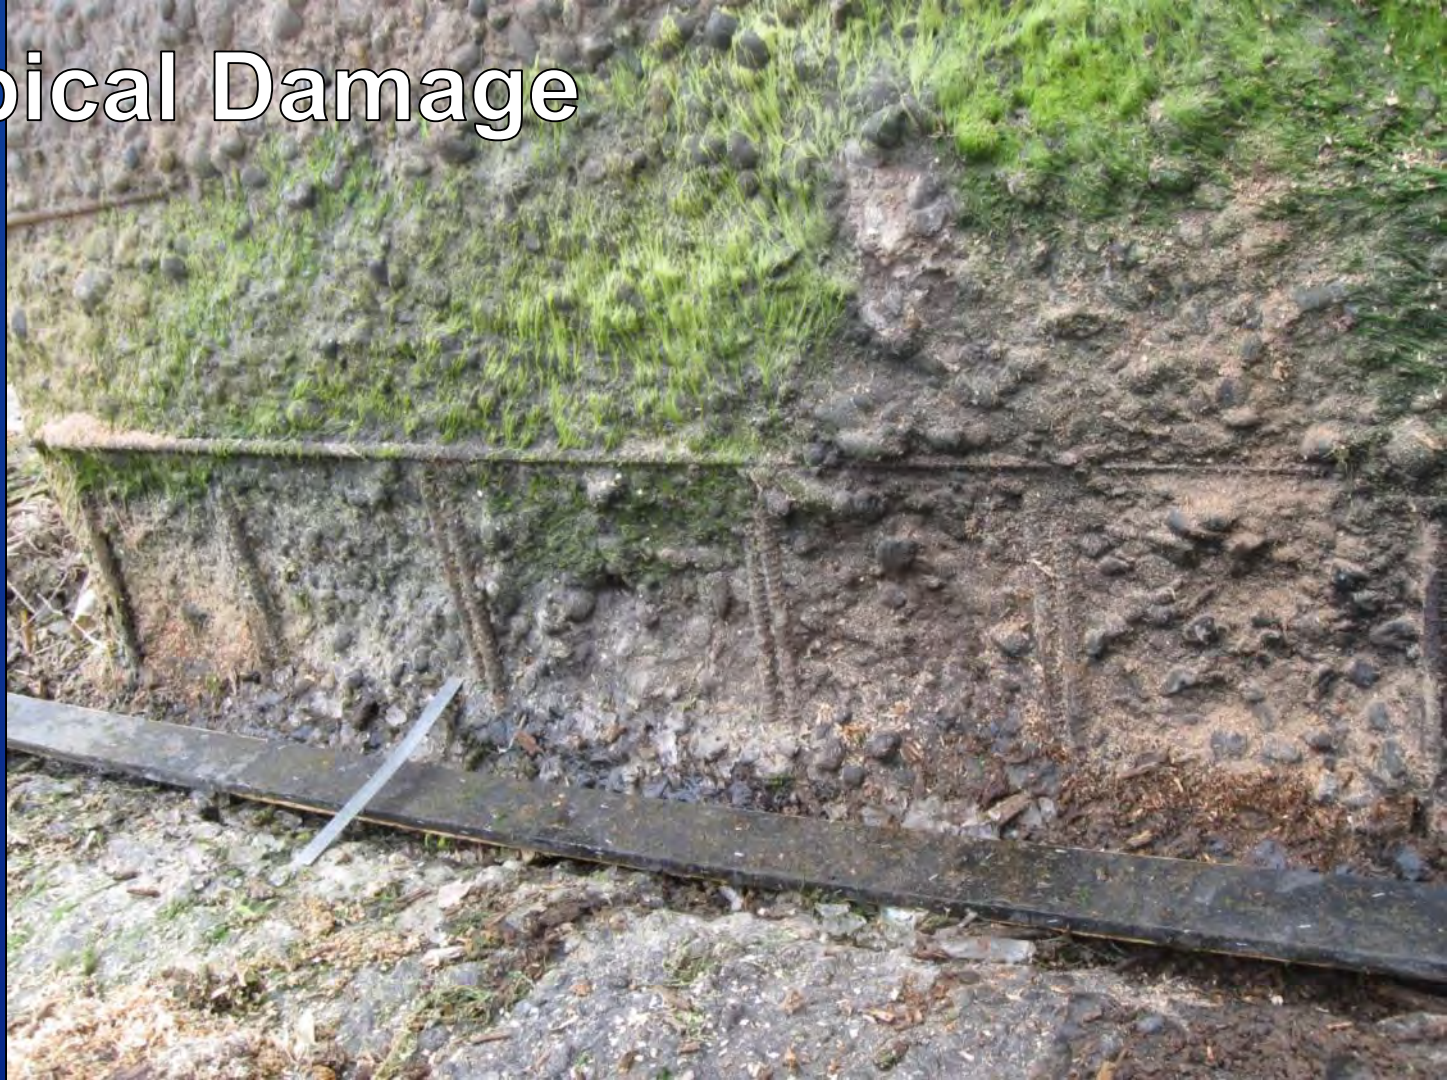
Typical Damage

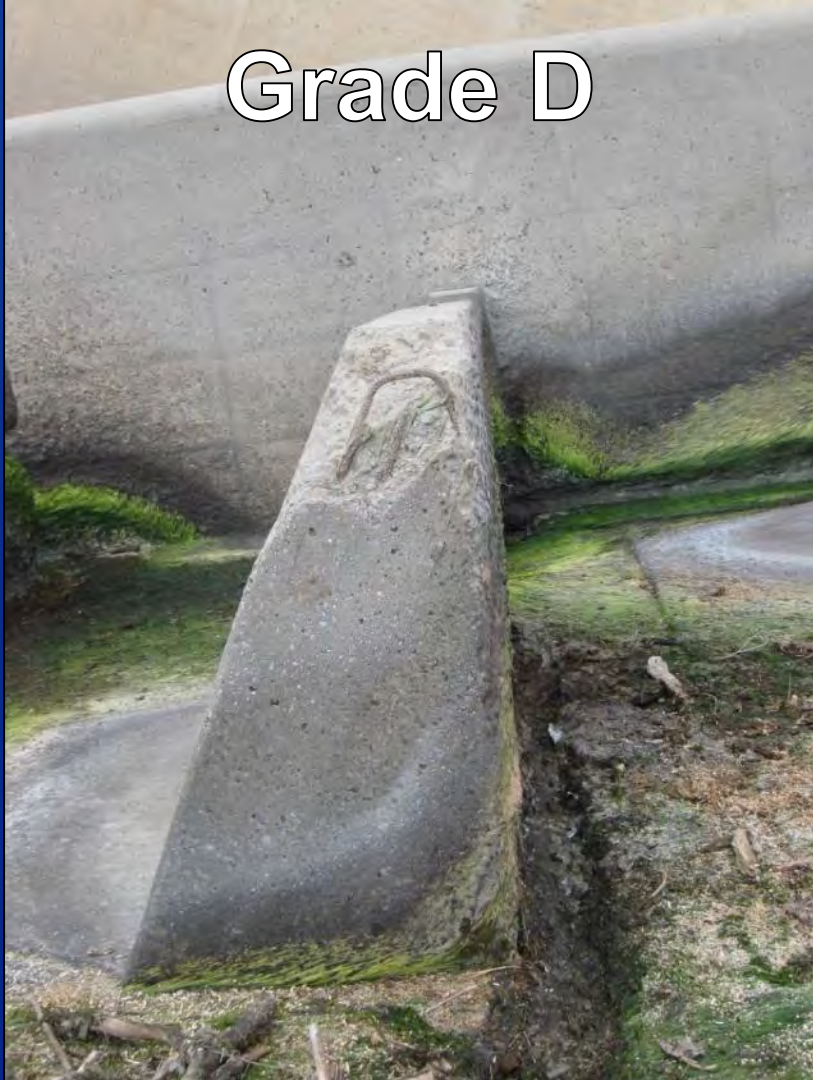
Grade D

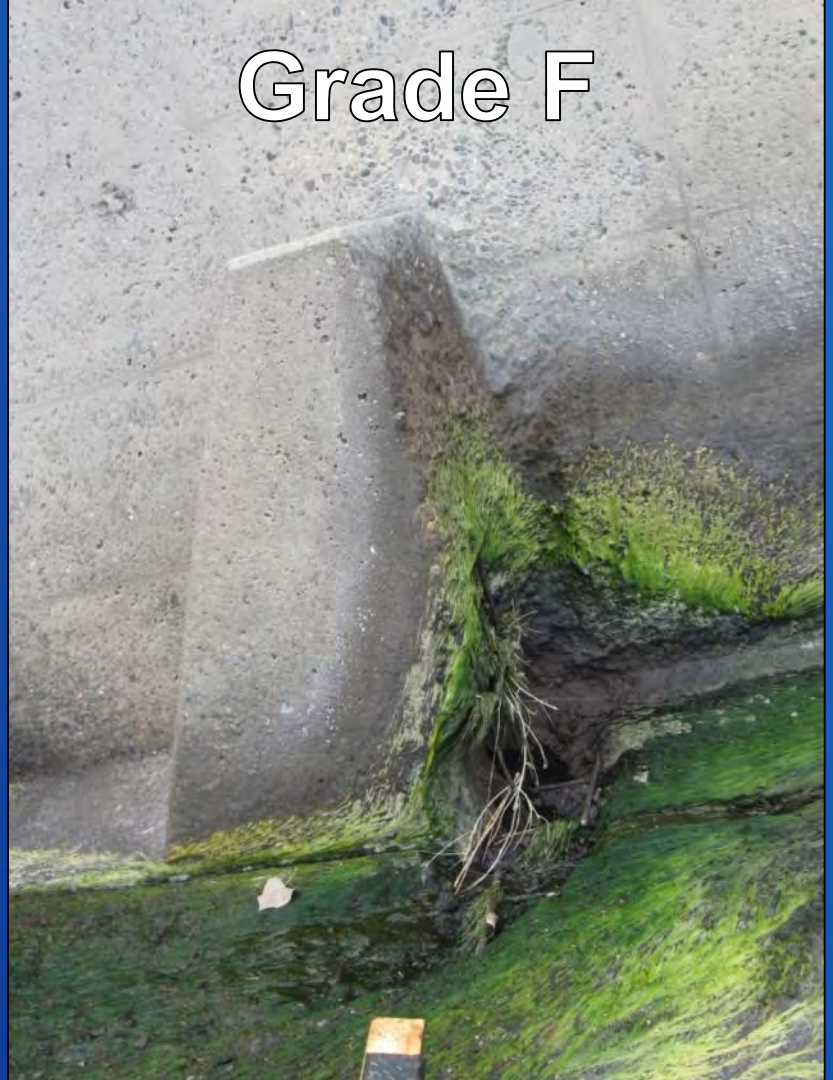
Grade F

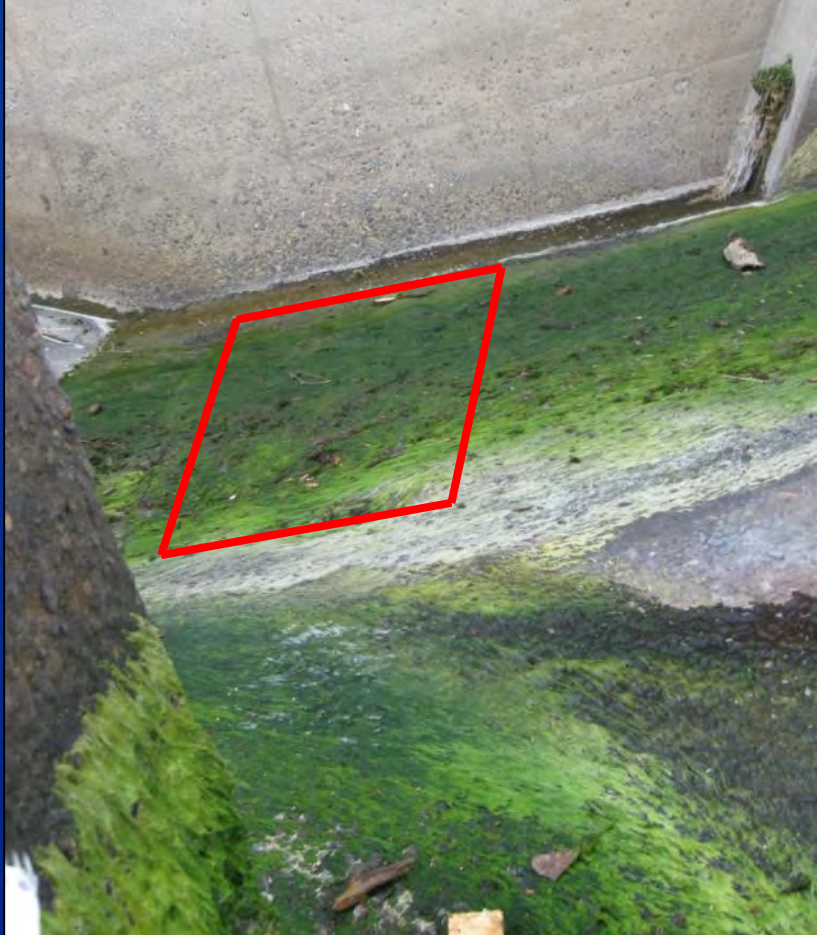
Grade X - Missing

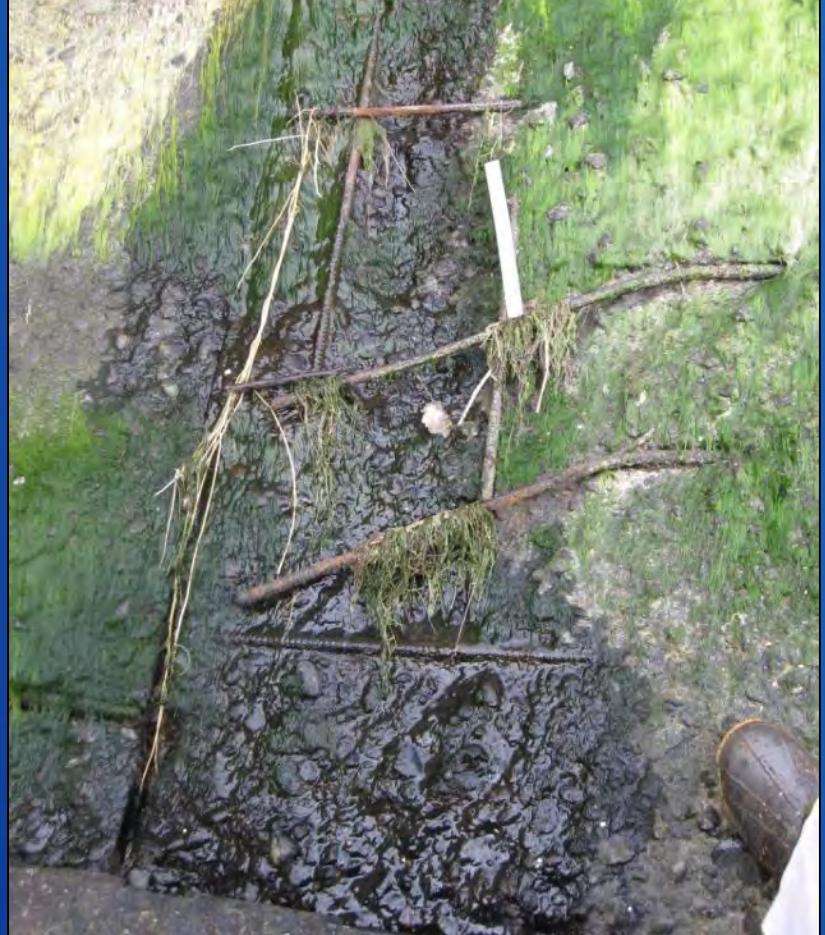
Grade F - Apron

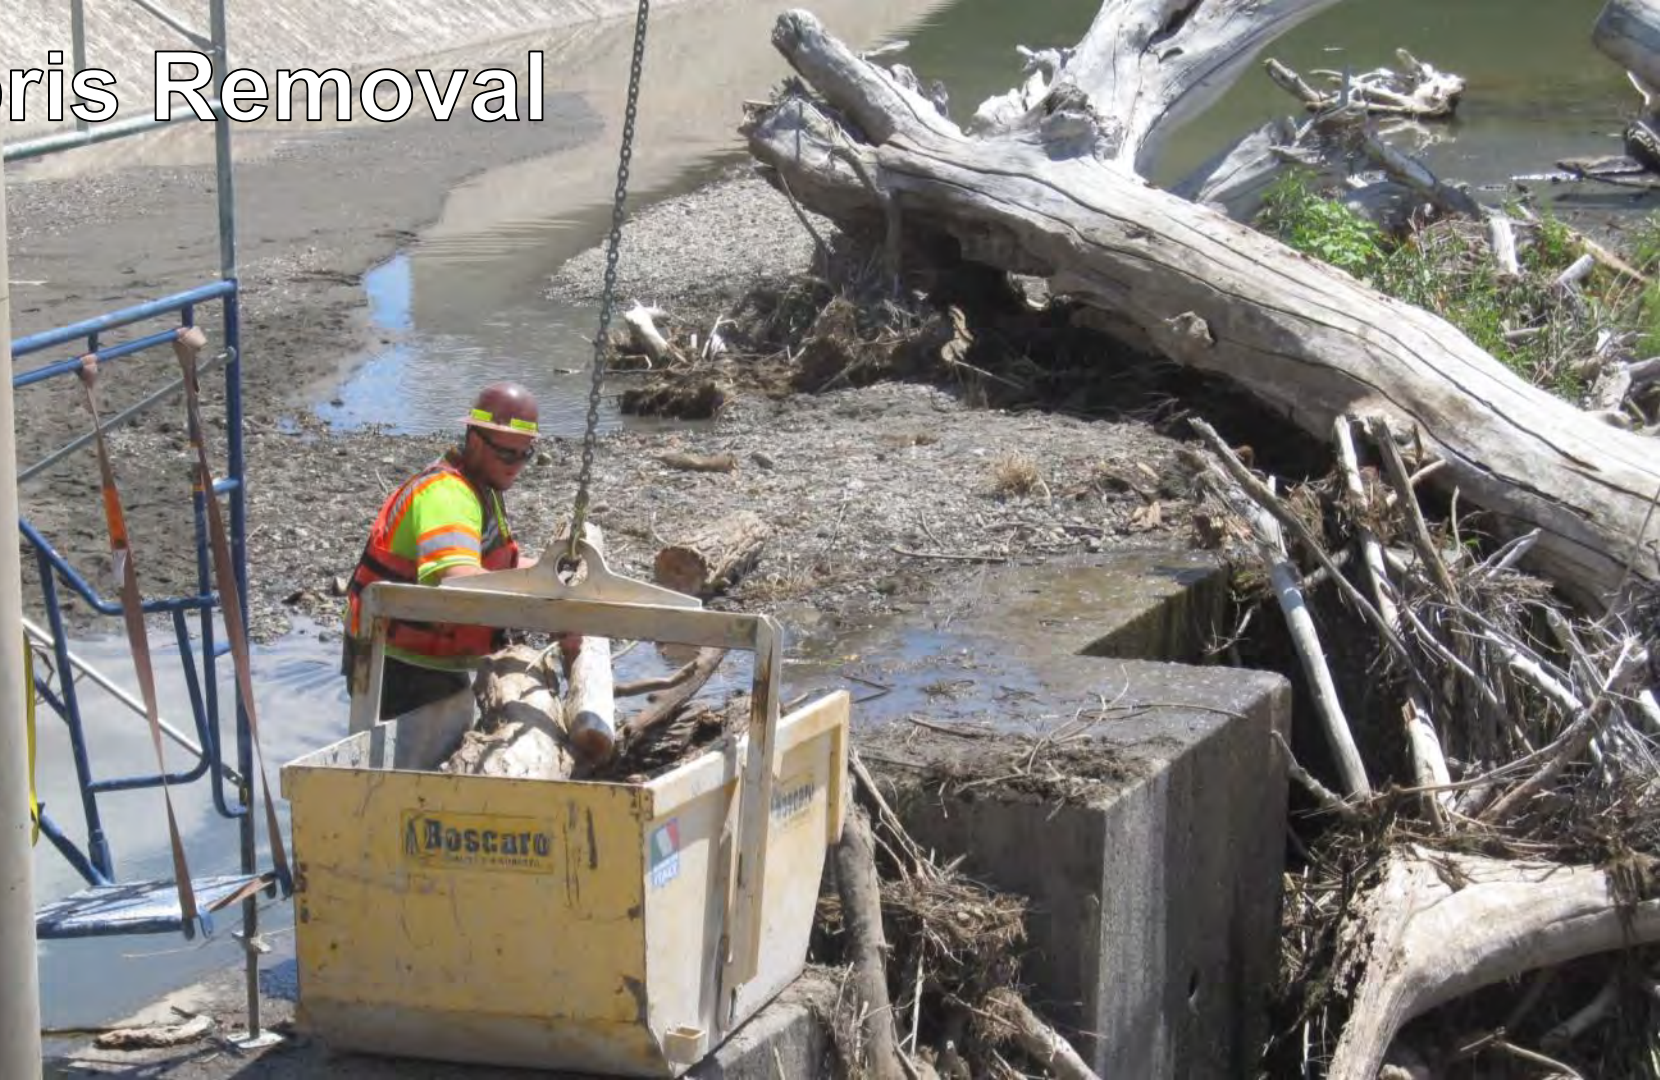
Debris Removal
