CONDITION ASSESSMENT OF FRP STRENGTHENING OF CONCRETE BRIDGE COMPONENTS

NUR YAZDANI, Ph.D., P.E.

Texas Department of Transportation

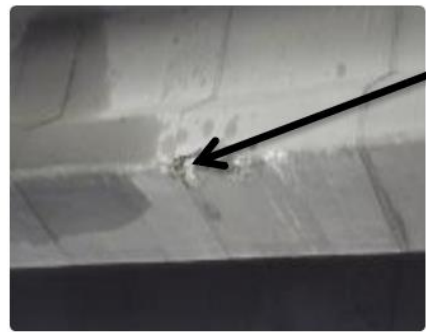
(a) Bridge 1

Damaged FRP

Exposed strand

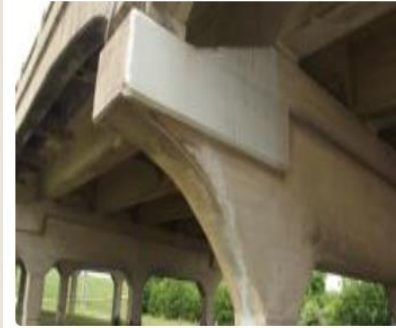
(e) Bridge 5

Exposed strand

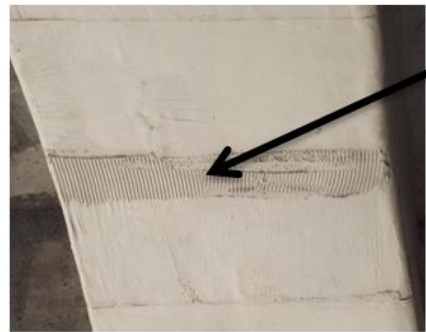
(c) Bridge 3

Improper application of FRP

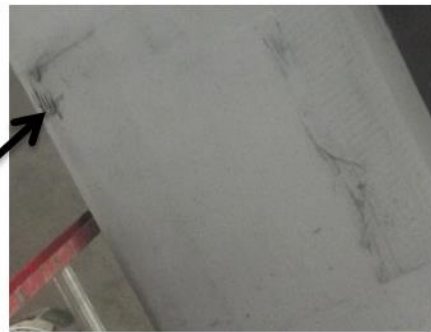
(d) Bridge 4

Cracked FRP surface

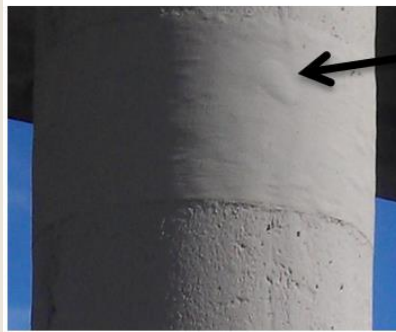
(g) Bridge 7

Air pockets

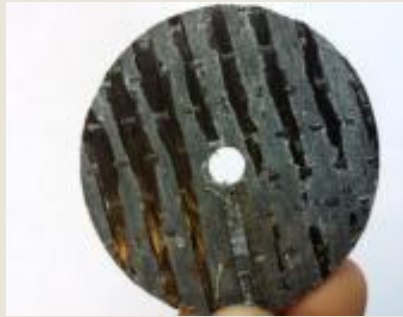
Core Failure
Sample 4, B-1

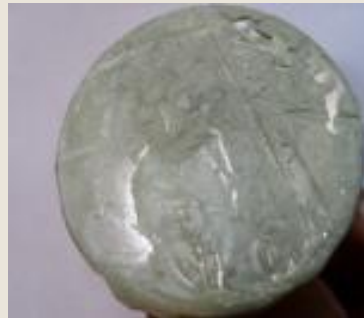
Mode-A
Sample 2, B-1

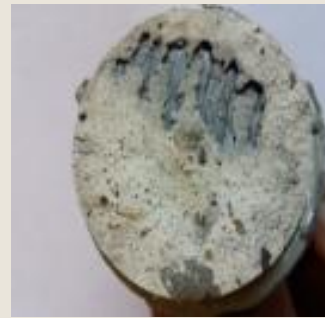
Modes G & C
Sample 3, B-1

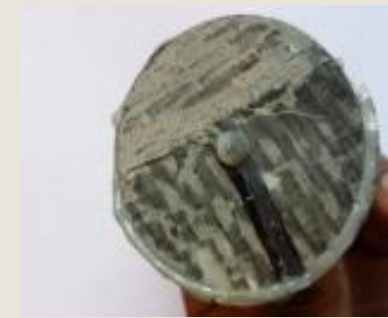
Mixed Mode M
Sample 5, B-1

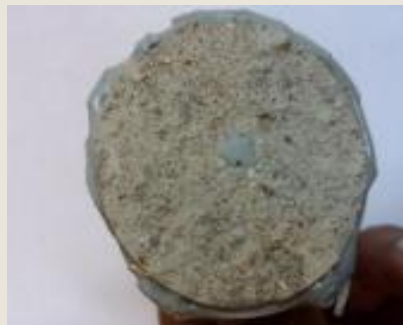
Mode-G
Sample 1, B-2

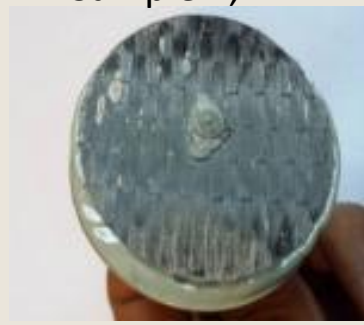
Mode-C
Sample 5, B-3

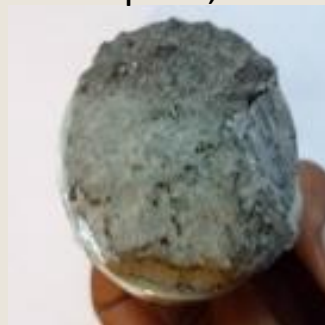
Mode-F
Sample 6, B-3

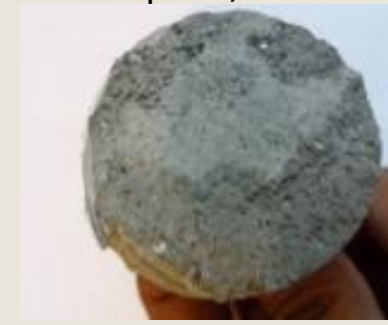
Mode-G
Sample 9, B-3
