Restorative Waterproofing for Below Grade Parking Structures

Walt Hanford – Euclid Chemical Company
William Nimis – Karins Engineering Group, Florida

Case Study, La Rive Condominium, Underground Parking Garage

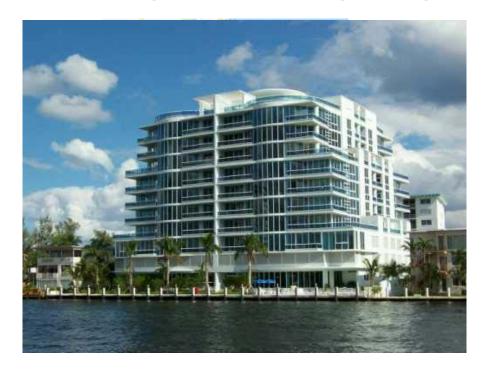
Water problems included

- Ground water infiltration
- Heavy Seasonal rains and a high ground water table
- Hydrostatic pressure
- Vapor drive through floors
- Non-structural cracks in walls
- Poor drainage & standing water

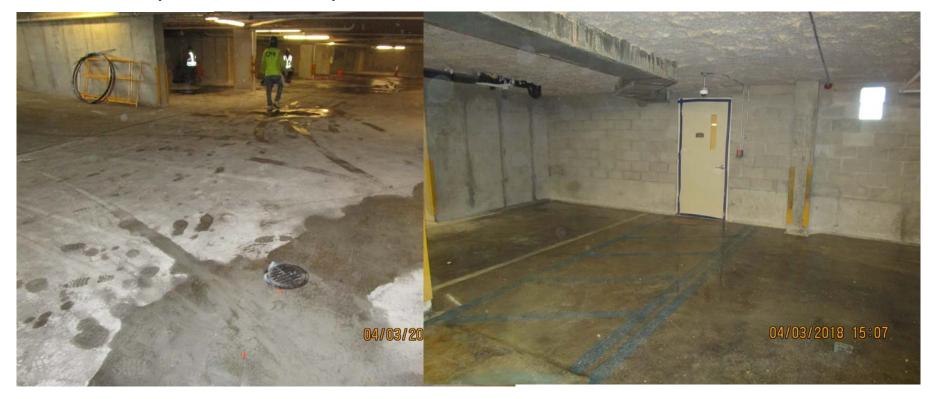
Always wet, some days were worse than others.

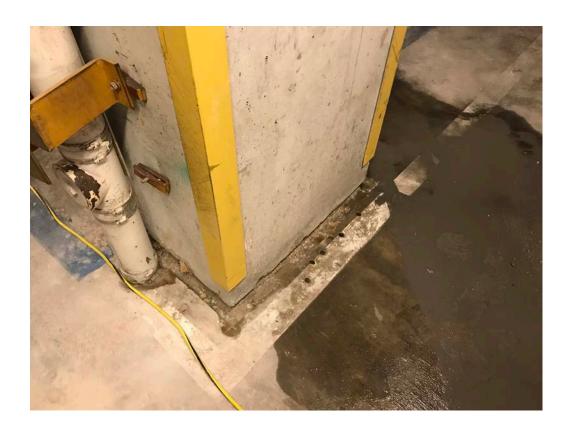
Water coming up and around the edges of the 16 inch thick structural floor presented a unique waterproofing challenge

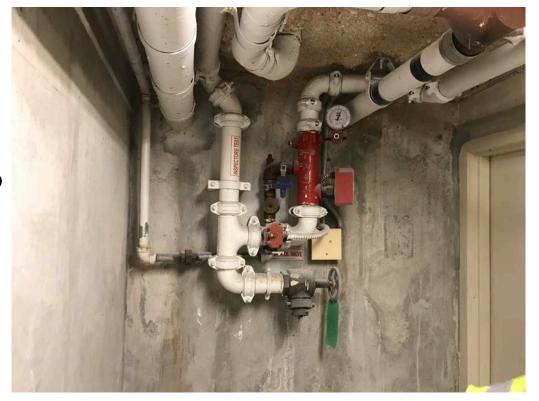
Pipe penetrations

When the water table was high they allowed water to weep into the structure.

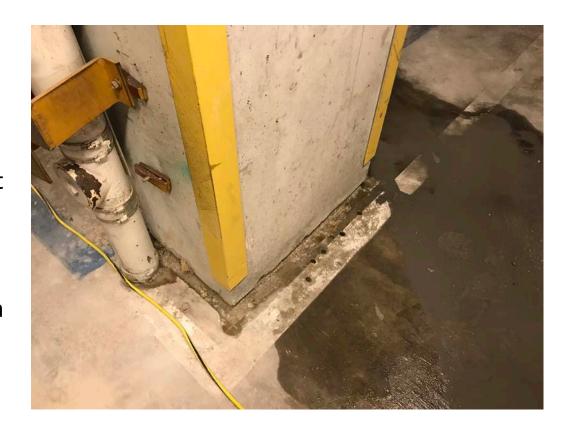
At the Floor Wall Interface **Belt & Suspenders solution**

- 1. Urethane injection grouting
- 2. A new channel of mortar that reacts to water and grows crystals to close off pores
- 3. A coating of crystalline waterproofing finished with a protective wear resistant decorative coating

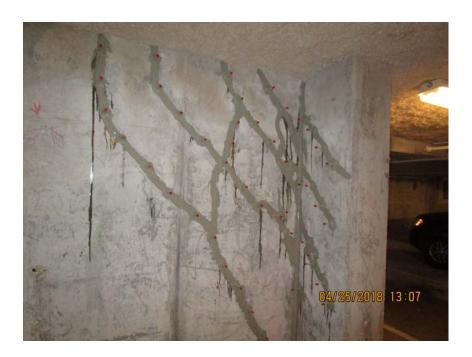
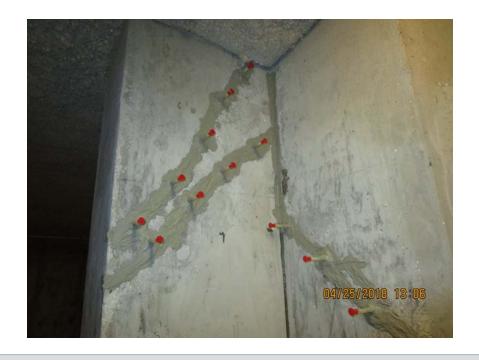
The below grade garage had two distinctly different types of cracks

1. Cracks in structural elements, repaired by epoxy injection.

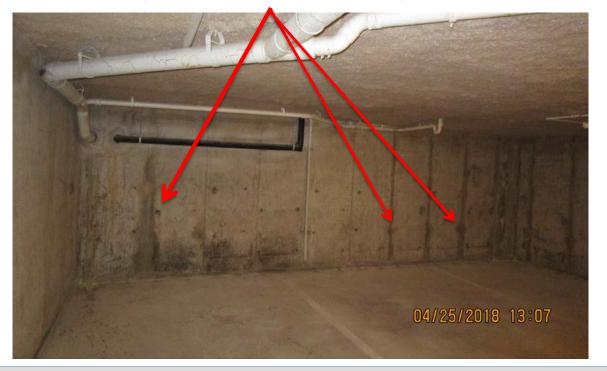
The below grade garage had two distinctly different types of cracks 2. Leaking water wall cracks along <u>form lines</u>

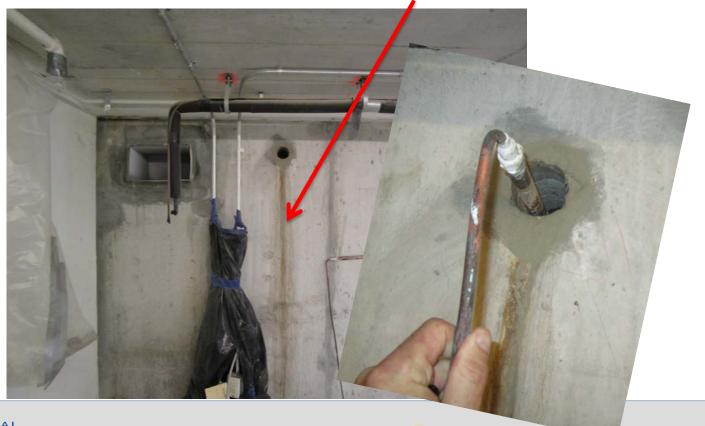
Pipe penetrations - a water infiltration problem

Sealed in a two-step process.

Step one: pack any voids between the pipe and wall with hydraulic cement.

Step two: inject behind the plug with expansive foam polyurethane grout

A belt and suspenders repair.

If the space between the penetrating pipe and the hole is too tight for installing the cement plug, then just inject the Urethane grout

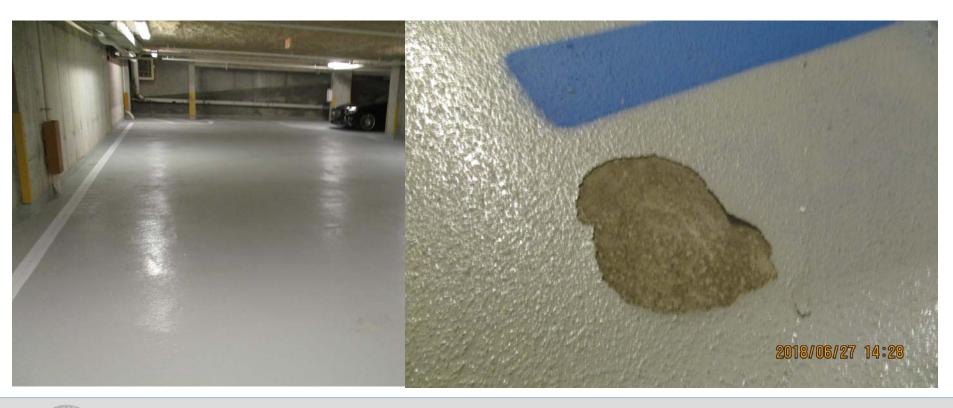
From Project Joy – to despair in four short weeks.

Vapor drive was blowing the coating off

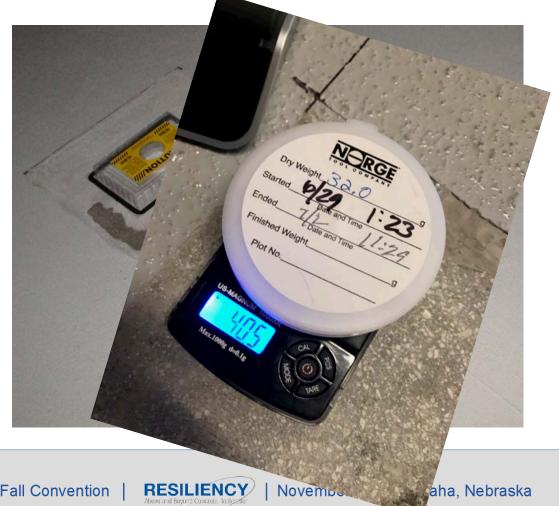
A small area of coating system was opened up.

Moisture vapor transmission Testing completed.

The numbers were very high. MVT Rate of 10 to 20 lbs per 1000 sq. ft. That's huge.
