Sodium Hypochlorite Storage Area Rehabilitation

Kevin Krawiec, P.E.
Senior Structural Engineer
Corrosion Probe, Inc.
Scituate, Massachusetts

East Shore Water Pollution Abatement Facility

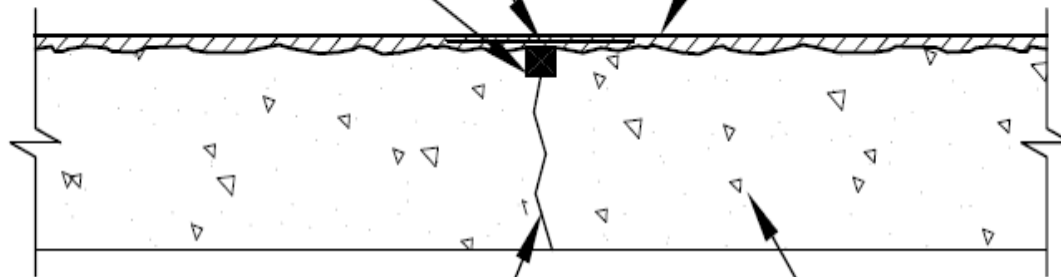
Crack Repair

CRACK

6" WIDE FIBERGLASS
REINFORCING FABRIC
CENTERED ON CRACK
IN PRIMER COAT

1/4" SQ. SAWCUT
RECESS W/ SEALANT

RESINOUS LINING

REPAIR MORTAR OVERLAY
