Evaluation, Restoration
and Protection of
Sandstone Façade on
a Historic Building –
The Boston Building
Denver, CO

Presenter: Leo Whiteley

ICRI 2016 Spring Convention / March 17, 2016
San Juan, Puerto Rico

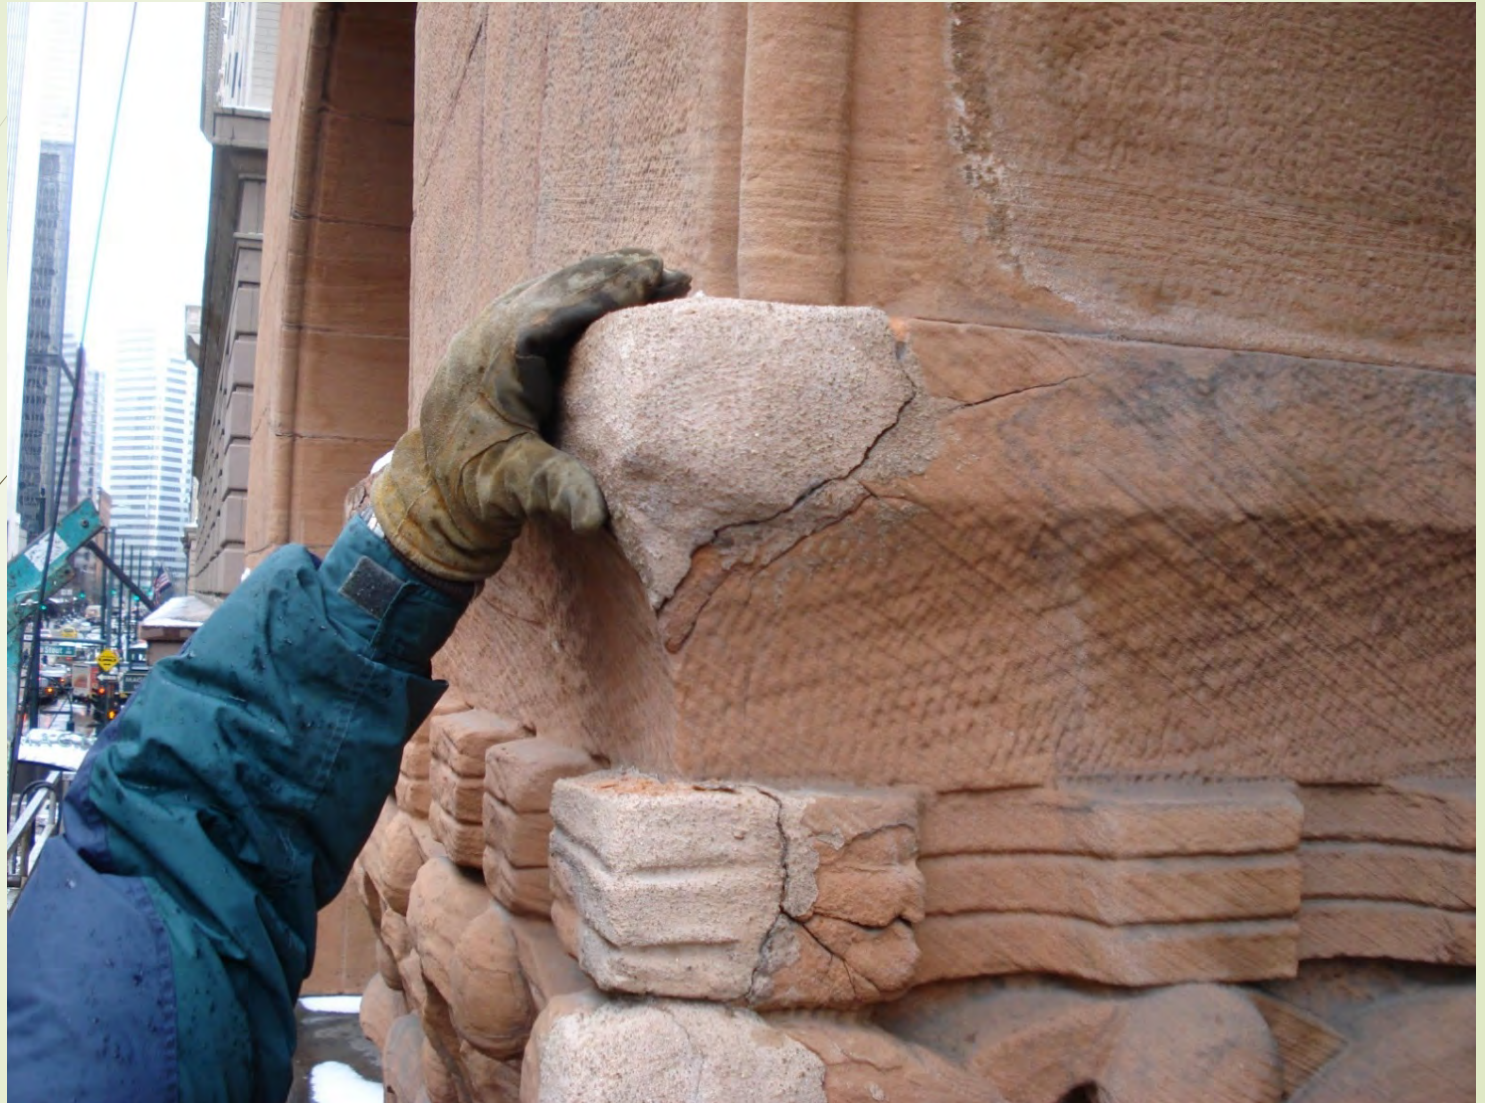
Failed Existing Patches

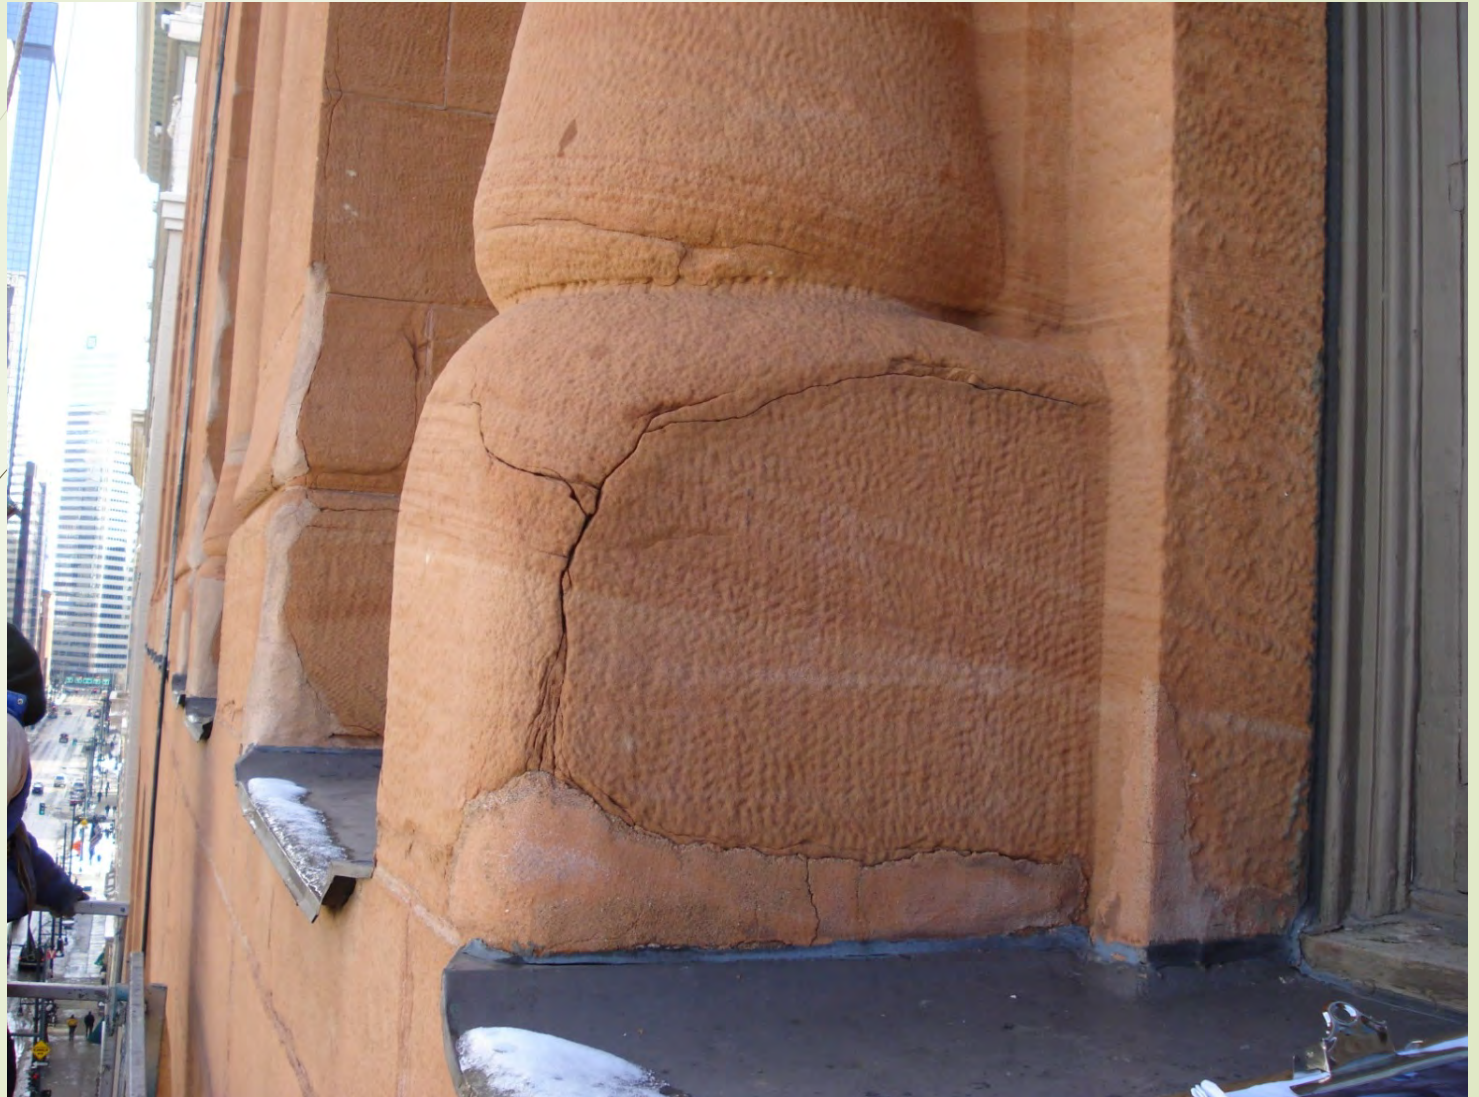
Mismatched Existing Patches

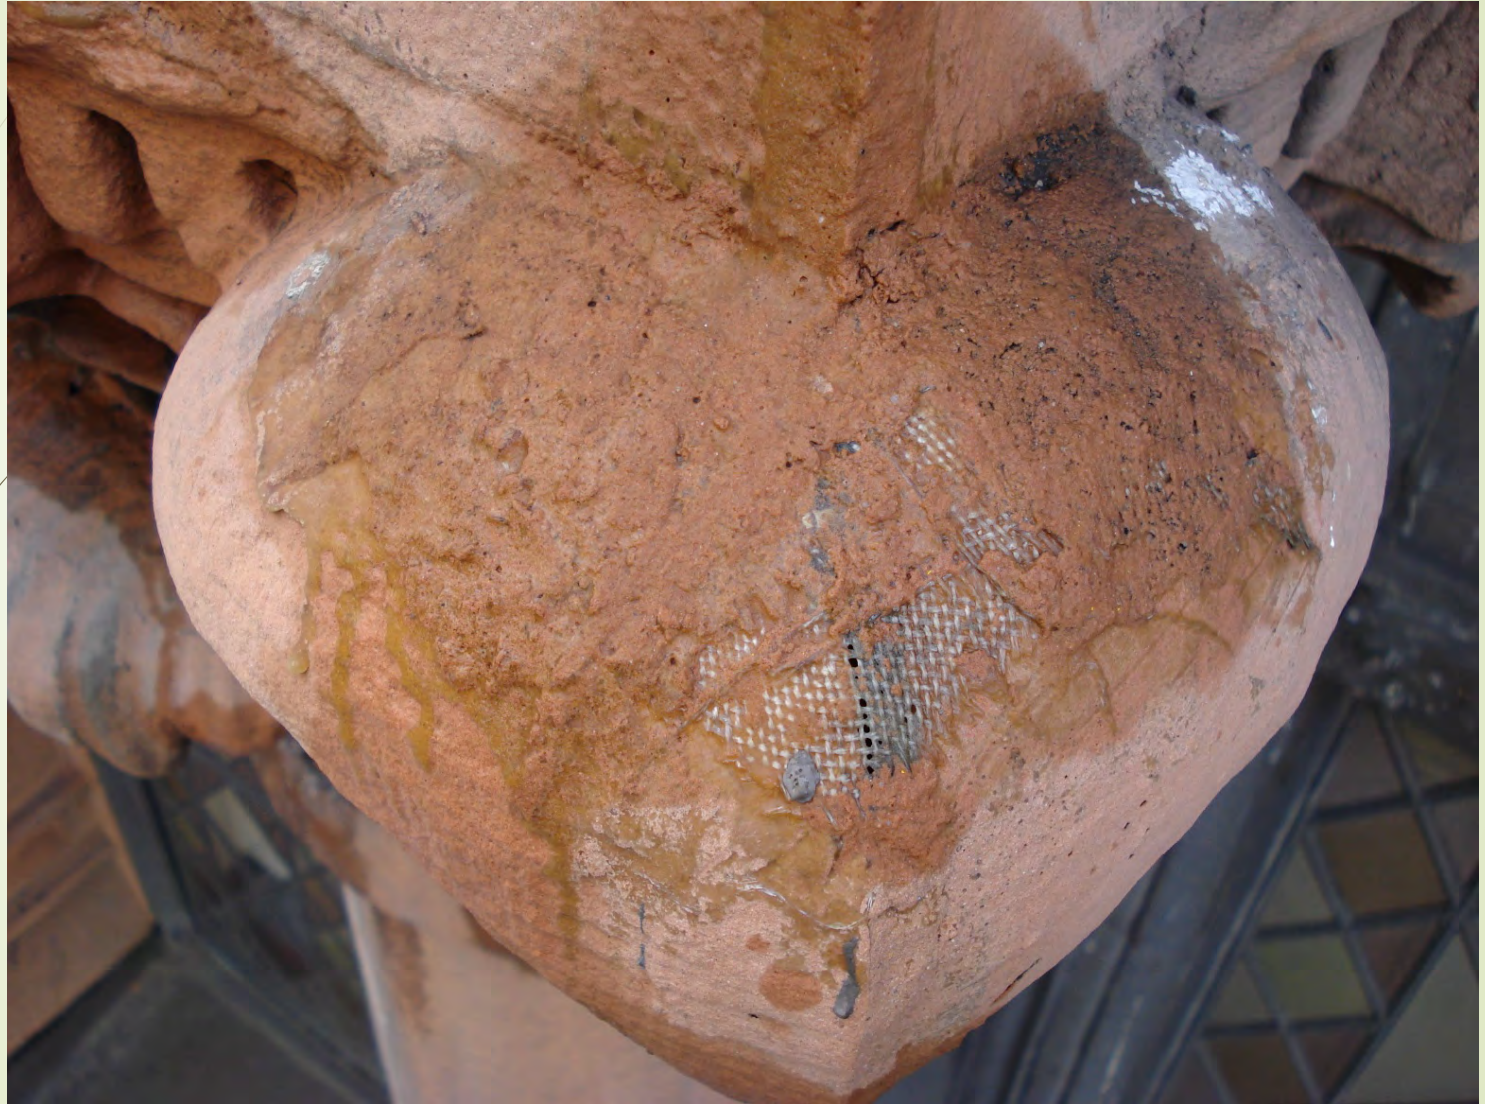
Deteriorated Existing Patches

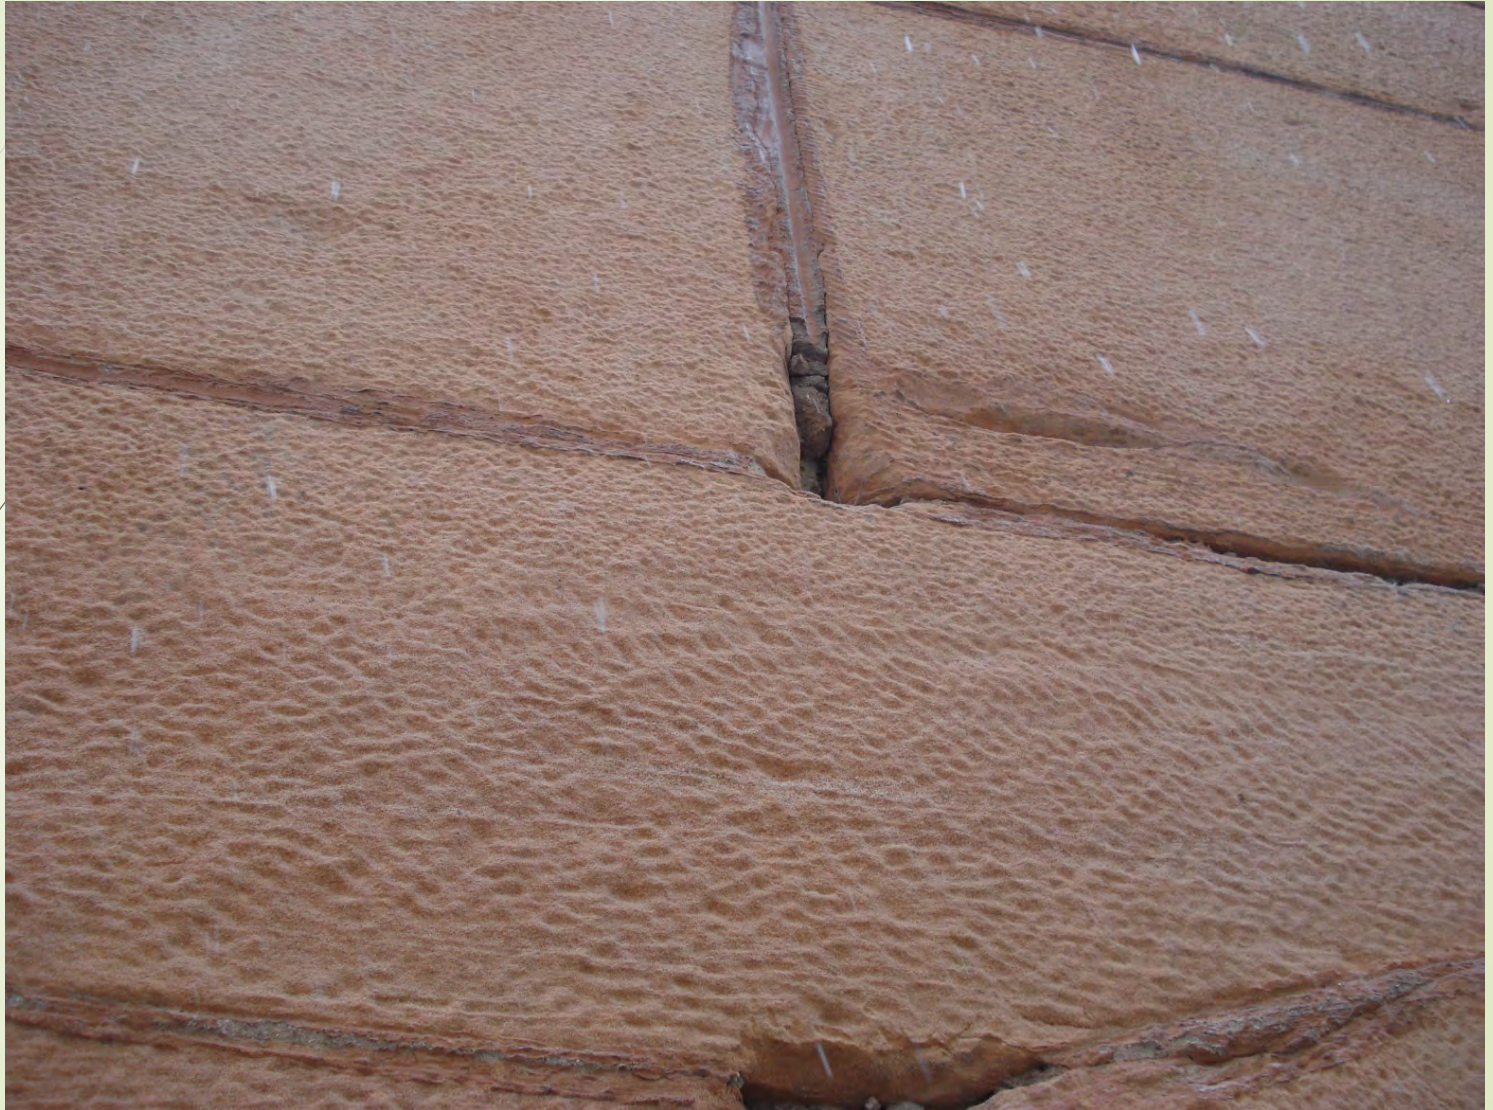
Failed Joints

- Mortar joints hand cut to minimize overcutting
- Install grout in "Lifts"

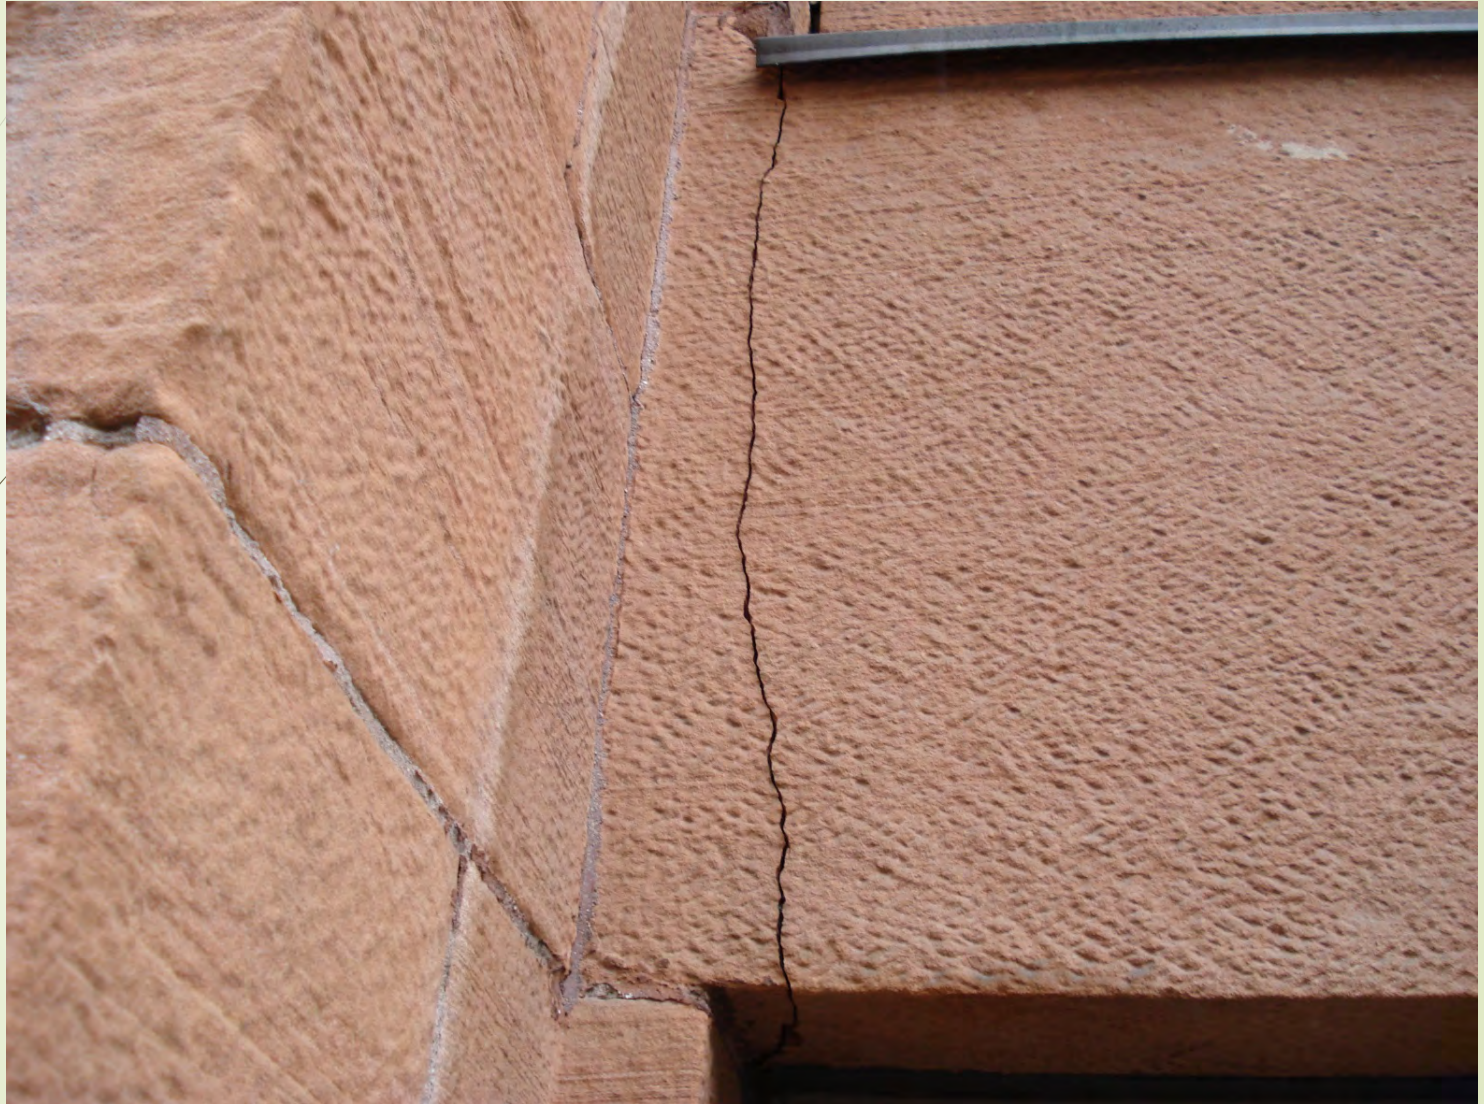
Structural Lintel Cracks

- Stainless steel dowels set in epoxy
- Pressure inject epoxy

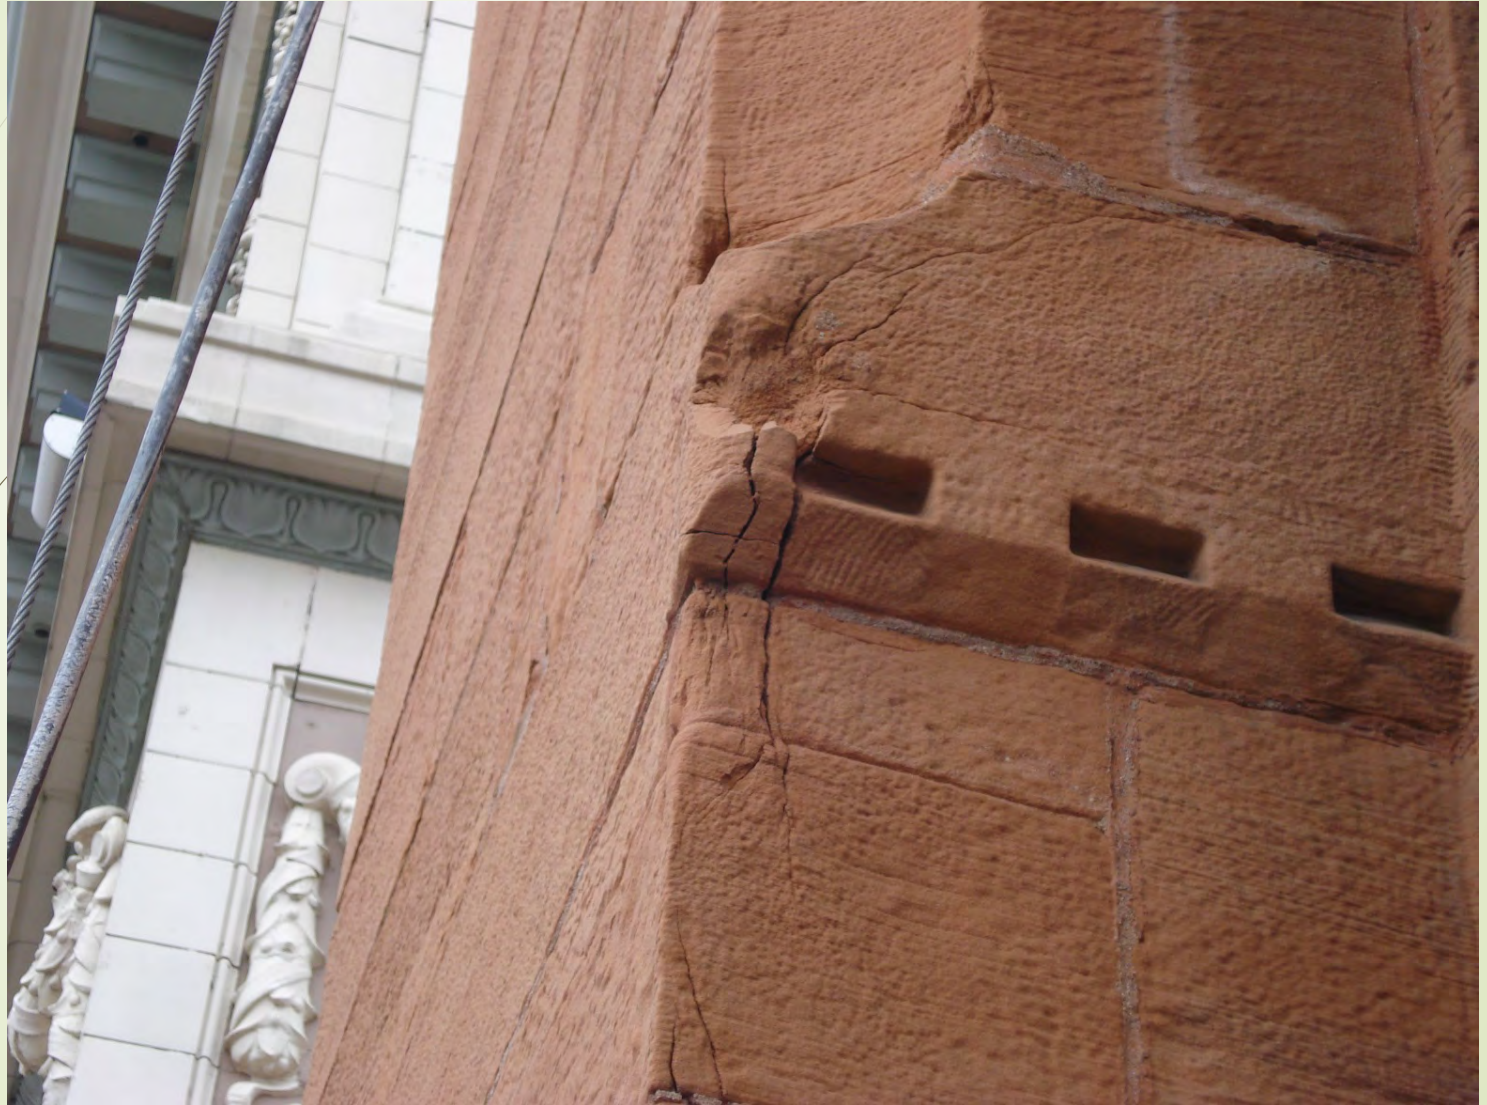
Deteriorated Sandstone

- Iron oxide is the prominent binding material in this type of sandstone which creates the warm red color
- Oxidation (rusting) of the iron in the stone has caused disintegration, and a loss of the cohesive binder.
- Material testing revealed that this stone is very absorbent, making it susceptible to saturation and freeze thaw damage.

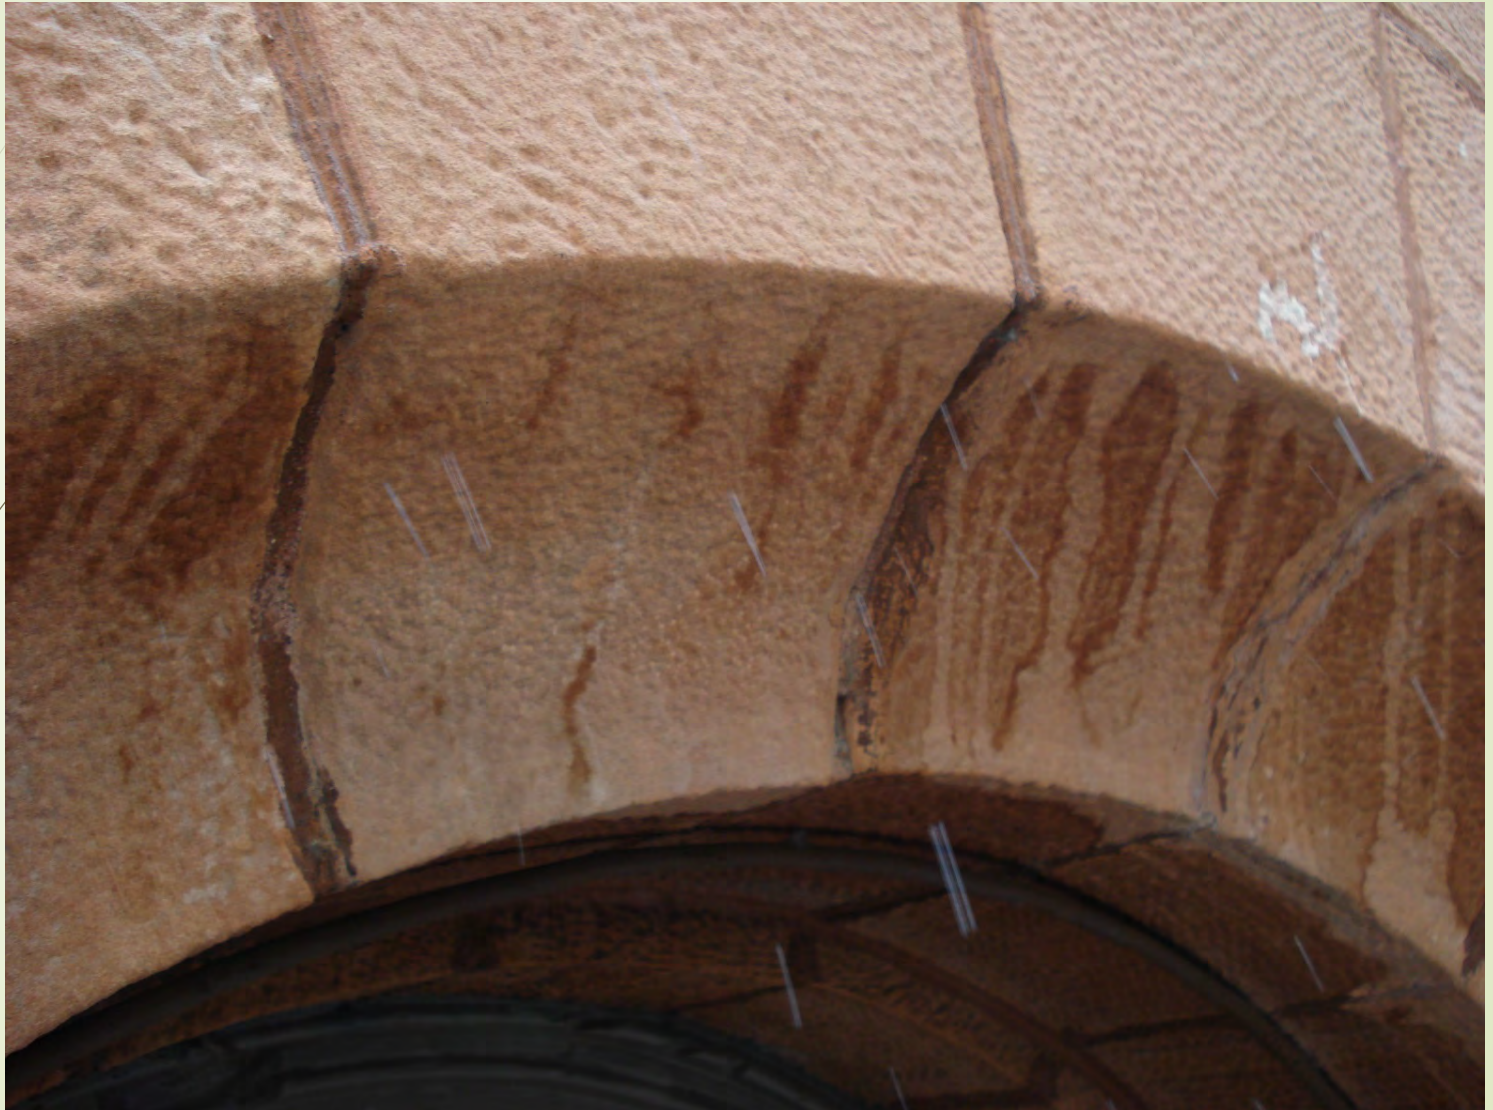
Dirt & Water Staining

- Cleaning the stone is important for:
 - ✓ Aesthetic Reasons
 - ✓ Remove surface contaminates: Carbon, crust, salts, pigeon droppings, mildew and atmospheric stains
 - ✓ To ensure proper saturation of the protective sealer
- Abrasive or Non-Abrasive
 - ✓ Avoid a cleaning method that is too aggressive, do not want the stone to wash away
- Tested Mild Detergents
 - ✓ Sandstone soaked up detergent and could not be rinsed out
- Hot Water & Nonacidic Liquid Cleaner
 - ✓ Medium / Low pressure hot water

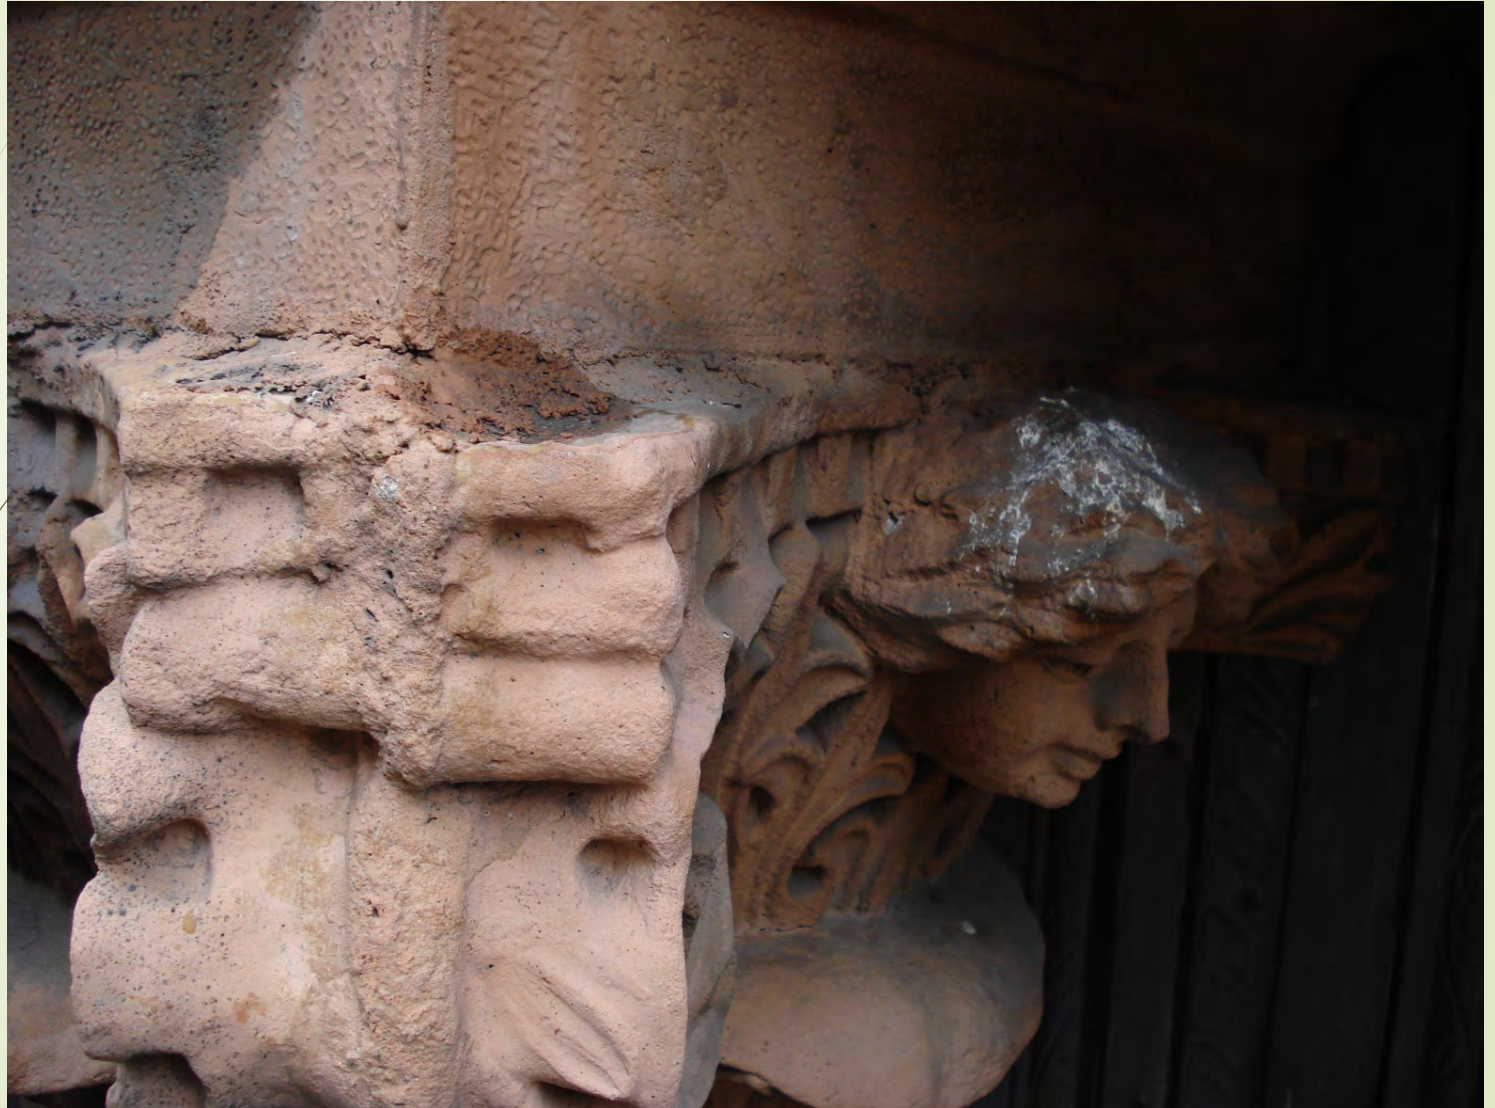
Pigeon Roost

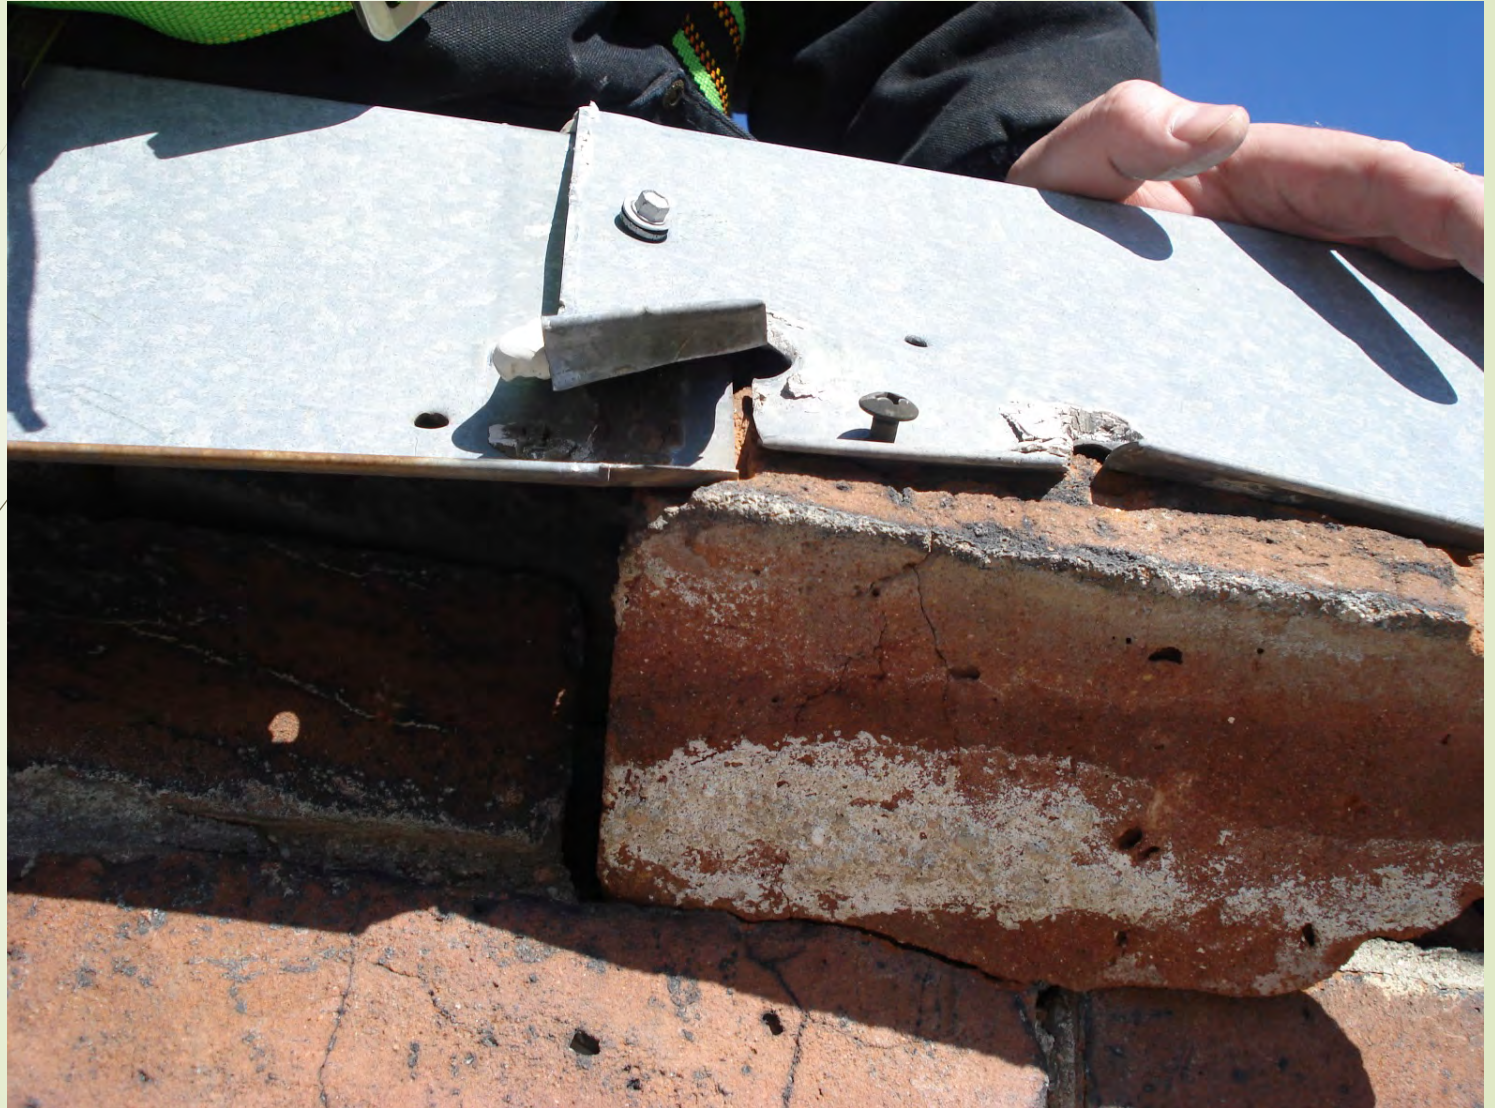
Parapet Walls & Flashing

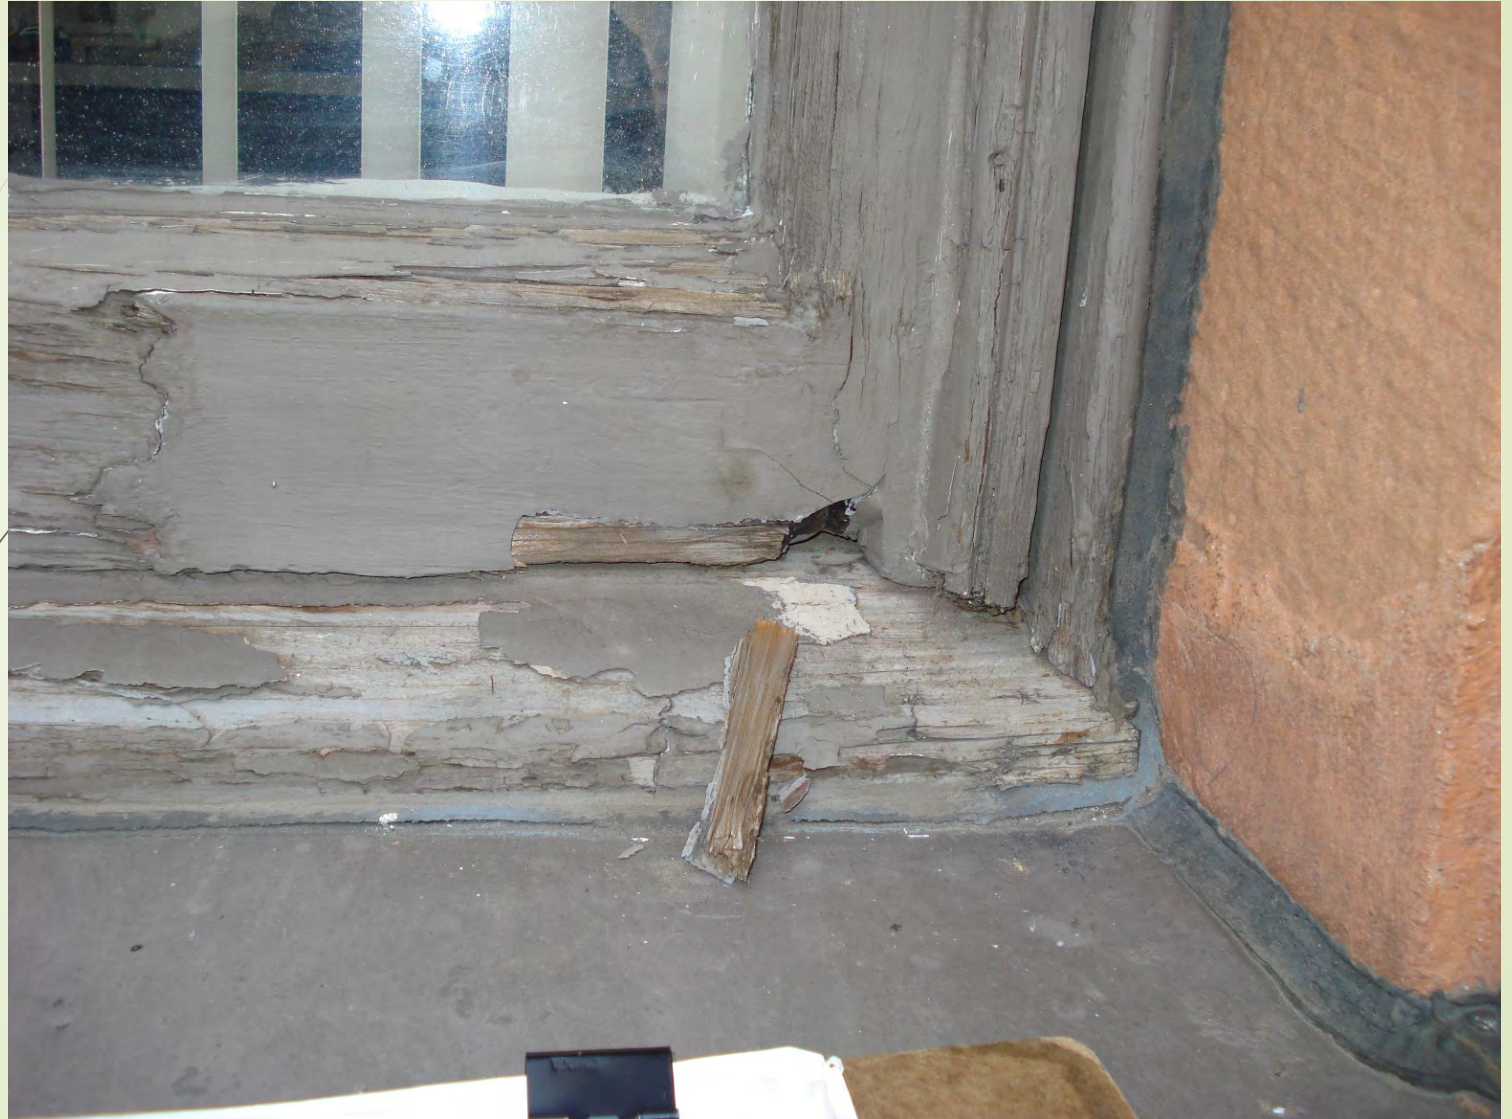
Deteriorated Wood Frames

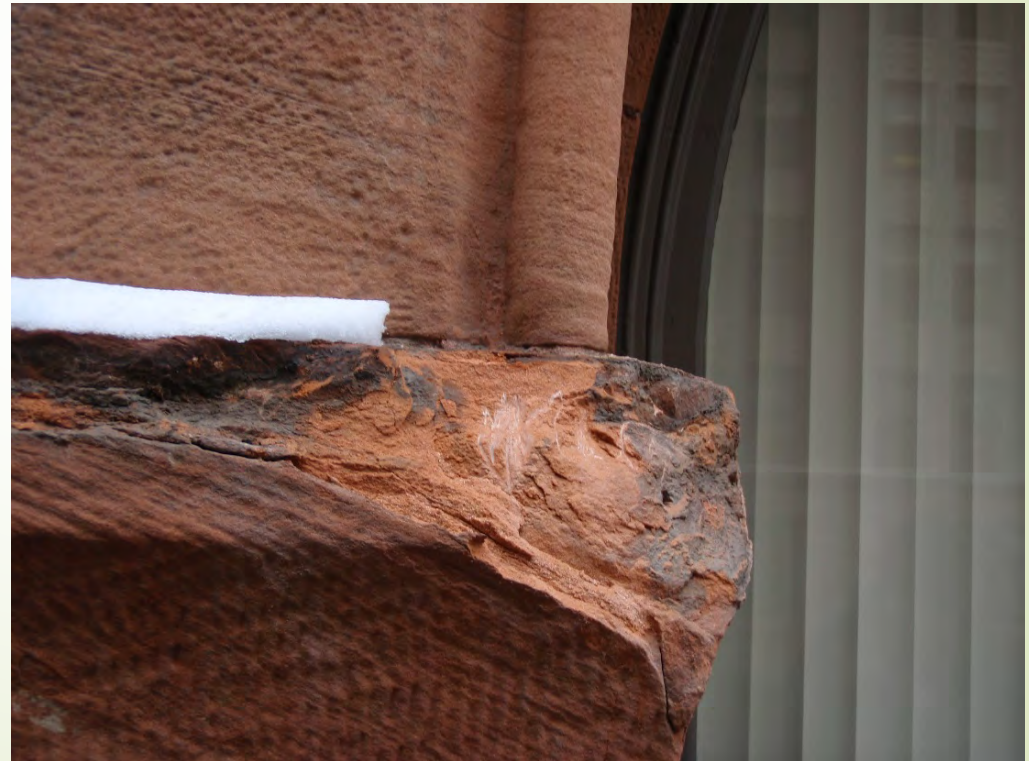
- Freeze/Thaw action
- 6.3% absorption characteristic holds water
- Ledges and detailed pieces suffer most damage due to collection of water

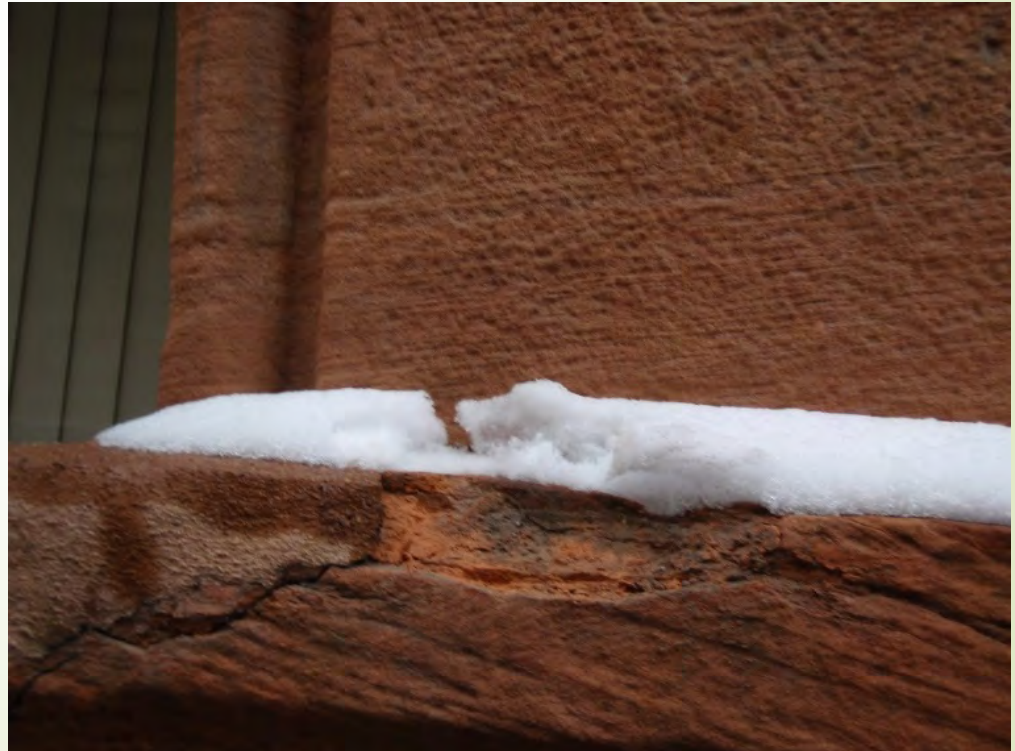
- Bedding planes of sandstone are natural lines of weakness and are strongest when horizontal
- Water is more likely to split the stone if the bedding planes are in a vertical orientation.
