Thomas L. Rewerts, SE  
THOS. REWERTS & CO., LLC  
Kansas City, MO  
[t.rewerts@rewerts.com](mailto:t.rewerts@rewerts.com)

**Complex and Innovative Structural Repair  
of Severely Damaged, 1917 era School Structures**

**Structural Repairs**  
 Phase II: Concrete Floor System Repairs  
 Allison Traditional Magnet Middle School  
 221 S. Street - White, Kansas

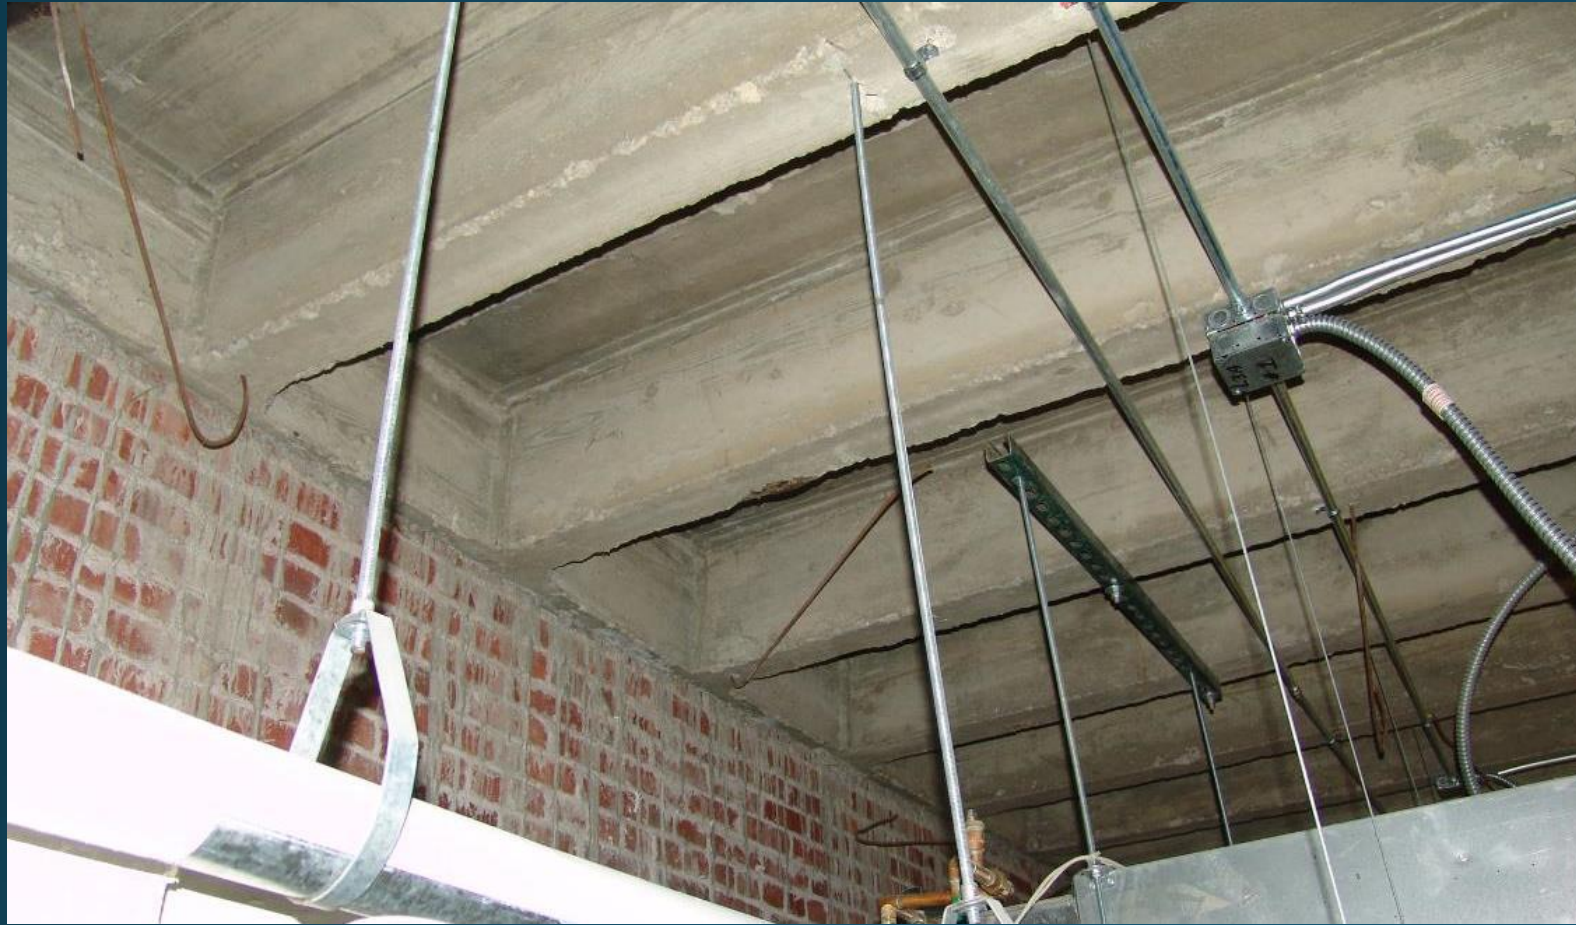
The structural problems were severe enough to require evacuation and complete closure of one of the buildings, and portions of the other, until comprehensive structural repairs could be made.

Existing long span, one-way, concrete pan joist floor systems were severely overloaded, and cracked extensively as a result.

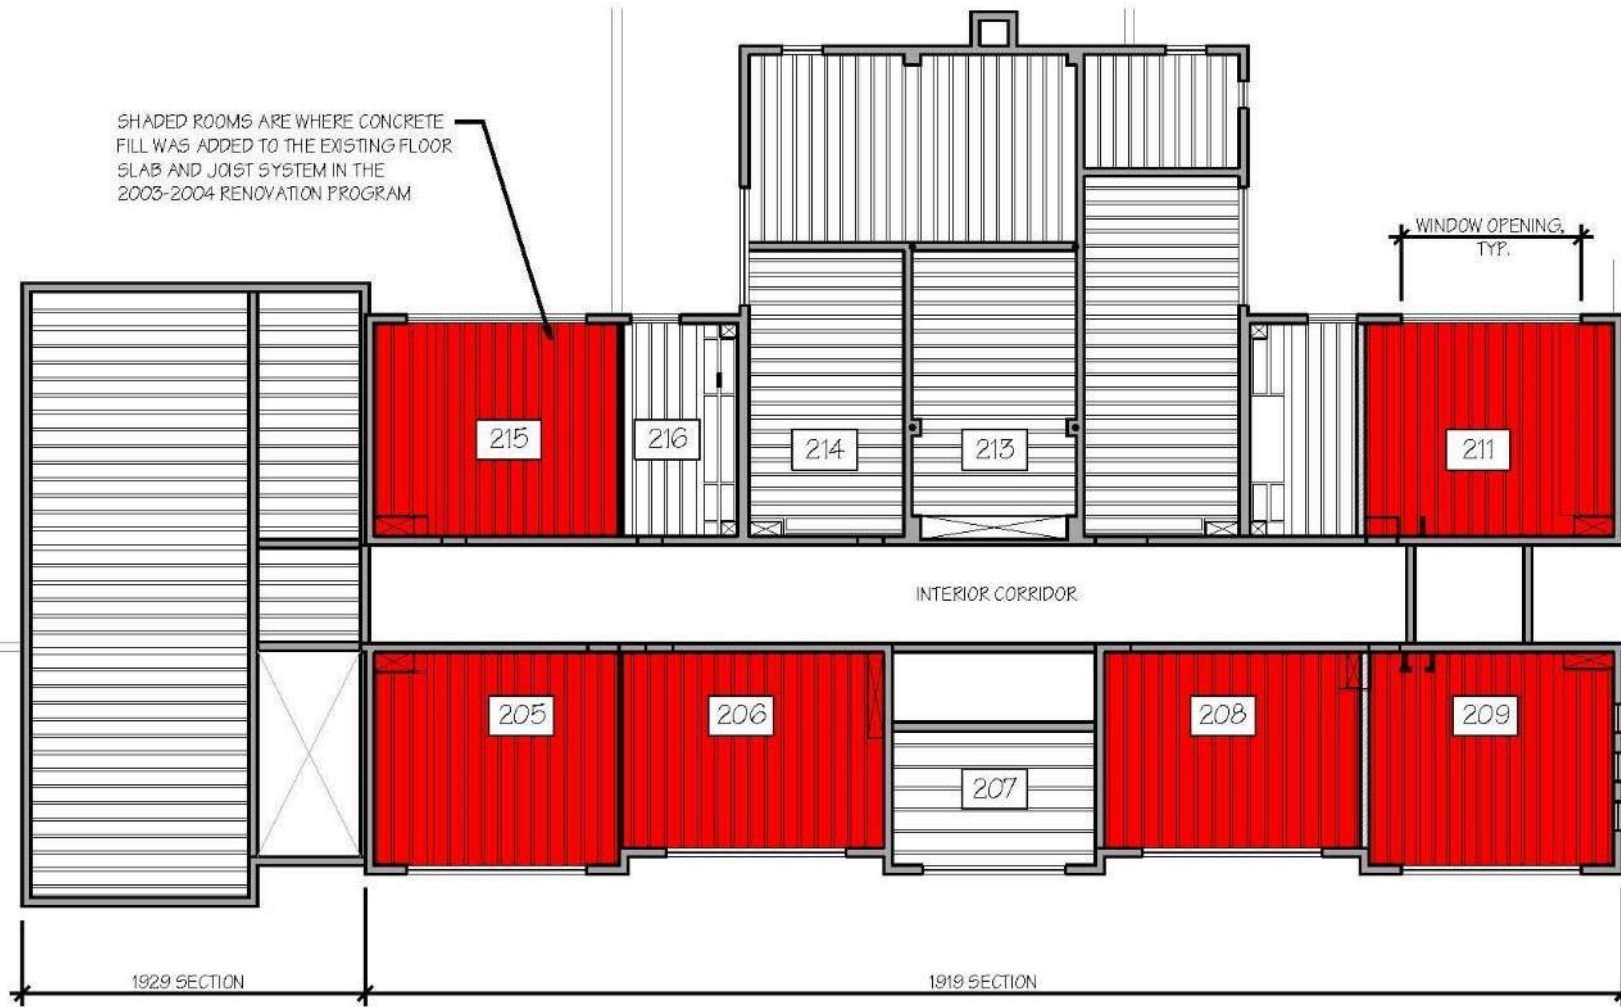
**Second Floor Structural Framing Plan**  
Not To Scale

SHADED ROOMS ARE WHERE CONCRETE FILL WAS ADDED TO THE EXISTING FLOOR SLAB AND JOIST SYSTEM IN THE 2003-2004 RENOVATION PROGRAM

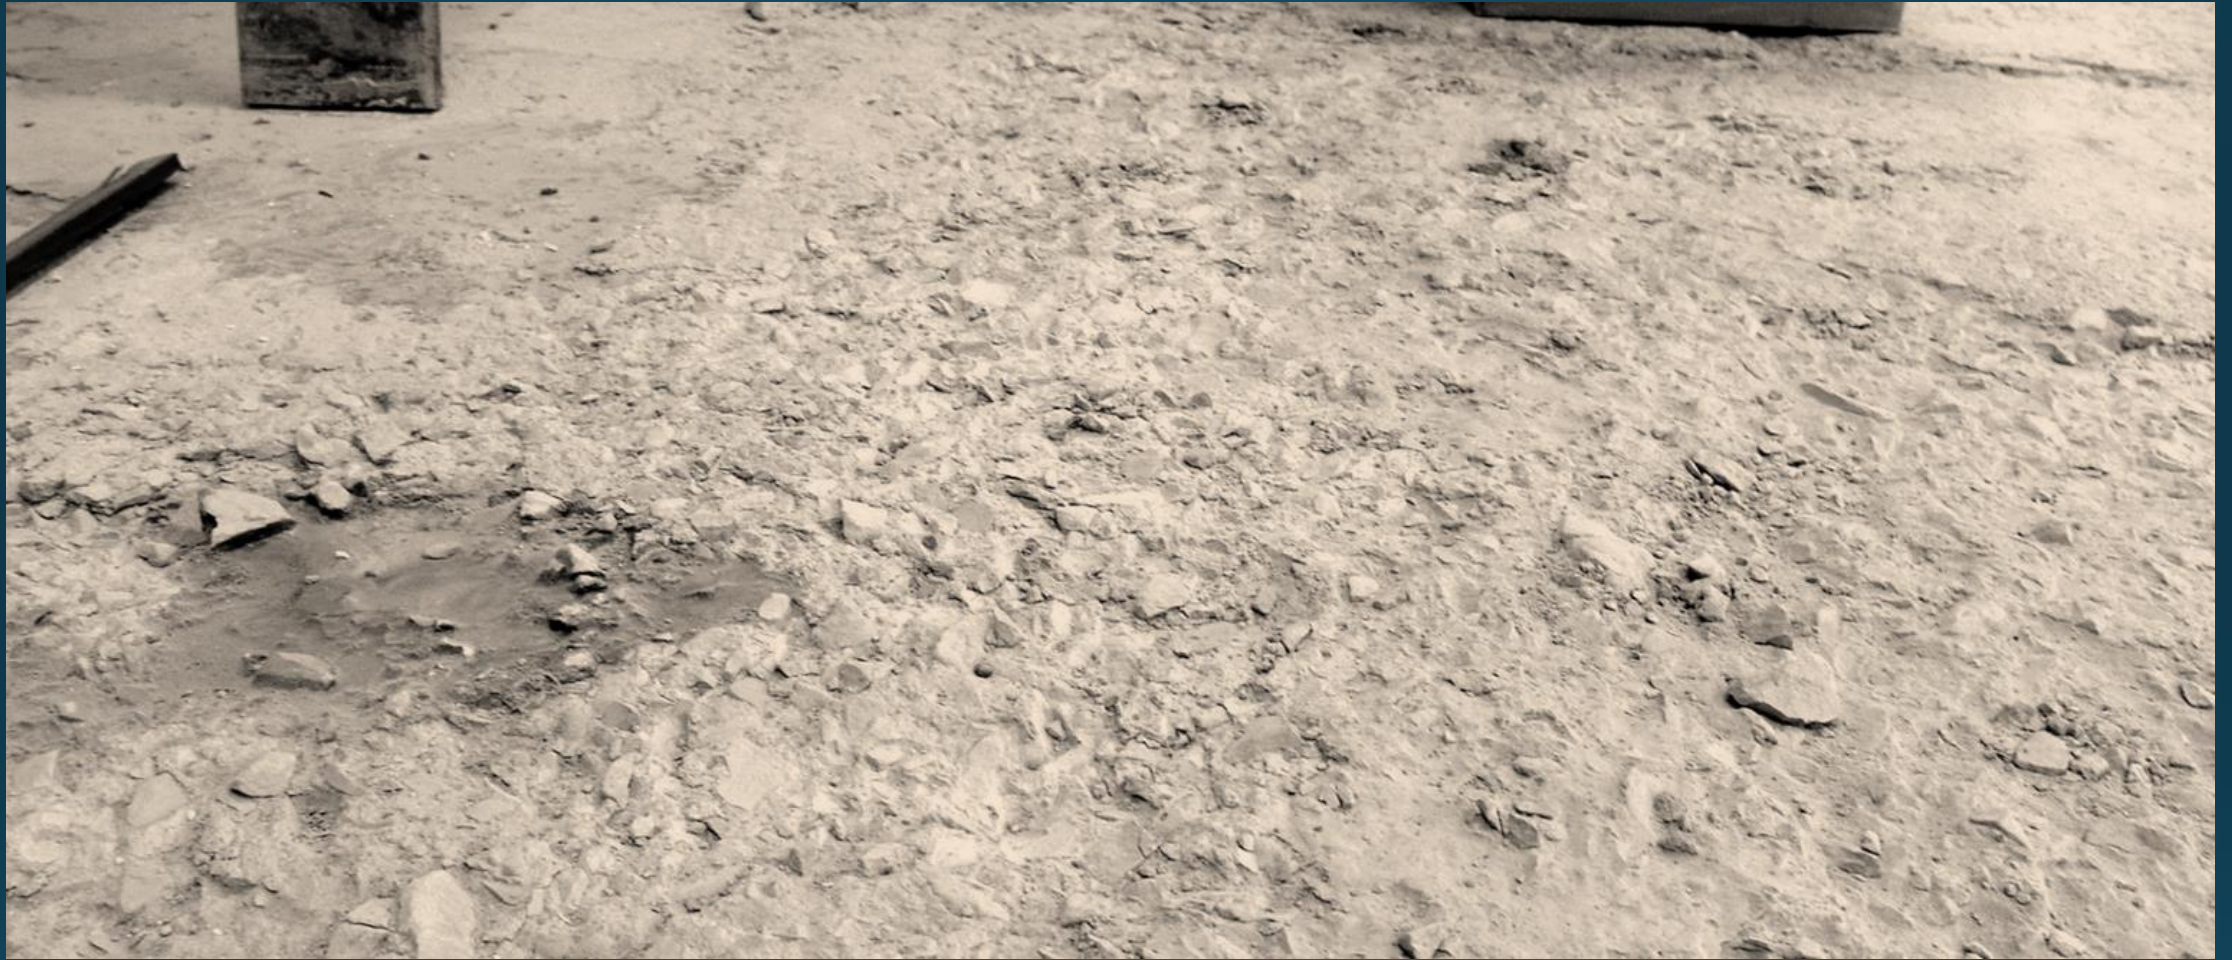
Selected areas of the existing concrete floor slab were in such bad condition, steel plates had to be installed to bridge between the joists below to prevent punching shear failures through the slab.

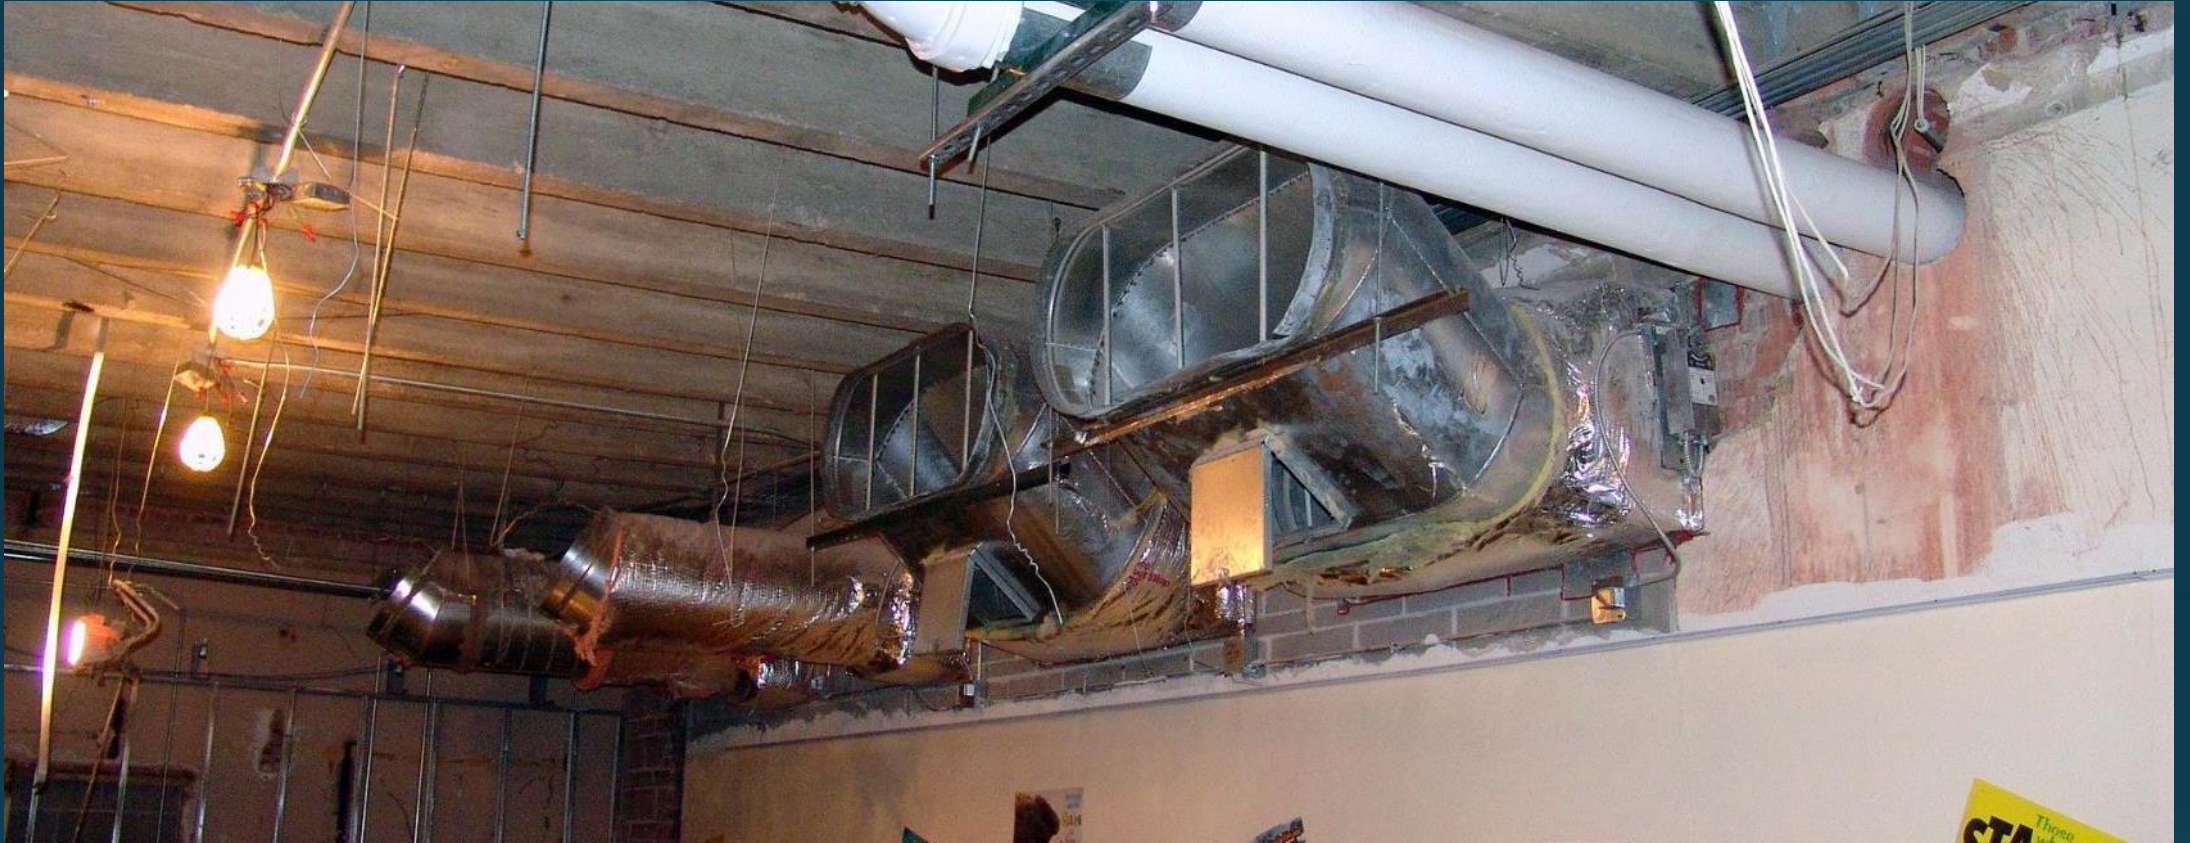
Installation of large banks of new HVAC ducts through interior load-bearing structural clay tile walls caused serious vertical displacement and near collapse of a section of the concrete floor system in one area of one of the buildings.
