# BRECKENRIDGE SKI & RACQUET CLUB RESTORATION

CONCRETE REPAIR AT HIGH ALTITUDE

# SKI & RACQUET CLUB

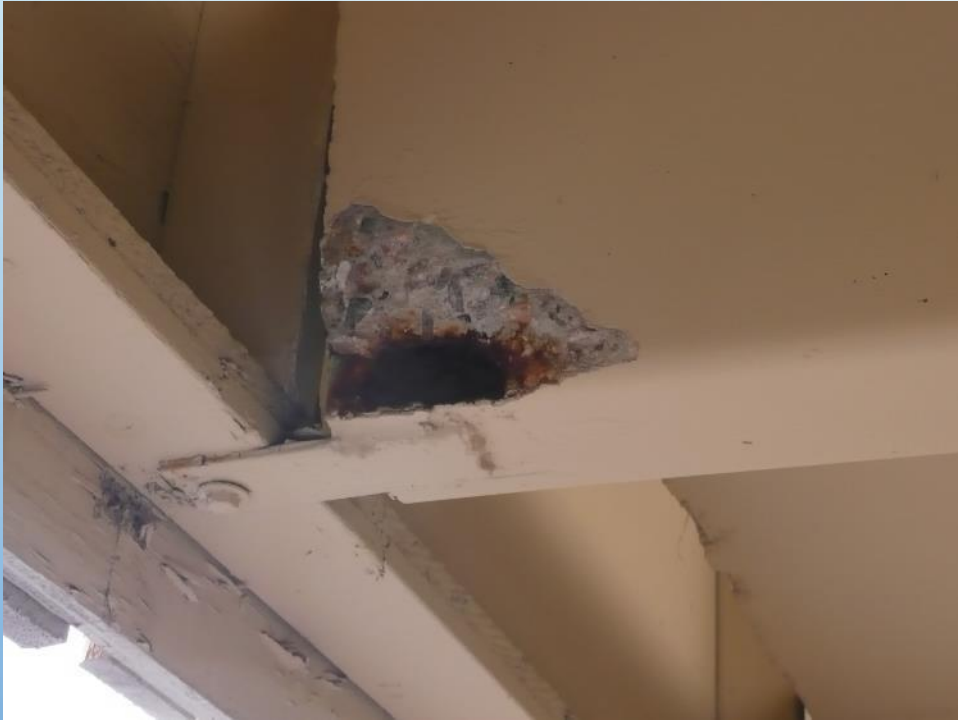
## 2 Types of Flange Deterioration

Concrete Spall

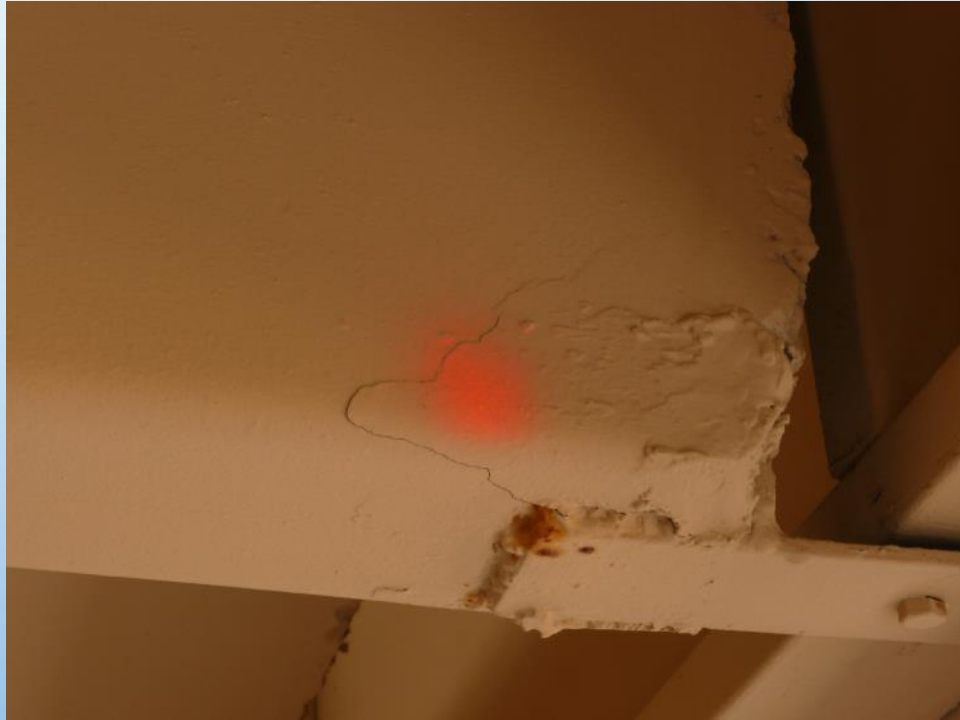
Concrete about to spall

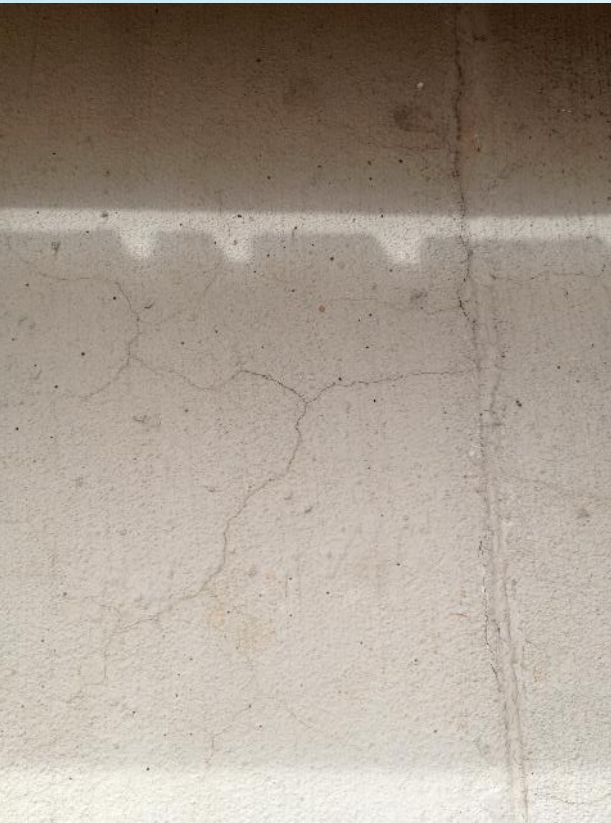
50% of the rear balconies were repaired in 2009

Not coated

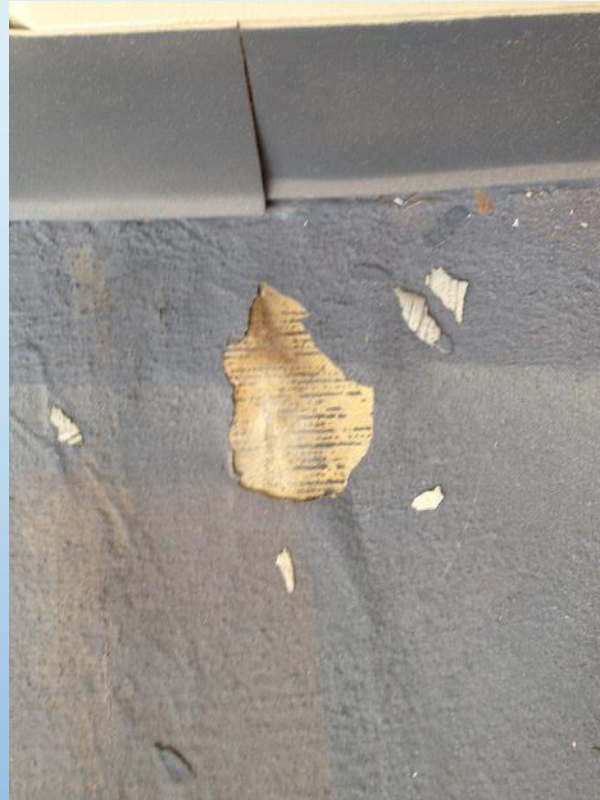
Cementitious coating

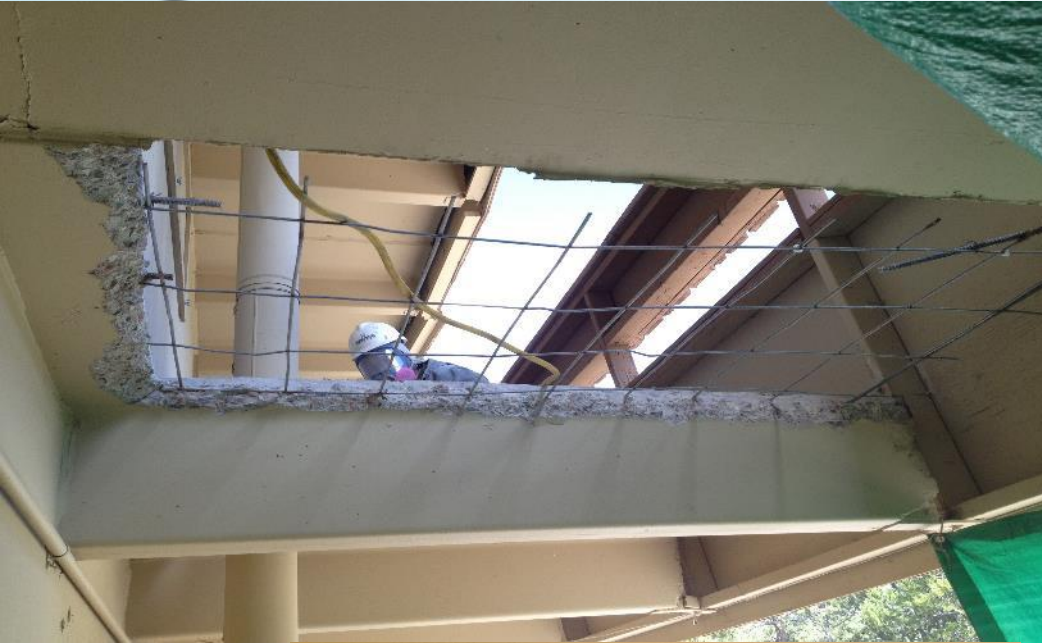
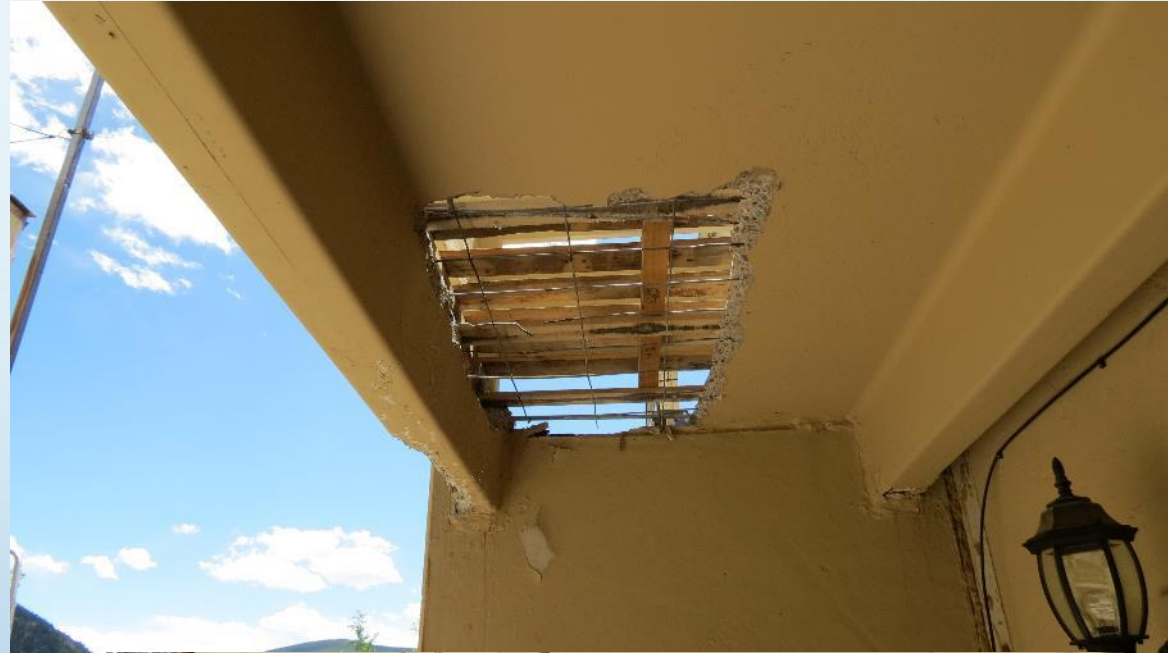
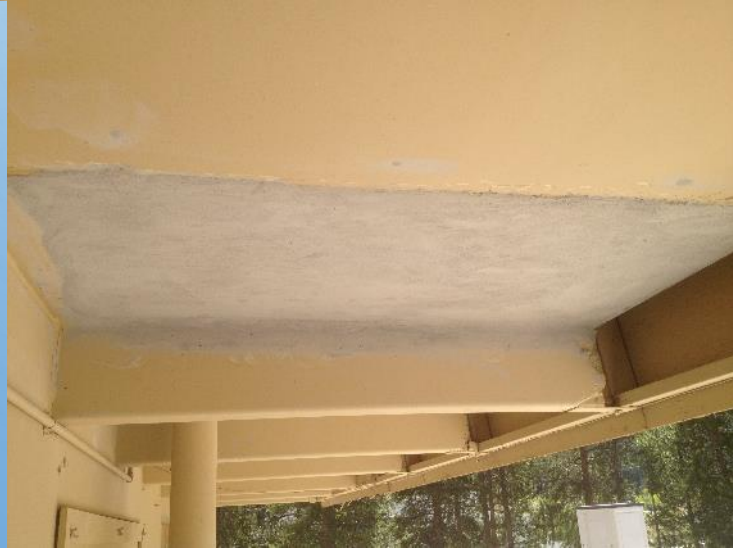
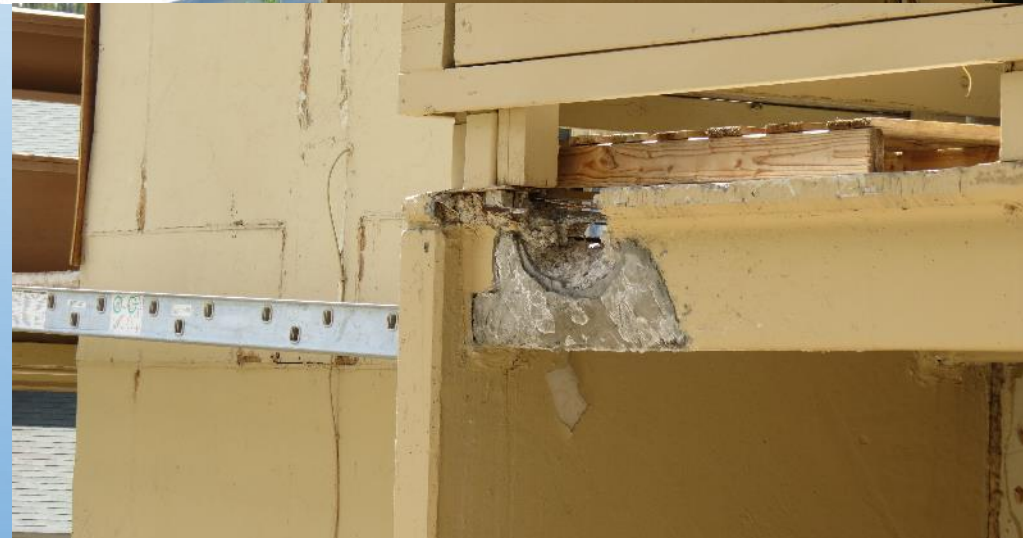
# SPALLS - DETERIORATION WORSE THAN EXPECTED

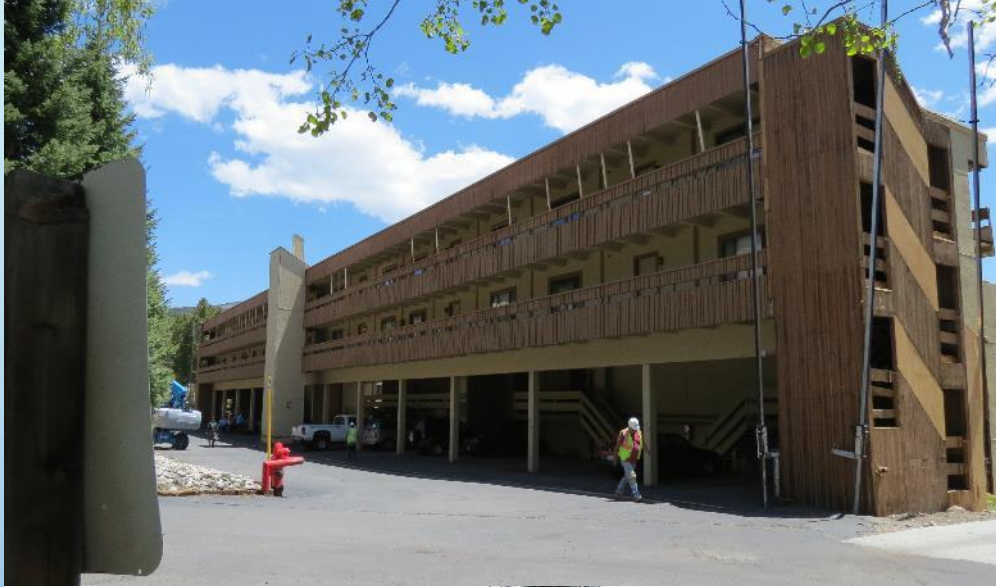
# NEW RAILING SYSTEM REQUIRED NEW CONNECTIONS TO THE T ENDS.

New railings required a 6"x12" header to accommodate the 6"x6" railing posts.
