A Design-Build Project: Repairing the Courthouse Square Complex

Courthouse Square Complex (CH2) Overview

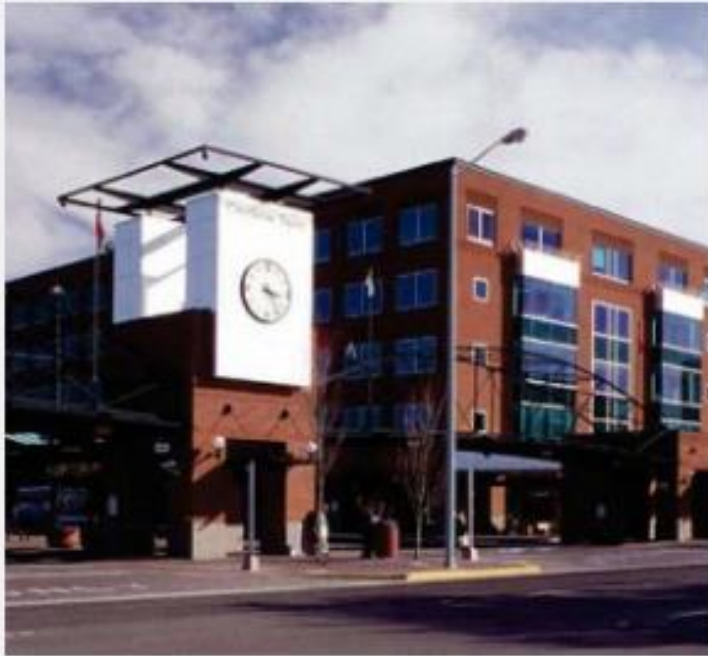
Marion County offices and other tenants will vacate the Courthouse Square building in Salem within 90 days after inspections found the building to be structurally unsound. (Photo courtesy of Marion County)

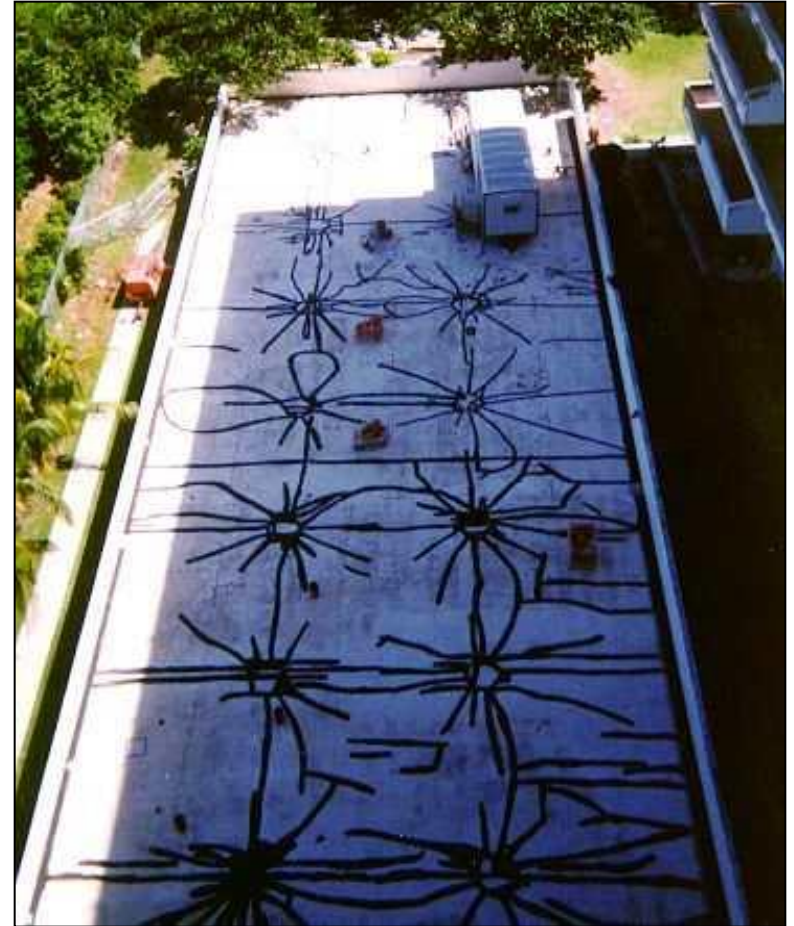
Cracking Pattern on the Roof of a Building with Punching Shear Deficiency (not CH2)
