INTERNATIONAL
CONCRETE REPAIR
INSTITUTE

2023 Fall Convention |

SPIRAL RAMP

Present Condition & Repair

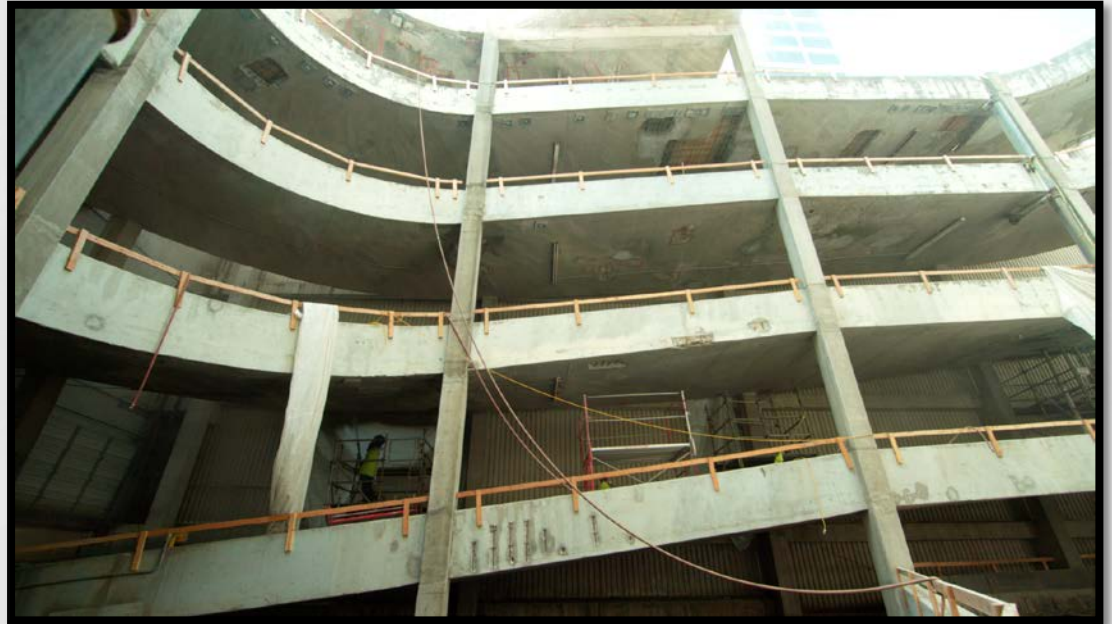
- ✦ Temporary handrail required for construction
- ✦ New steel handrail designed to meet code for reopening

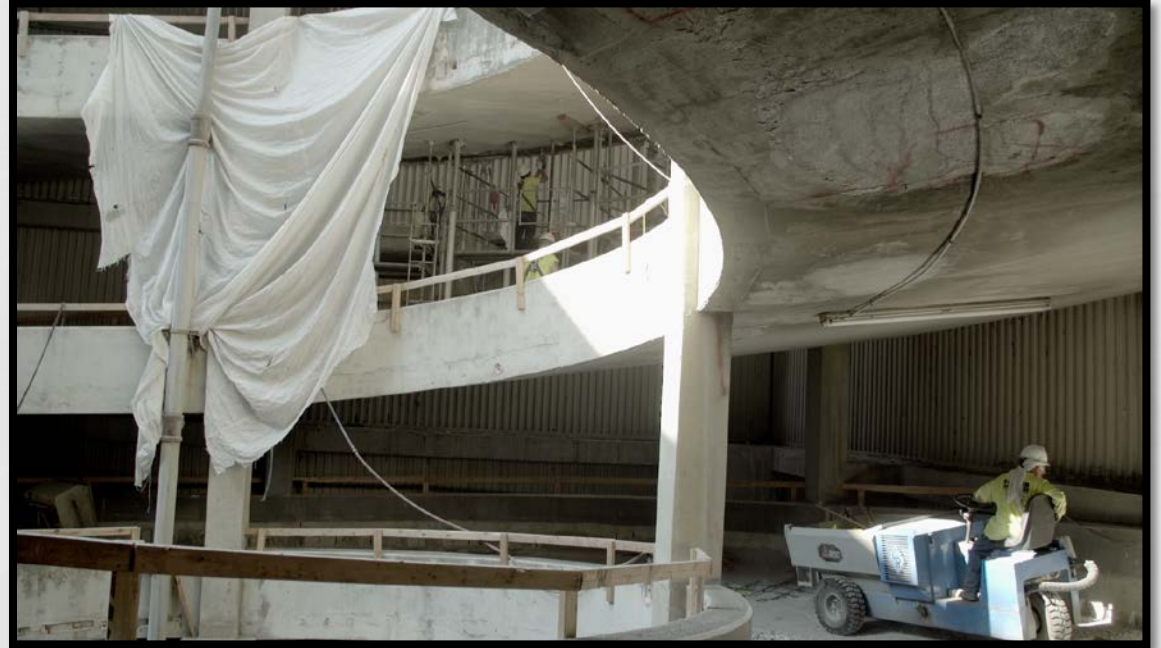
- † Repairs could only be performed on one ramp at a time

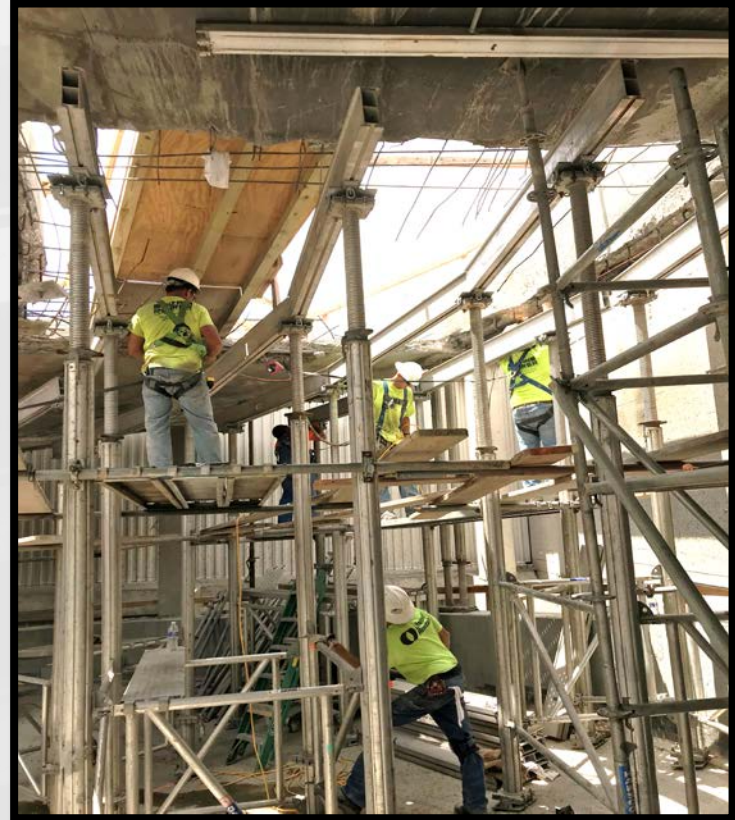
- † Height and large full depth patches required extensive shoring and forming design
