Repairs to Classic Spanish Revival Facade

ICRI 2015 Spring Convention
New York, NY

Presented By:
Allen Roth, P.E.

JOSEPH B. CALLAGHAN, INC.
CONSULTING ENGINEERS

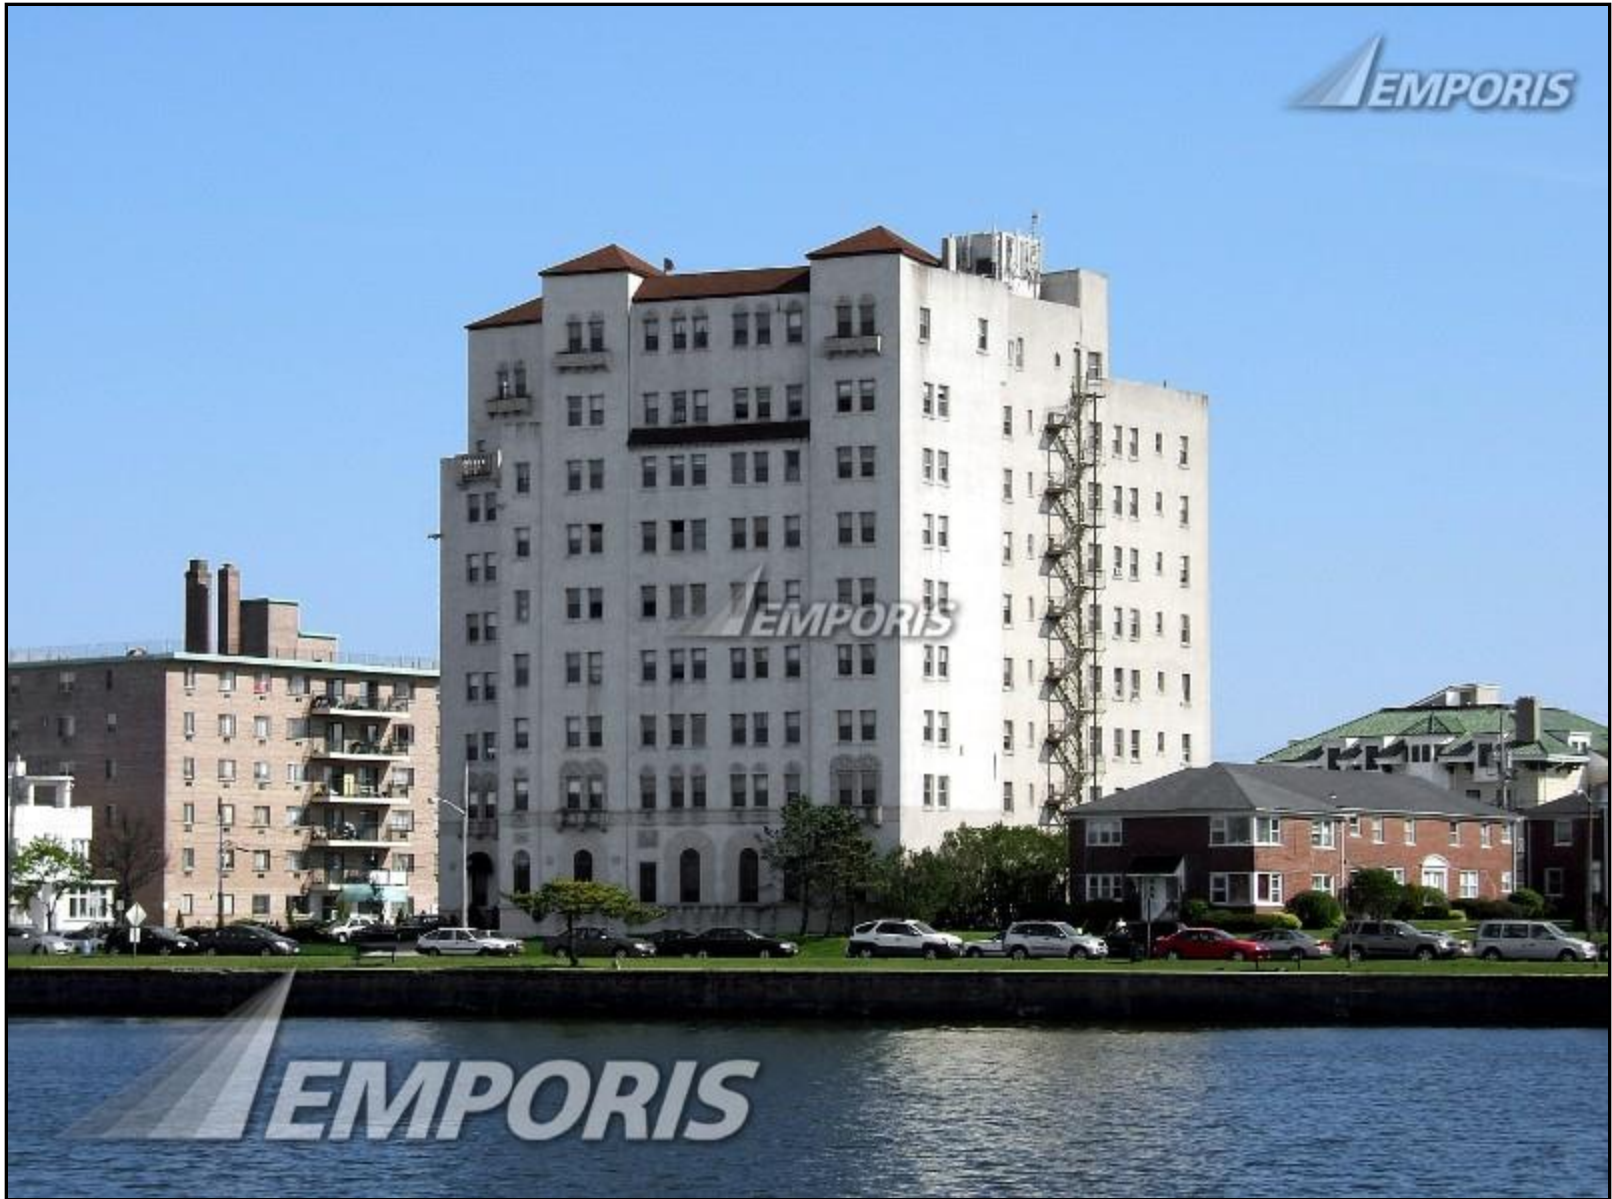
2010 – Exterior Façade Concerns

- Extensive water intrusion & air drafts
- Extensive stucco cracking above windows
- Extensive stucco spalling, delamination and bulging
- Open vertical cracking at building corners
- Discoloration

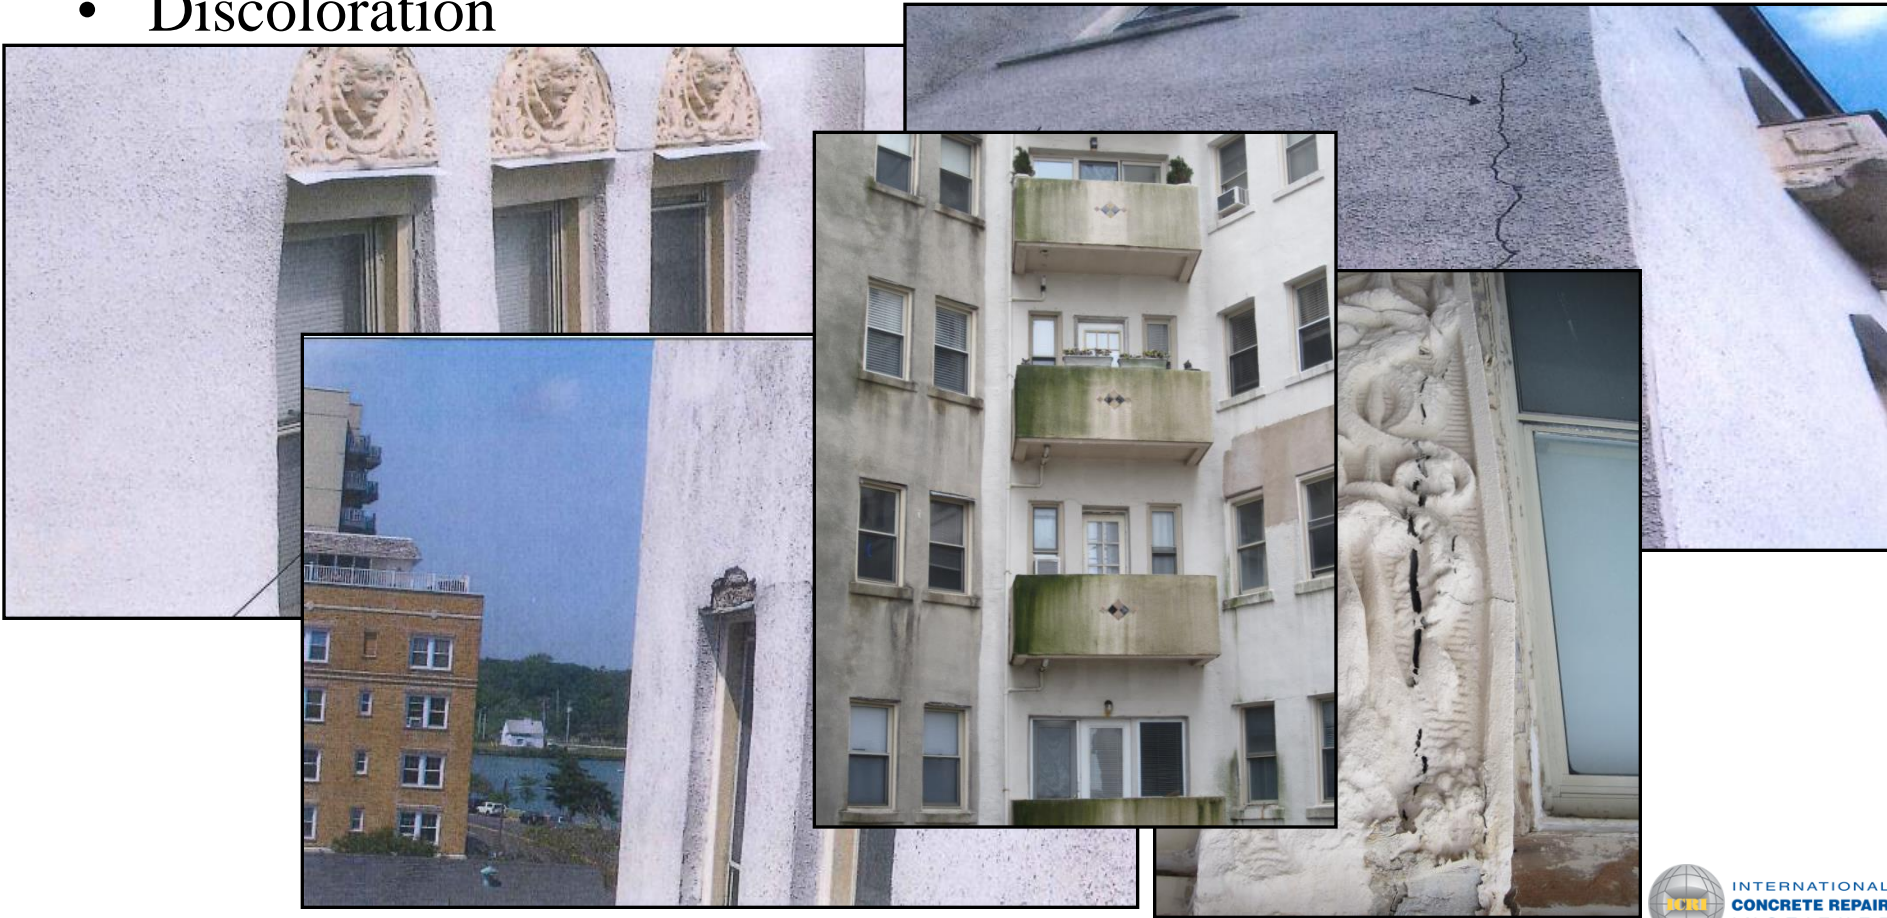
Emergency Repairs Required

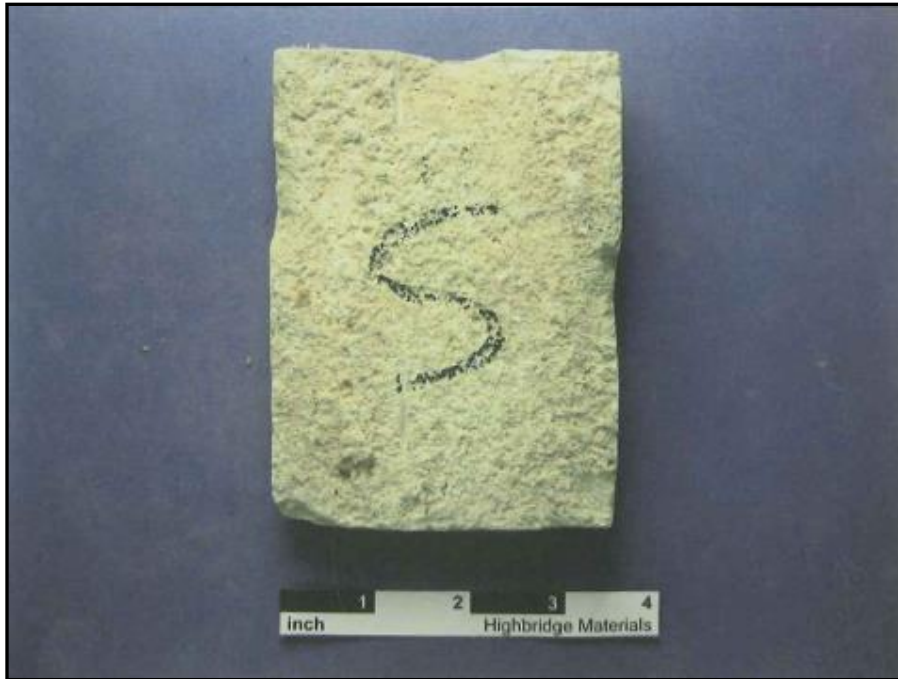
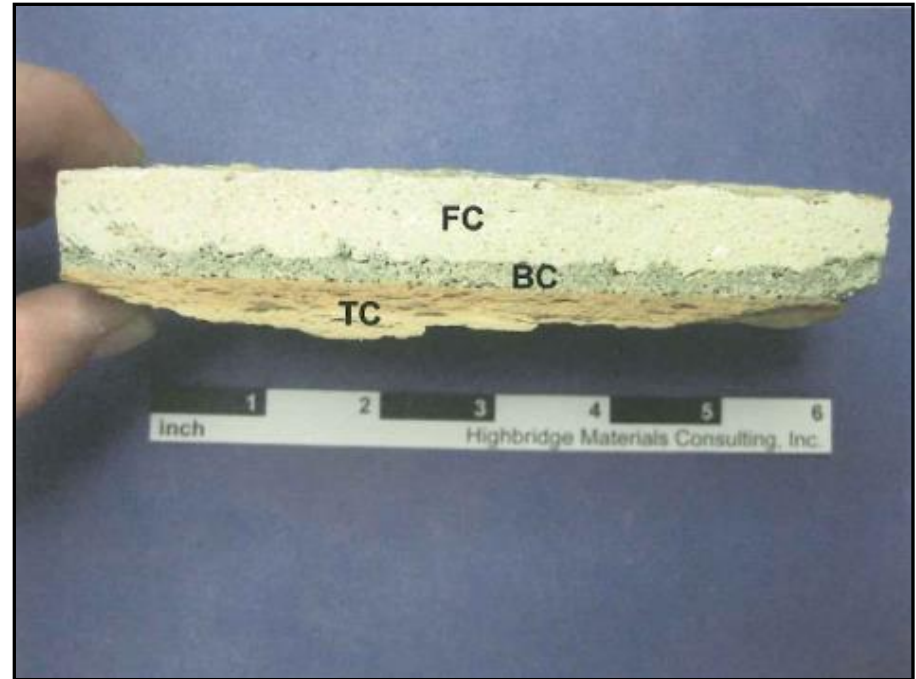
Stucco Petrographical Analysis

- All stucco components were well mixed, placed and hydrated.
- No micro-cracking, chemical reactions or instabilities were found.
- Both the finish coat and the brown coat are well bonded to the substrate terra cotta.

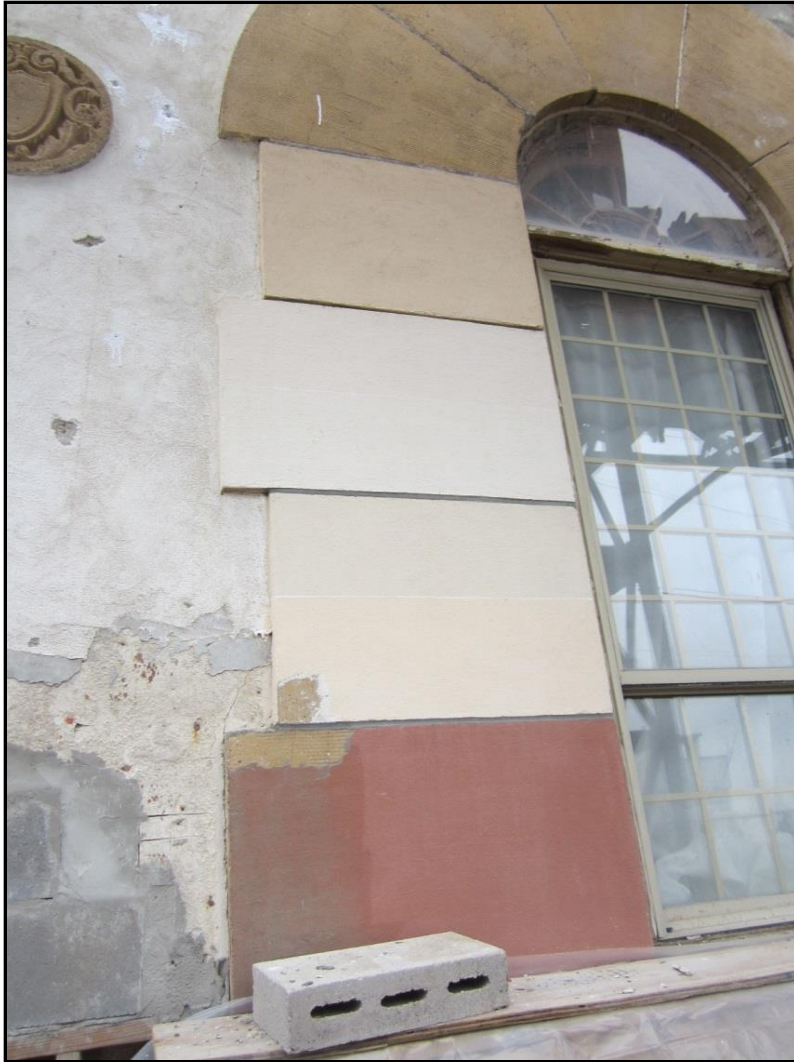
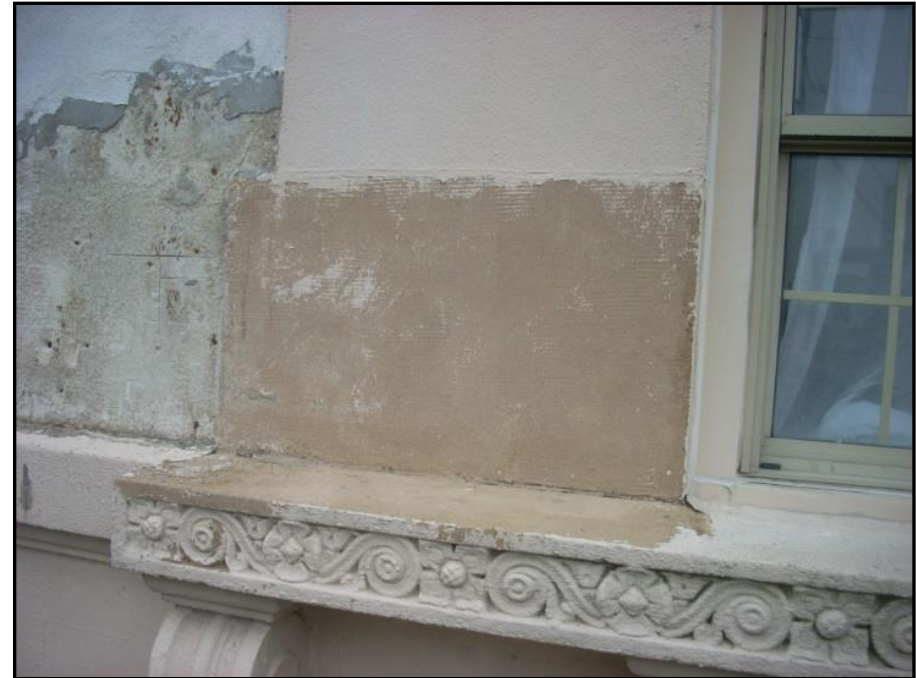
Ornamental Precast Mockups

- Intricate precast detailing exposed when paint was removed.

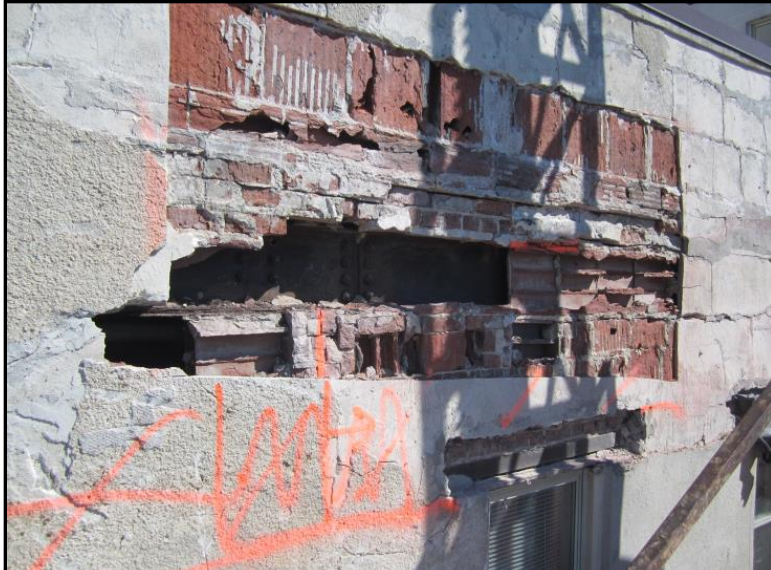
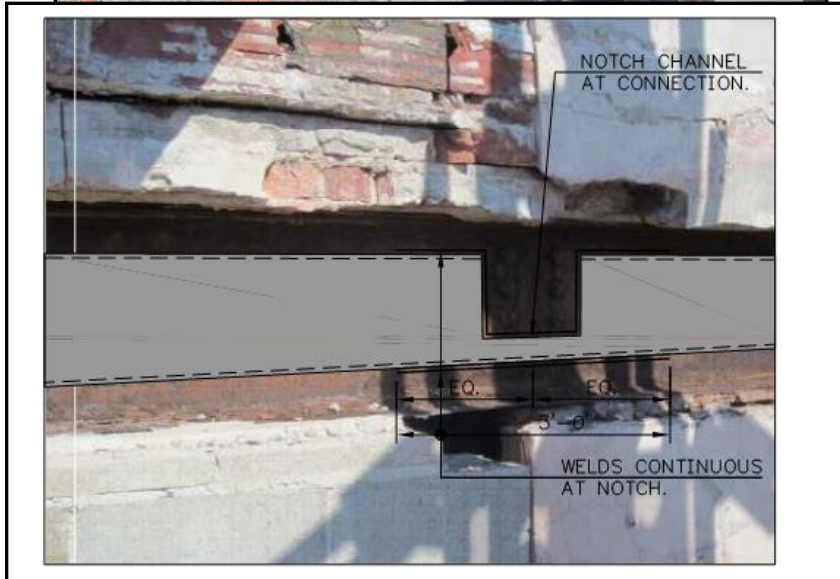
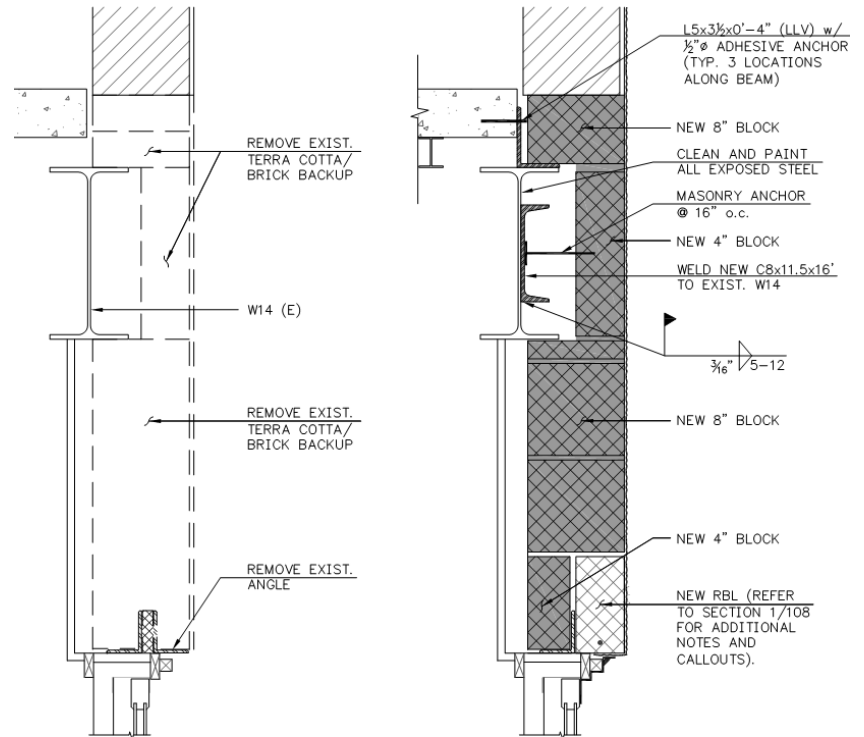
Uncovered Structural Steel Conditions

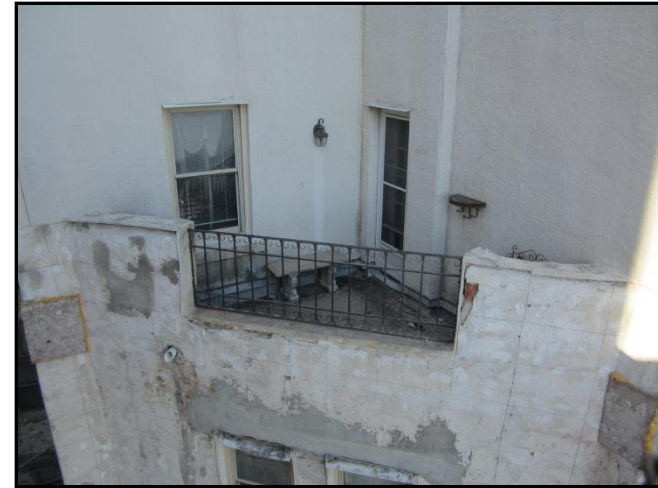
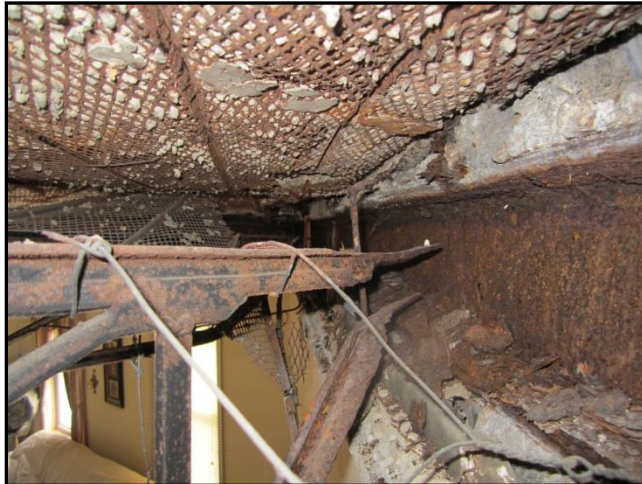
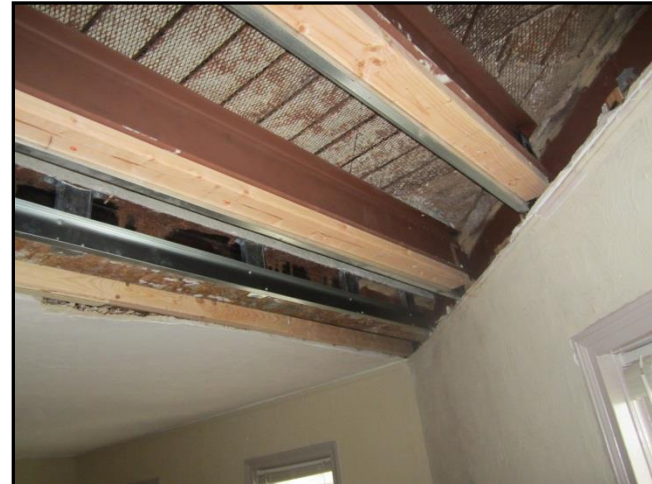
Terrace Steel Framing Damage

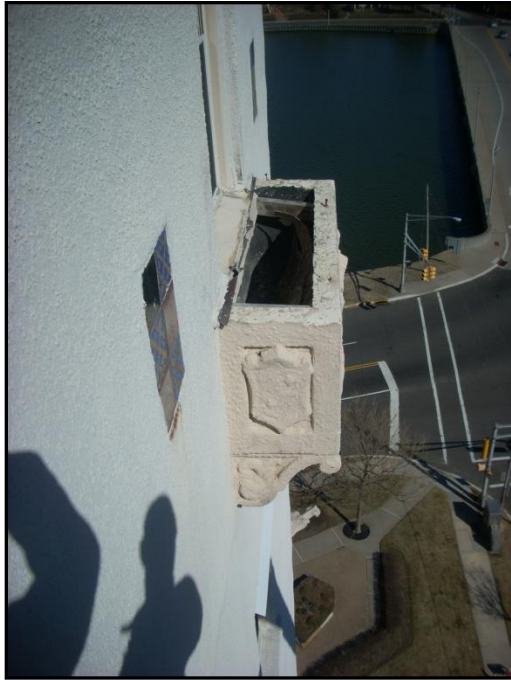
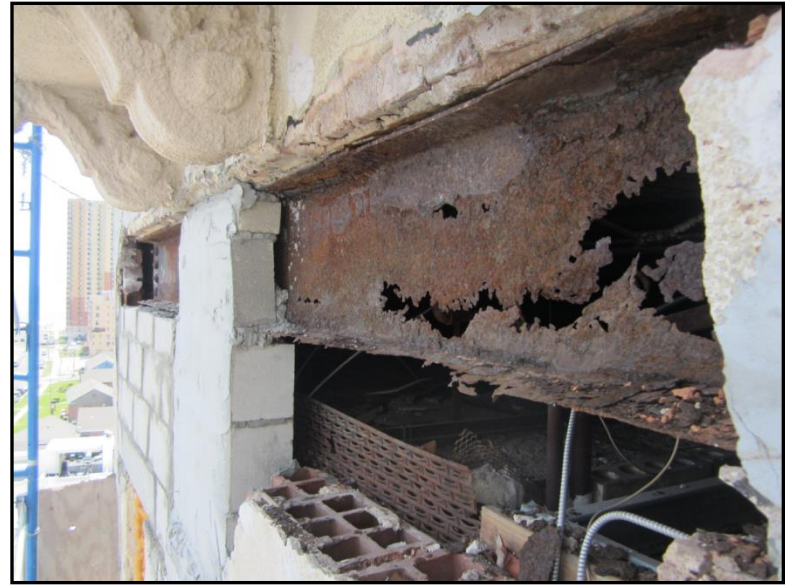
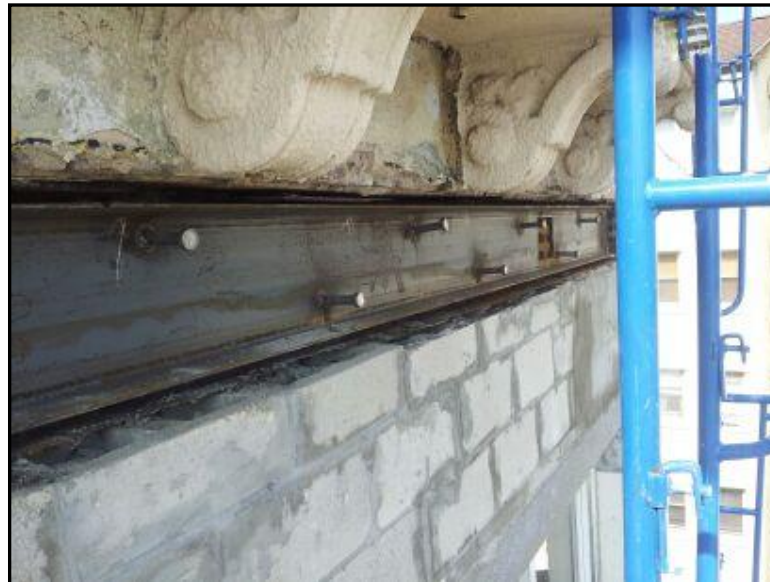
Planter Structural Steel Damage

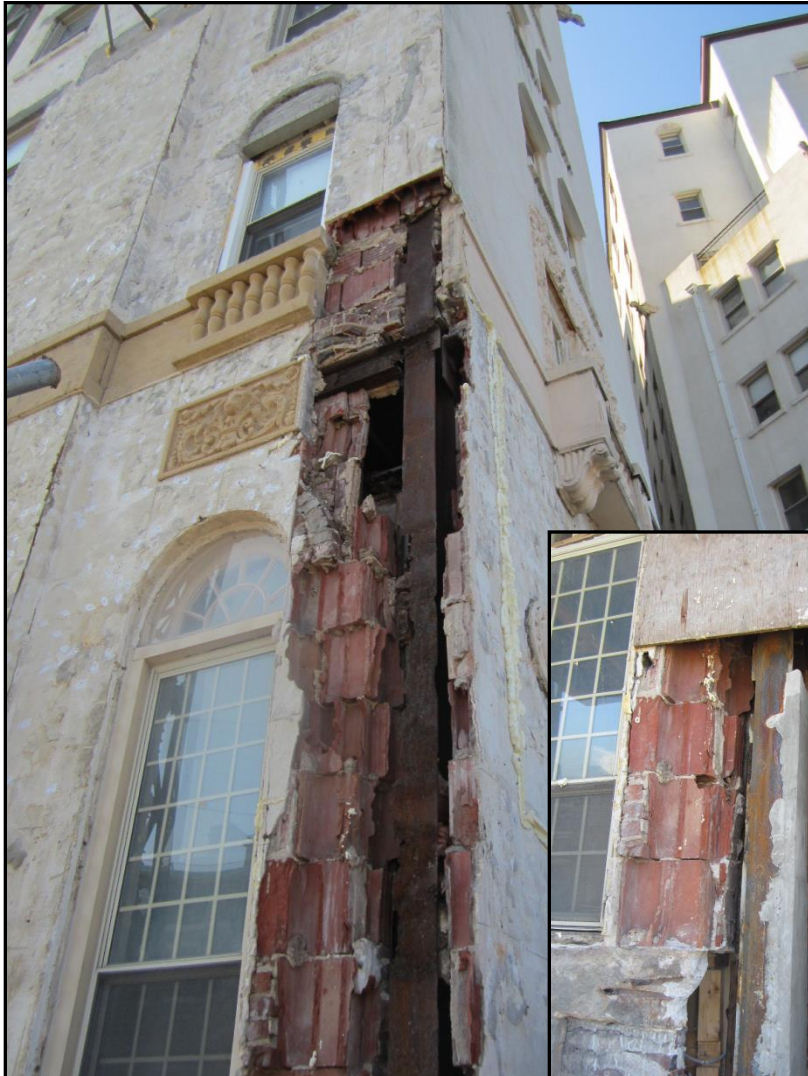
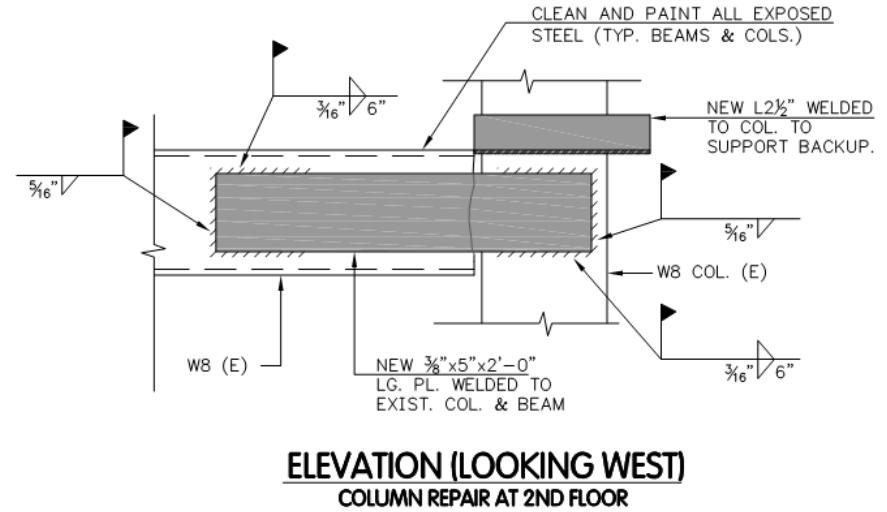
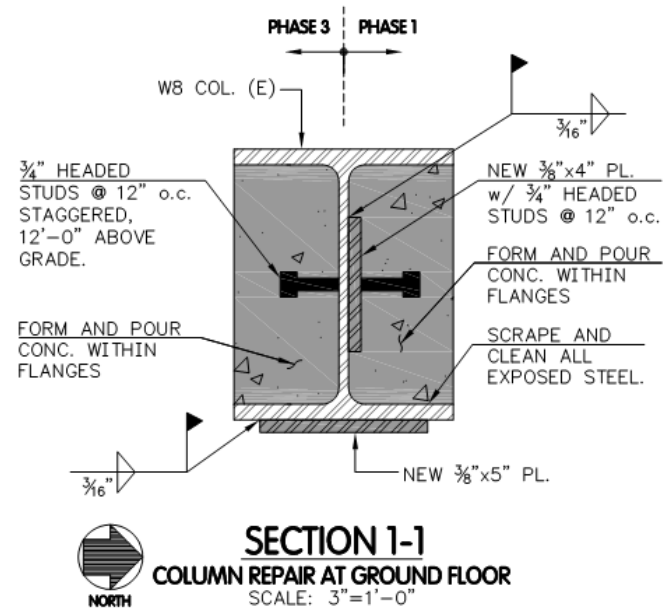
Steel Column Damage

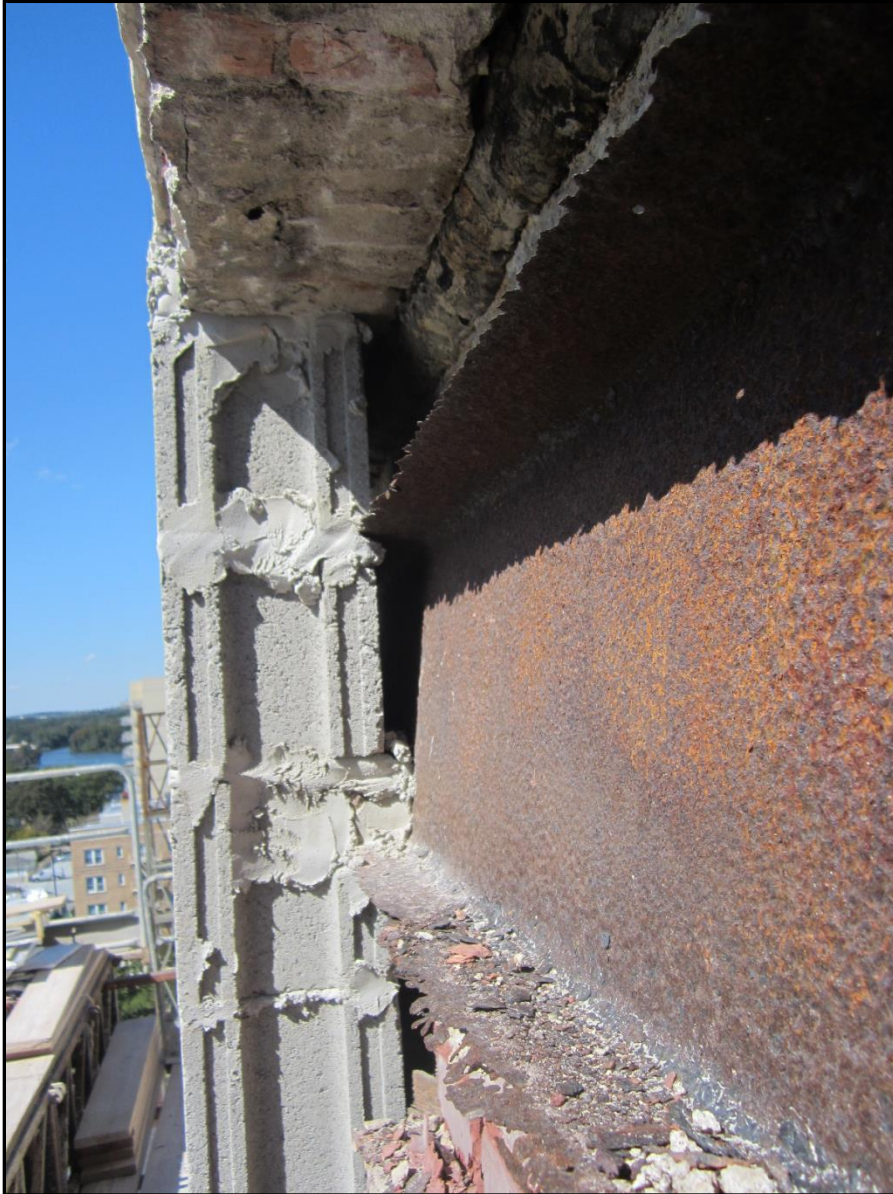
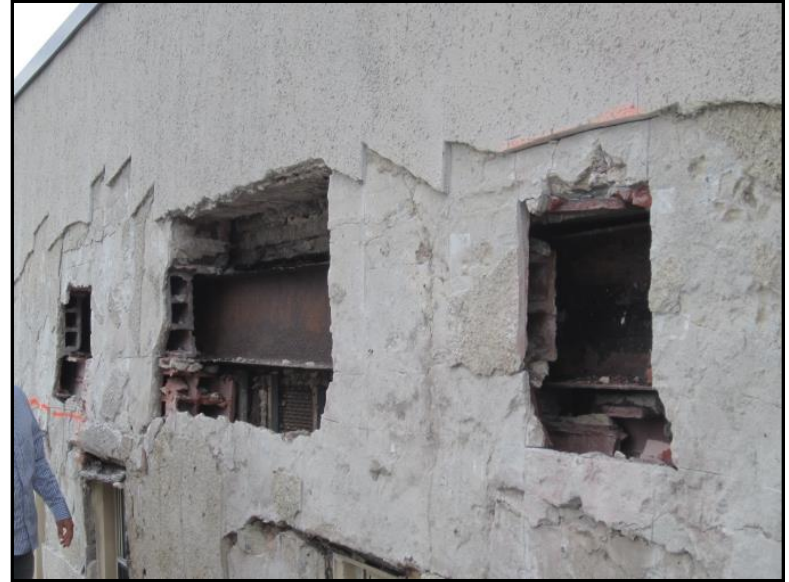
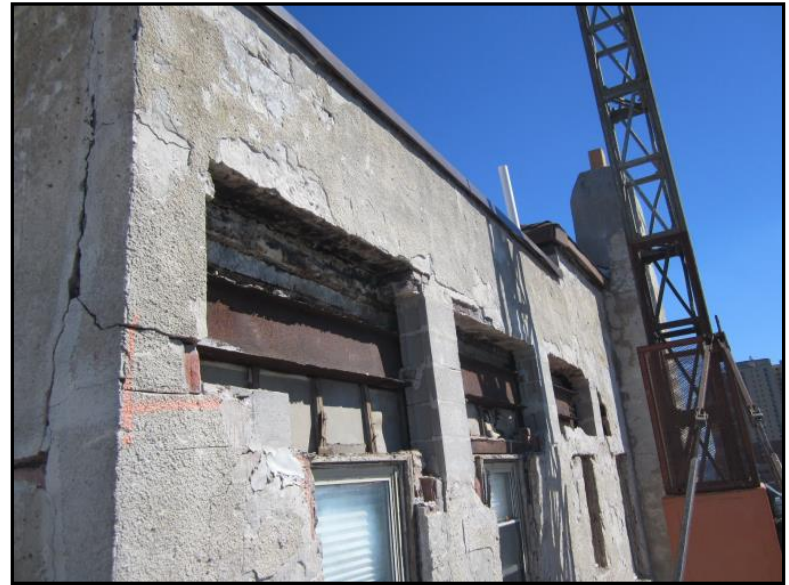
Terrace Spandrel Beam Damage

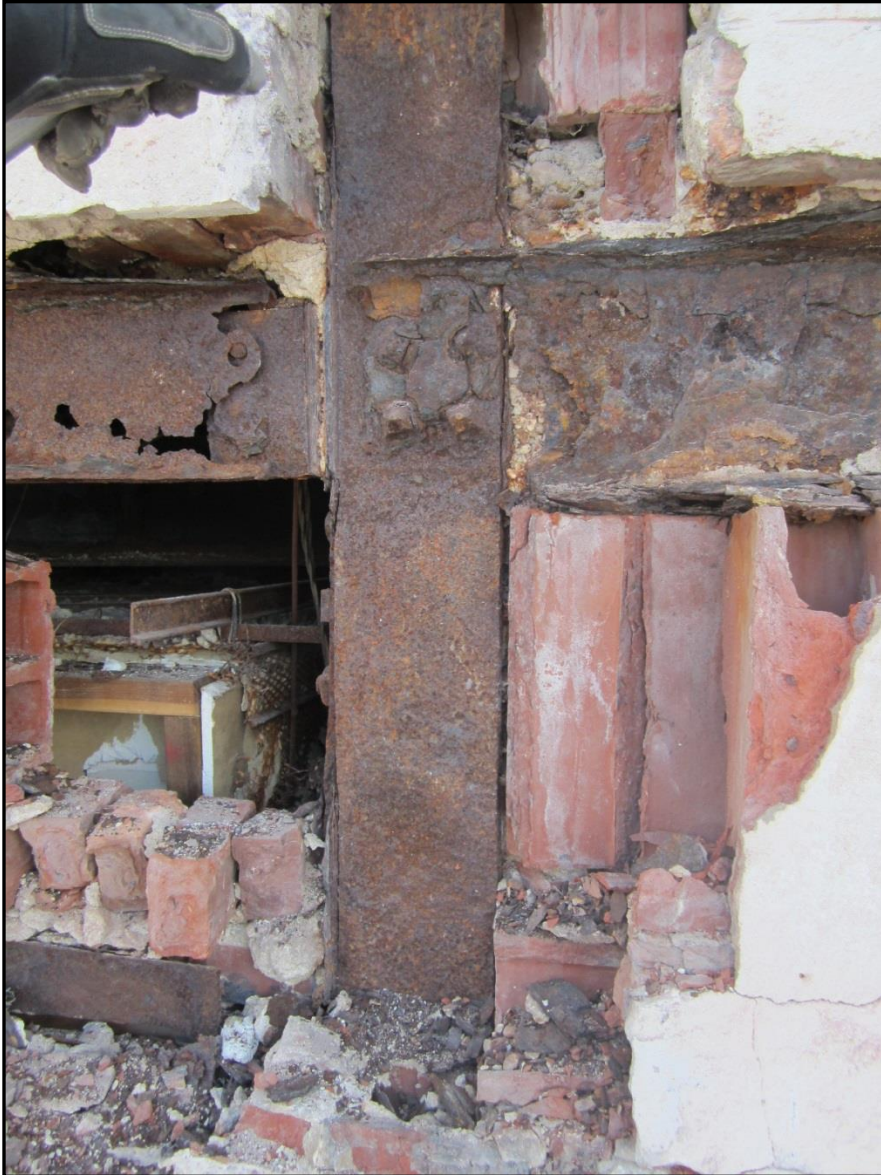
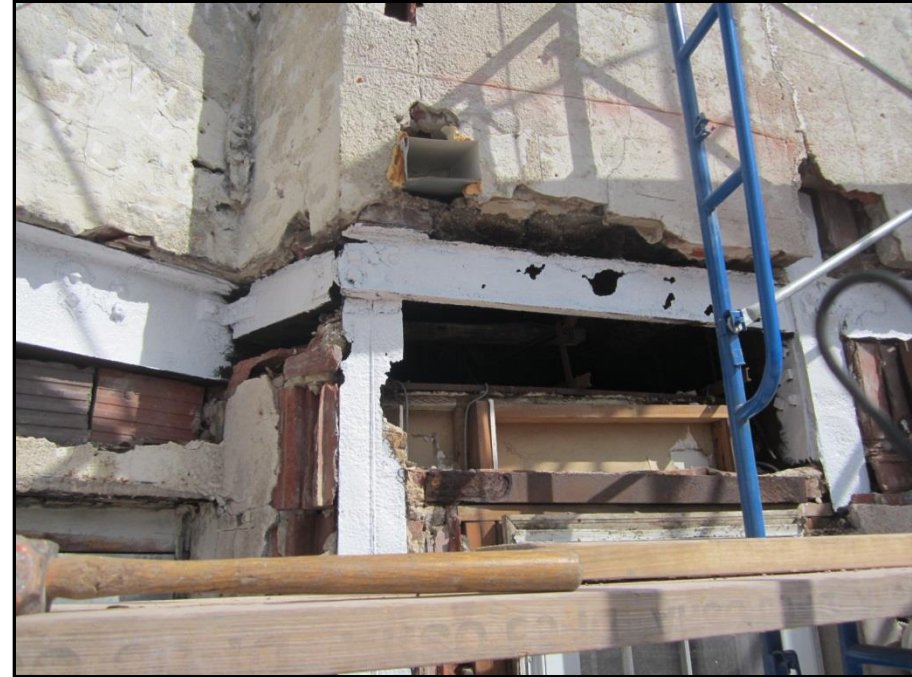
Penthouse Wall Framing Damage

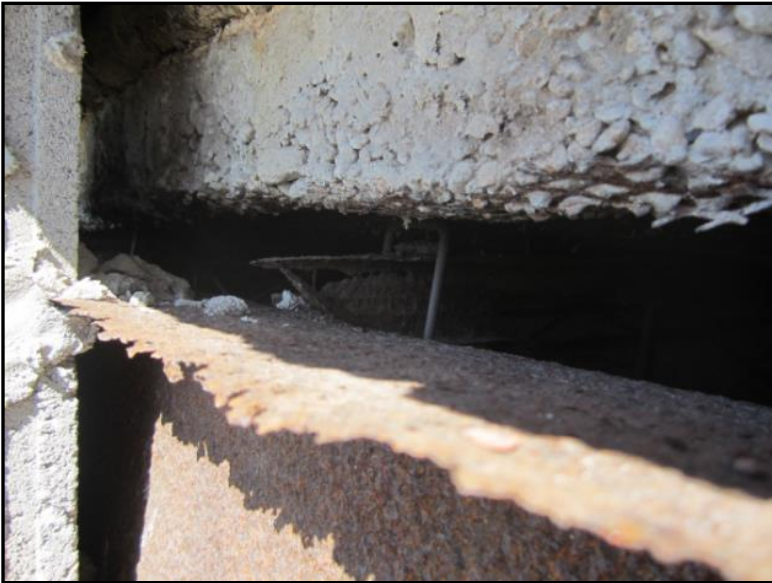
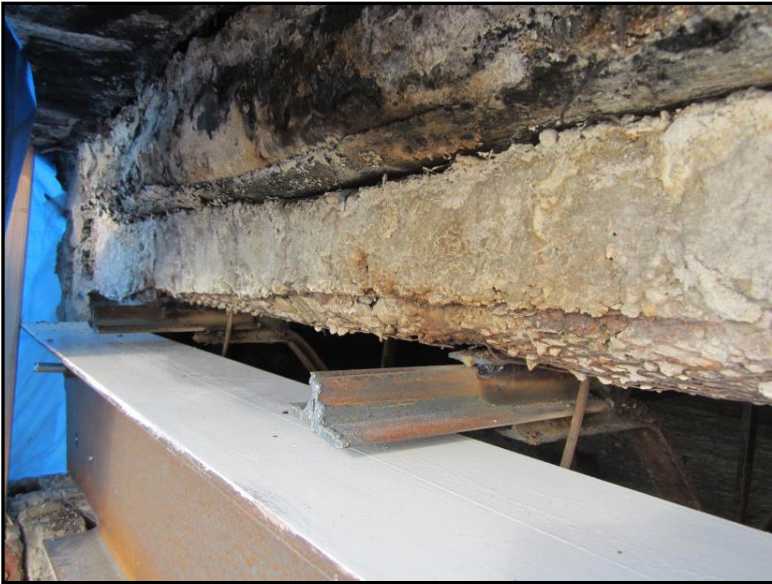
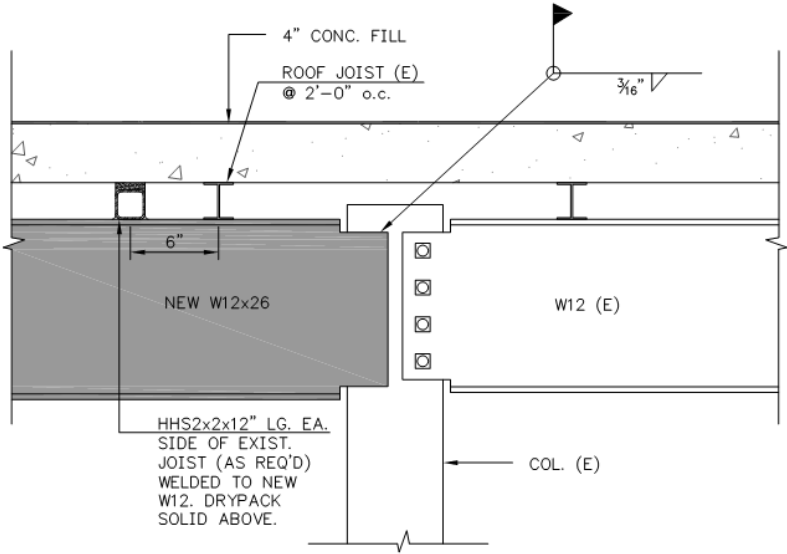
Terrace Spandrel Beam/Floor Joist Damage
