October 18, 2023
ICRI 2023 Fall Convention

Lower St. Anthony Falls Dam Sill Joint Repair

Jake Fall, P.E.
Senior Materials Engineer

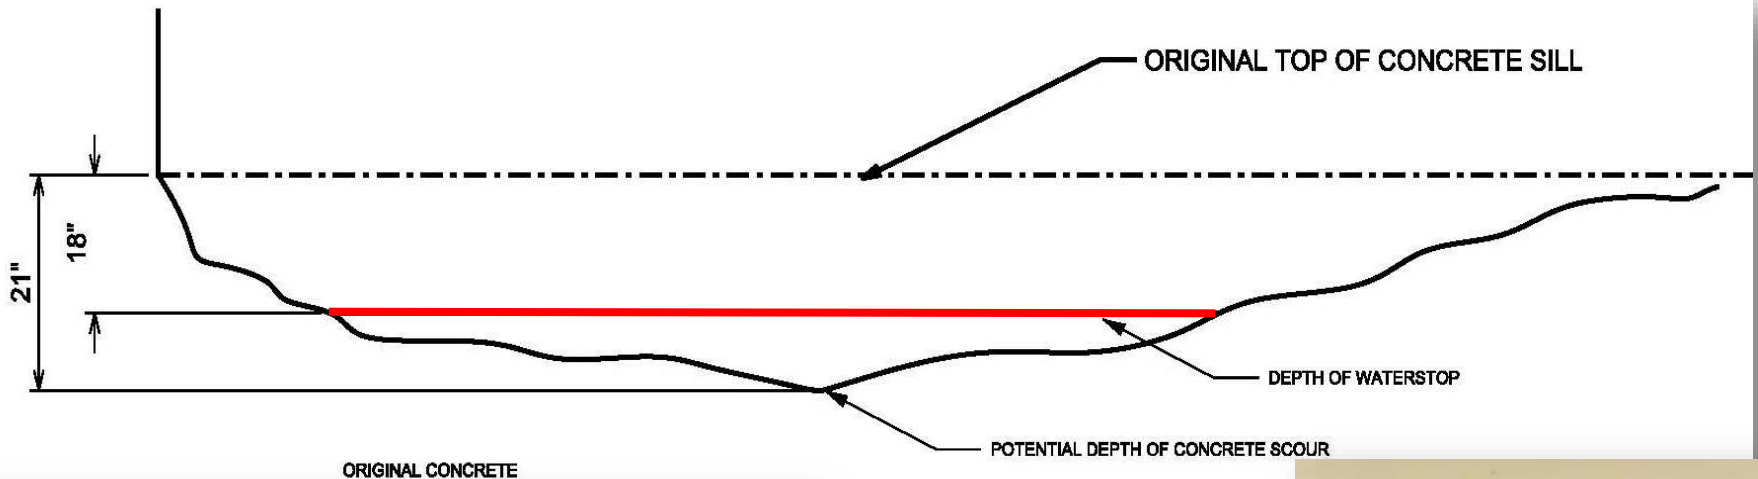
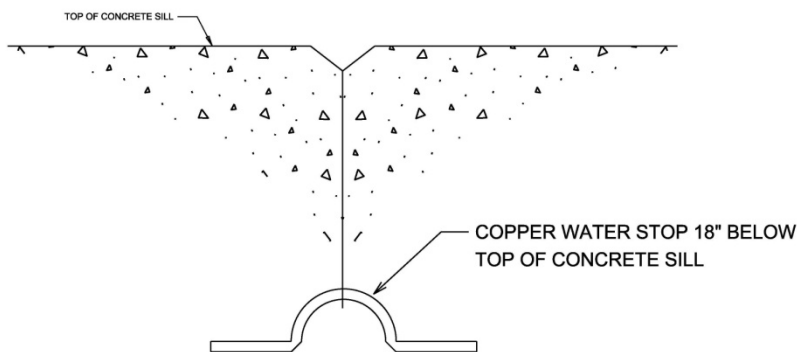
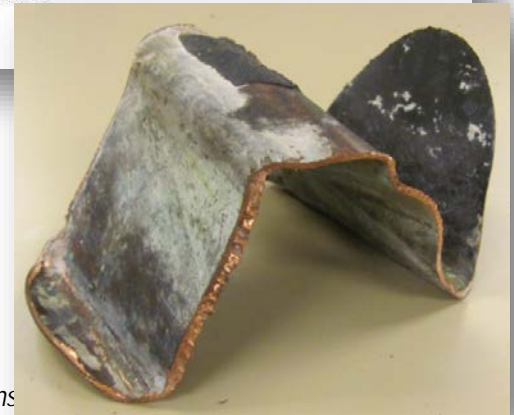
- Compromised / Failed Water-stops.
- Gate bay 3 has experienced 18 – 21 inches of concrete scour in the monolith joint.
- The depth of the water stop is 18 inches below the concrete sill.

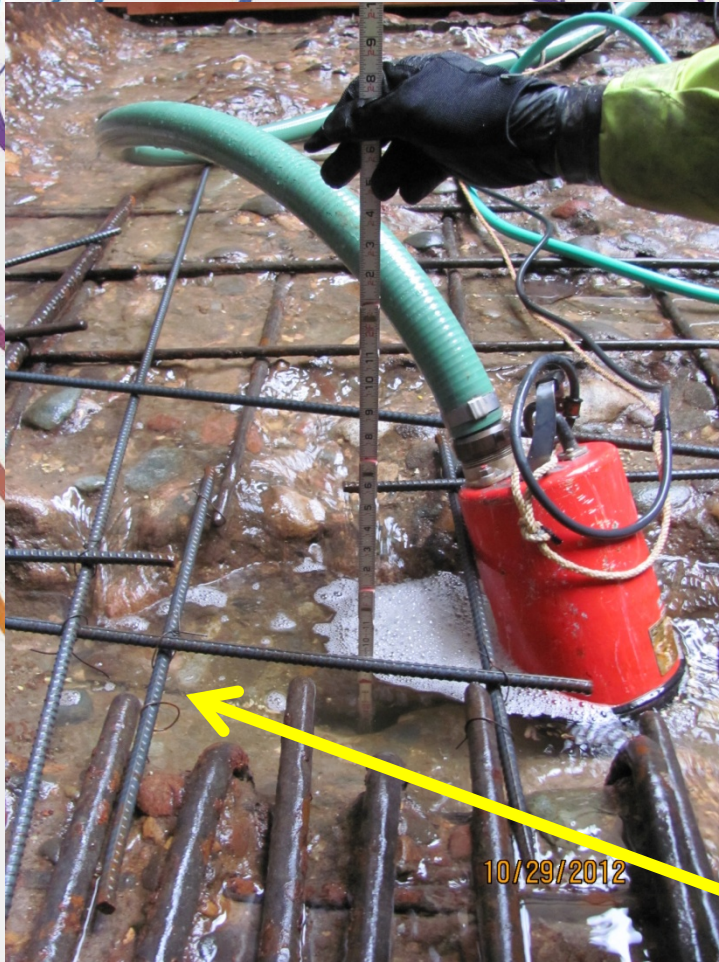
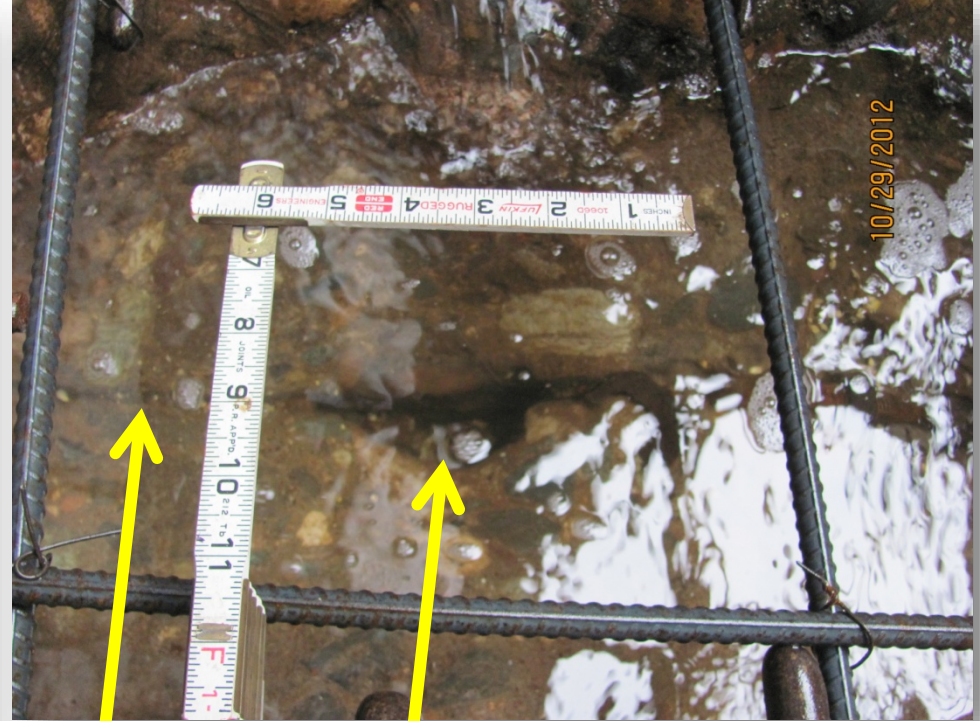
Gate Bay 3, Western Monolith Joint

2" diameter hole

Monolith Joint
